# 5629 Lickton Pike Culvert Replacement

## Existing Conditions

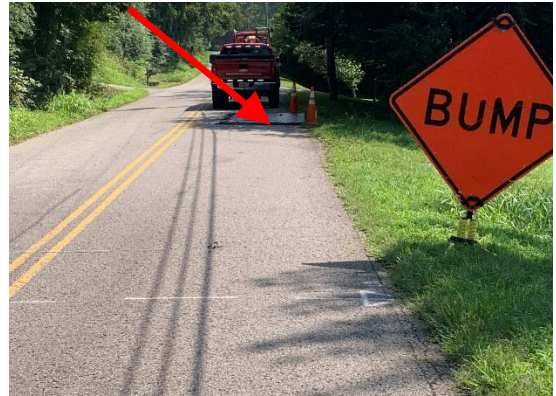
**Roadway Failure w/ Steel Road Plate**

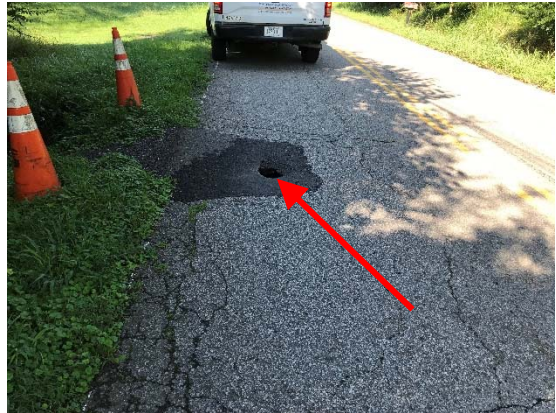
**Roadway Failure**

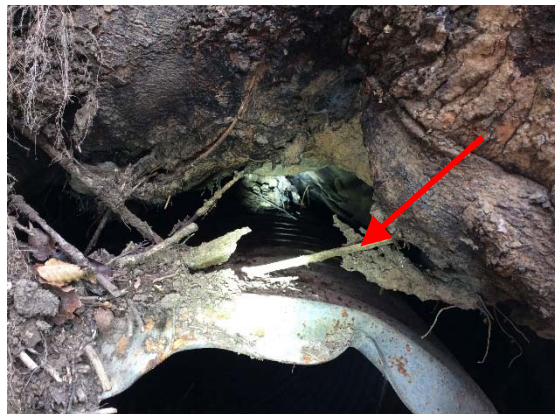
**Pipe Collapse**
