812 Belton Drive Culvert Replacement

Existing Conditions

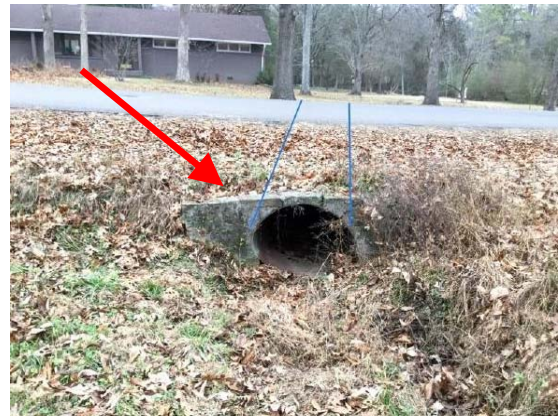
Inlet Headwall

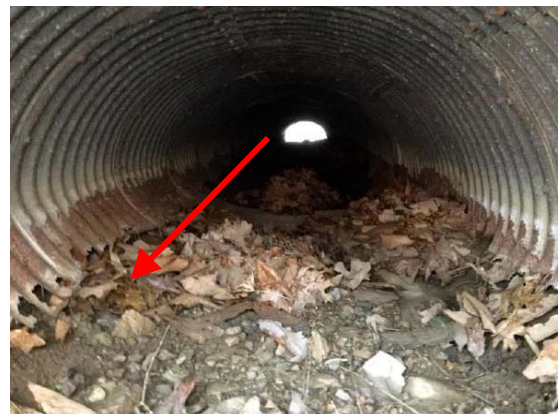
The culvert outlet is located approximately 46' east of 812 Belton Drive. The existing culvert consists of a 46' long 40"x30" CMP with stone headwalls. The pavement has moderate scaling with random locations of transverse and longitudinal cracks. There is erosion behind the inlet headwall measuring approximately 2' wide x 3.5' long x 2' deep. The CMP has areas of 100% section loss throughout the pipe invert. There is also sediment buildup at the culvert outlet.

100% Section Loss

The proposed culvert construction will include two 30"x19" reinforced concrete pipes, reinforced concrete headwalls, roadway reconstruction, and site restoration to ensure proper functionality.

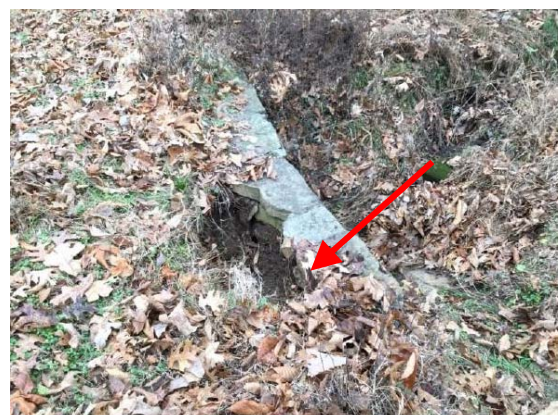
Embankment Erosion
