1108 Frances Ave Culvert Replacement

Existing Conditions

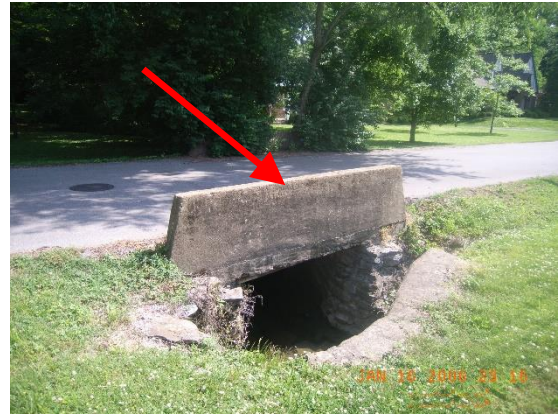
The culvert structure consists of a 22' long 72"x44" Timber Framed Slab Bridge. The timber framing has rotten members, there is an area of embankment destabilization at the inlet, and there are areas of scour that are destabilizing the abutment walls. Additionally, there is asphalt cracking over the structure.

Culvert Inlet

The proposed culvert replacement shall include the installation of a 34' long 12'x4' Slab Bridge with reinforced concrete wingwalls. Additionally, the project will require the relocation of a water main, gas main, and sanitary sewer main.

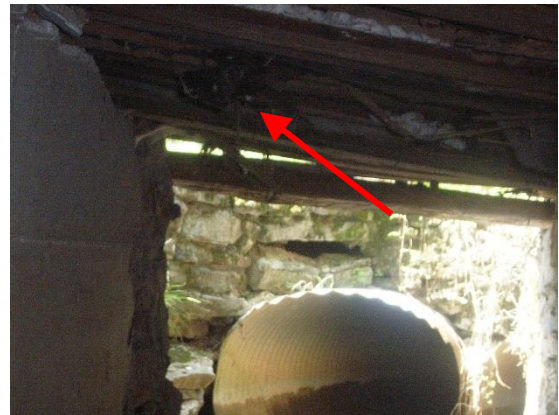
Rotten Timber Frame Superstructure

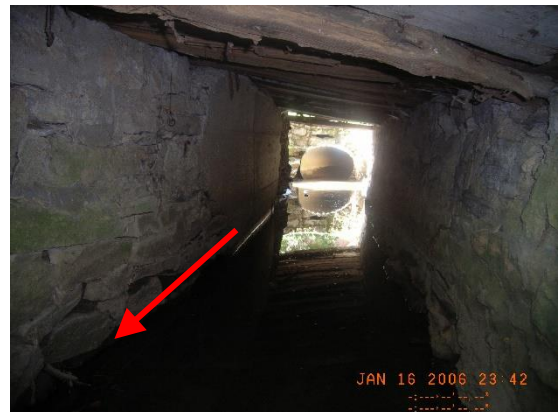
Scour w/ Associated Abutment Wall Destabilization
