4345 Grays Point Road Culvert Replacement

Existing Conditions

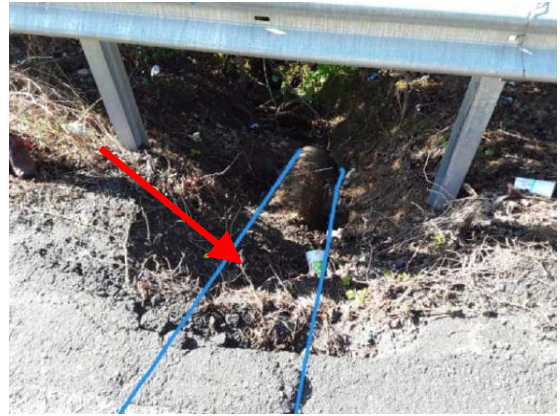
The culvert is located approximately 310' east of the featured address, 4345 Grays Point Road. The culvert consists of a single 18" CMP. The CMP shows minor to moderate corrosion at the inlet with an area of partial pipe collapse. There is a 6' long section of pipe at the outlet with 100% section loss. The section loss is more than likely responsible for the shoulder failure. The pavement over the culvert has areas of large transverse and longitudinal cracks, as well as potholes located in the center of the roadway.

Embankment Failure

The proposed culvert construction will include an 18" reinforced concrete pipe, reinforced concrete headwalls, roadway reconstruction, and site restoration to ensure proper functionality.

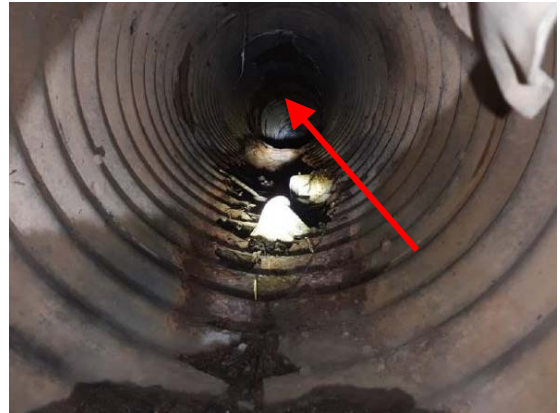
Partial Pipe Collapse

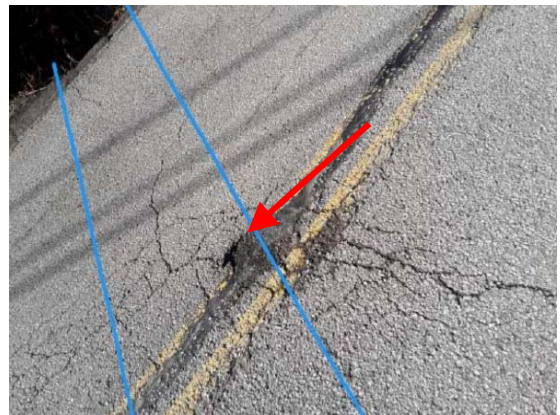
Pavement Settlement & Cracks
