METROPOLITAN GOVERNMENT OF NASHVILLE AND DAVIDSON COUNTY

STAFF RECOMMENDATION
105 Lindsley Park Drive
February 20, 2013

Application: Demolition-contributing building and New construction-infill
District: Lockeland Springs-East End Neighborhood Conservation Zoning Overlay
Council District: 06
Map and Parcel Number: 08309046400
Applicant: Jim Richie, Owner; Zach Provonchee, Architect
Project Lead: Sean Alexander, sean.alexander@nashville.gov

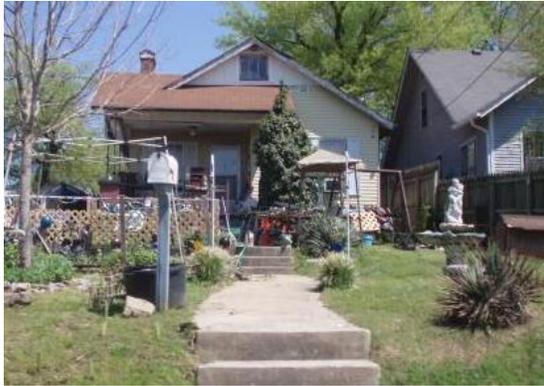
2013

The house has typical Craftsman-style features including three-over-one windows, bracketed eaves, and exposed rafter tails. The foundation is continuous brick with cedar piers, the siding currently is vinyl, and the roof is asphalt shingle. Based on the architectural style, historic context, materials, the development of the street and city directories, the building was constructed circa 1930. It has not undergone any major alterations that have changed its original form and character. The footprint is approximately 842 square feet.

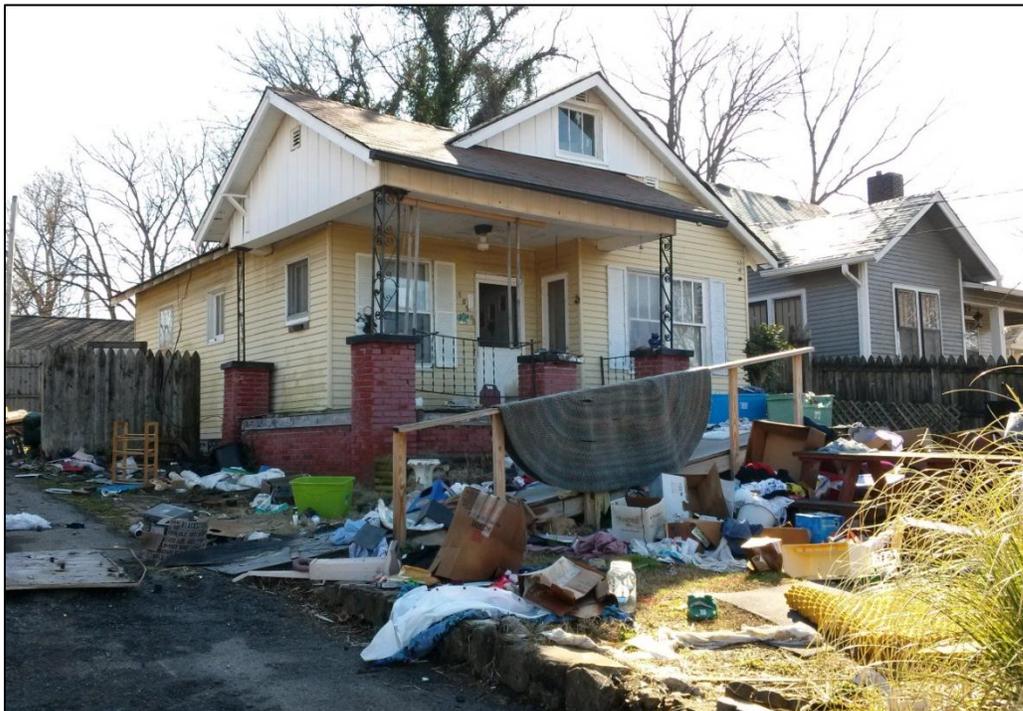
105 Lindsley Park Drive, current photo.
