**METROPOLITAN GOVERNMENT OF NASHVILLE AND DAVIDSON COUNTY**

**STAFF RECOMMENDATION**  
**3720 Central Avenue**  
**June 18, 2014**

**Application:** New construction—addition  
**District:** Richland-West End Neighborhood Conservation Zoning Overlay  
**Council District:** 24  
**Map and Parcel Number:** 10409002100  
**Applicant:** George Clements  
**Project Lead:** Melissa Baldock, [melissa.baldock@nashville.gov](mailto:melissa.baldock@nashville.gov)

<p><b>Description of Project:</b> Applicant proposes to alter the house’s porch roof slope and to add a pedimented vent to the porch roof to address water drainage issues.</p> <p><b>Recommendation Summary:</b> With the condition that staff approve the roof material and color, Staff recommends approval of the demolition of the deteriorated porch roof and the increase in the slope of the porch roof, finding that they meet Sections II.B.e and III.B.2. of the <i>Richland-West End Neighborhood Conservation Zoning Overlay: Handbook and Design Guidelines</i>.</p> <p>Staff recommends disapproval of addition of the pedimented vent, finding that it does not meet Sections II.B.2.a. of the <i>Richland-West End Neighborhood Conservation Zonin

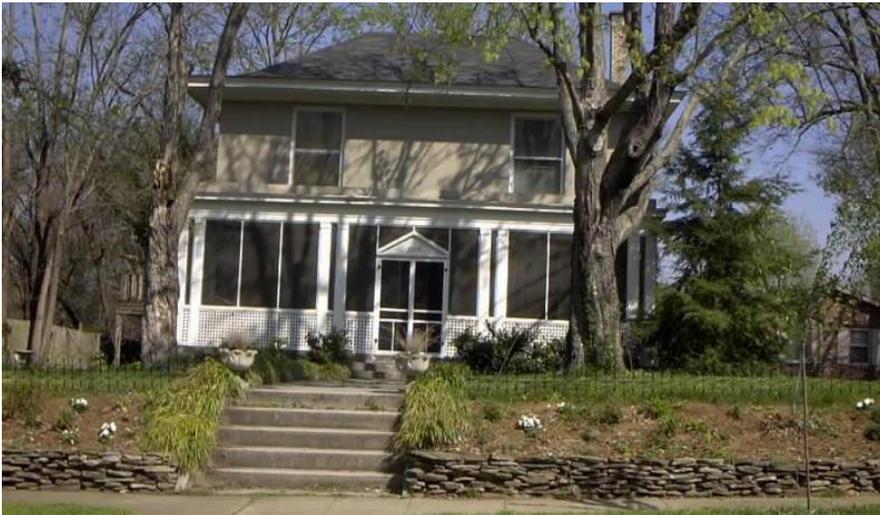
Figure 1. 3720 Central Avenue

**Background:** 3720 Central Avenue is a c. 1920 four square structure that contributes to the Richland-West End Neighborhood Conservation Zoning Overlay (Figure 1). MHZC staff recently issued administrative permits to demolish a non-historic side deck and to construct a carport on the site. The front porch was enclosed sometime after 1980, as a photograph from 1980 shows the porch as open (Figure 2).

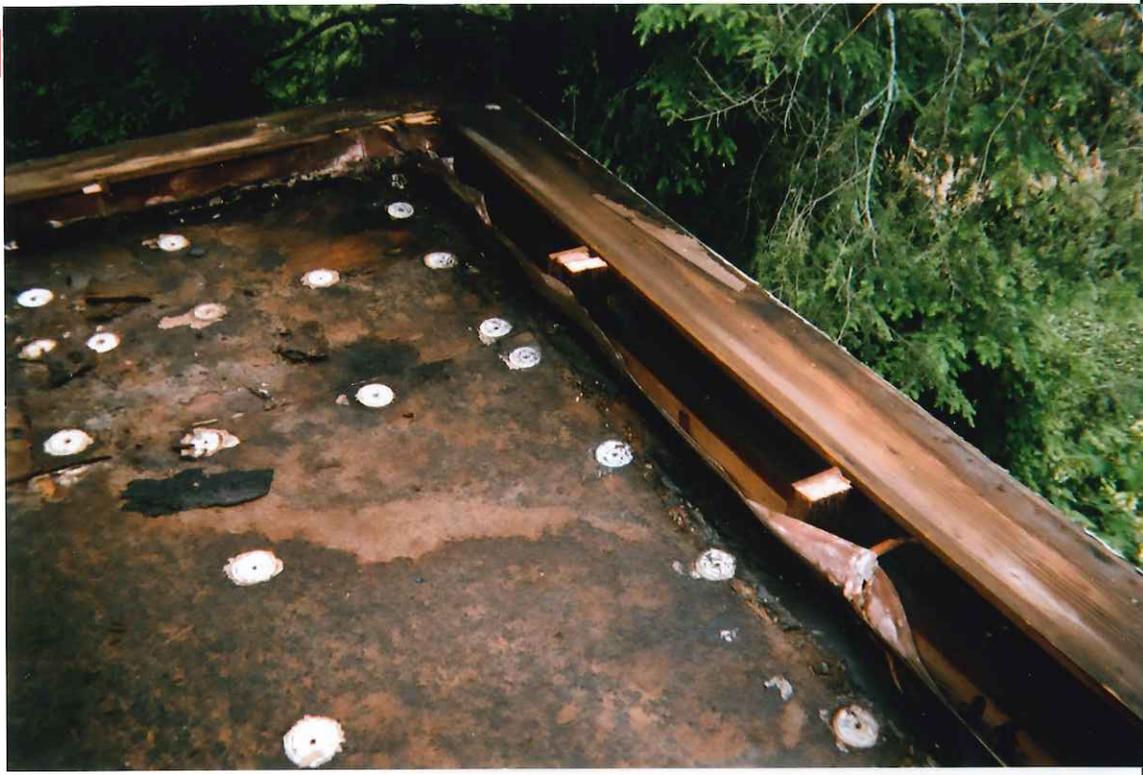
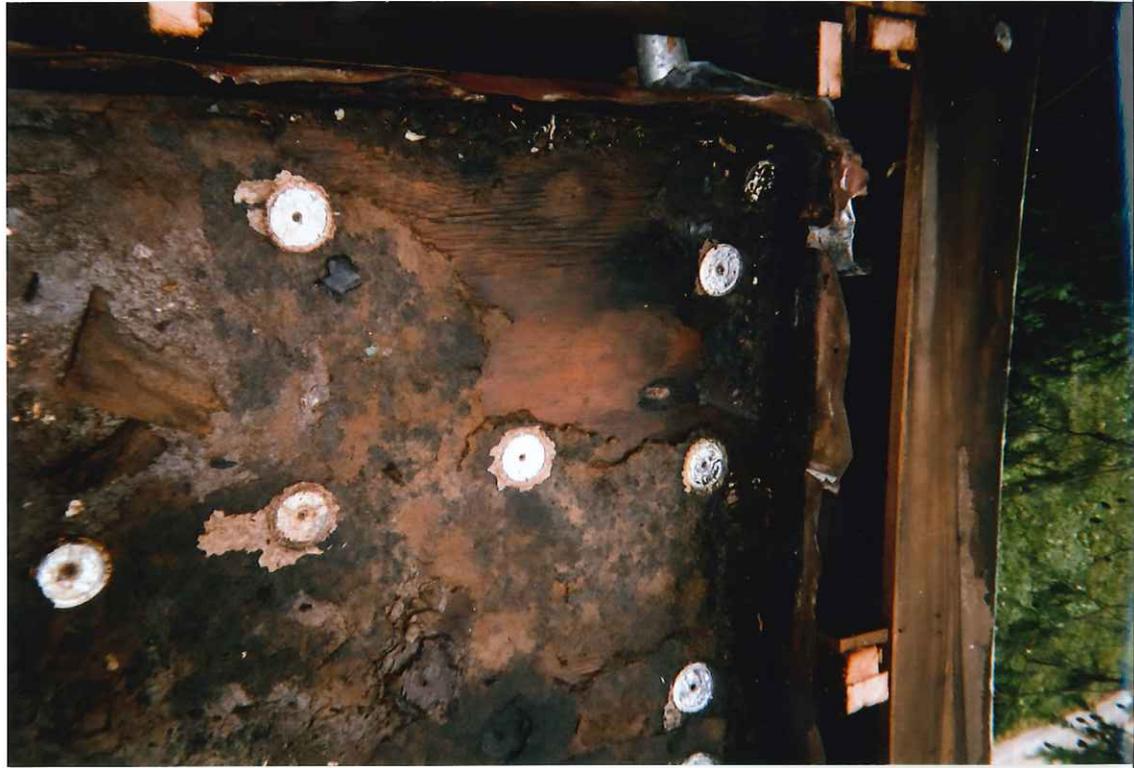
Porch roof

Demolition: The applicant has submitted photographic evidence showing that the existing low-slope porch roof has not allowed for adequate water drainage and has resulted in substantial damage to the roof of the structure (see photographs in Attachment A). The applicant is proposing to remove the damaged roof and reconstruct it to better allow for water drainage and evaporation. Although the porch roof is a significant feature of the historic house, staff finds that the removal of the existing damaged porch roof in order to reconstruct it to allow for better water drainage is appropriate in this instance because of the extent of the damage. Staff therefore finds that the project meets Section III.B.2 for appropriate demolition and does not meet section III.B.1 for inappropriate demolition.

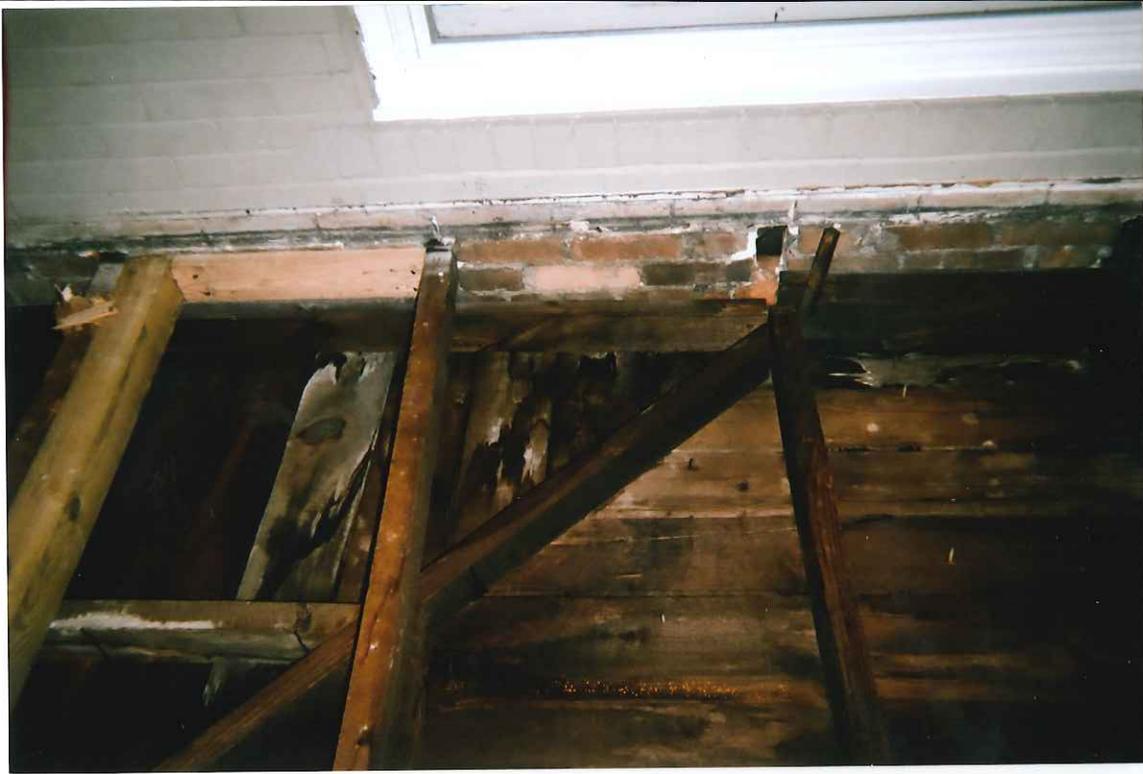
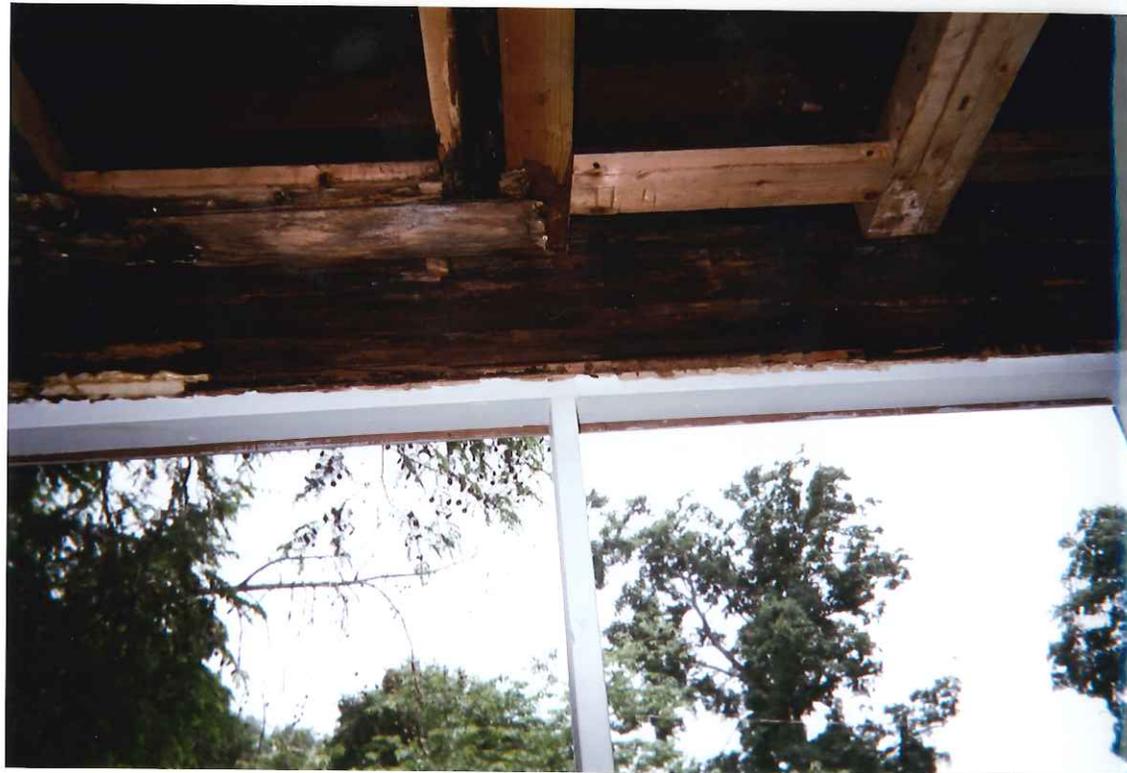
Top Photo - porch roof from above

Bottom photo - porch roof from inside the porch

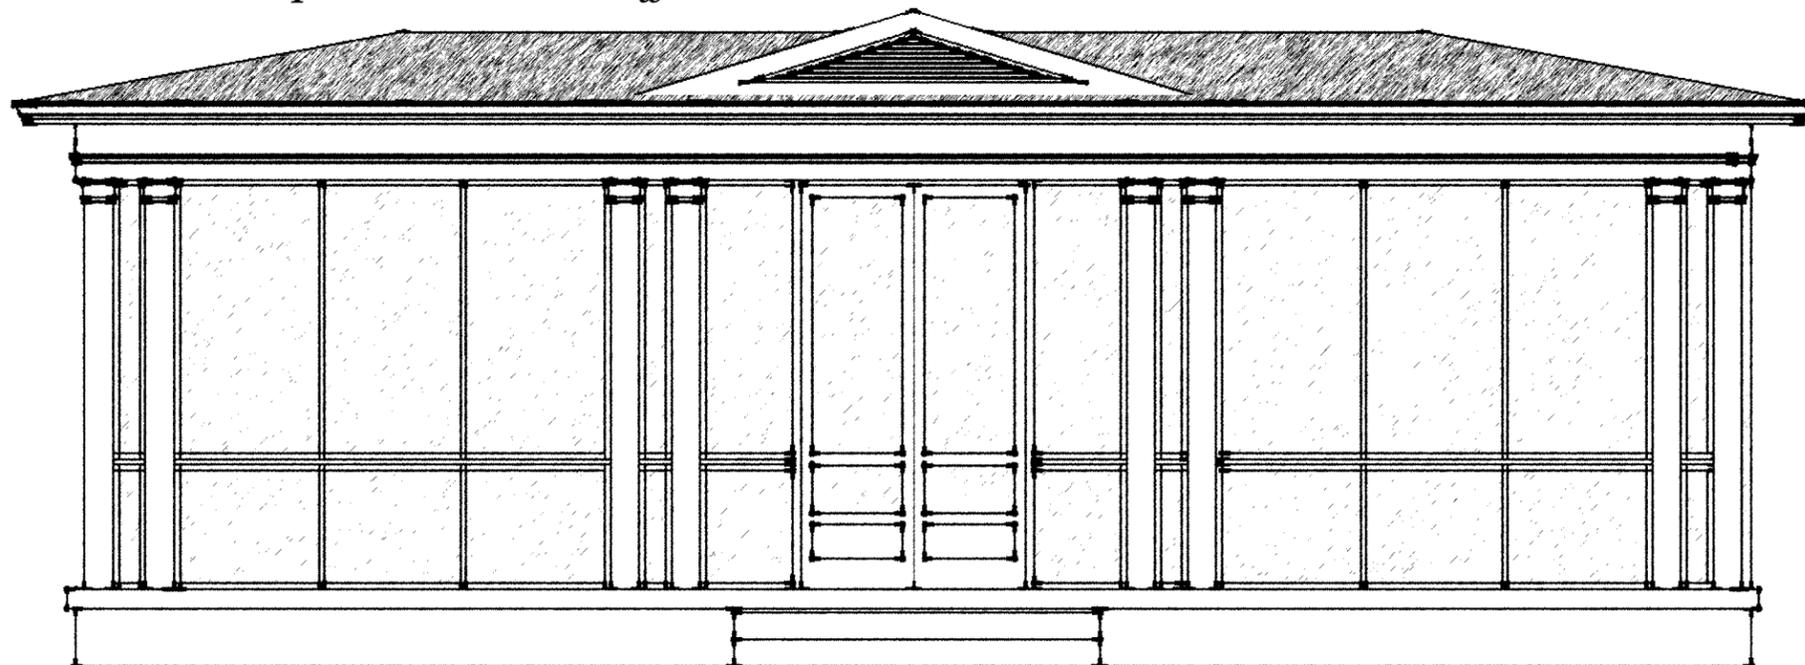
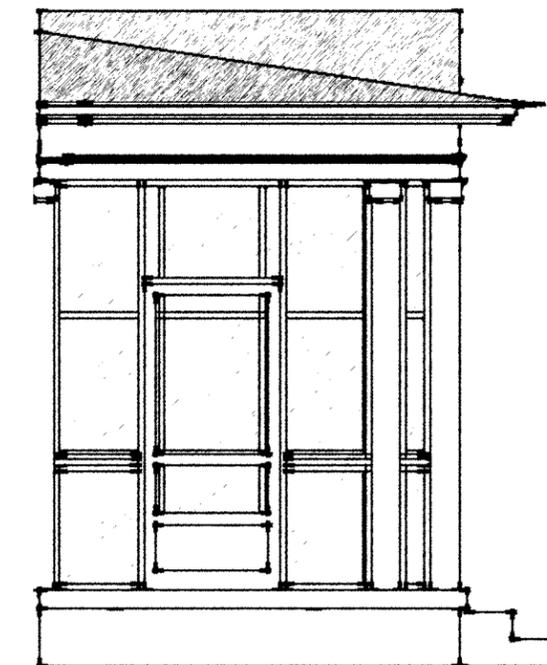
**Proposed Porch:**  
*2' louvered pediment and 16" soffit*

The applicant is also proposing to add to the front of the porch roof a pedimented vent to help with water evaporation. There is no evidence that this porch roof ever had a pedimented vent at the front, and the element would alter the historic look of the front porch, which is a significant architectural feature. The Secretary of the Interior's Standards for Treatment of Historic Properties, upon which the design guidelines are based, state that "alteration of features and spaces that characterize a property shall be avoided." In addition, they state that "Changes that create a false sense of historical development, such as adding conjectural features or architectural elements from other buildings, shall not be undertaken." This direction is evident in design guidelines section II.B.a and b for additions which states that generally additions should be where they are minimally visible. In this case, the porch is highly visible. In addition it states that contemporary designs are only appropriate when such additions do not destroy significant historical characteristics of the property. In this case, the proposal requires a redesign of the original porch configuration.

Because the pedimented vent it is not a common feature for porch roofs in the Richland-West End neighborhood, staff finds that it does not meet section II.B.1.e. of the design guidelines. Lastly, the Secretary of Interior's Standards state that "Replacement of missing features shall be substantiated by documentary, physical, or pictorial evidence." Since there is no evidence that the pedimented vent ever existed, staff finds that the feature does not meet the Secretary of the Interior's guidelines.

Staff notes that the ventilation of the porch roof could be accomplished with a combination of soffit vents and a roof to wall vent, which would not significantly impact the historic character of the porch or house.

Staff recommends disapproval of addition of the pedimented vent, finding that it does not meet Sections II.B.1.e and II.B.2.a. of the *Richland-West End Neighborhood Conservation Zoning Overlay: Handbook and Design Guidelines*.
