METROPOLITAN GOVERNMENT OF NASHVILLE AND DAVIDSON COUNTY

STAFF RECOMMENDATION
312 Broadway
October 15, 2014

Application: Rehabilitation – storefront and windows; New construction – addition
District: Broadway Historic Preservation Zoning Overlay
Council District: 19
Map and Parcel Number: 09306400500
Applicant: Bill Johnson, Architect
Project Lead: Sean Alexander, sean.alexander@nashville.gov

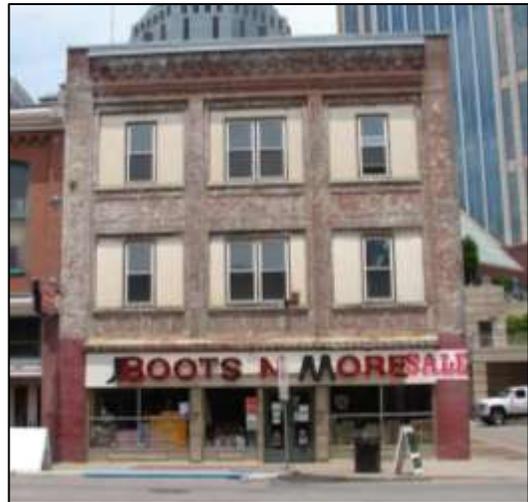
Figure 1: 312 Broadway

Background: 312 Broadway is a three-story brick commercial building with a storefront on the first story and a row of corbelled brick brackets at the cornice. The building is shown on the 1888 Sanborn Map.

The historic storefront appears to be largely intact, but the original bulkheads, columns and other components have been covered with wood panels to give the building a faux “western” look. Additionally, the second and third story windows have been replaced, but the original window openings are still apparent.

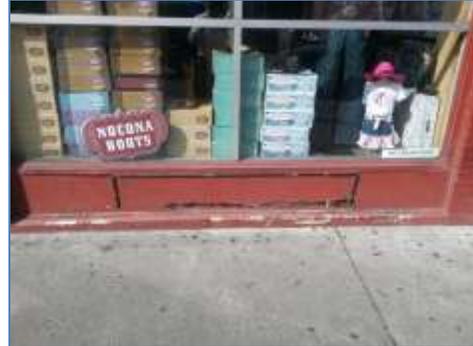
Figure 2: Example of existing bulkheads

The existing display windows and bulkheads are not original and are in poor condition. Replacing these components in-kind to match the original features and materials would meet guidelines II.C and II.E. Staff recommends as a condition of approval that selective demolition of the bulkhead be done to determine if the original bulkhead is intact, and that the reconstructed bulkheads match them as closely as possible.

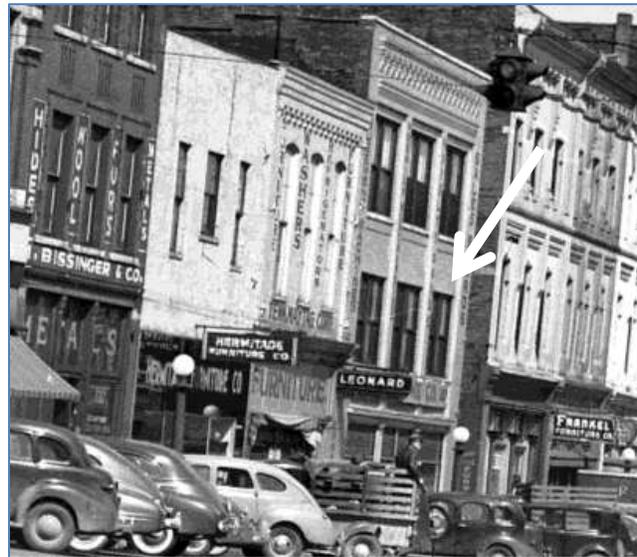
Figure 3: 312 Broadway in 1935 with paired double hung windows.

Historically, the windows in the upperstory of 312 Broadway were double-hung sash windows, with a pair of windows in each bay. The original windows have been replaced and the window openings partially filled-in, but the original openings are still apparent.

The applicant proposes to replace the upperstory windows and re-open the original openings. The new windows would be out-swinging casements with a false check rail, with four windows in each bay. The existing windows are not original and replacement may be appropriate, however Staff finds that the proposed windows are not compatible with the building's style and period, as they do not match the appearance of the original windows. Replacing the existing windows with ones that match the appearance of the historic double-hung sash windows would meet guideline II.H.3
