METROPOLITAN GOVERNMENT OF NASHVILLE AND DAVIDSON COUNTY

STAFF RECOMMENDATION 128 Second Avenue North August 19, 2015

Application: Violation
District: Second Avenue Historic Preservation Zoning Overlay
Council District: 19
Map and Parcel Number: 09306207900
Applicant: Nancy Jones, Possum Legend, LLC
Project Lead: robin.zeigler@nashville.gov

Description of Project: This application is for alterations made that do not match the permit and/or design guidelines. The applicant would like to request approval of the alterations.

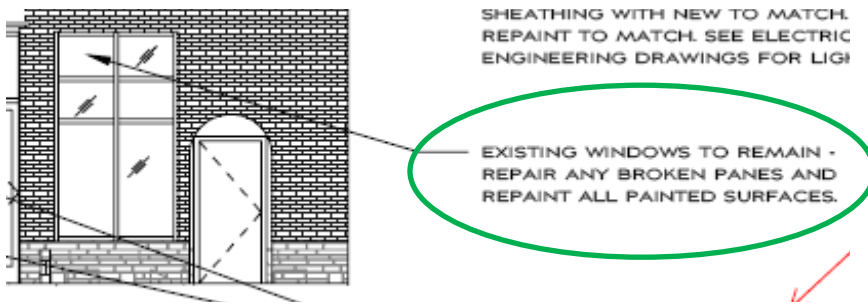
Figure 1: Excerpt of plans from preservation permit

Storefront windows: The drawings submitted in December 2014 for alterations notes that there were no plans to alter the existing storefront windows.

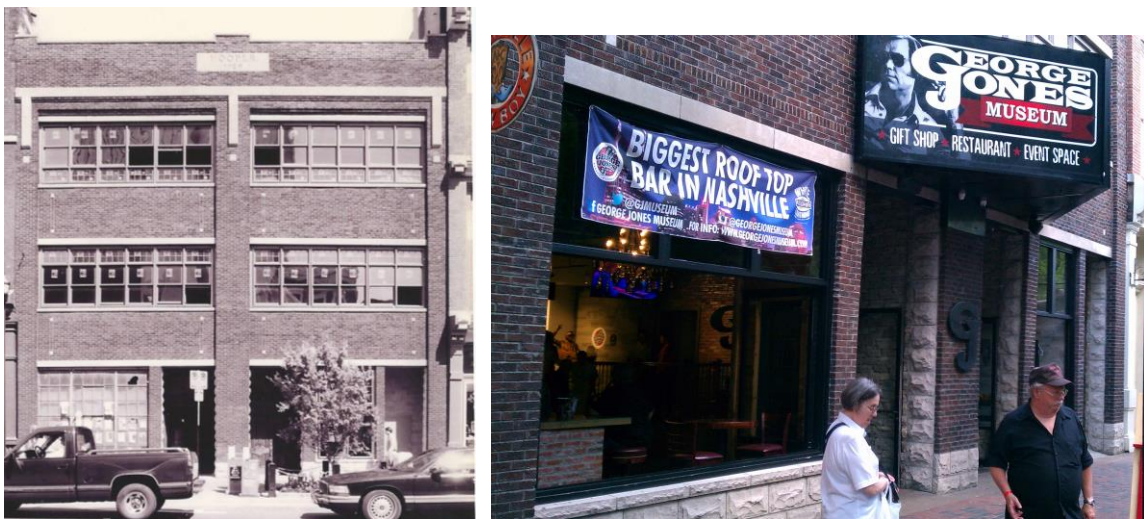
The new storefront incorporates NANA walls with transoms above, which have been approved in the past. (See figure 3.)

Figures 2 and 3: The left image shows an earlier storefront configuration. The right image shows the recent alteration.

The original storefront did not exist; therefore replacement is appropriate. The design guidelines state that replacement windows should mimic the original or be “compatible with the general appearance of the original. In this case, the windows are similar to a configuration approved through MDHA in 1996, with the advice of the MHC. Since a true replication of the original windows would not be conducive to the openness of first-level retail establishments, because the alteration is similar to one approved in 1996, and because the alteration is similar to historic storefronts found in the district, Staff finds the alteration to meet section II.A.3.

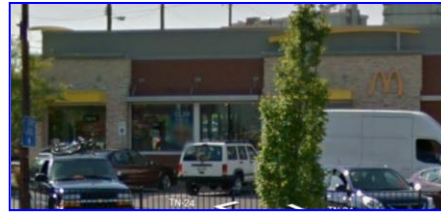
the original no longer exists. Section II.A for general principles of street level facades states that the use of contemporary materials are only appropriate if they possess characteristics similar in scale, design finish, texture, durability, and detailing to historic materials. The narrow dry-stack stone and textured wall used in the entrances does not replicate historic stone. In addition, the stone design is one typically seen on much later buildings than those found in this district.

Figures 4: A similar product is found on McDonalds on Broadway. It is also frequently used on suburban residential buildings.

Because the stone does not meet the design guidelines, Staff recommends it be disapproved and replaced with another material that is approved administratively. Brick to match the existing brick, wood or smooth-faced cement fiber panels would be appropriate substitutes.

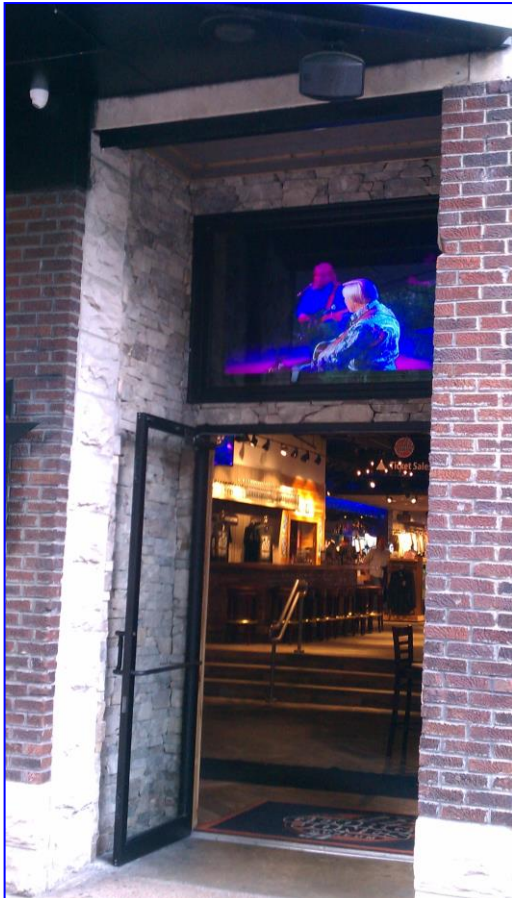
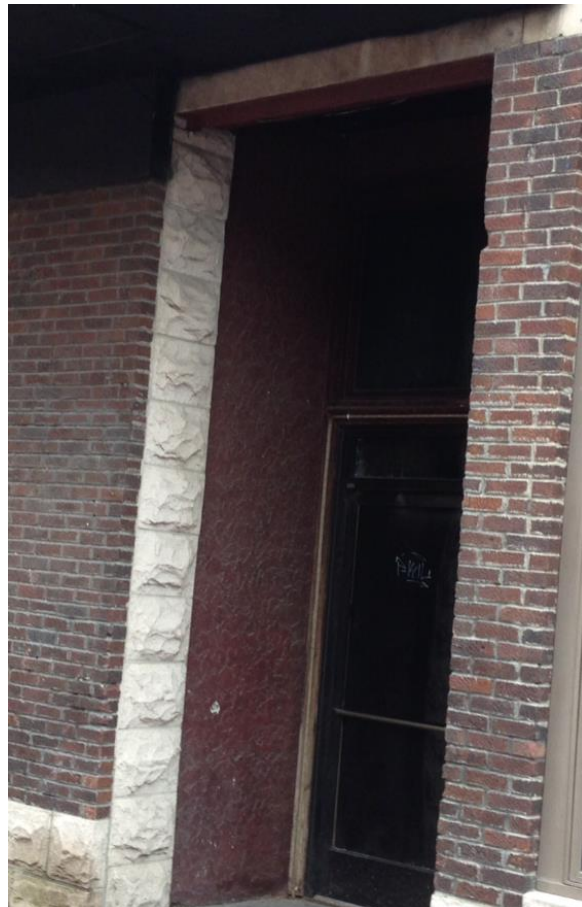
Street Level Facades: The recessed entrances were replaced with a narrow dry-stack stone veneer and a textured material. Replacing the previous material is appropriate since

Figures 5 and 6: The left images shows the recessed walls of the primary entrance that has a veneer that was not approved and does not meet the design guidelines. The right image shows the secondary entrance on the Second Avenue side and the textured walls that were added.

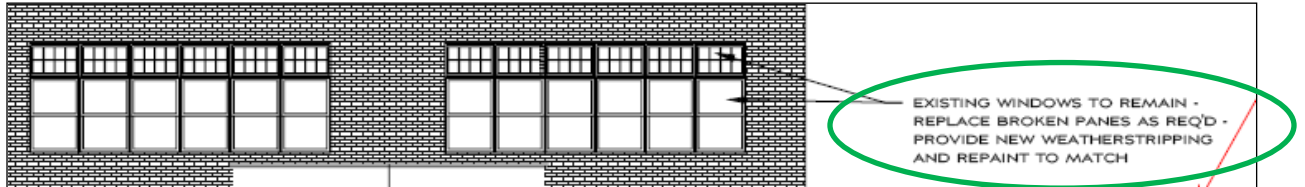
Figure 7: Excerpt of plans from preservation permit

Windows: The First Avenue façade had a roll-up door on the second floor (1st level from Second Avenue). Roll-up doors are not appropriate on principle facades in the historic district; however, since the building already had existing doors, the applicant was advised they could keep them, as shown on the plans they submitted in December.

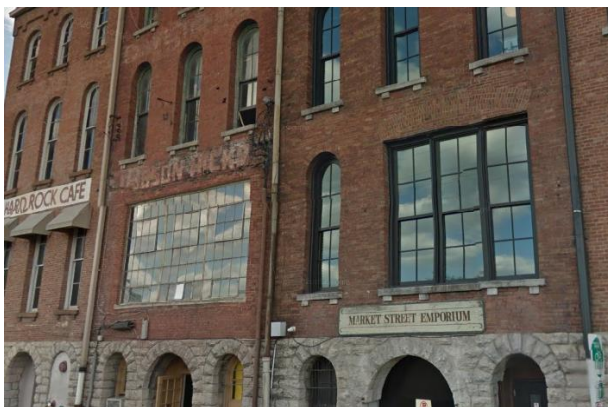
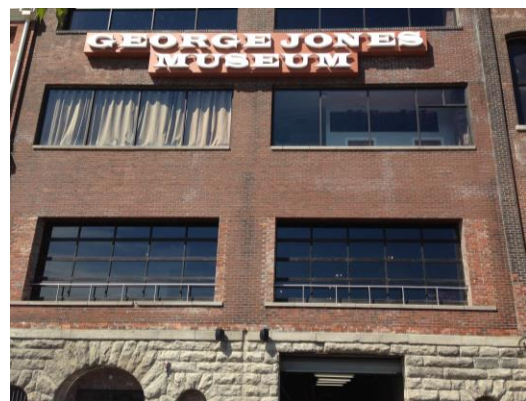
The applicant has replaced them with new roll-up doors that have changed the dimensions of the previous opening. Roll-up doors do not meet section III. H as they do not replicate the original windows nor are they similar to windows found on this style and period of building. Because the alteration does not meet section III.H of the design guidelines. Staff recommends disapproval of this alteration and that the roll-up doors be replaced with windows that meet the design guidelines. One option is to reestablish the punched, arched, window openings that were there originally. A second option would be to reestablish the previous opening, as it lined up with the windows above, and replace the roll up doors with windows that meet the design of industrial windows seen on multiple buildings on the First Avenue side and seen originally on the historic Second Avenue façade of this building. This is the same treatment that was recommended in 1996 when a previous owner proposed to change the windows.

Figures 8 and 9: On the left is an example of historic industrial window that was a common alteration for First Avenue facades. The right shows the current alteration. The change in brick color shows how the opening was altered.

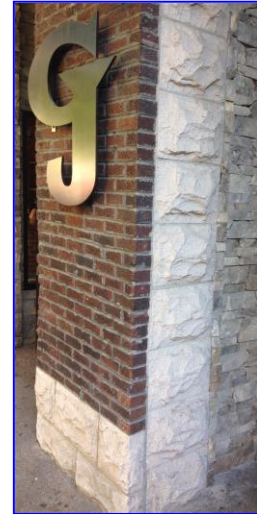
Signage: A small wall sign (48 sq ft) and banner sign (dimension unknown) were added to the front façade. (See figures 3 and 10). The Second Avenue side of the building is allotted ninety-nine and one-half square feet (99.5 sq ft) since there is a projecting sign. The existing marquee sign, originally approved under different design guidelines in 1997, includes two signs that together are approximately 120 square feet. The existing signage on the Second Avenue side exceeds the sign allotment of the current design guidelines; therefore staff recommends disapproval of the addition of the wall and banner signs.

Figures 10: Wall sign added without a permit.
