METROPOLITAN GOVERNMENT OF NASHVILLE AND DAVIDSON COUNTY

Metropolitan Historic Zoning Commission
Sunnyside in Sevier Park
3000 Granny White Pike
Nashville, Tennessee 37204
Telephone: (615) 862-7970
Fax: (615) 862-7974

STAFF RECOMMENDATION
128 Second Avenue North
August 19, 2015

Application: Violation
District: Second Avenue Historic Preservation Zoning Overlay
Council District: 19
Map and Parcel Number: 09306207900
Applicant: Nancy Jones, Possum Legend, LLC
Project Lead: robin.zeigler@nashville.gov

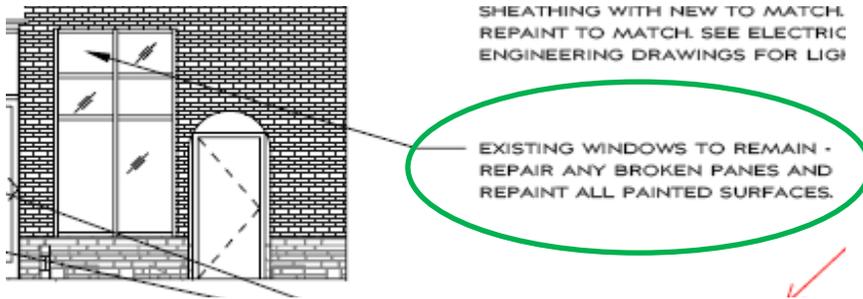
Figure 1: Excerpt of plans from preservation permit

Storefront windows: The drawings submitted in December 2014 for alterations notes that there were no plans to alter the existing storefront windows.

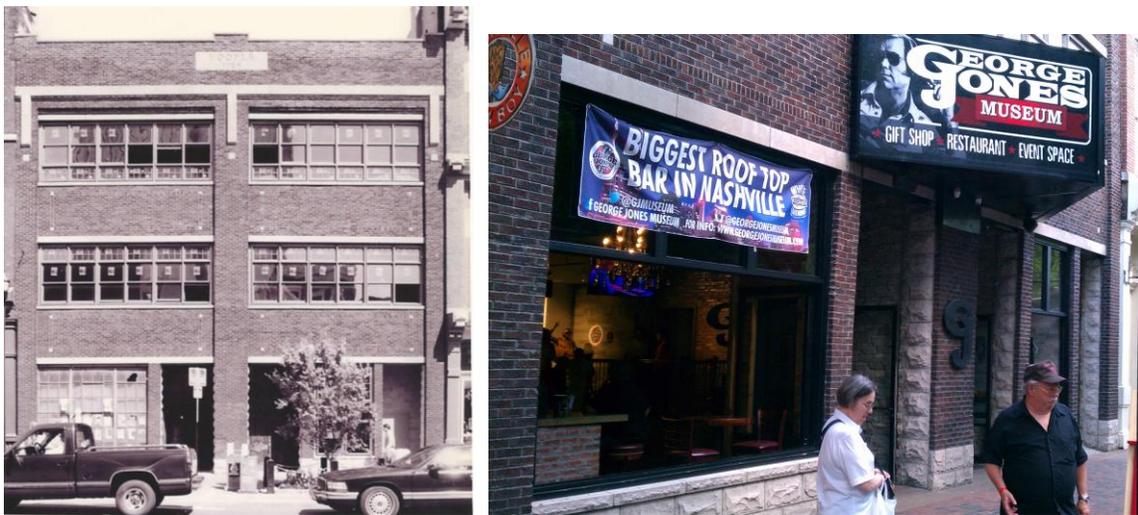
The new storefront incorporates NANA walls with transoms above, which have been approved in the past. (See figure 3.)

Figures 2 and 3: The left image shows an earlier storefront configuration. The right image shows the recent alteration.

The original storefront did not exist; therefore replacement is appropriate. The design guidelines state that replacement windows should mimic the original or be “compatible with the general appearance of the original. In this case, the windows are similar to a configuration approved through MDHA in 1996, with the advice of the MHC. Since a true replication of the original windows would not be conducive to the openness of first-level retail establishments, because the alteration is similar to one approved in 1996, and because the alteration is similar to historic storefronts found in the district, Staff finds the alteration to meet section II.A.3.

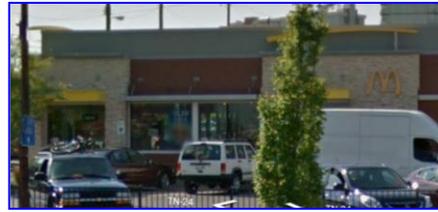
the original no longer exists. Section II.A for general principles of street level facades states that the use of contemporary materials are only appropriate if they possess characteristics similar in scale, design finish, texture, durability, and detailing to historic materials. The narrow dry-stack stone and textured wall used in the entrances does not replicate historic stone. In addition, the stone design is one typically seen on much later buildings than those found in this district.

Figures 4: A similar product is found on McDonalds on Broadway. It is also frequently used on suburban residential buildings.

Because the stone does not meet the design guidelines, Staff recommends it be disapproved and replaced with another material that is approved administratively. Brick to match the existing brick, wood or smooth-faced cement fiber panels would be appropriate substitutes.

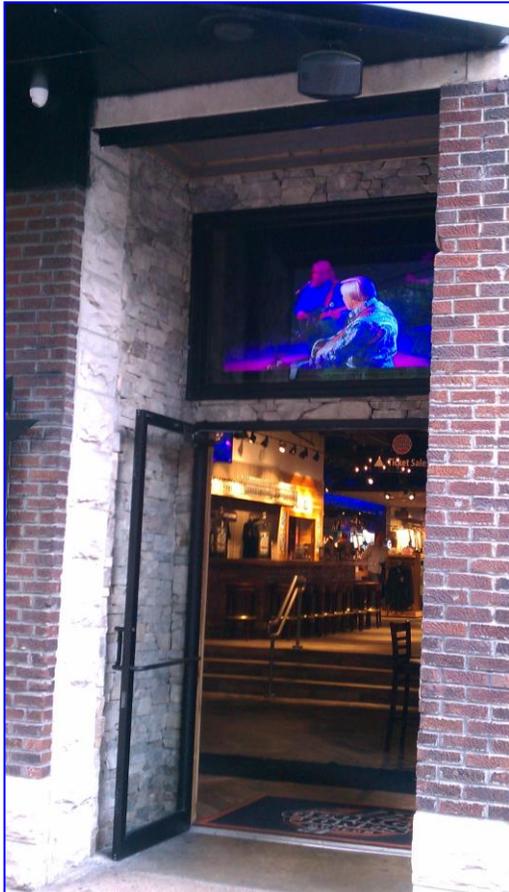
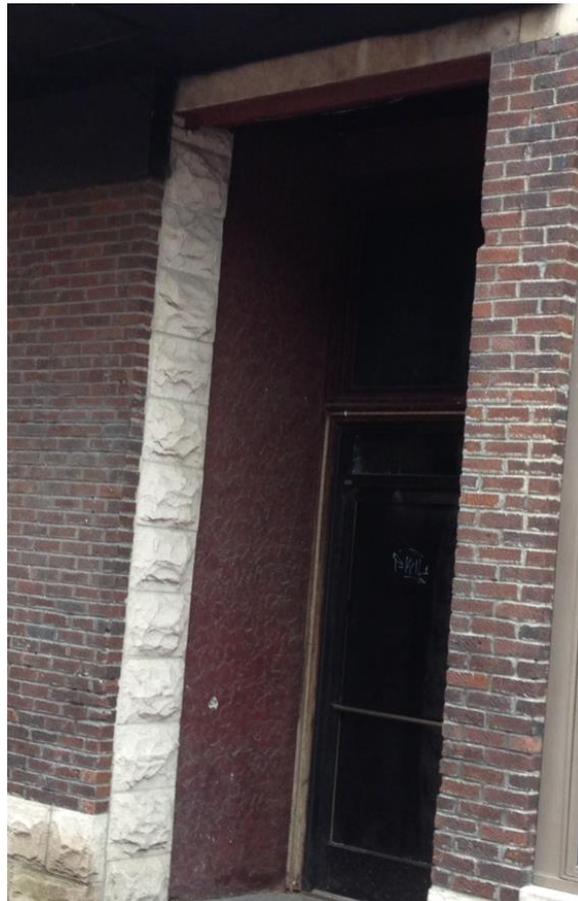
Street Level Facades: The recessed entrances were replaced with a narrow dry-stack stone veneer and a textured material. Replacing the previous material is appropriate since

Figures 5 and 6: The left images shows the recessed walls of the primary entrance that has a veneer that was not approved and does not meet the design guidelines. The right image shows the secondary entrance on the Second Avenue side and the textured walls that were added.

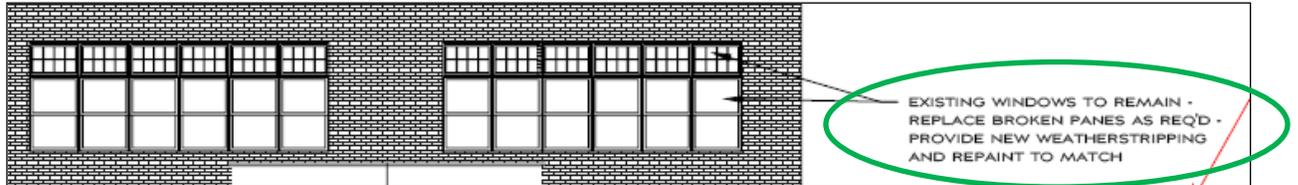
Figure 7: Excerpt of plans from preservation permit

Windows: The First Avenue façade had a roll-up door on the second floor (1st level from Second Avenue). Roll-up doors are not appropriate on principle facades in the historic district; however, since the building already had existing doors, the applicant was advised they could keep them, as shown on the plans they submitted in December.

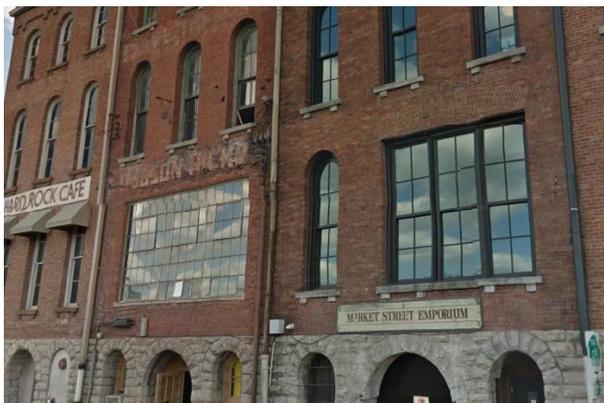
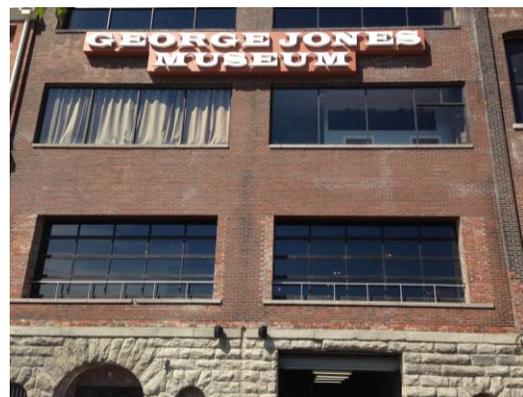
The applicant has replaced them with new roll-up doors that have changed the dimensions of the previous opening. Roll-up doors do not meet section III. H as they do not replicate the original windows nor are they similar to windows found on this style and period of building. Because the alteration does not meet section III.H of the design guidelines. Staff recommends disapproval of this alteration and that the roll-up doors be replaced with windows that meet the design guidelines. One option is to reestablish the punched, arched, window openings that were there originally. A second option would be to reestablish the previous opening, as it lined up with the windows above, and replace the roll up doors with windows that meet the design of industrial windows seen on multiple buildings on the First Avenue side and seen originally on the historic Second Avenue façade of this building. This is the same treatment that was recommended in 1996 when a previous owner proposed to change the windows.

Figures 8 and 9: On the left is an example of historic industrial window that was a common alteration for First Avenue facades. The right shows the current alteration. The change in brick color shows how the opening was altered.

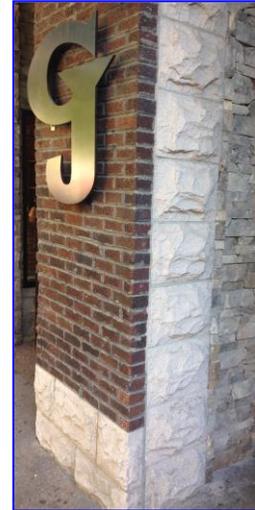
Signage: A small wall sign (48 sq ft) and banner sign (dimension unknown) were added to the front façade. (See figures 3 and 10). The Second Avenue side of the building is allotted ninety-nine and one-half square feet (99.5 sq ft) since there is a projecting sign. The existing marquee sign, originally approved under different design guidelines in 1997, includes two signs that together are approximately 120 square feet. The existing signage on the Second Avenue side exceeds the sign allotment of the current design guidelines; therefore staff recommends disapproval of the addition of the wall and banner signs.

Figures 10: Wall sign added without a permit.
