STAFF RECOMMENDATION 1712 Fifth Avenue North September 20, 2017

Application: Addition and Alterations - violation
District: Salemtown Neighborhood Conservation Zoning Overlay
Council District: 19
Map and Parcel Number: 08205003400
Applicant: Saint Petka Serbian Orthodox Church
Project Lead: Melissa Sajid, melissa.sajid@nashville.gov

Description of Project: A cupola addition was constructed, windows replaced and brick cladding removed without a Preservation Permit.

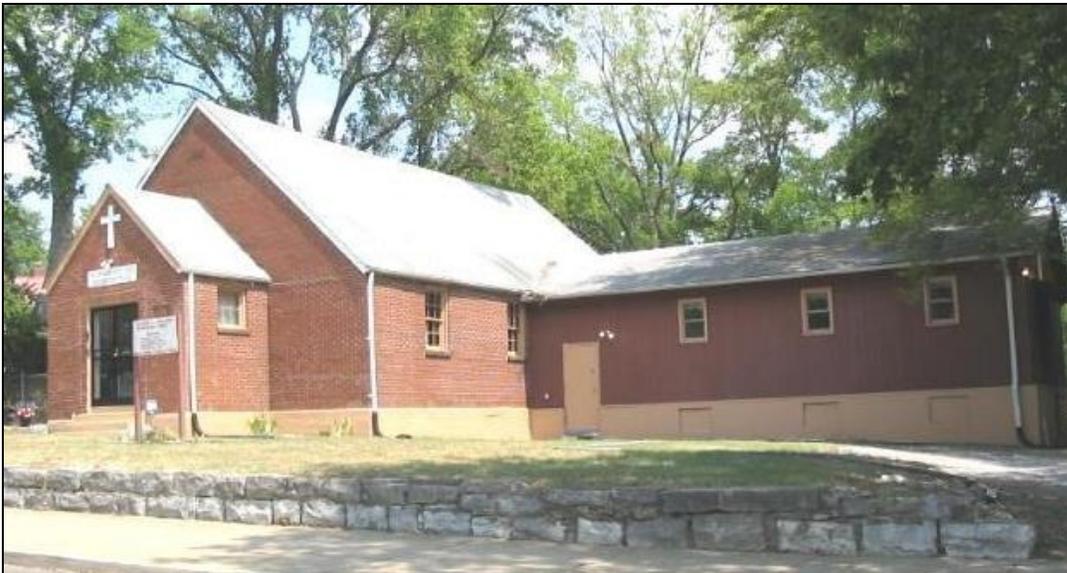
Figure 3: Historic church prior to addition and alterations.

The applicant has made a number of changes to the property without obtaining a Preservation Permit. (See Figures 3 and 4 for photos of the church before and after the unpermitted addition and alterations). These changes include the following:

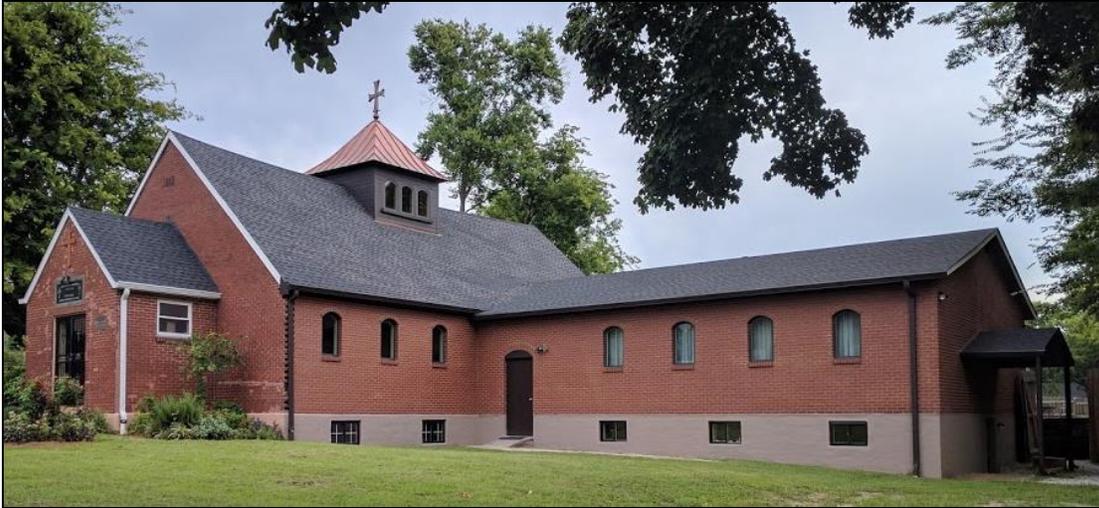
Figure 4: Historic church after unpermitted cupola addition and alterations.

- Addition of a cupola on the historic portion of the church
- Replacing the historic brick on the sides of the building
- Adding brick cladding to the addition
- Altering the size, shape, and location of windows and a door as well as adding new windows

1. The cupola is removed and the original roof form restored to its original configuration with a roofing material to match the existing material.
2. The brick on the two sides of the historic portion of the church be altered so that the vertical stretchers that were located at the bottom of the brick wall (see figure 6) and above windows is reinstalled. No more historic brick is approved for removal.
3. The original window locations, dimensions, design and materials be reinstalled. The applicant shall submit drawings showing the original window dimensions and locations as well as information about materials for staff review, prior to making the change.

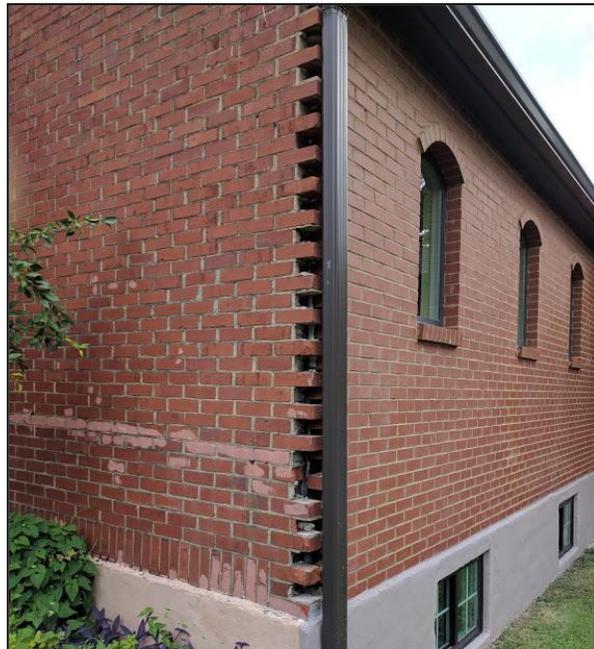
The applicant has removed the historic brick on the historic portion of the church and it no longer exists, therefore it cannot be reinstalled (Figure 5). In addition the entire left façade was removed. On the non-historic portion of the church, the applicant replaced the existing T-1-11 siding with brick. There have been no changes to the cladding on the rear of the building.

Figure 5: This image shows the historic brick on the front that has not yet been tied-into the new brick on the side. The historic brick has been removed on both sides and is no longer available.

applicant did not apply for a preservation permit for this work. When the masonry was replaced, the brick work on the corners of both the left and right façades was not completed (Figures 7 and 8). Since the original brick no longer exists, staff recommends that the two sides of the historic portion of the church be altered so that the vertical stretchers that were located at the bottom of the brick wall (see Figure 5) and above windows is reinstalled.

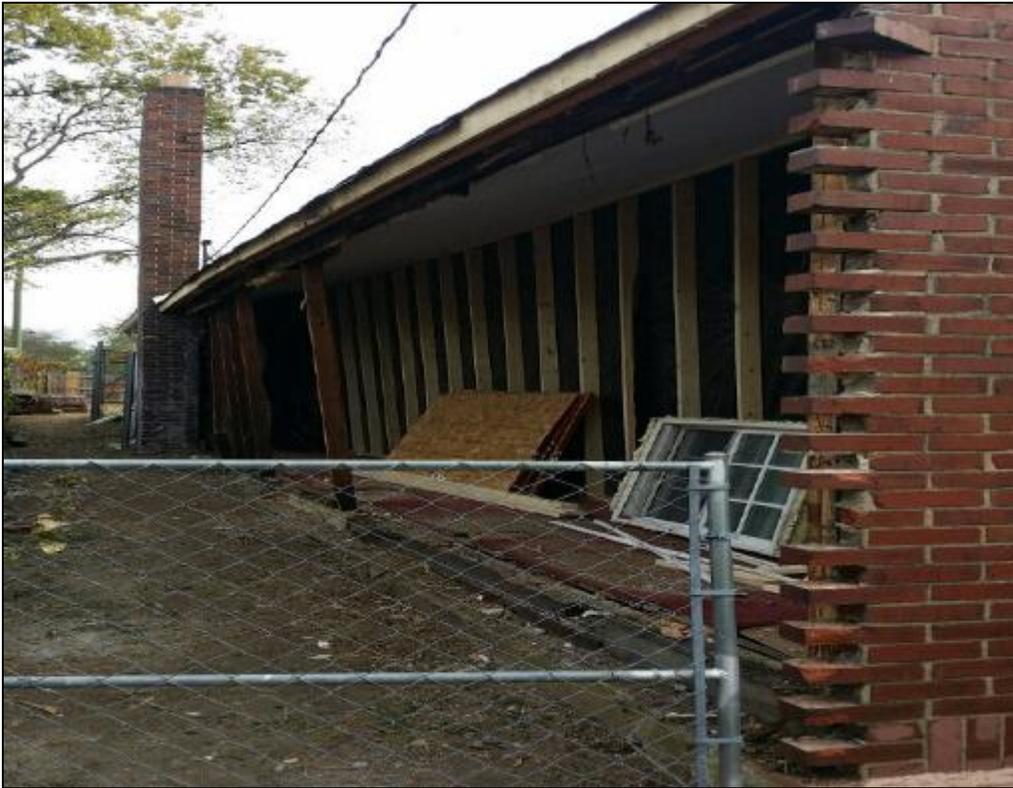
According to the engineer’s report, wall frame rot and deterioration were discovered during the window replacement, and the brick on the left side of the historic building tilted outward during the window replacement, causing the roof framing to fail. It is not clear as to whether the scope at that time was for window replacement as permitted or for alteration of window openings, which was not permitted. The applicant then proceeded to repair the structural damage that was discovered by removing the brick on the left side of the façade (Figure 6) and did not inform MHZC.

Figure 6: Removal of left side façade of historic church (Photograph provided by applicant.)

Removing the entire left façade of the historic building is considered partial demolition and should have been reviewed under a preservation permit so that staff could determine the appropriateness of the partial demolition

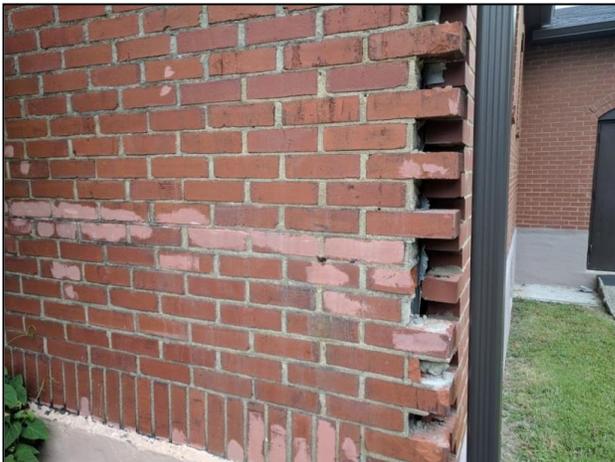
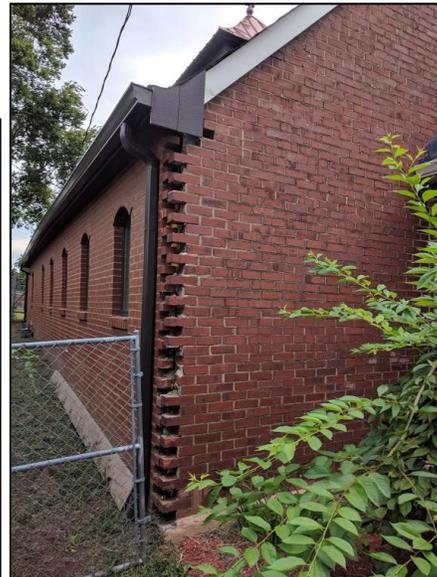
Figures 7 and 8: Unfinished brick work on front corners of historic church
