**METROPOLITAN GOVERNMENT OF NASHVILLE AND DAVIDSON COUNTY**

**STAFF RECOMMENDATION**  
**215 Broadway and 110 3<sup>rd</sup> Avenue South**  
**July 15, 2020**

**Application:** New Construction - Violation  
**District:** Broadway Historic Preservation Zoning Overlay  
**Council District:** 19  
**Base Zoning:** DTC  
**Map and Parcel Number:** 09306404300  
**Applicant:** Broadway Hotel, LLC  
**Project Lead:** Jenny Warren, jenny.warren@nashville.gov

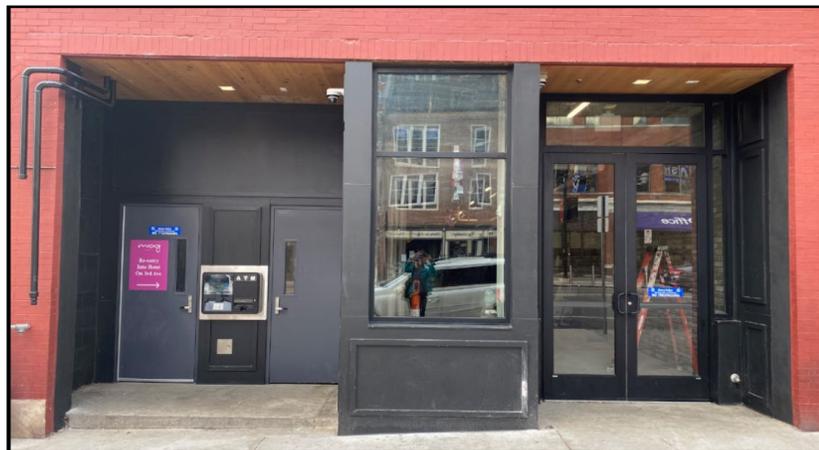
Figures 4: Storefront as currently configured.

Staff finds the current configuration to be inappropriate, as it does not match the permit and does not comply with General Principles, Section II of the design guidelines which state “Replacements of street-level facades should be in keeping with the style and period of the building.”

The lack of transparency on the left side, including the solid transom, the nearly solid doors and the ATM are not typical of a historic primary façade on Broadway.

Staff recommends that the doors and transom be installed into the left side of the storefront, as per the plans approved in 2014, which would also result in removal of the ATM installed without a permit.

Staff recommends disapproval of the current Broadway storefront configuration including the ATM, finding that it does not meet Section II of the design guidelines for rehabilitation and Section III of the design guidelines for new construction. Staff suggests that the storefront be reconstructed as previously permitted within 120 days. Staff recommends approval of the revised interpretation regarding ATMs and the ATM installed at the 3<sup>rd</sup> Avenue entrance.

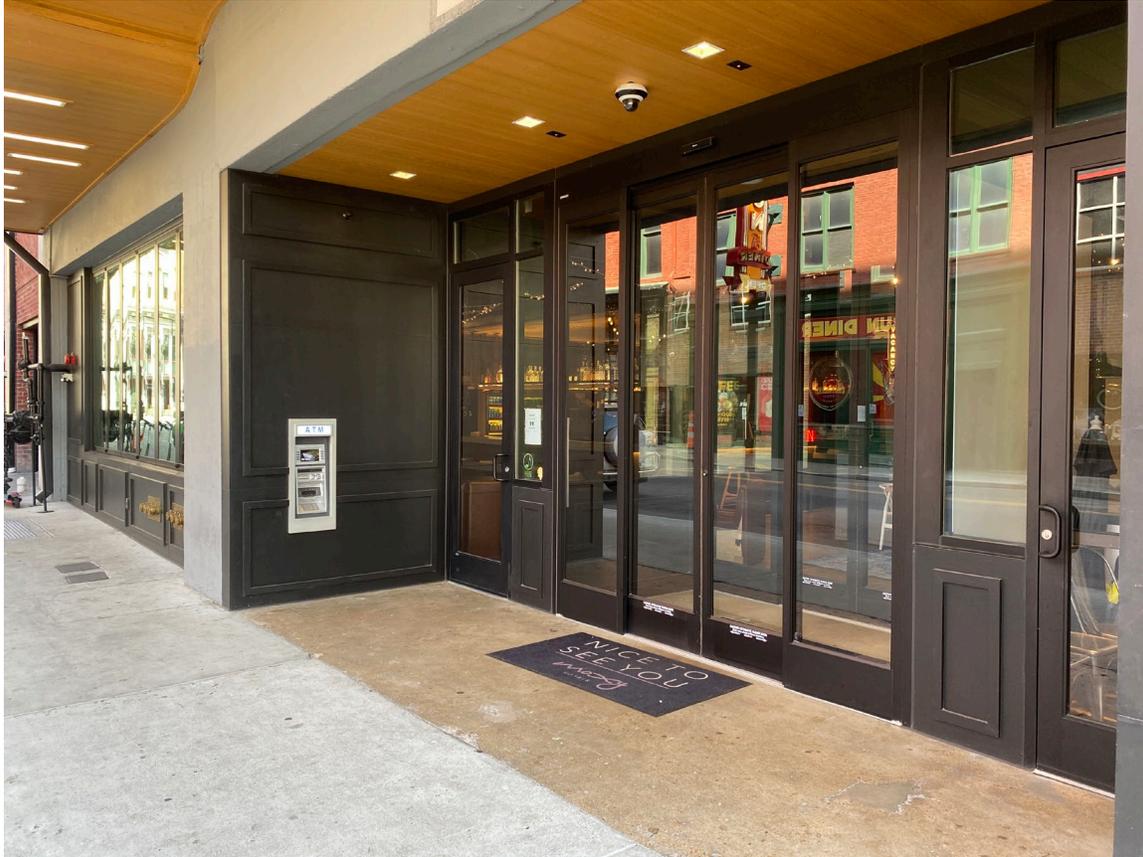
Figure 5: ATM installed at 3<sup>rd</sup> Avenue South entrance.

If the revised interpretation of the design guidelines is agreed upon, the violation at the 3<sup>rd</sup> Avenue South entrance would meet the guidelines. The ATM is located within a deep recess (approximately 6' 2" deep) on the façade and is stepped back from the exterior wall by more than one foot (1'). It is installed in a new side-wall so did not require removal of any historic features. It measures approximately fifteen inches (15") wide, which would meet the three foot (3') wide maximum. The signage is located on the machine itself. No additional lighting or signage has been added or is proposed.

If the Commission finds that the 2004 interpretation is still valid, the ATM meets the design guidelines due to its location. The interpretation the Commission established in 2004 does not allow for ATMs on primary facades. Although this entrance appears as a primary façade, this part of the building is a later addition to the Broadway facing building and is non-contributing and so could be considered a secondary façade.
