October 31, 2022

Master Plan Design Review

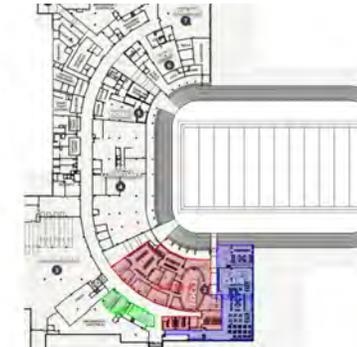
- 1 FIELD CLUB
- 2 TRANS LOCKER
- 3 LOADING DOCK
- 4 CENTRAL COMMISSARY
- 5 VISITOR LOCKER
- 6 MAINTENANCE SHED
- 7 GENERAL STORAGE
- 8 EGRESS RAMP

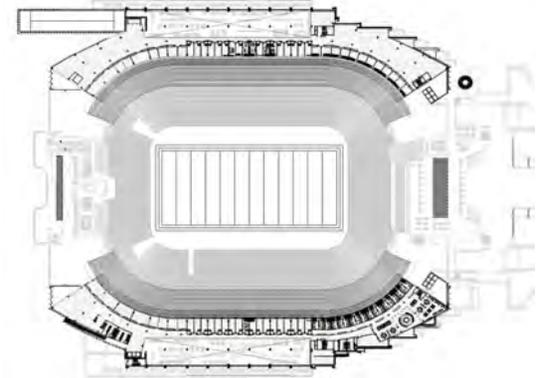
New Finishes in Restrooms	1	3,000	3,000	SF	\$150.00	\$ 450,000	
Repair / Replace Fire Protection Heads and Piping as needed.	1	93,000	93,000	SF	\$3.00	\$ 279,000	
<b>Base Infrastructure (HVAC / Electrical)</b>							
HVAC and Plumbing Systems	1	93,000	93,000	SF	\$85.00	\$ 7,905,000	
Electrical - Switchgear, Panels, Branch	1	93,000	93,000	SF	\$70.00	\$ 6,510,000	
<b>Sub-Total</b>						<b>\$ 29,133,500</b>	
<b>TOTAL - LOWER SUITES</b>			<b>93,000 SF</b>		<b>\$341.26</b>	<b>\$ 31,737,500</b>

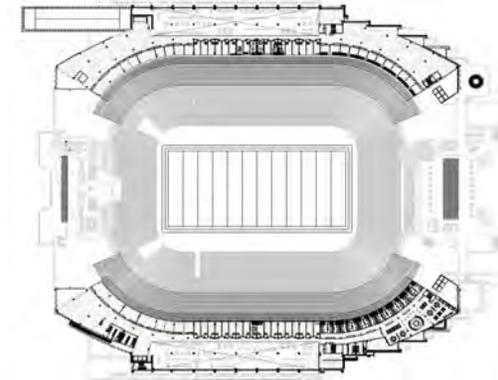
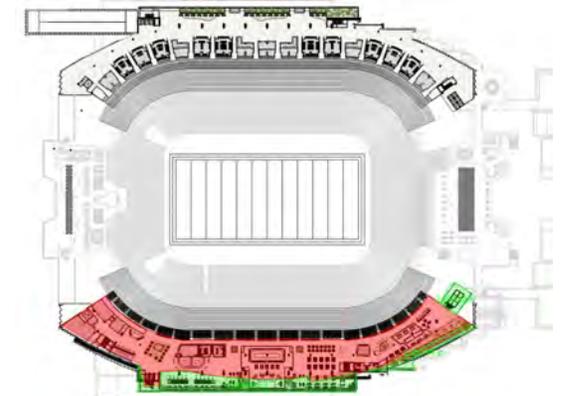
Replace Electrical Light Fixtures throughout with LED	1	61,500	61,500	SF	\$10.00	\$ 615,000	
	Replace and Tie-into Existing Lighting Controls throughout	1	61,500	61,500	SF	\$2.00	\$ 123,000	
	Relocate Electrical Equipment to meet code	1	61,500	61,500	SF	\$1.00	\$ 61,500	
	Provide new Panels to meet code.	1	61,500	61,500	SF	\$4.00	\$ 246,000	
	Repair / Replace Damaged Elect Branch Systems (Conduits, J-Boxes, Panels etc.)	1	61,500	61,500	SF	\$2.00	\$ 123,000	
	Demolition and Replacement of Walls / Ceilings to facilitate MEP Replacement	1	61,500	61,500	SF	\$5.00	\$ 307,500	
	<b>Base Infrastructure (HVAC / Electrical)</b>							
	HVAC and Plumbing Systems	1	61,500	61,500	SF	\$85.00	\$ 5,227,500	
	Electrical - Switchgear, Panels, Branch	1	61,500	61,500	SF	\$70.00	\$ 4,305,000	
		<b>Sub-Total</b>						\$ 48,741,150
	<b>TOTAL - 300 UPPER CONCOURSE</b>				61,500 SF		\$802.54	\$ 49,366,150

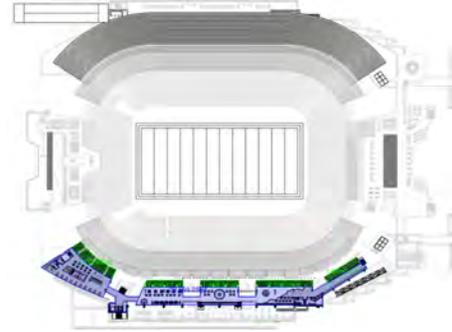
HVAC and Plumbing Systems	1	39,700	39,700	SF	\$75.00	\$ 2,977,500			
Electrical - Switchgear, Panels, Branch	1	39,700	39,700	SF	\$60.00	\$ 2,382,000			
<b>Sub-Total</b>						\$ 11,884,000			
<b>TOTAL - 350 WEST UPPER DECK &amp; CANOPY</b>			39,700 SF		\$420.25	\$ 16,684,000

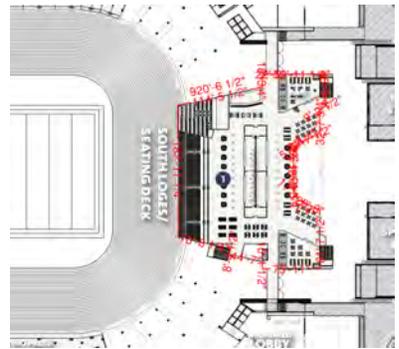
Roof Deck Waterproofing	1	27,500	27,500	SF	\$35.00	\$ 962,500			
Exterior Skin +25'	25	920	23,000	SF	\$75.00	\$ 1,725,000			
<b>Base Infrastructure (HVAC / Electrical)</b>									
HVAC and Plumbing Systems	1	59,500	59,500	SF	\$85.00	\$ 5,057,500			
Electrical - Switchgear, Panels, Branch	1	59,500	59,500	SF	\$70.00	\$ 4,165,000			
<b>Sub-Total</b>						\$ 39,421,110			
<b>TOTAL - SOUTH END ZONE SUITES &amp; CLUB</b>			59,500 SF		\$666.84	\$ 39,677,110

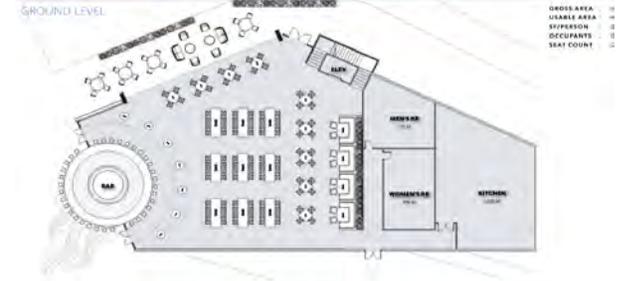
FLOOR PLANS & RENDERINGS  
SPORTS BAR

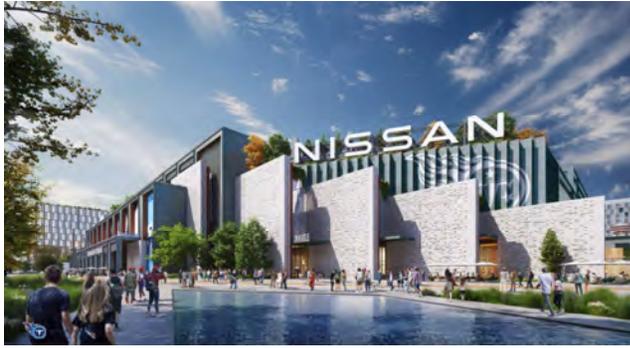
## **Nissan Stadium Post Renovation Scenario Capital Improvement and Upgrades 2027 - 2039**

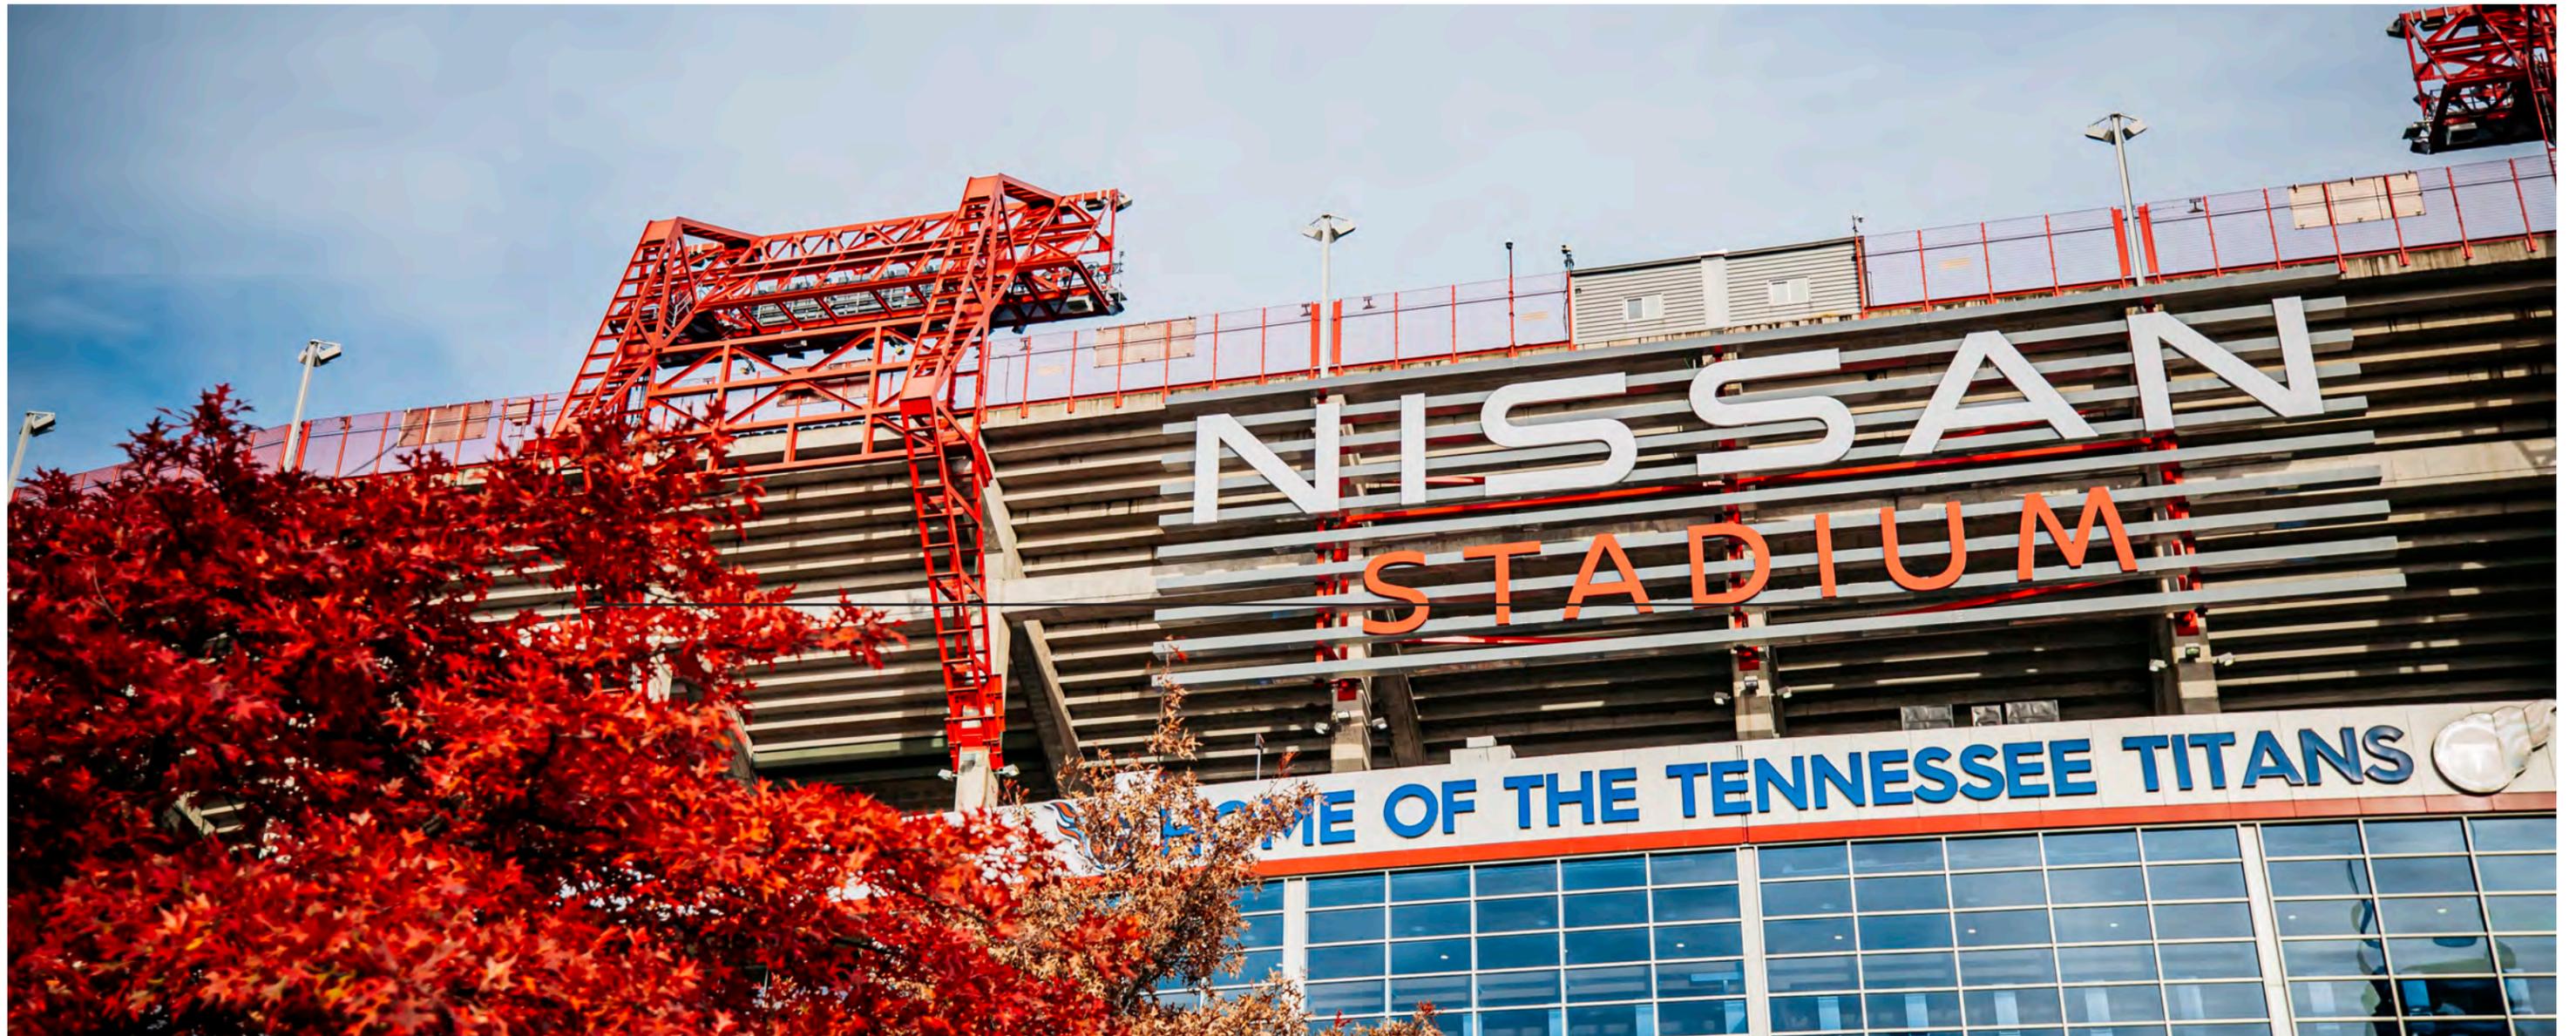
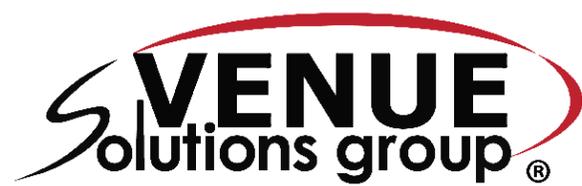
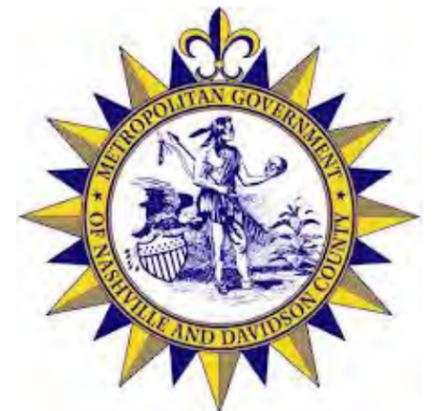
**Facility Condition Assessment**

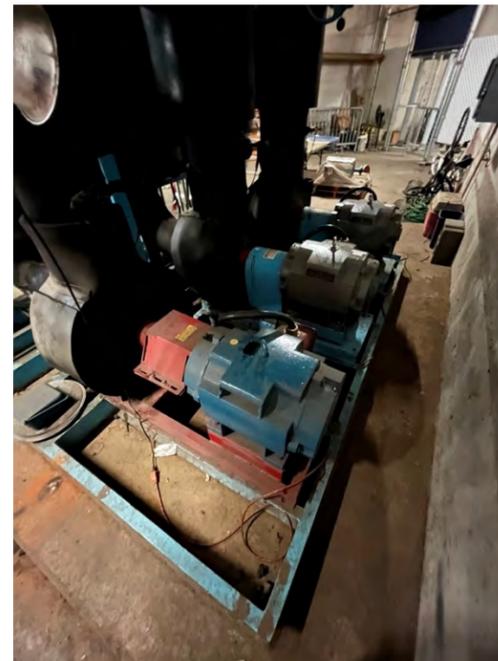
Chilled water pump skid

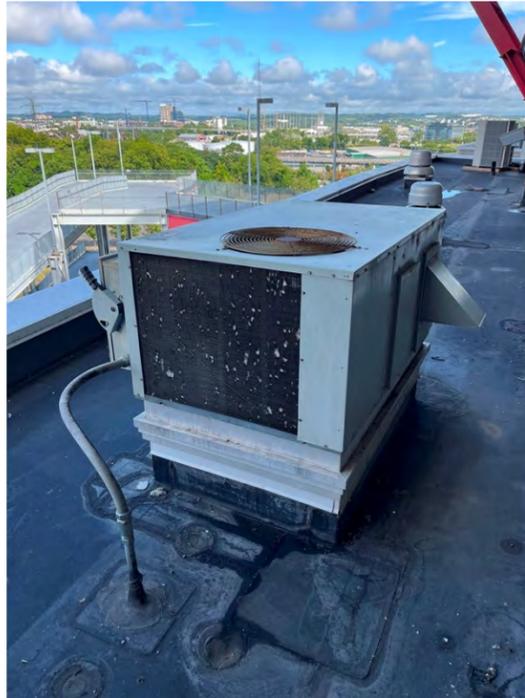
Continue to maintain chilled water units if R-22 refrigerant is still available for purchase.

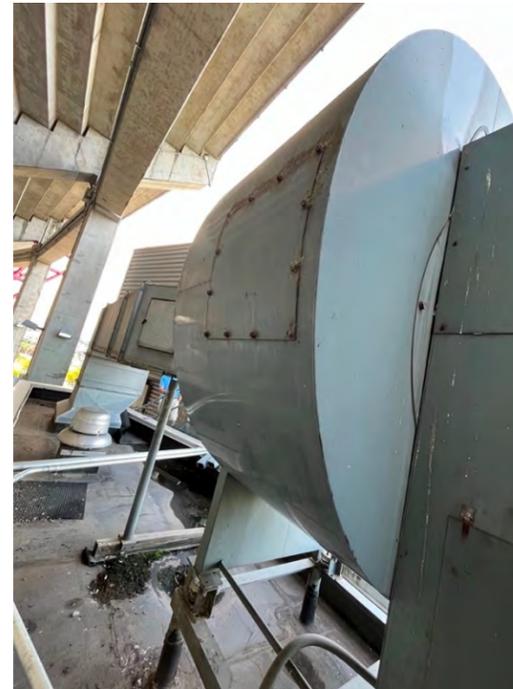
Functional testing should be performed to confirm there are no issues. Consider replacing due to life safety functions, or pending functional testing, continue with routine maintenance.

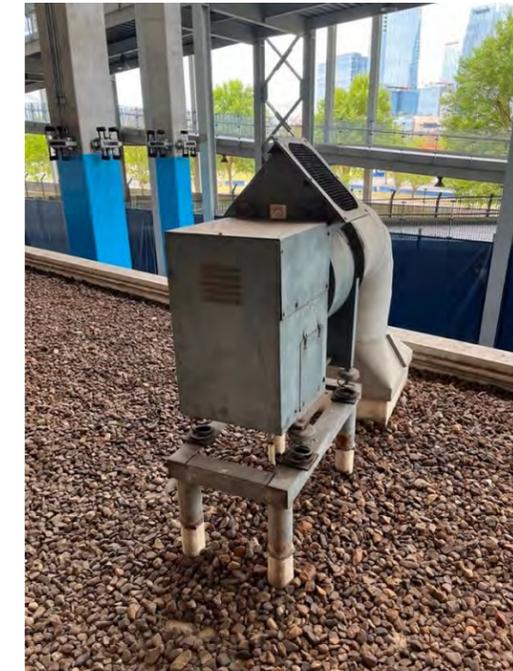
Kitchen exhaust fan Quad B

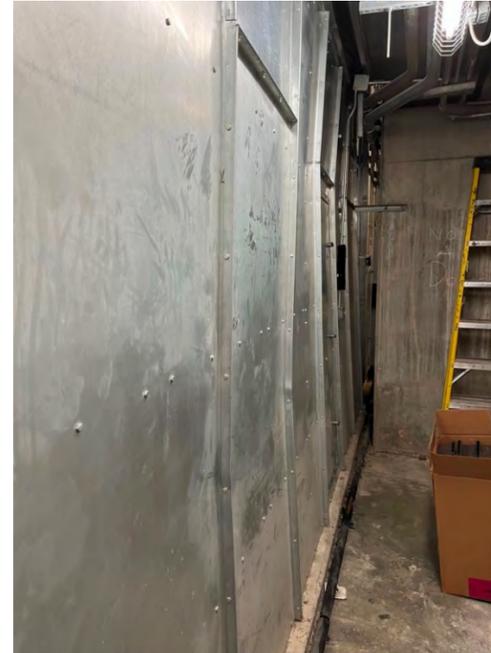
*Buckled return air plenum AHU 3B1*

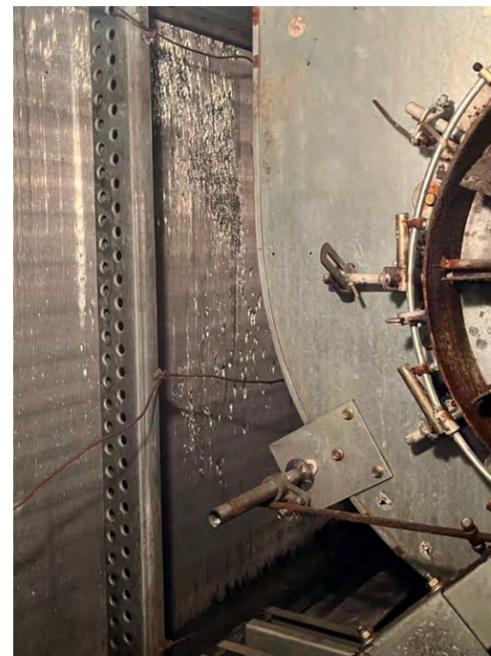
*Fin damage of cooling coil on service level AHU*

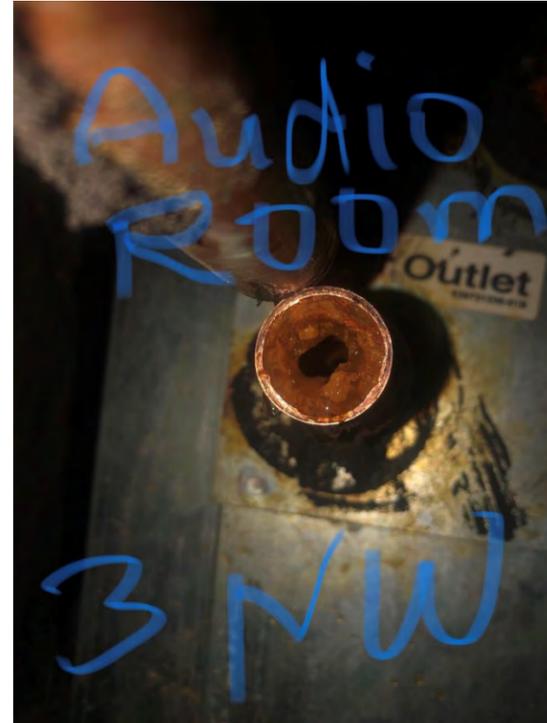
Chilled water scaling build-up within fan coil unit

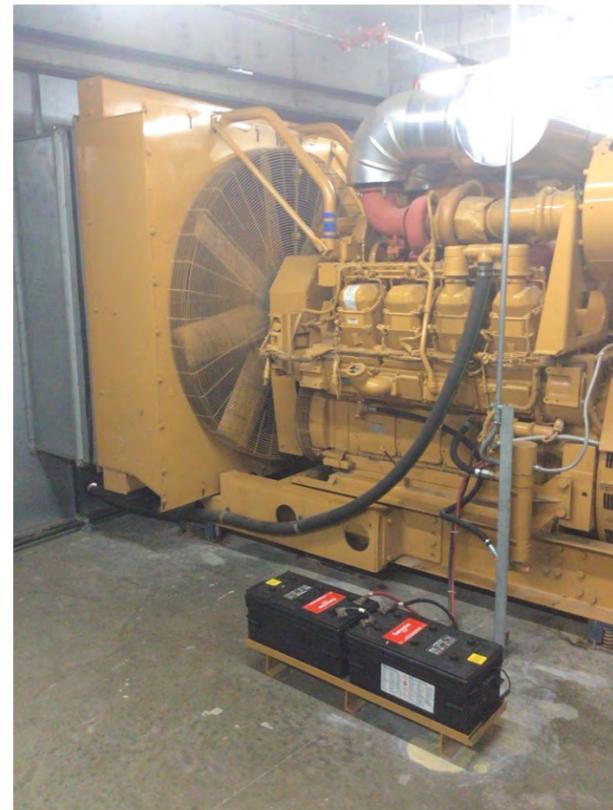
They do not require replacement within the next five years.

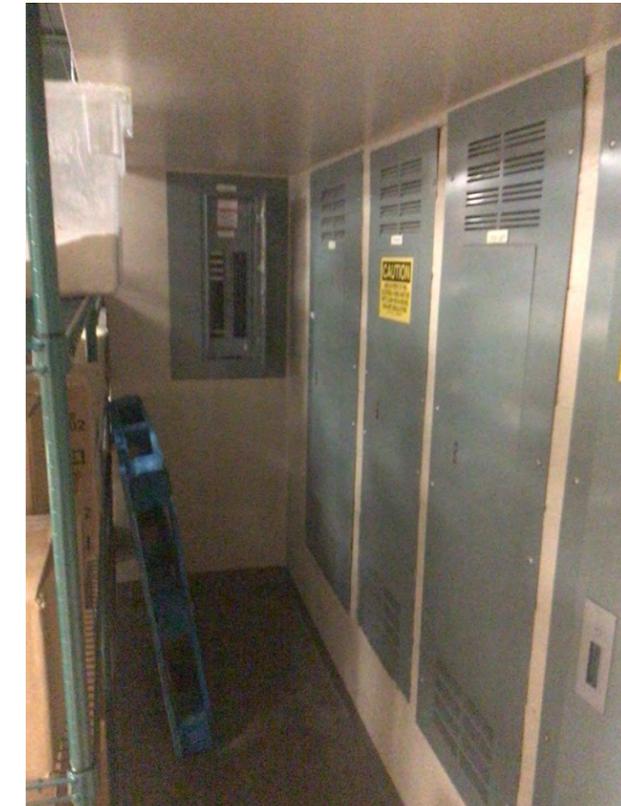
*Example of clearance at a concession panel*

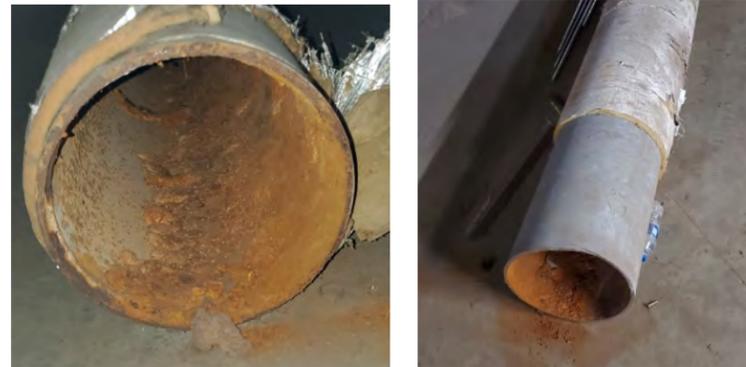
*Domestic water galvanized steel pipe corrosion*

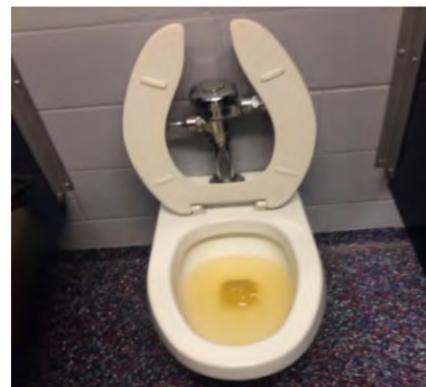
*Corroded water within water closet bowl*

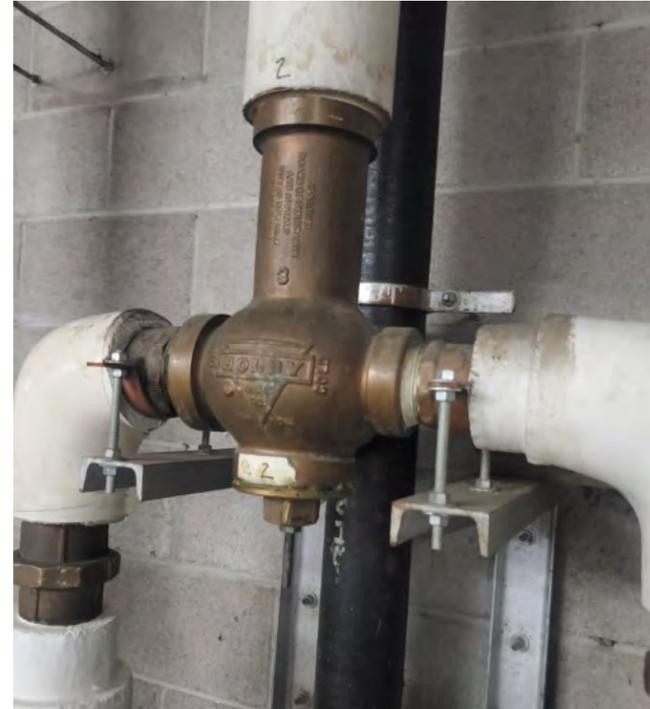
*Domestic water galvanized steel pipe corrosion*

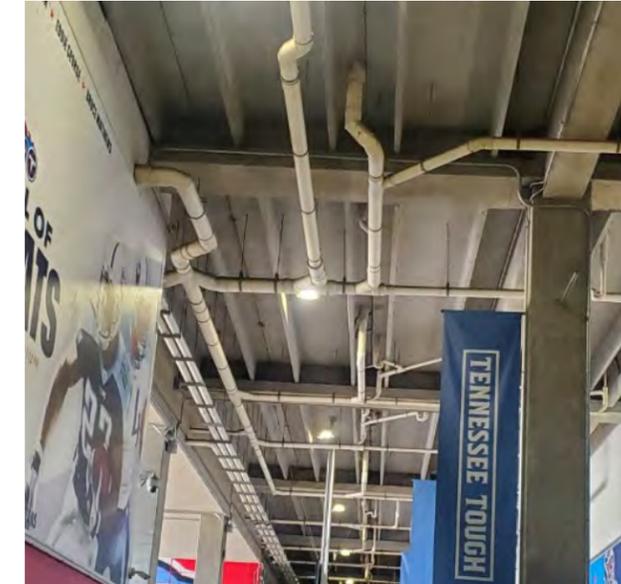
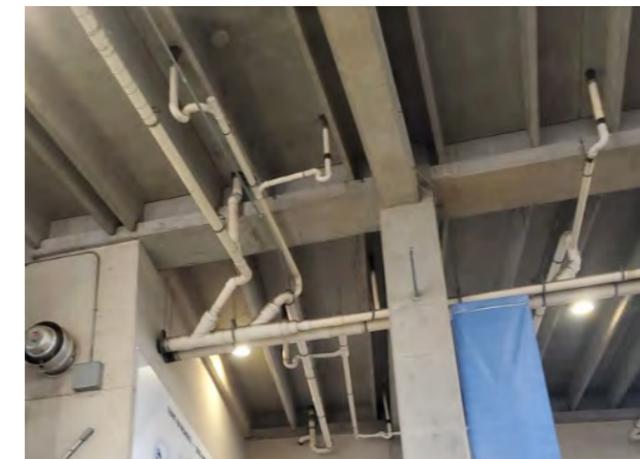
*Exposed PVC uninsulated waste piping observed from main concourse*

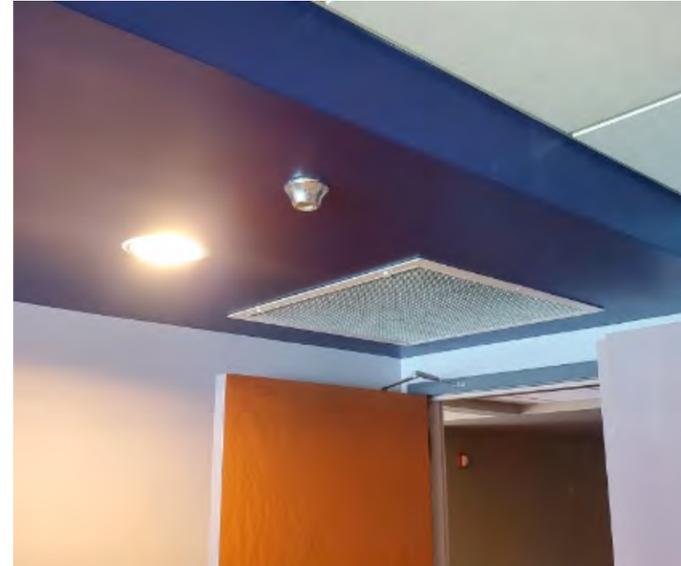
Auxiliary condensate terminations above suite entrances and lavatories

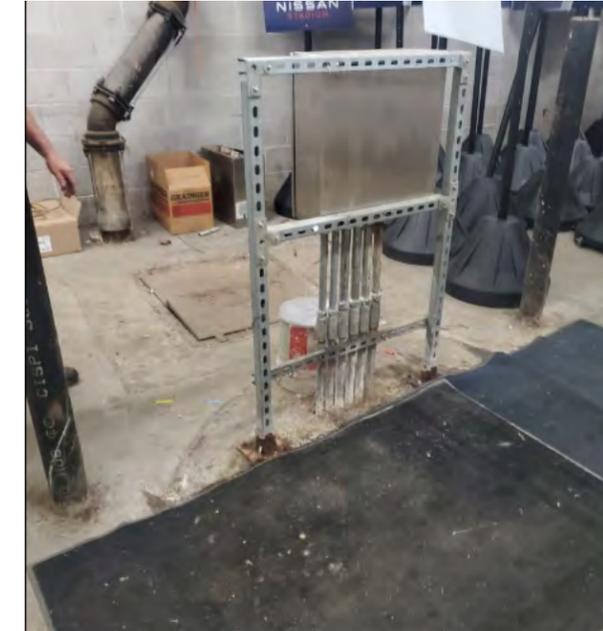
Sewage ejector pit cover and capped vent

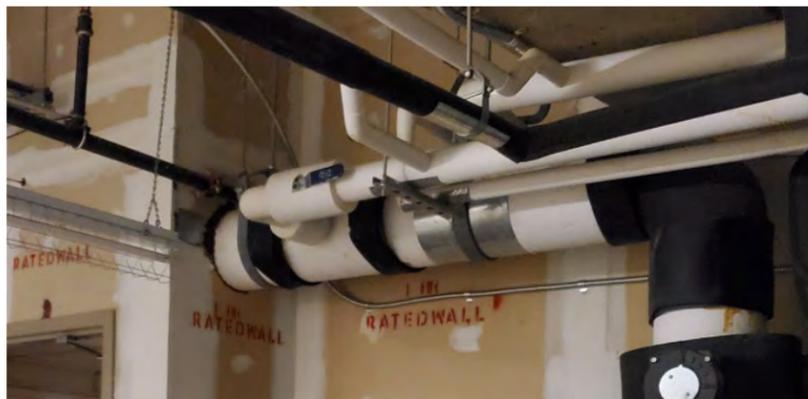
Fire proof caulking not observed at plumbing penetrations through rated walls

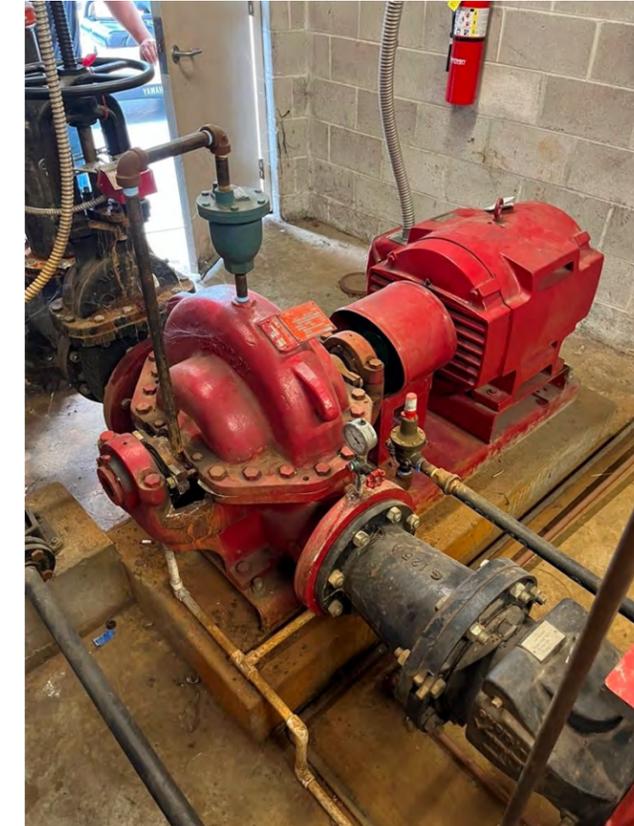
The fire pump and casing does not show significant signs of corrosion or deterioration. Continue routine testing, maintenance, and cleaning of the system.

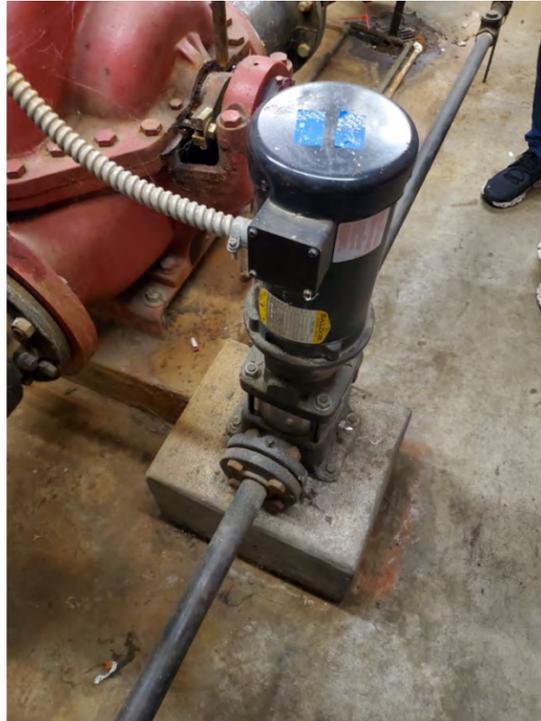
The fire pump and casing does not show significant signs of corrosion or deterioration. Continue routine testing, maintenance, and cleaning of the system.

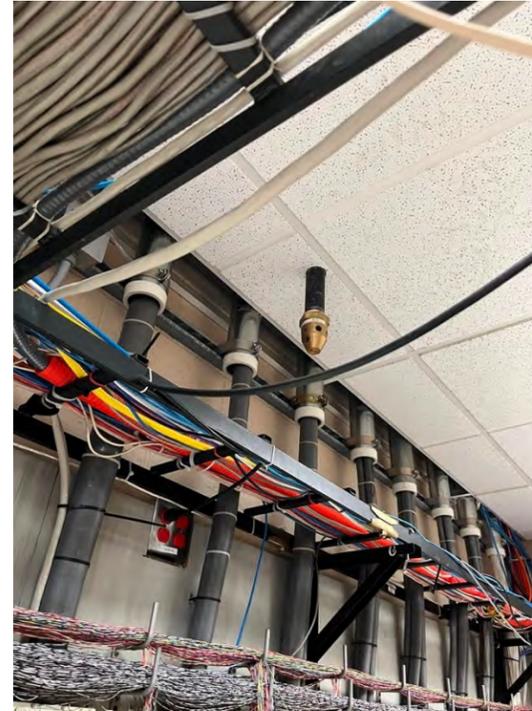
Continue routine testing, maintenance, and cleaning of the system.

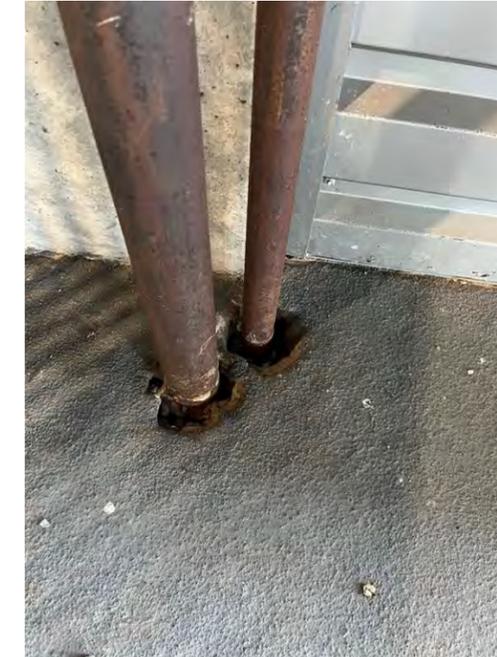
Corrosion on piping exterior and missing slab penetration sleeve/collar

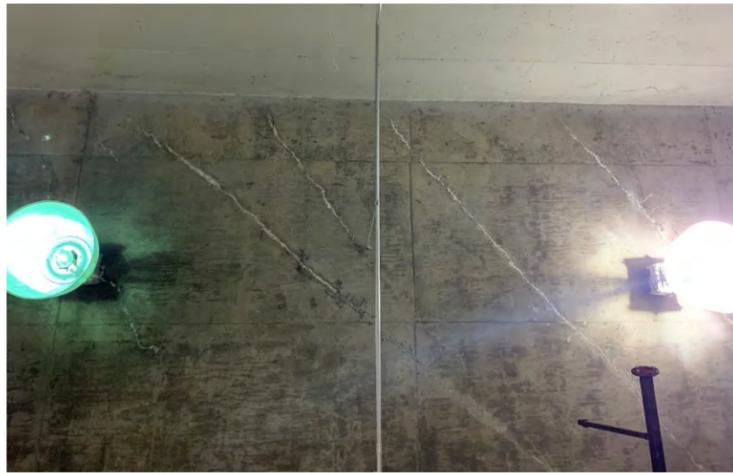
Cracking in slab above loading dock

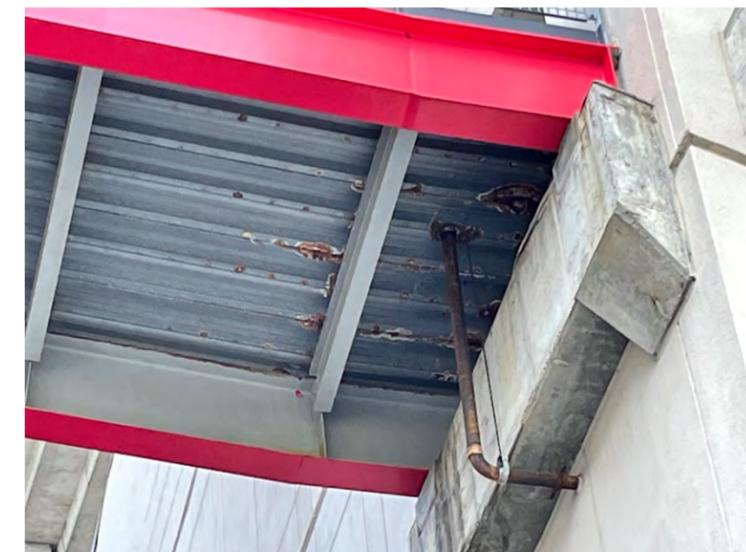
*Corrosion of metal deck at access ramps*

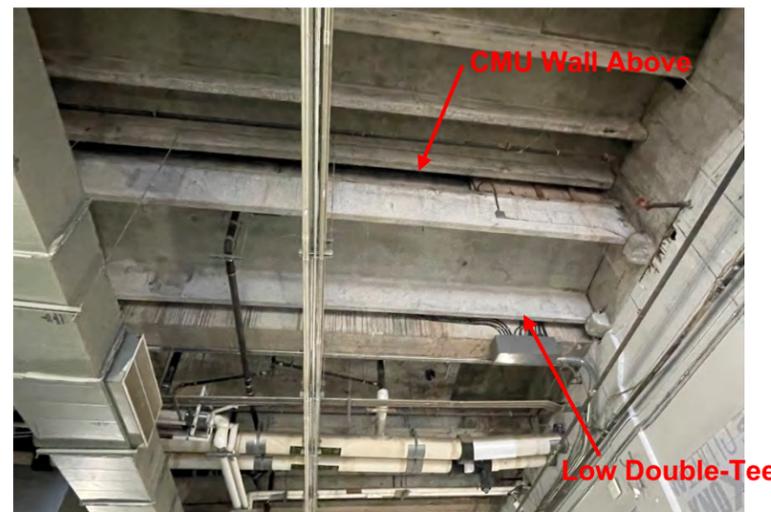
Precast double-tee supporting CMU walls

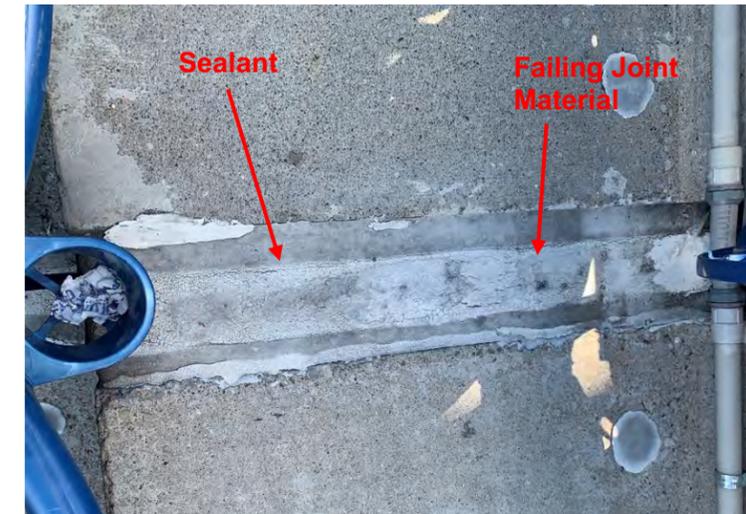
Expansion joint degradation at upper bowl

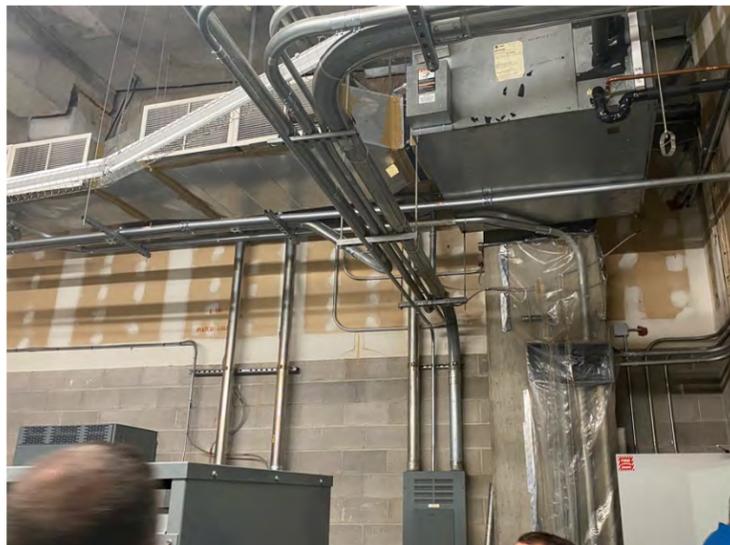
Expansion joint above electrical equipment

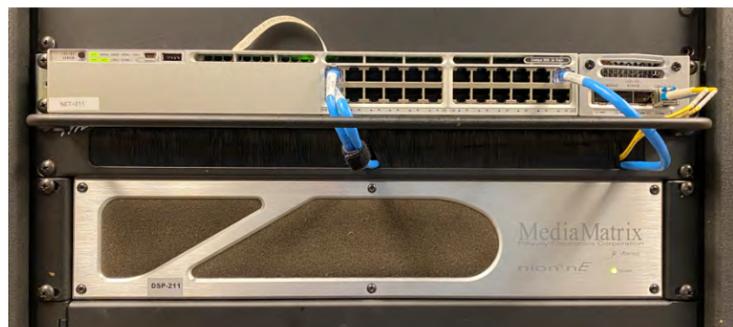
At the moment, there are very long lead times for this type of equipment. To this point in its life cycle there have been no major failures and there is a slight chance that it would remain operational with minor maintenance. However, we do see this as a high-risk item that would have the potential to affect the bowl and back of house sound.

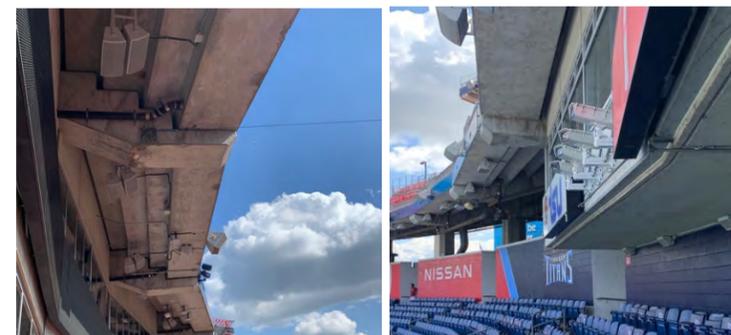
*Typical seating zone speaker conditions*

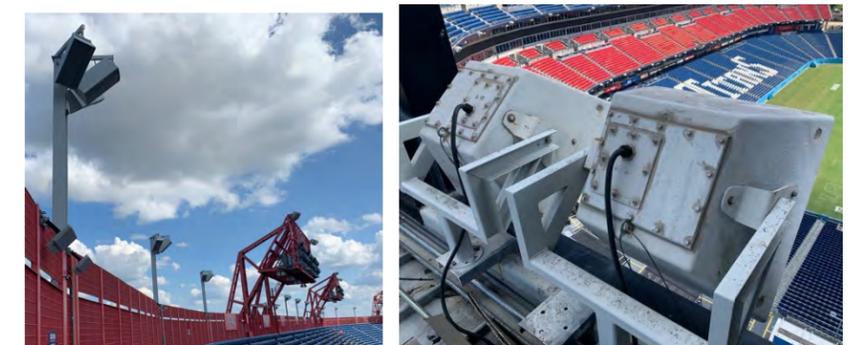
*Typical eating zone speaker conditions*

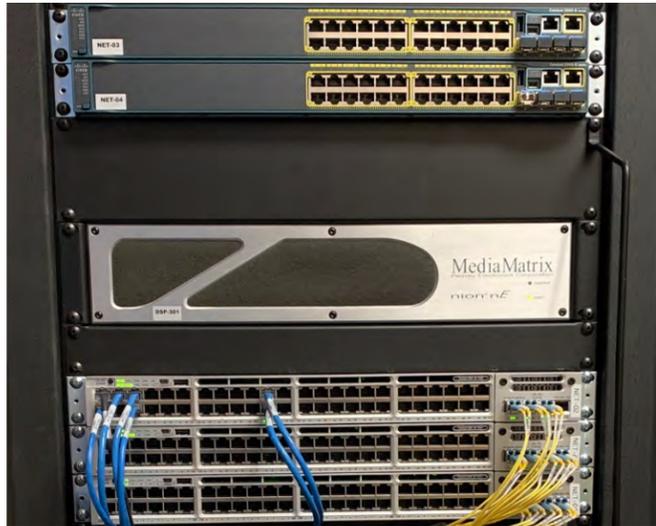
Core network switches and DSP processor location

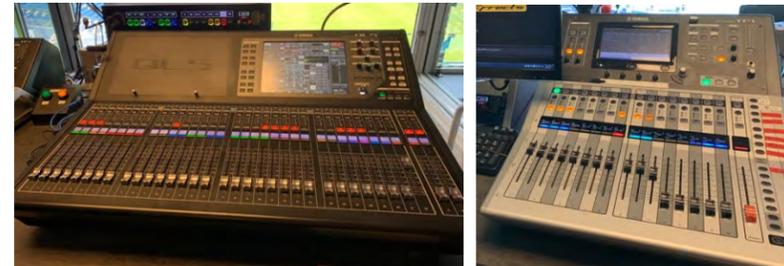
Audio consoles located in audio control room

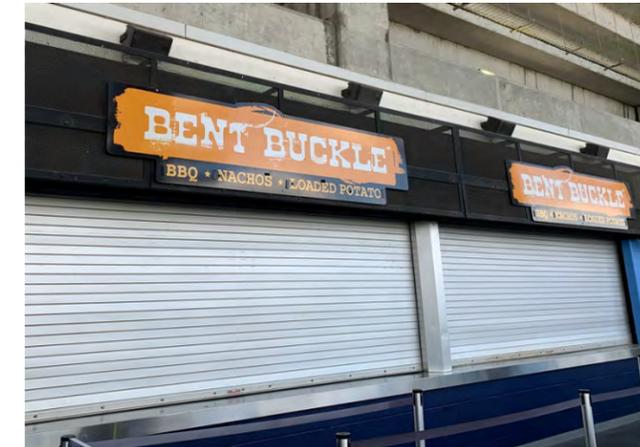
Typical concourse speaker coverage

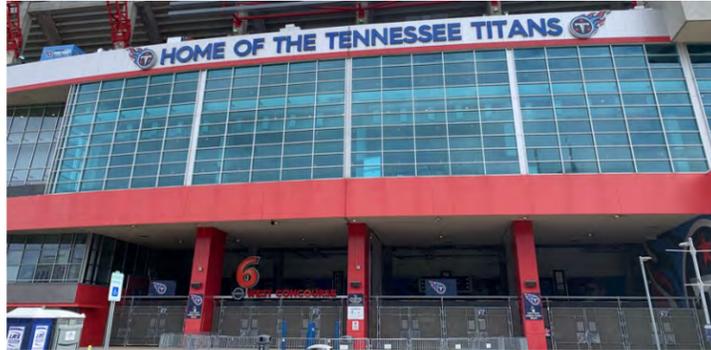
Main entrance gate speaker coverage

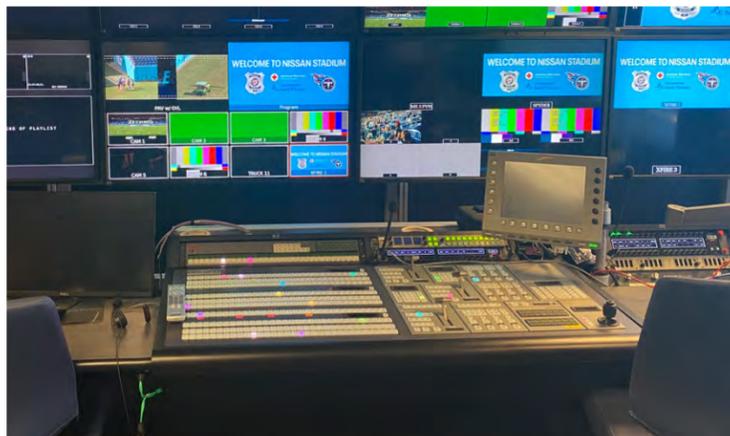
Primary video production switcher

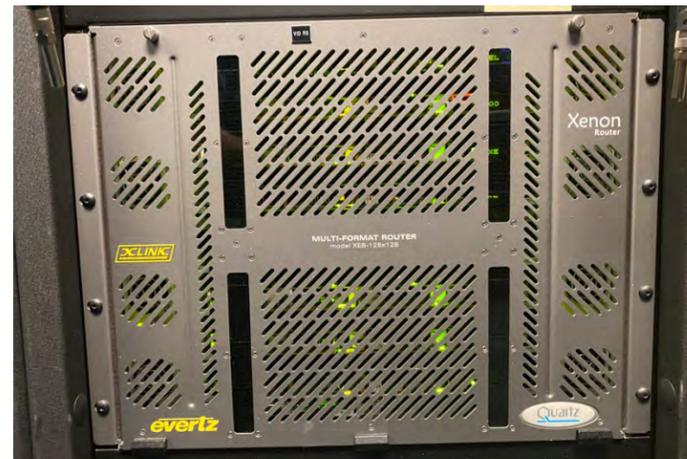
Primary video router

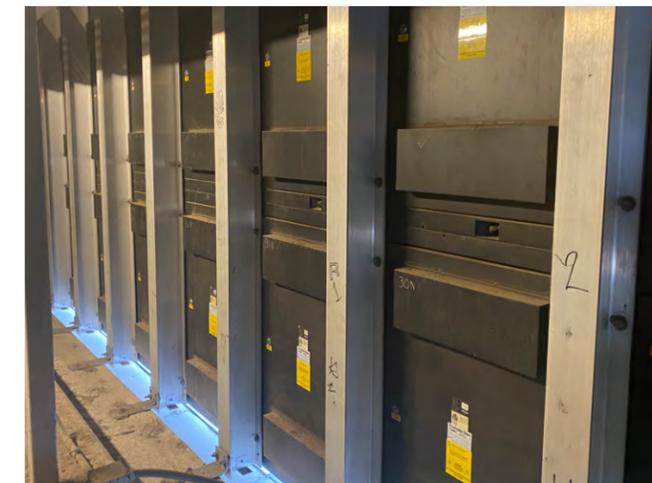
Primary scoreboard structure

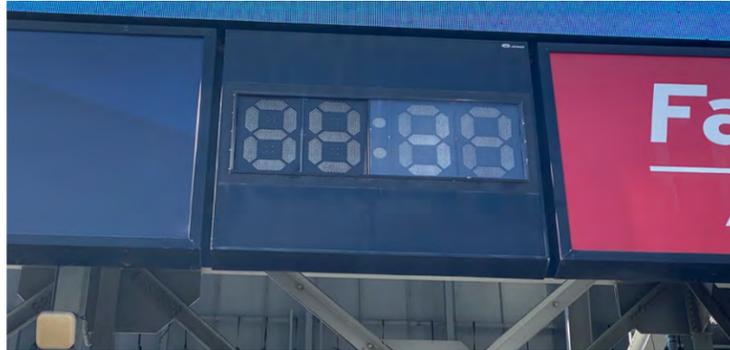
4-digit timing system

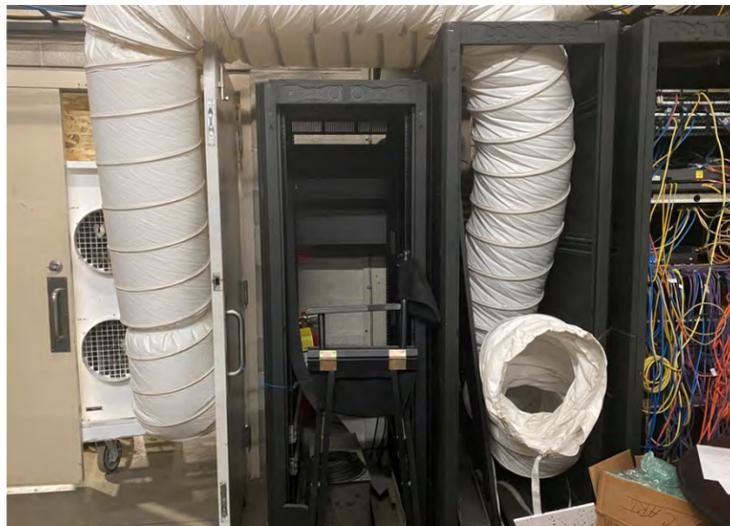
Truck dock head end room with portable HVAC

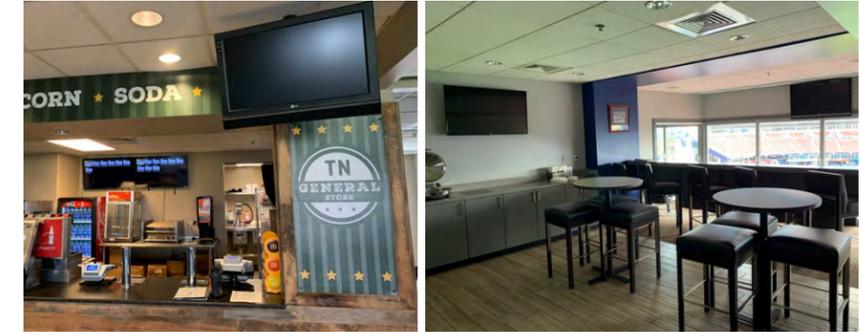
Typical display conditions

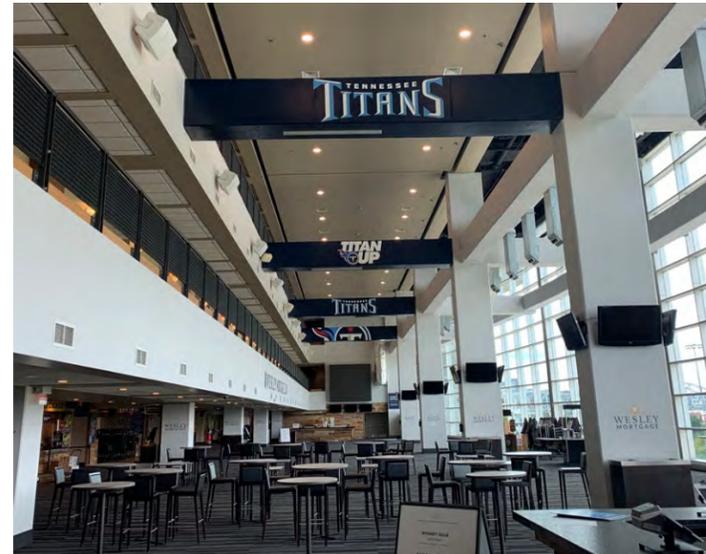
*Wesley Mortgage Club*

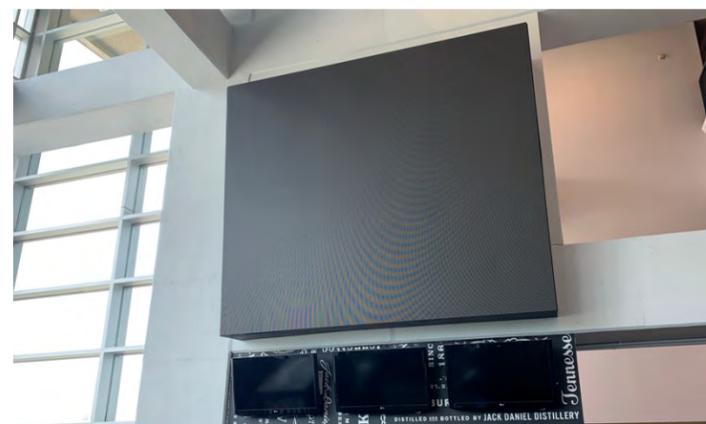
*Wesley Mortgage Club LED display*

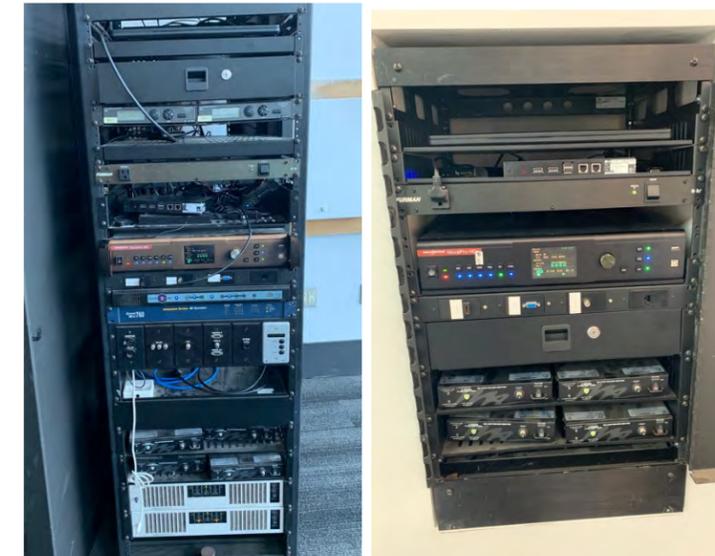
*Wesley Mortgage Club AV racks*

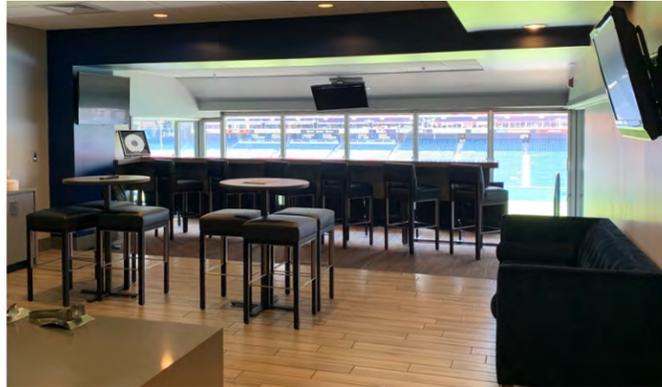
Typical suite conditions

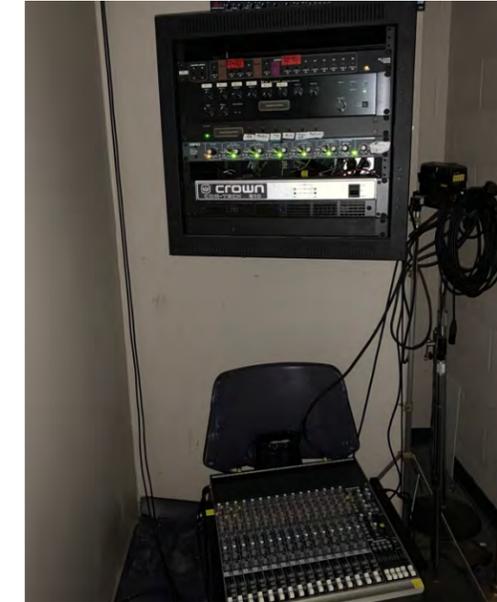
Interview room sound operator

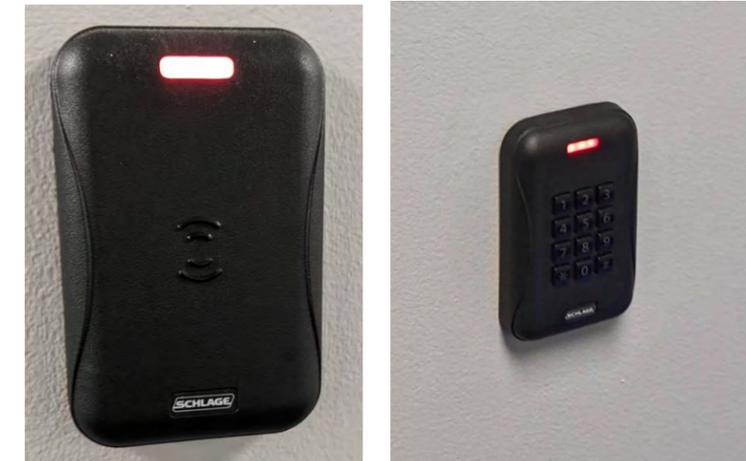
Card reader (left) & card reader keypad combination device (right)

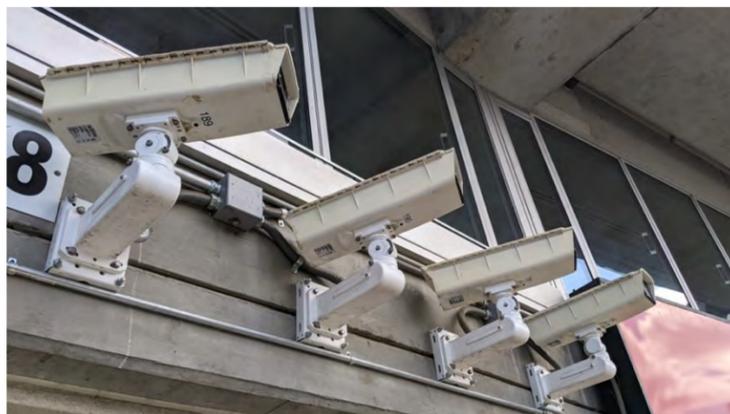
*Long range bowl security cameras*

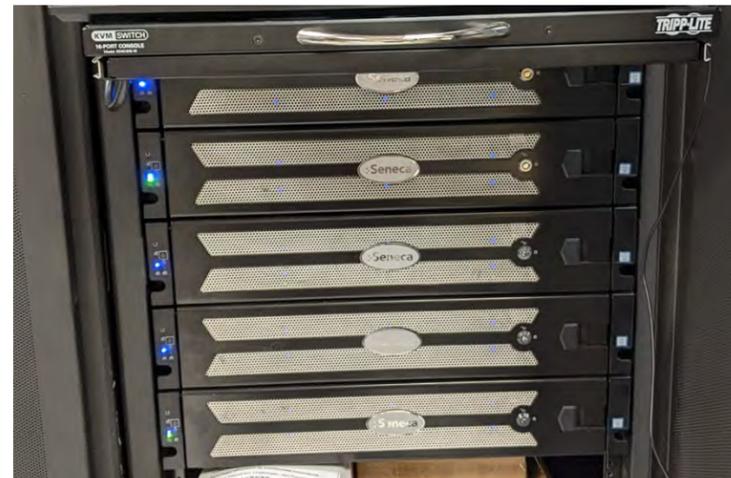
*Video management system Genetec rack-mounted servers*

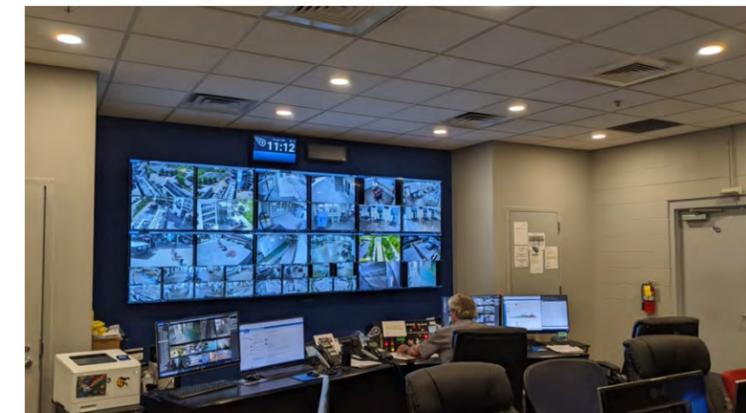
*Main security control room with video wall and individual workstations*

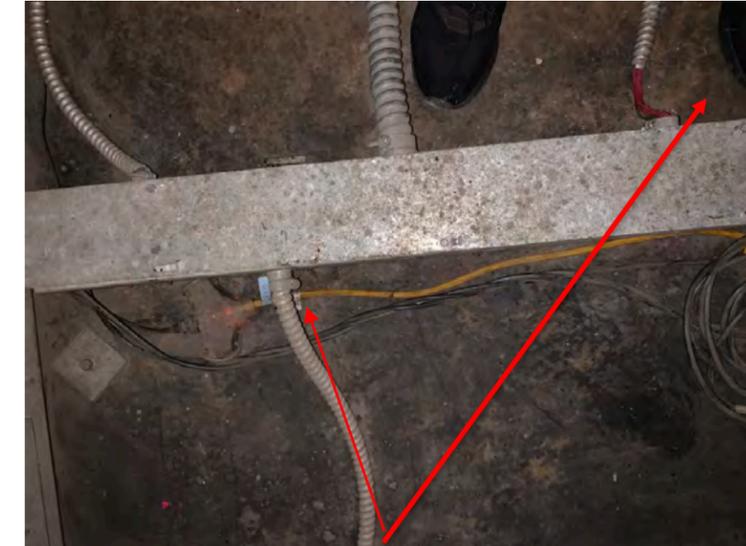
Extension cord is laying on cartop and greenfield is pulled loose from the duct fitting

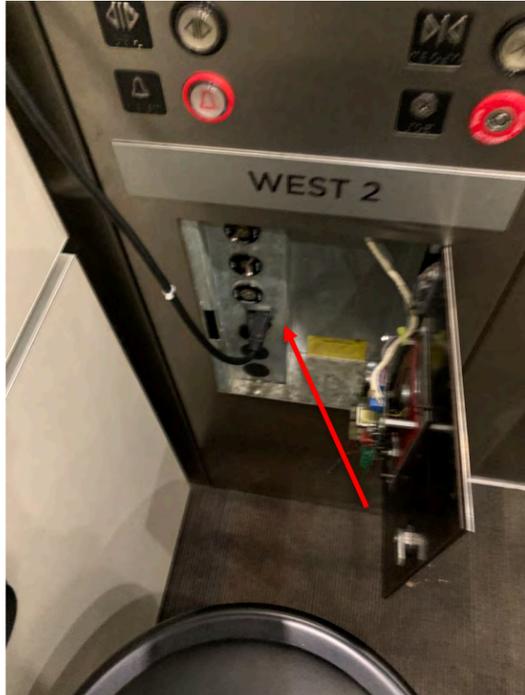
Fans are plugged into the car operating panel behind inspection doors
