October 31, 2022

Master Plan Design Review

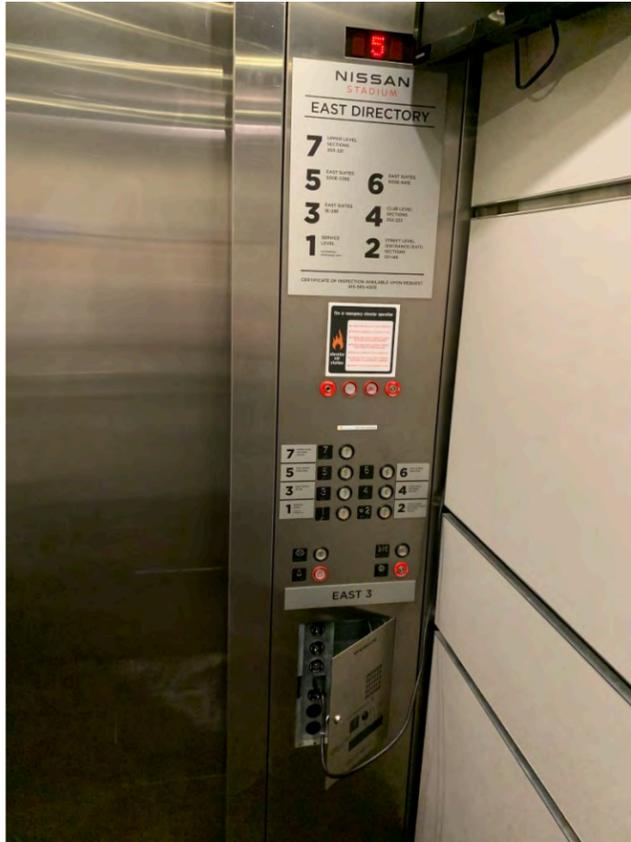
Typical car operating panel for elevators #1-#8

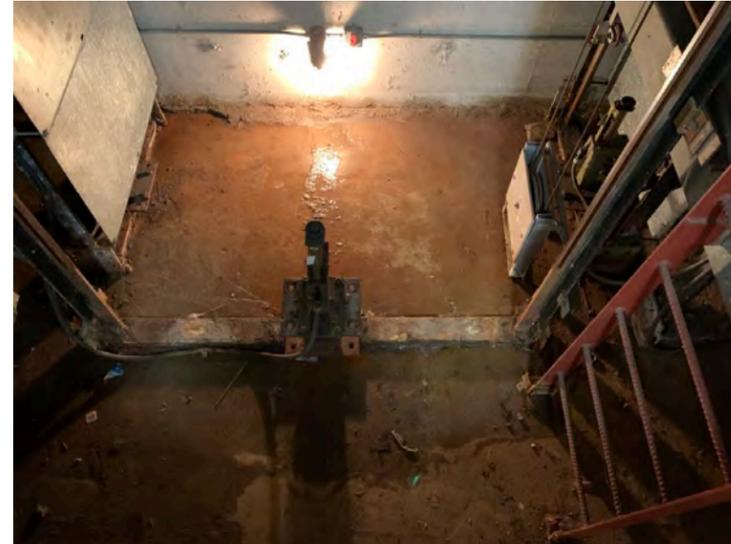
Elevator #6 pit has standing water and the equipment is rusting

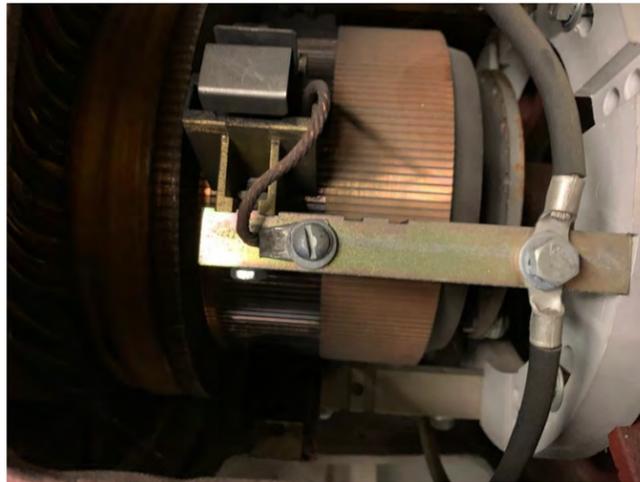
DC motor has carbon dust buildup on commutator segments which could result in a short circuiting

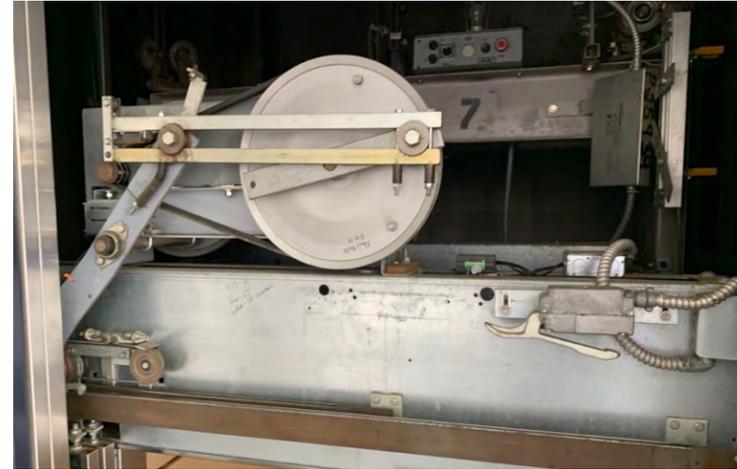
Typical MAC operator for elevators #1-#8

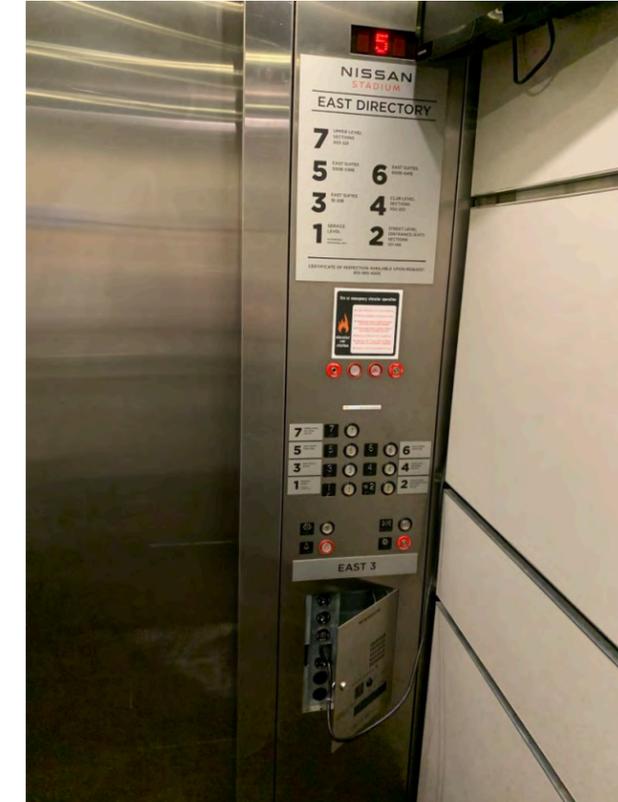
Typical car operating panel for elevators #1-#8

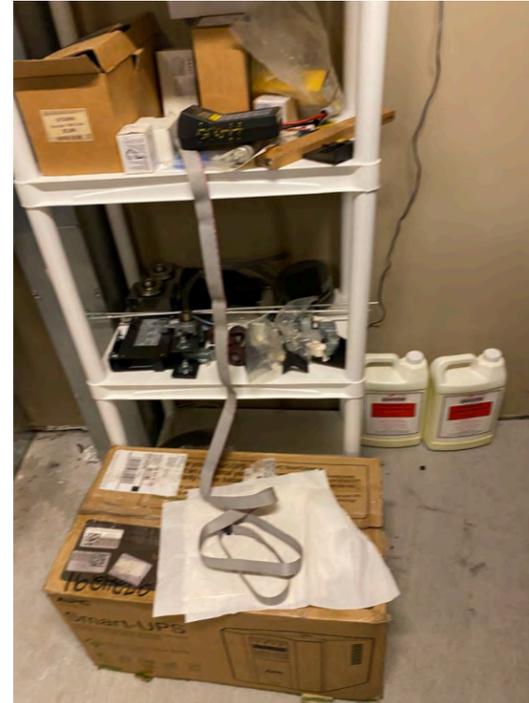
Machine room lubrication containers are not properly stored

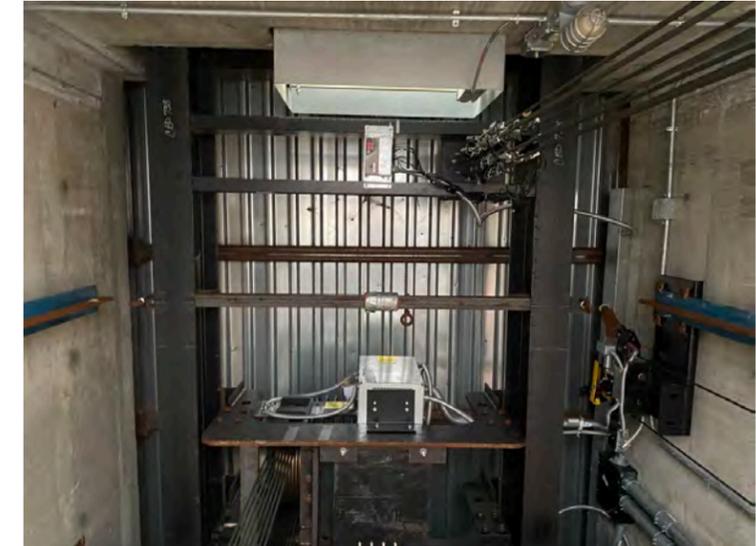
Typical rust on equipment in overhead on express cars

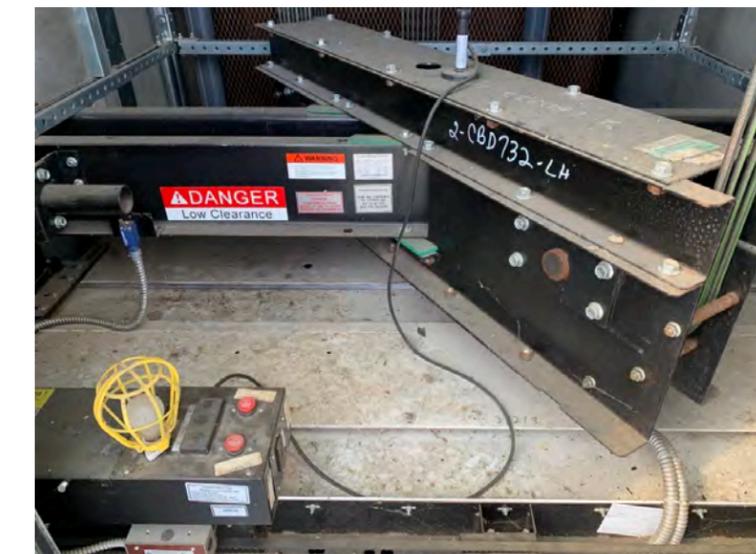
Car tops are dirty and in need of cleaning and rusted surfaces should be painted

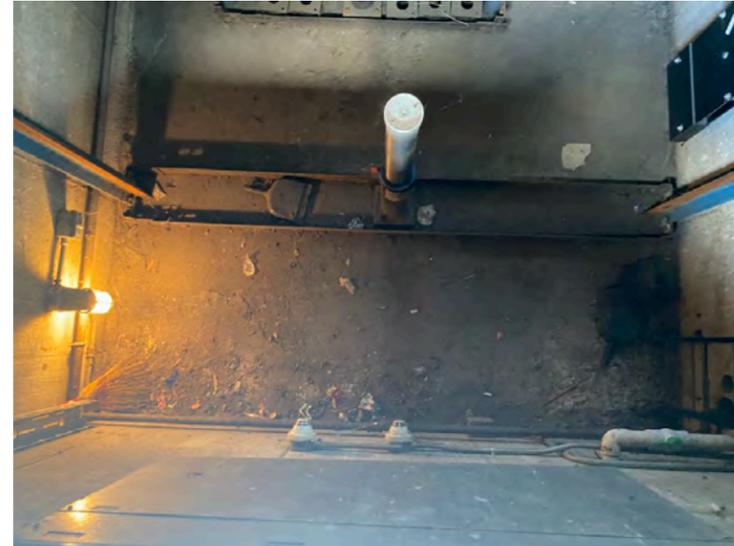
Pits have trash and debris and need additional cleaning

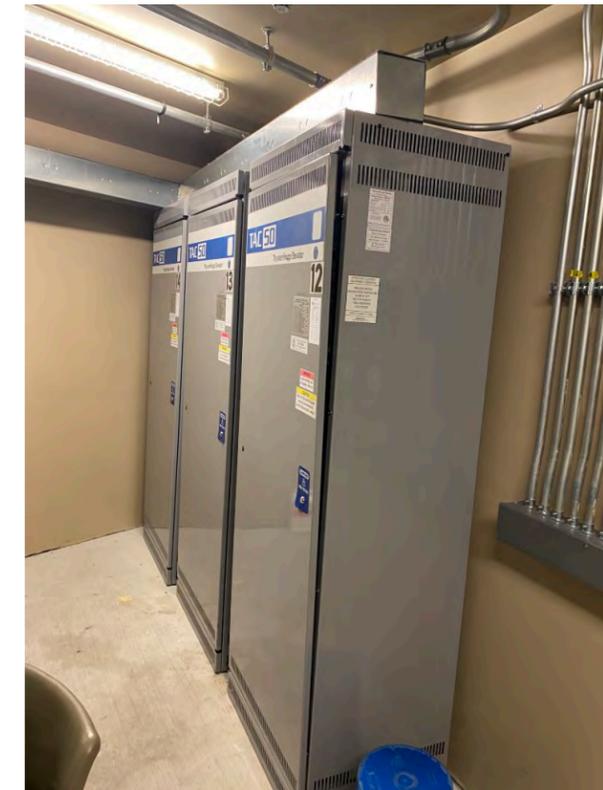
Typical controller layout in the controller rooms

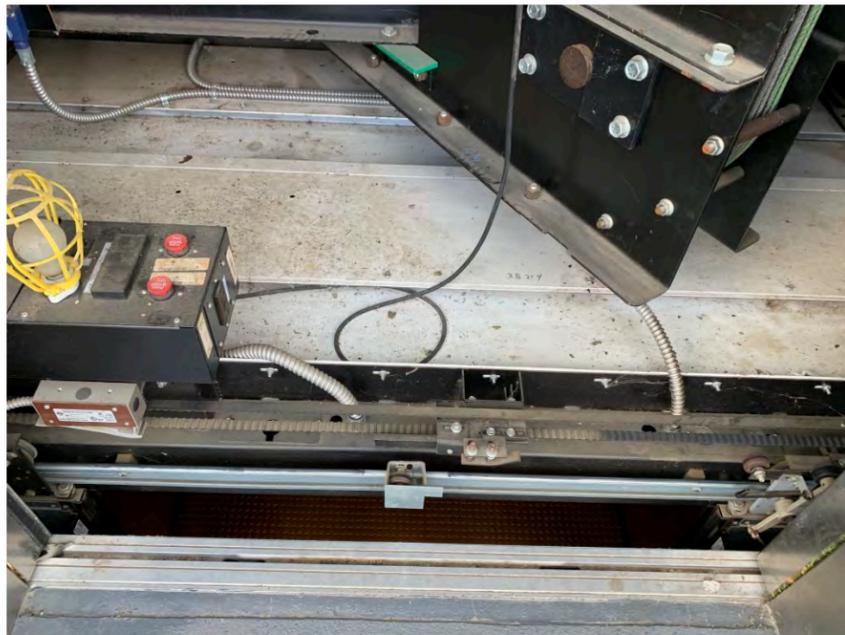
Typical car door operator and inspection station for group

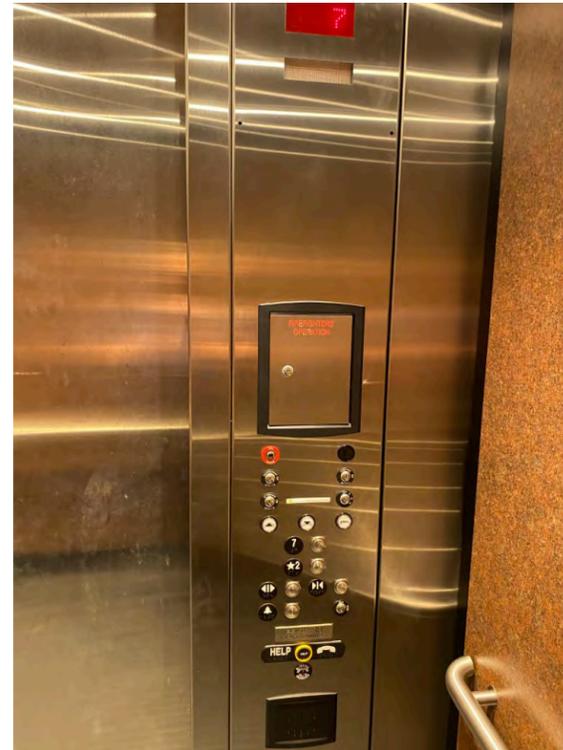
Typical car operating panel and fixtures for these elevators

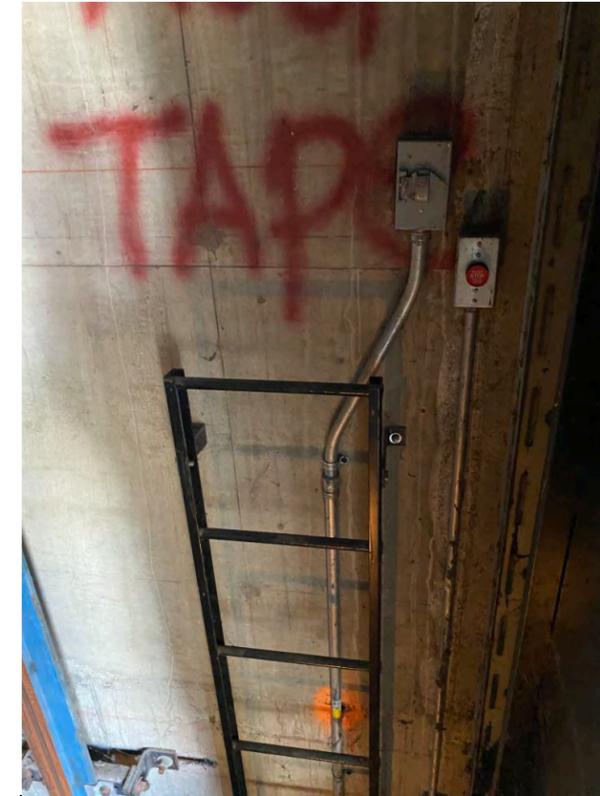
Express elevator pits are missing identification numbers

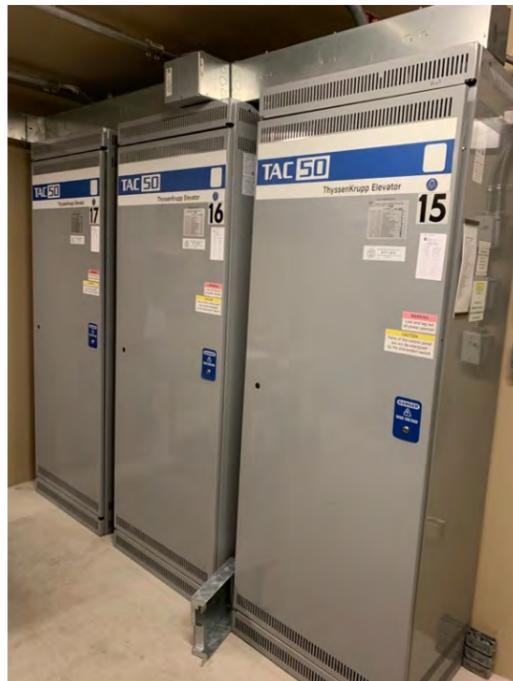
TKE TAC50 Microprocessor controllers

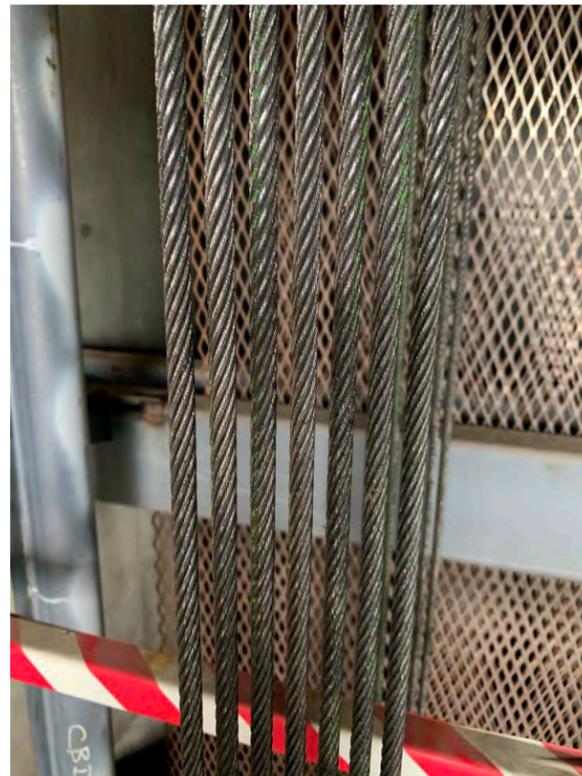
Hoist ropes have slight crown wear and tensioning, and lubrication is needed

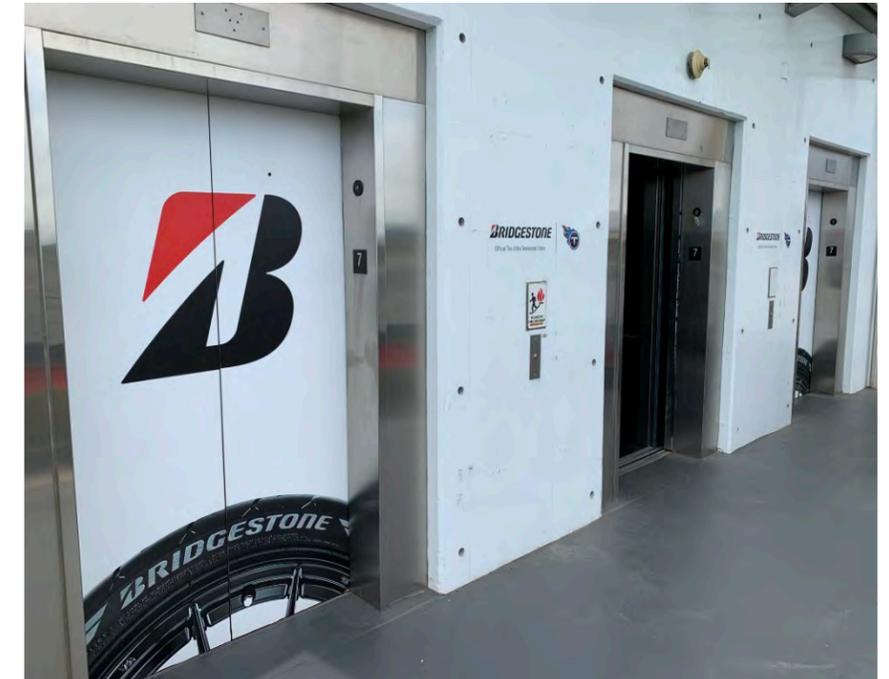
Express elevators at outdoor top landing 7<sup>th</sup> floor entrance

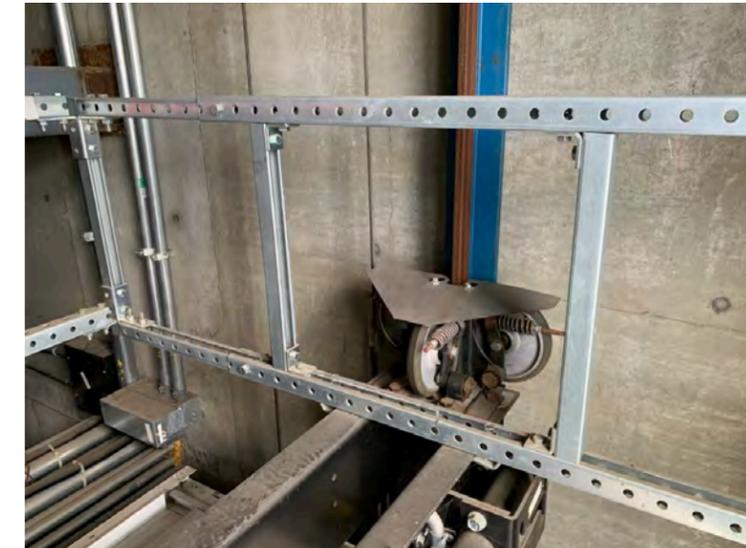
Car tops are equipped with handrails and roller guides roughly operating

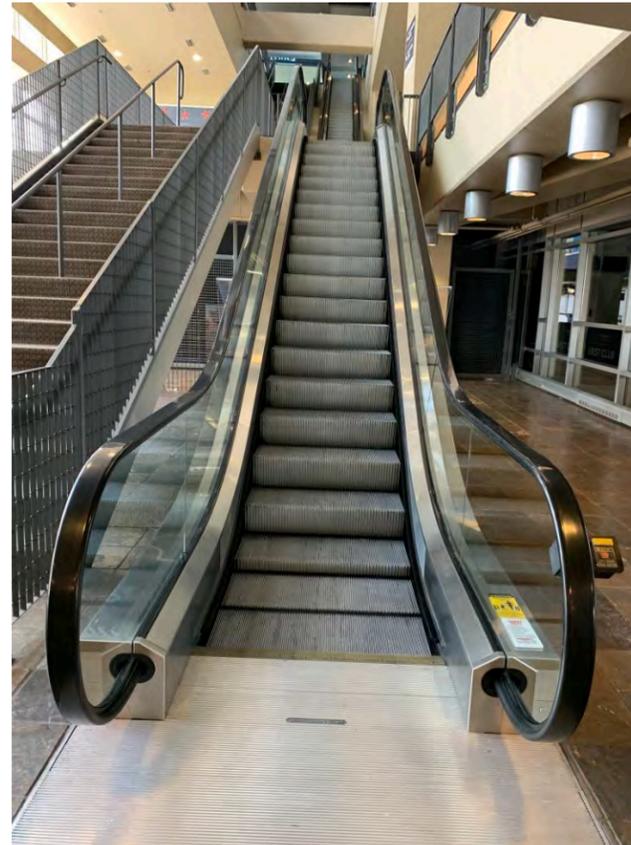
Escalator landings, balustrades, and steps are in good condition

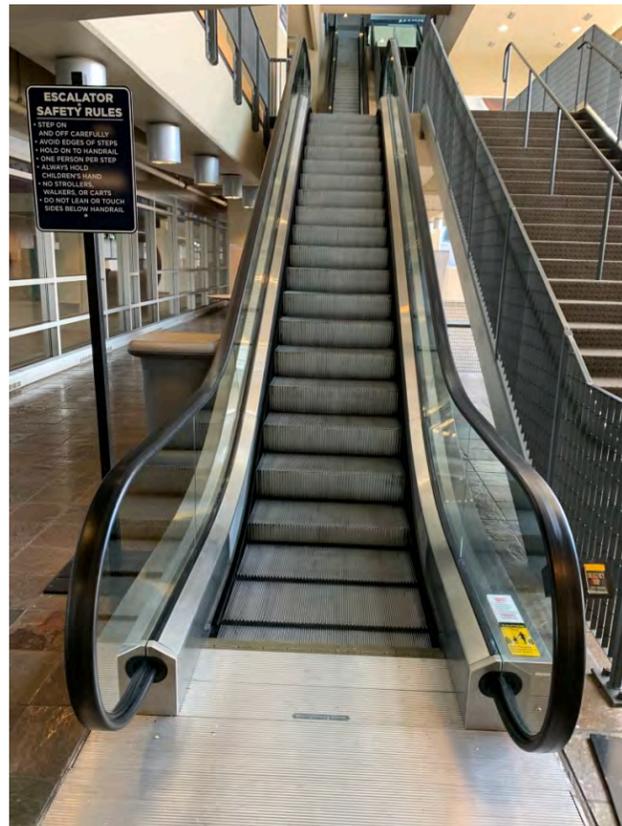
Escalator view from the 2<sup>nd</sup> landing looking up to long unit above

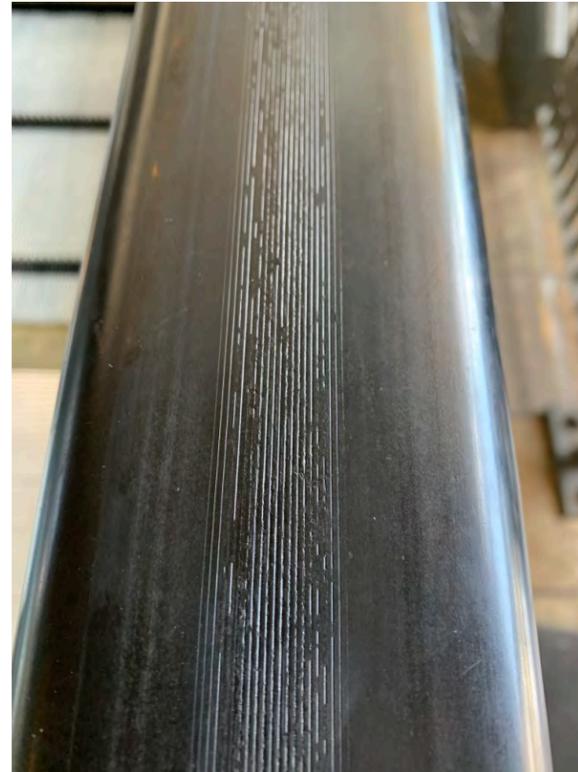
Right side handrail is damaged from rubbing on drive wheel

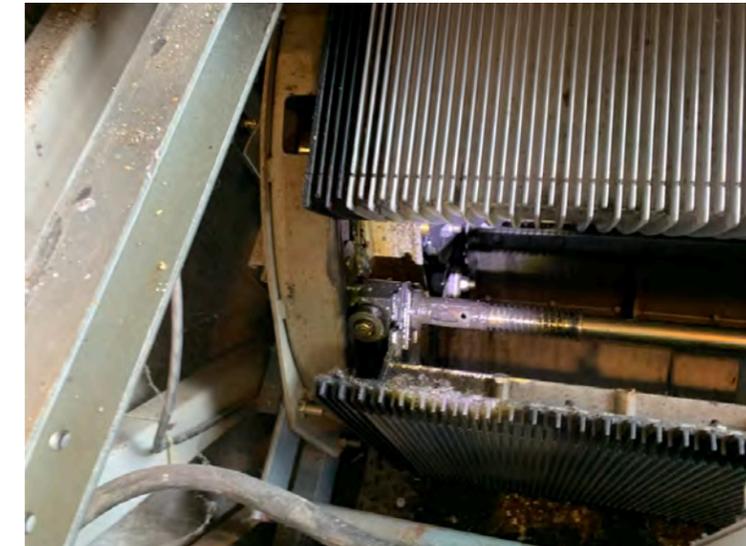
Step chains appear to be well lubricated, and no damaged rollers or step axles were found during the visual inspection

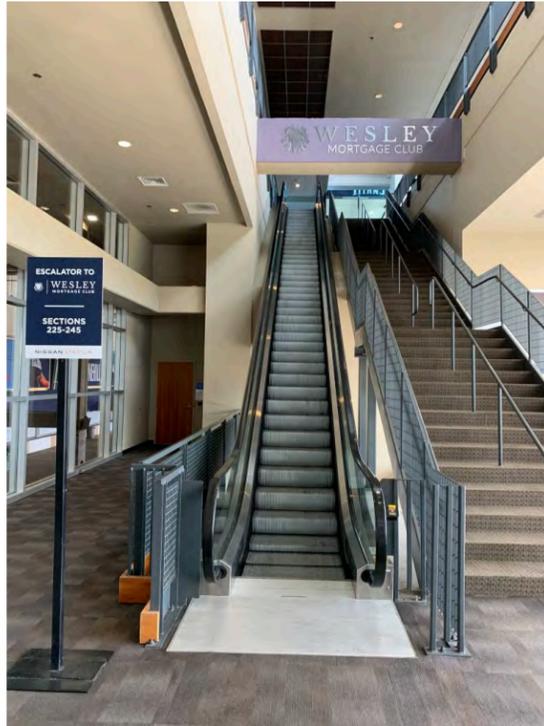
*West long escalator transports patrons to the Wesley Mortgage Club Level*

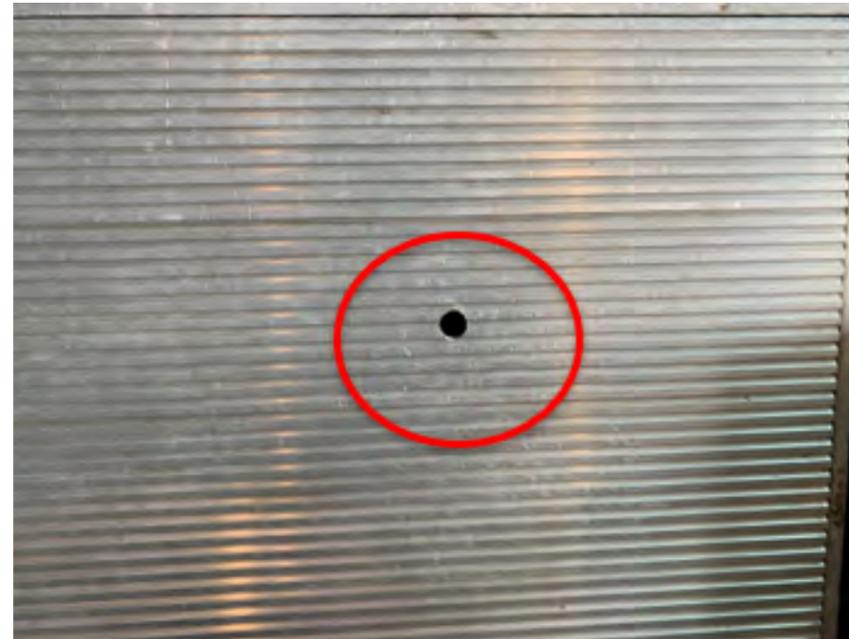
*Upper landing floor plate was not secured with a hole in the plate which TKE has since repaired*

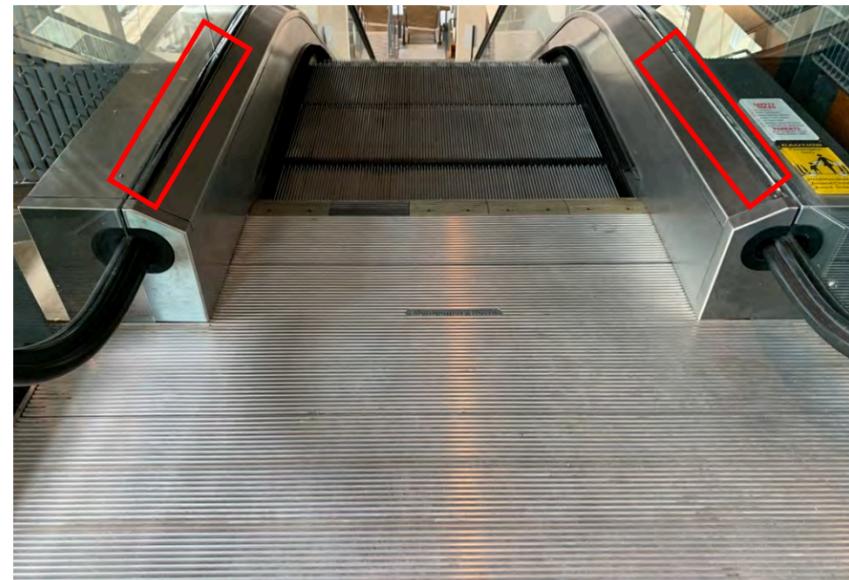
*Upper landing plastic skirting cover on the right side is missing and damaged on the left side*
