## 1.10 Photographs

### Transit Authority

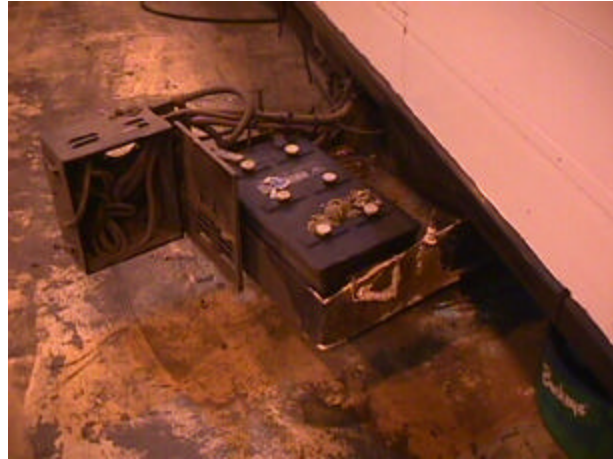
**Battery care and maintenance is not well managed. Road calls and frequent “jump-starts” are a result.**

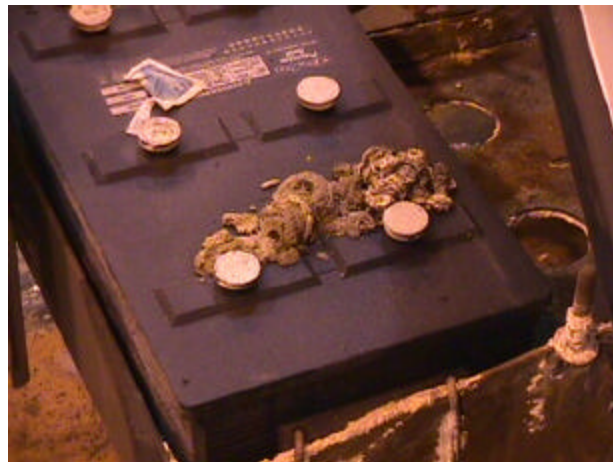
**Another example of poor battery maintenance. Costly damage has occurred to the cables, tray, and hold down bracket.**

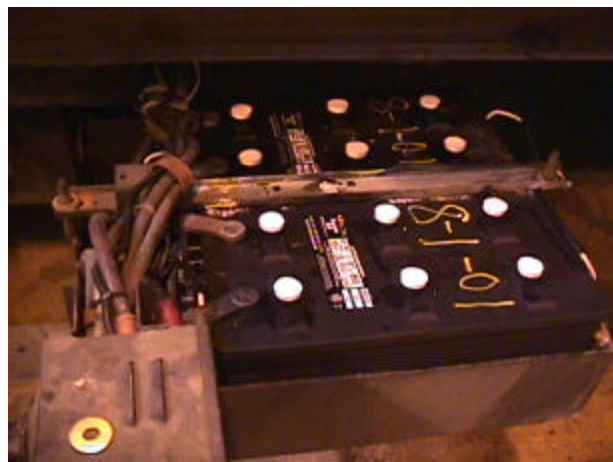
**This bus had received a new battery only days prior to this photograph. Note that neither cables or brackets were serviced as part of the replacement.**

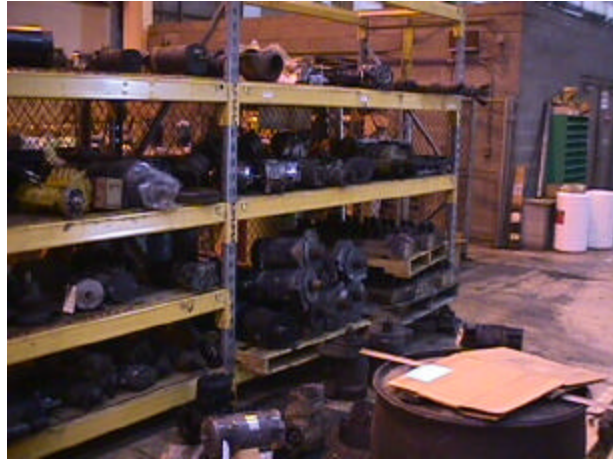
**The shop rebuilds many small components that should be more economically outsourced, exchanged with remanufactured or purchase new. “In-house” rebuilt components do not provide warranty and it is exceedingly difficult to stay current with manufacturers technological updates for older components.**

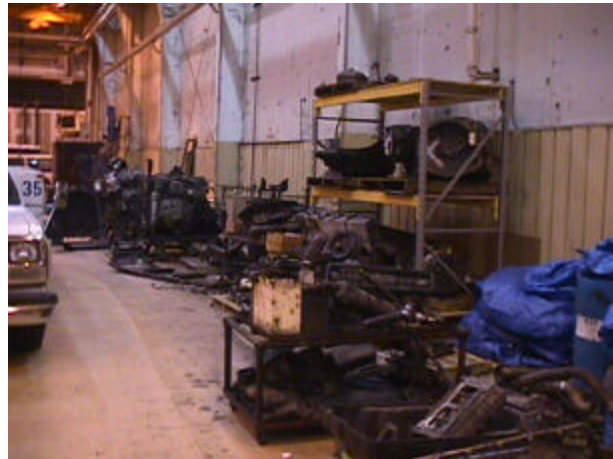
**Used parts and supplies should be inventoried, tagged, and secured.**

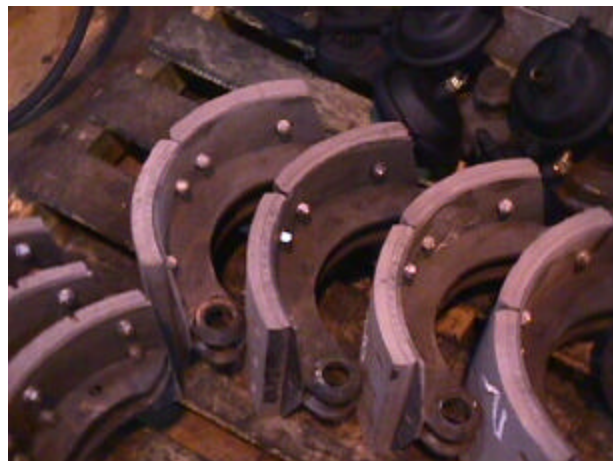
**These locally relined brakes were not on exactly the same shoes but appeared as a set. Only exact matches should be used for shoe and friction sets.**

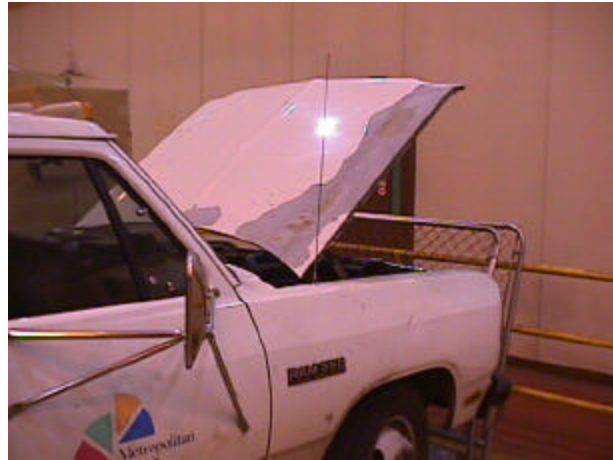
**The support fleet appearance requires attention. Note the peeled hood paint.**

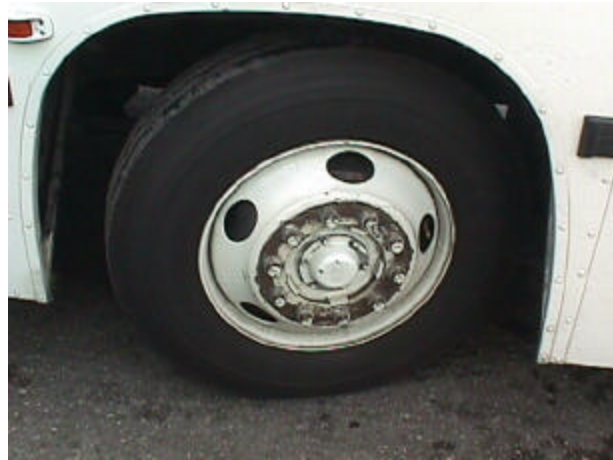
**Many busses have wheels in need of paint. A little effort in this area would enhance overall fleet appearance.**

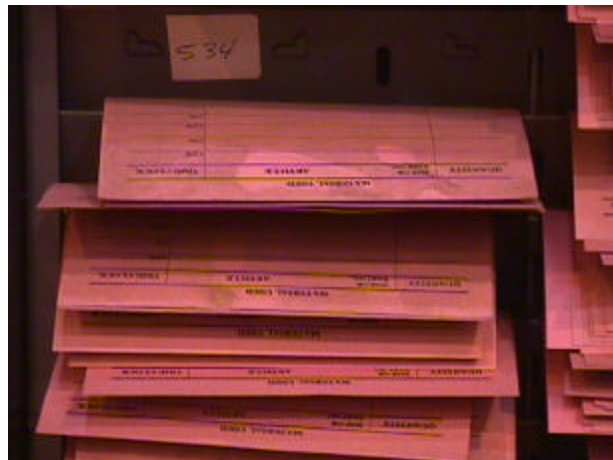
**Hundreds of open work tickets appear "open" dating back to December 1998. One supervisor stated that these were no longer in use. Another supervisor stated that they were.**

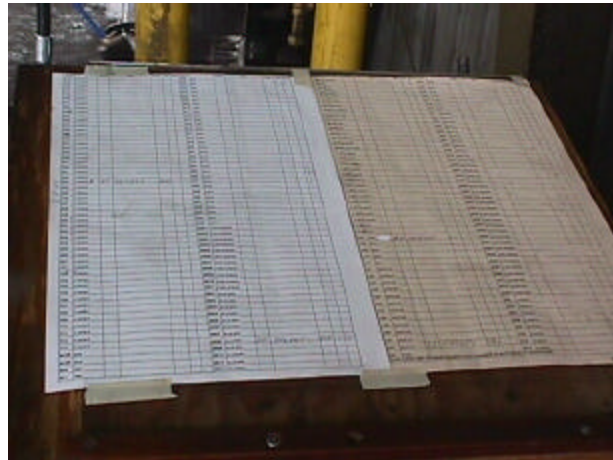
**The end of shift fueling process is slow and subject to errors as manual systems are. An automated system should be installed.**

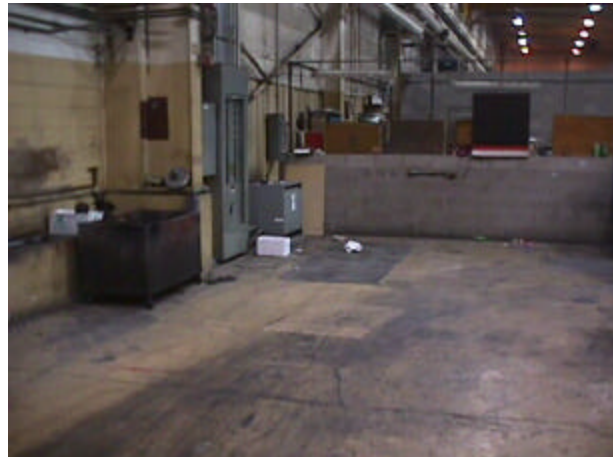
**The large shop is in need of paint and a thorough cleaning. Trash and debris should be removed each day.**

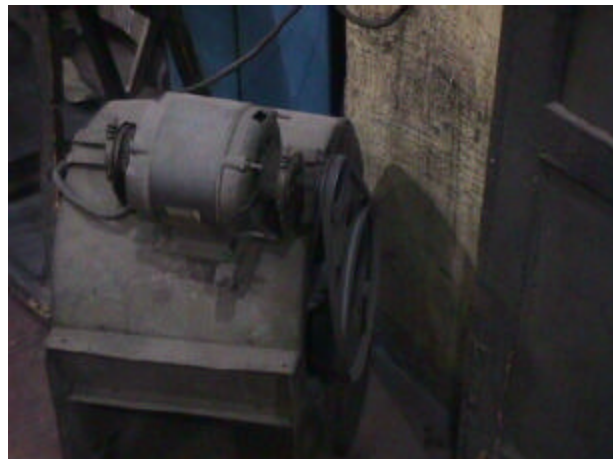
**The shop has several portable fans that are not properly equipped with belt guards. These should be repaired or removed from service.**
