PAINT COLOR SURVEY

EDGEFIELD HISTORIC DISTRICT

RICHLAND - WEST END

Metropolitan Historical Commission
Nashville, Tennessee

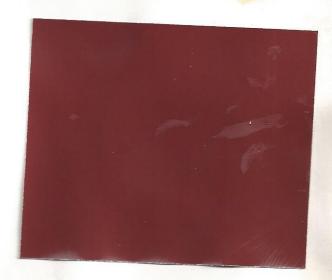
801 Boscobel $1\frac{1}{2}$ story, frame

Location	Paint	Paint	Munsell
	Color	Type	Code
Siding, porch balusters:	tan	oil	10YR 8/2

Window and door frames, porch columns, top and bottom rail:

dark oil 10R red 3/1 grey

Window sash:

dark oil 10R red 3/6

Door:

mahogany oil graining

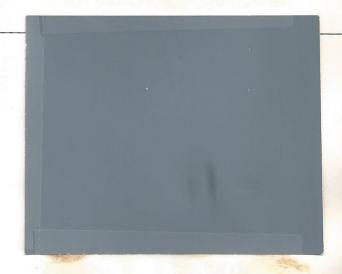
805 Boscobel (cont'd)

SECOND PAINT LAYER

Location	Paint	Paint	Munsell
	Color	Type	Code
Siding:	medium grey	oil	10B 5/1

Window and door frames, porch columns and railing, corner boards, and skirting:

10B 1ight oil 7/1 grey

Window sash:

black oil

N1.

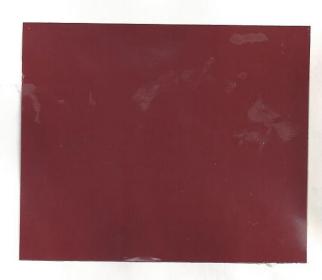
800 Russell (cont'd)

FOURTH PAINT LAYER

Window and

door frames:

dark red oil

7.5R 3/6

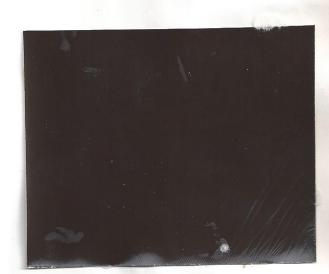
804 Russell

FIRST (ORIGINAL) PAINT LAYER

Window frames:

cream

oil

5Y

8.5/2

Window sash, main door, door frame

and sidelights:

dark brown oil

10YR 2/2

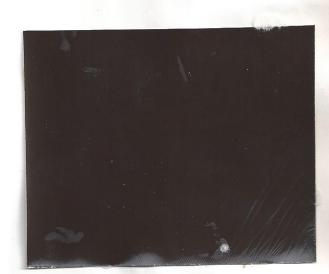
804 Russell

FIRST (ORIGINAL) PAINT LAYER

Window frames:

cream

oil

5Y

8.5/2

Window sash, main door, door frame

and sidelights:

dark brown oil

10YR 2/2

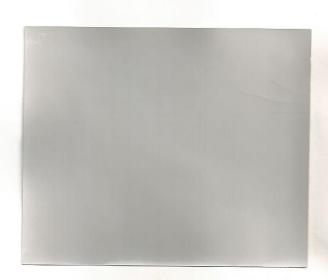
519 Fatherland (cont'd)

SECOND PAINT LAYER

Location	Paint	Paint	Munsell
	Color	Type	Code
Siding, cornice brackets:	light grey	oil	5Y 7/1

Door and window frames, porch columns and railing, porch cornice:

medium oil 5Y grey 6/1

Window sash:

dark oil red

10R 2/6

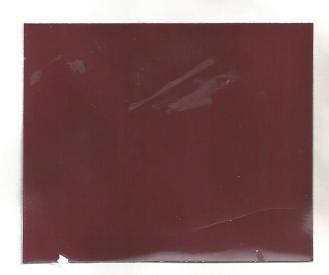
517 Fatherland (cont'd)

THIRD PAINT LAYER

Location	Paint	Paint	Munsell
	Color	Type	Code
Siding,			
cornice

railing: grey oil N5.25

Door and
window frames,
window sash,
porch
columns,
cornice,
door:

dark oil 10R red 3/4
