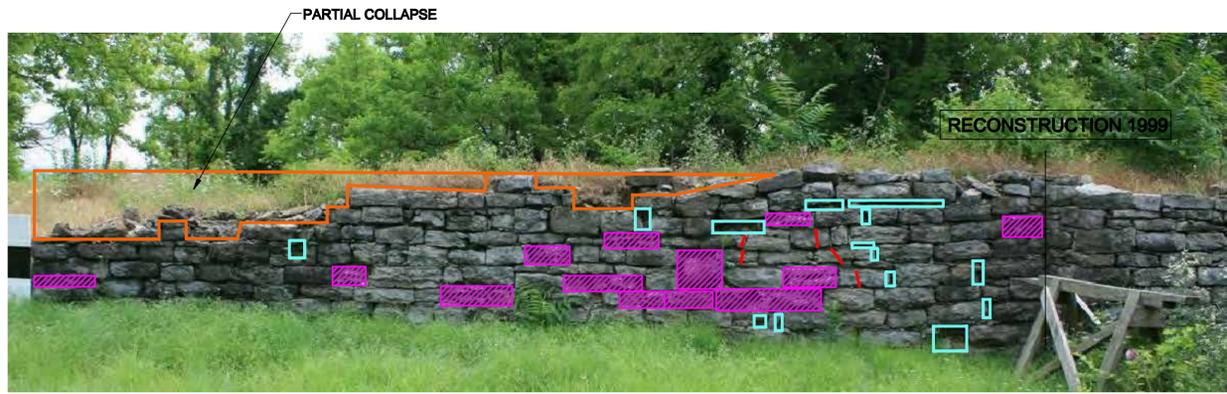
48 EAST BASTION - REDAN #8 CONNECTION WALL
A116 SCALE: 3/8" = 1'-0"

CAMBER: WALL IS PERPENDICULAR WITH MINIMAL BATTER
STONE SIZE: MEDIUM TO SMALL STONES
COURSING: SOMEWHAT COURSED, MORE COURSED ON RIGHT THAN LEFT
CHINKING: SMALL ROCKS USED AS FACE CHINKING
VEGETATION: SMALL WEEDS IN FACE, NO TREES
SLOPE: GROUND IS FAIRLY LEVEL

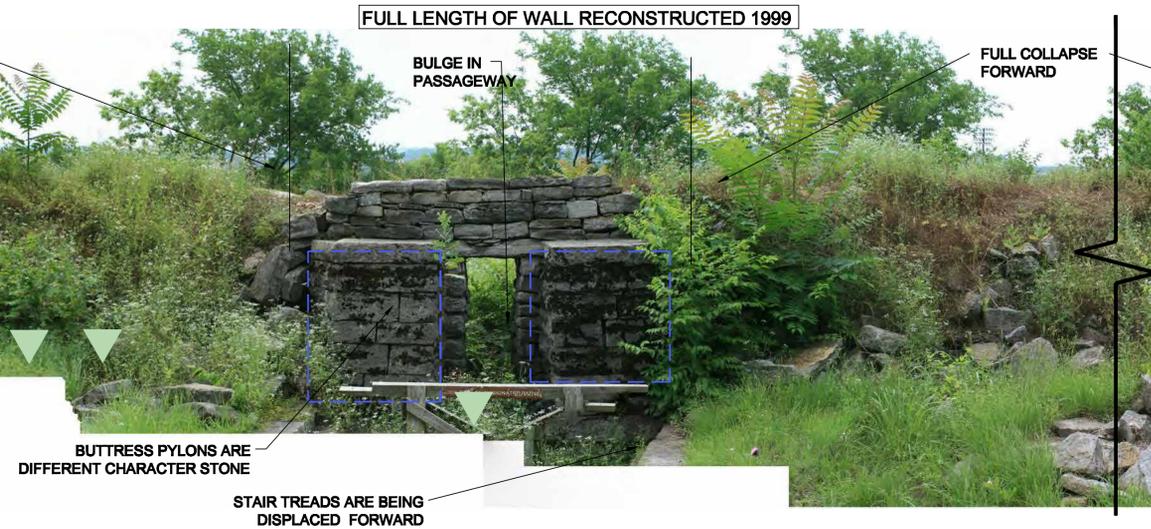
50 SOUTH MAIN WORKS - WEST WALL - FACING EAST BASTION
A116 SCALE: 3/8" = 1'-0"

CAMBER: WALLS ARE BULGING OR HAVE COLLAPSED FORWARD. WALLS AT STAIR ARE BATTERED.
STONE SIZE: IRREGULAR, EXCEPT AT BUTRESSES AT PORTAL. STONES MEDIUM SIZE.
COURSING: STRONG COURSING, WHERE WALLS STILL REMAIN
CHINKING: LARGE AND SMALL CHINKING USED, MANY GAPS AT FORMER CHINKING
VEGETATION: SMALL WEEDS IN FACE. SAPPLINGS VISIBLE ALONG WALL
SLOPE: MOSTLY LEVEL IN FRONT OF WALL

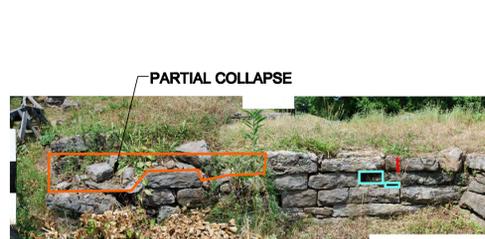
CAMBER: BATTERED AT RIGHT, LEANING OUT AT LEFT SIDE
STONE SIZE: RANDOM, SOME LARGE STONES. STONE AT RIGHT SIDE IS OF LESSER QUALITY
COURSING: NOT WELL DEFINED, IRREGULAR
CHINKING: NOT MUCH
VEGETATION: MOSTLY VINES AND WEEDS IN WALL, NO TREES
SLOPE: FALLS AWAY ROUGHLY PERPENDICULAR TO WALL

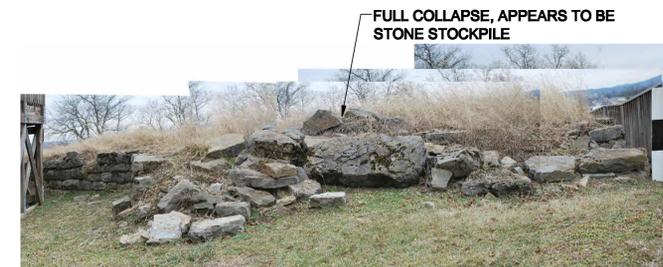
CAMBER: NOT DISCERNABLE
STONE SIZE: NOT DISCERNABLE
COURSING: NOT DISCERNABLE
CHINKING: NOT DISCERNABLE
VEGETATION: VINES AND WEEDS IN WALL, NO TREES
SLOPE: FALLS AWAY SLIGHTLY ROUGHLY PERPENDICULAR TO WALL, FAIRLY LEVEL

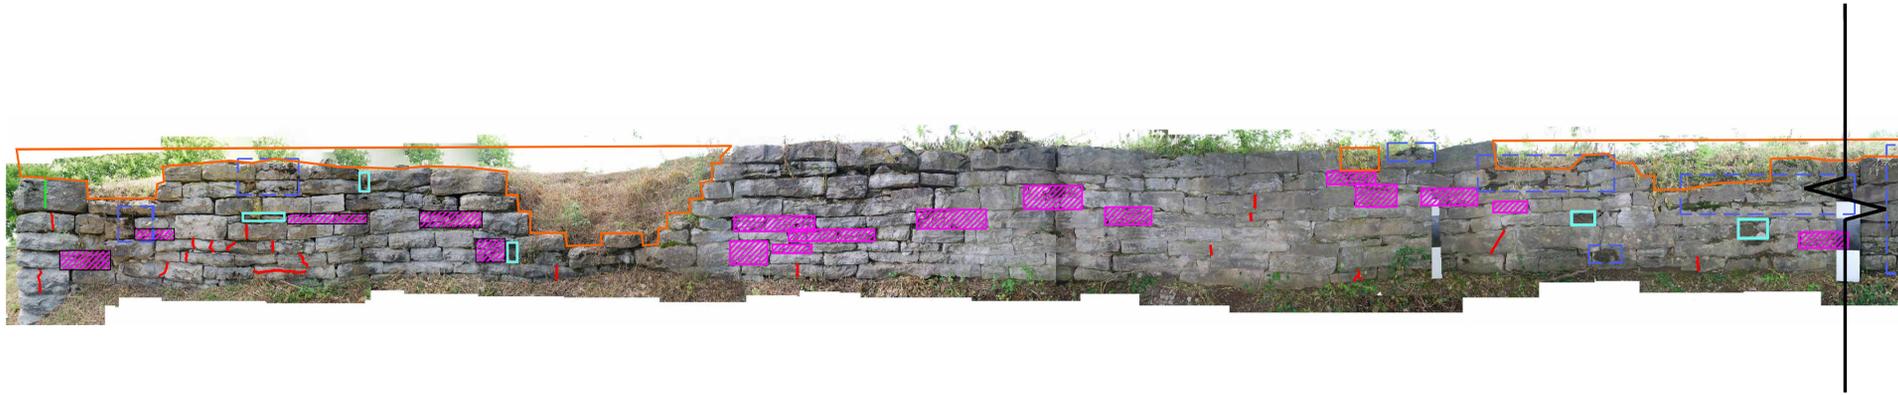
60A EAST INNER WORKS - EXTERIOR - SOUTH - LEFT END
A118 SCALE: 3/8" = 1'-0"

CAMBER: MOSTLY VERTICAL
STONE SIZE: MEDIUM, HORIZONTAL, FAIRLY HOMOGENOUS
COURSING: FAIRLY WELL COURSED
CHINKING: NOT MUCH, BUT SOIL FILLS JOINTS
VEGETATION: SMALL WEEDS IN FACE, NO TREES
CRACKS: FALLS AWAY SLIGHTLY, ROUGHLY PERPENDICULAR TO WALL

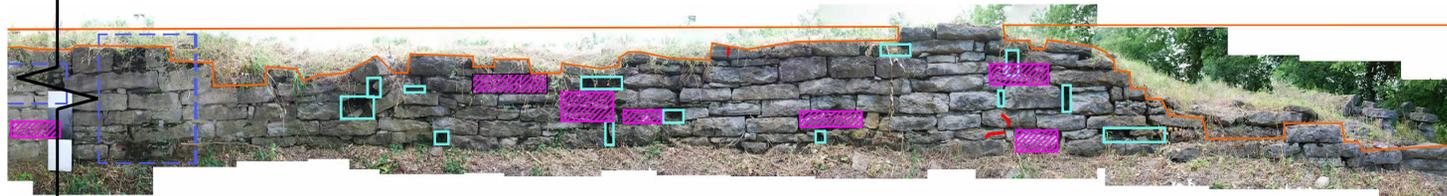
60B EAST INNER WORKS - EXTERIOR - SOUTH - RIGHT END
A118 SCALE: 3/8" = 1'-0"

CAMBER: MOSTLY VERTICAL
STONE SIZE: MEDIUM, HORIZONTAL, FAIRLY HOMOGENOUS
COURSING: FAIRLY WELL COURSED
CHINKING: NOT MUCH, BUT SOIL FILLS JOINTS
VEGETATION: SMALL WEEDS IN FACE, NO TREES
CRACKS: FALLS AWAY SLIGHTLY, ROUGHLY PERPENDICULAR TO WALL

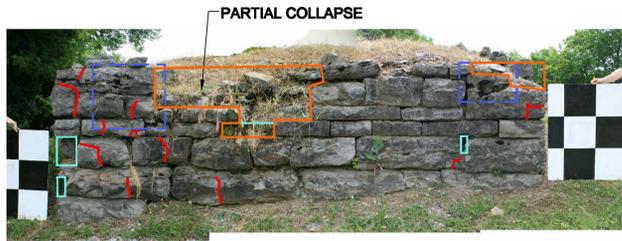
62 EAST INNER WORKS - NORTH END FACING NORTH MAIN WORKS
A119 SCALE: 3/8" = 1'-0"

CAMBER: VERTICAL OR LEANING OUT
STONE SIZE: MEDIUM AND LARGE, BY COURSE
COURSING: COURSED
CHINKING: NONE
VEGETATION: VINES AND WEEDS IN WALL, NO TREES
SLOPE: FALLS AWAY ROUGHLY PARALLEL TO WALL.

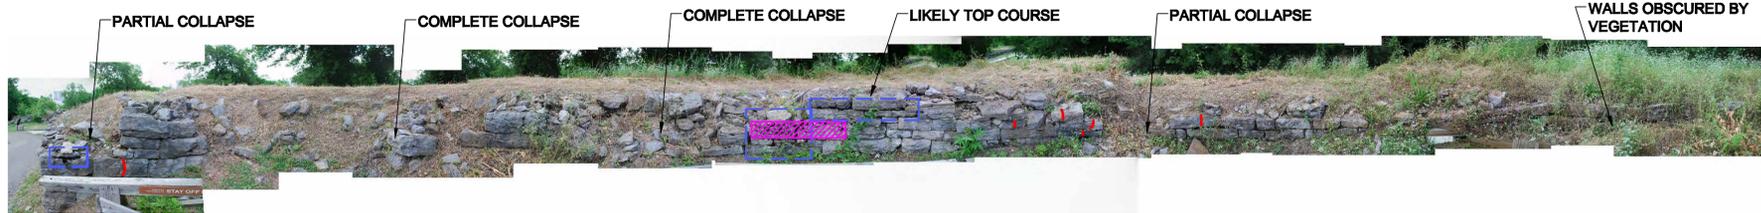
63 EAST INNER WORKS - INTERIOR - NORTH
A119 SCALE: 3/8" = 1'-0"

CAMBER: VERTICAL OR LEANING OUT
STONE SIZE: MEDIUM AND FAIRLY REGULAR
COURSING: NOT WELL DEFINED, IRREGULAR
CHINKING: NOT MUCH
VEGETATION: VINES AND WEEDS IN WALL, NO TREES
SLOPE: MOSTLY LEVEL.

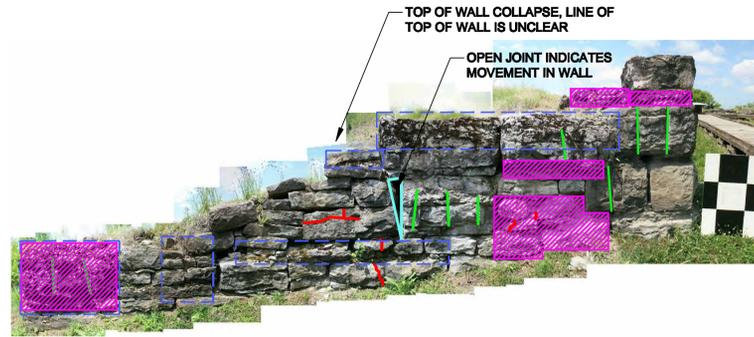
67 WEST INNER WORKS - SOUTH END - FACING SOUTH MAIN WORKS
A120 SCALE: 3/8" = 1'-0"

CAMBER: MOSTLY VERTICAL
STONE SIZE: MIXED, BUT SOME VERY
LARGE STONES. SOME OF BAD
QUALITY
COURSING: IRREGULAR COURSING
CHINKING: SOME SMALL STONES,
FALLING OUT IN AREAS
VEGETATION: MINIMAL
SLOPE: SLOPED PARALLEL TO WALL

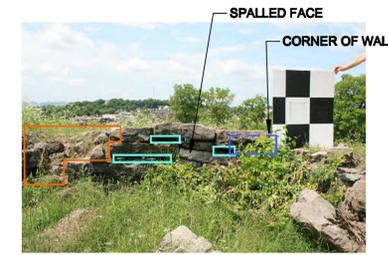
69 WEST INNER WORKS - INTERIOR - INSIDE CENTER FACING WEST
A120 SCALE: 3/8" = 1'-0"

CAMBER: WALLS ARE VERTICAL
STONE SIZE: IRREGULAR, MANY VERY
LARGE STONES
COURSING: IRREGULAR COURSING
CHINKING: LARGE CHINKING STONES
HAVE FALLEN OUT
VEGETATION: SMALL WEEDS IN FACE
SLOPE: AWAY FROM WALL SLIGHTLY

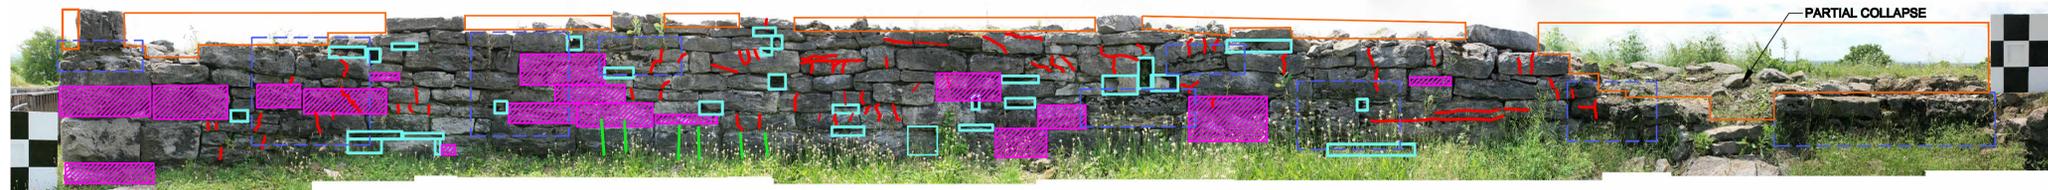
68 WEST INNER WORKS - INTERIOR - INSIDE FACING SOUTH
A120 SCALE: 3/8" = 1'-0"

CAMBER:
STONE SIZE: MIXED, BUT SOME VERY
LARGE STONES. MANY OF BAD
QUALITY
COURSING: IRREGULAR COURSING
CHINKING: HEAVY, FALLING OUT OR
MISSING IN AREAS
VEGETATION: SMALL WEEDS IN FACE
SLOPE: MOSTLY LEVEL

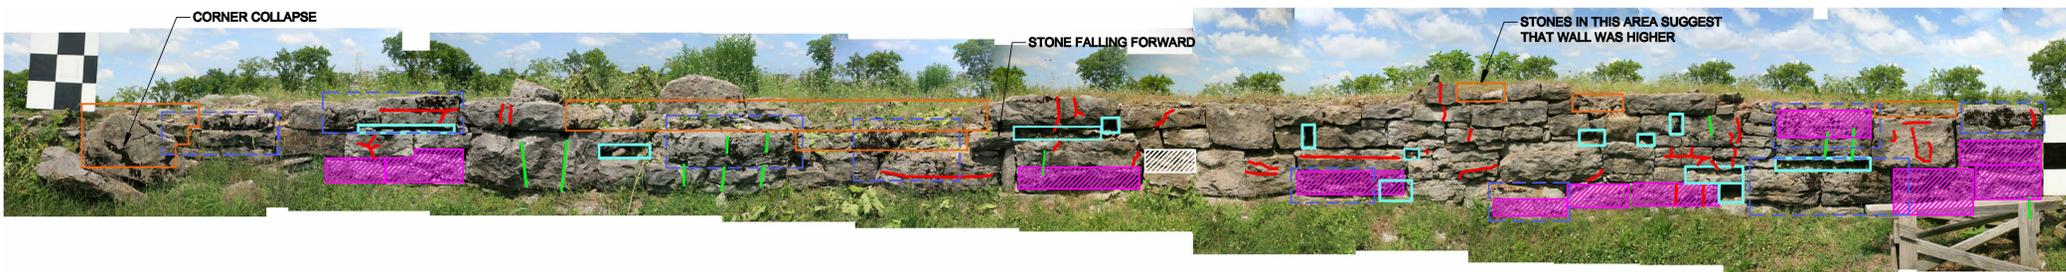
70 WEST INNER WORKS - INTERIOR - INSIDE FACING NORTH
A120 SCALE: 3/8" = 1'-0"

CAMBER: WALL HAS FALLEN FORWARD
STONE SIZE: MEDIUM TO SMALL STONES
COURSING: IRREGULAR COURSING
CHINKING: HEAVILY CHINKED AT LEFT
END
VEGETATION: SMALL WEEDS IN FACE, GRASS
HAS GROWN OVER AND
THROUGH
SLOPE: GROUND SLOPES AWAY FROM
WALL BOTH PERPENDICULAR
AND PARALLEL

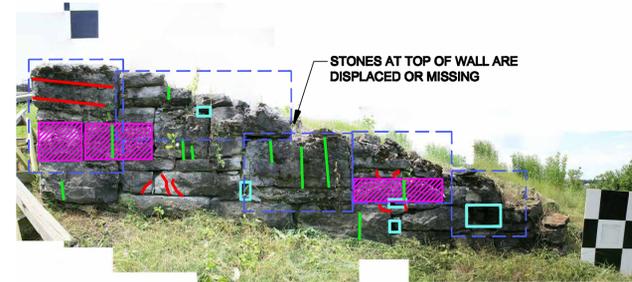
71 WEST INNER WORKS - INTERIOR - INSIDE FACING NORTH MAIN WORKS
A120 SCALE: 3/8" = 1'-0"

CAMBER: WALLS ARE SLIGHTLY
BATTERED
STONE SIZE: IRREGULAR, MANY VERY
LARGE STONES
COURSING: IRREGULAR COURSING
CHINKING: FAIRLY LARGE STONES USED
AS CHINKING
VEGETATION: SMALL WEEDS IN FACE, SOME
TREES
SLOPE: AWAY FROM WALL AND ALSO
PARALLEL TO RIGHT

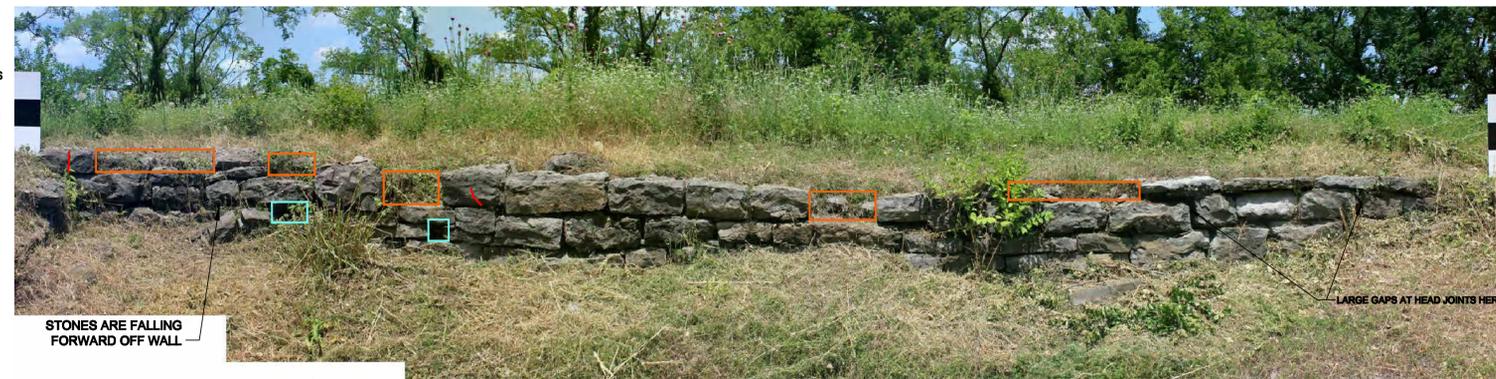
CAMBER: WALLS ARE MOSTLY
BATTERED
STONE SIZE: MEDIUM
COURSING: COURSED BUT NOT
LEVEL, WALL FEELS LIKE
IT IS SETTLING INTO
GRADE IRREGULARLY
CHINKING: NONE
VEGETATION: SMALL WEEDS IN FACE,
SOME TREES
SLOPE: MOSTLY LEVEL, BUT
IRREGULAR PARALLEL TO
WALL

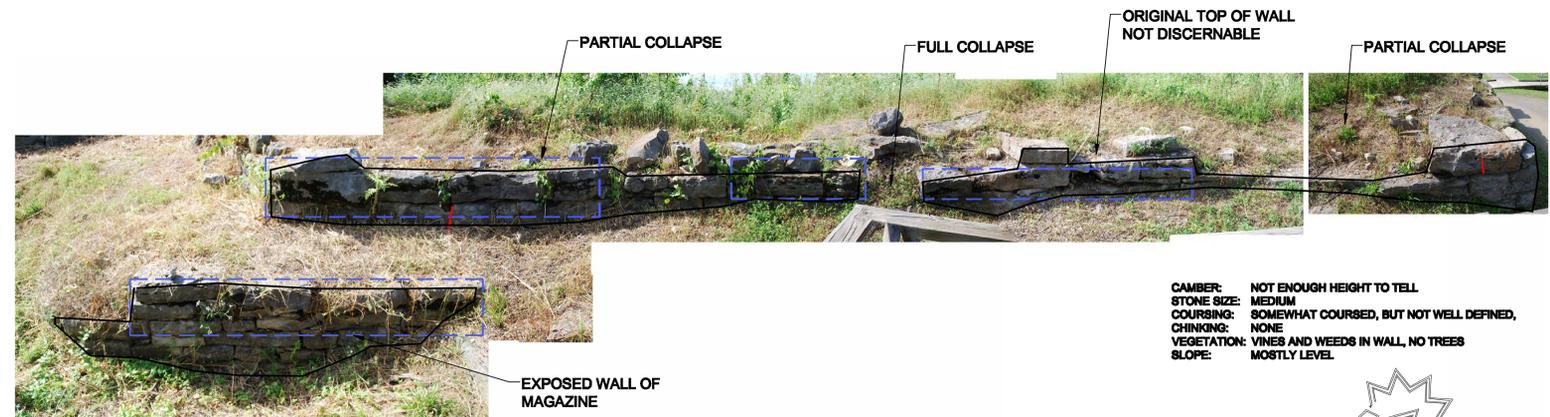
CAMBER: NOT ENOUGH HEIGHT TO TELL
STONE SIZE: MEDIUM
COURSING: SOMEWHAT COURSED, BUT NOT WELL DEFINED,
CHINKING: NONE
VEGETATION: VINES AND WEEDS IN WALL, NO TREES
SLOPE: MOSTLY LEVEL
