METROPOLITAN GOVERNMENT OF NASHVILLE AND DAVIDSON COUNTY

STAFF RECOMMENDATION
204 South 11th Street
December 18, 2013

Application: Demolition

Description of Project: The applicant proposes to demolish a contributing historic building to the Lockeland Springs-East End Neighborhood Conservation Overlay based on economic hardship.

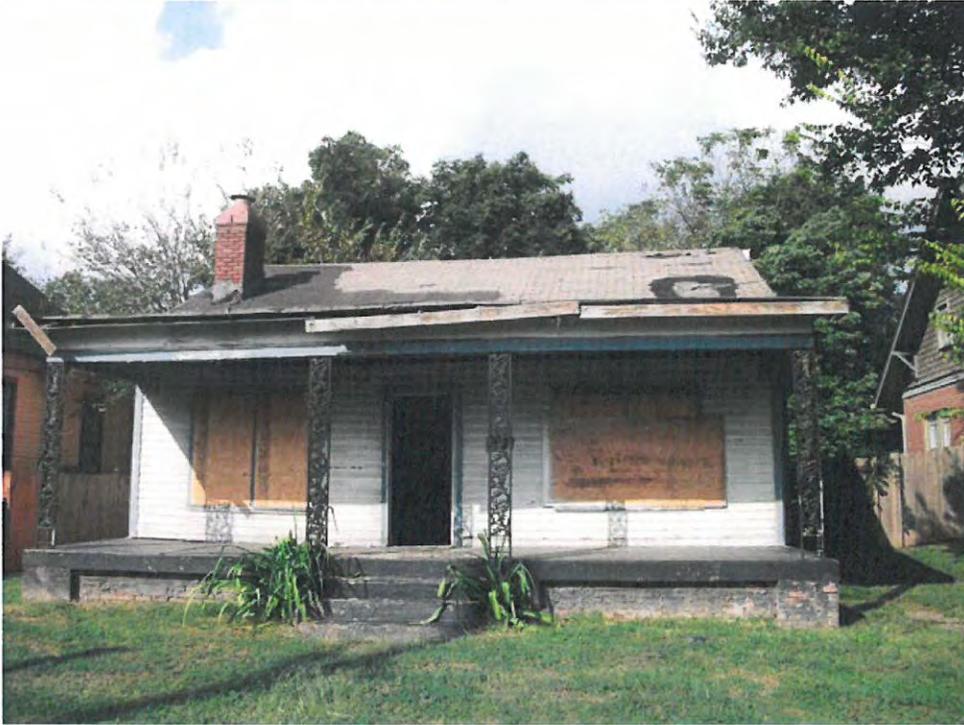
As requested, I met David Baird at the above listed residence on October 4, 2013, to perform structural observations to evaluate the condition of the residence (Photo 1). I understand you wanted to document the structural condition of the residence as part of the process of developing a cost analysis for the rehabilitation of the structure. The structure has been completely gutted and the amount of rehabilitation work required will require the structure to meet current building codes, the 2006 IRC.

Photo 1: View of front of residence at 204 S. 11th St.

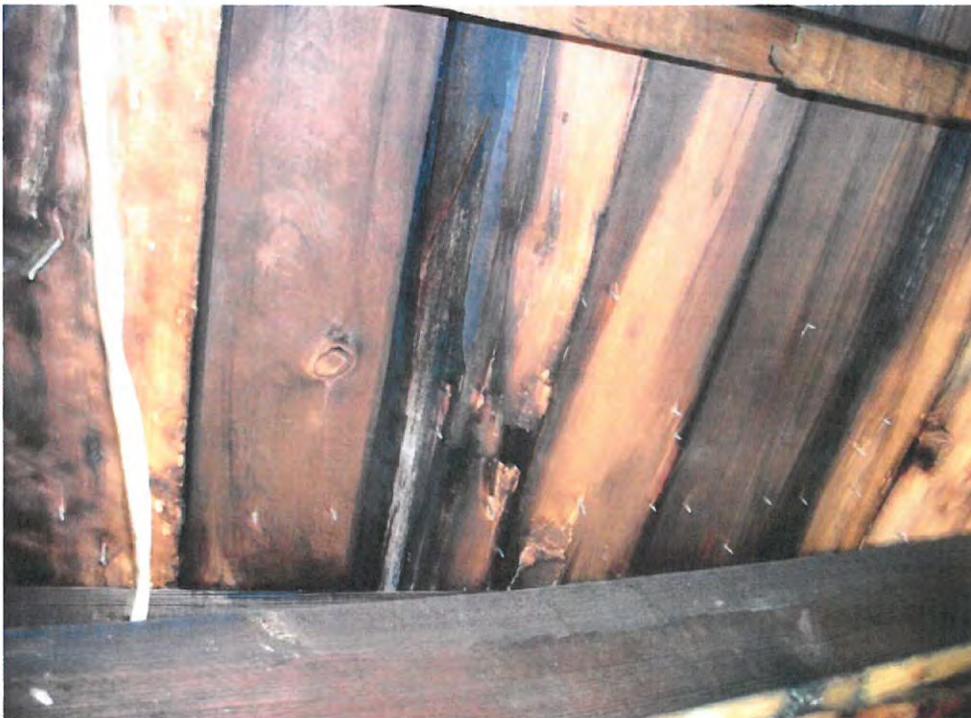
The roof shingles need to be replaced (Photo1). The presence of patches on top of the shingles acts to impede runoff flow making leaks more likely. The roof deck is planking that has been exposed to fire as evidenced by black staining, many splits, and isolated cracks typical of those created by heat damage (Photo 2). The roof rafters are 2x4 at a spacing of about 24-inches on-center. Current codes require 2x8 rafters at 16-inches on-center for the span of the rafters. GEC recommends:

Photo 2: View of roof decking showing fire damage.

- The roof covering and roof framing need to be completely replaced.

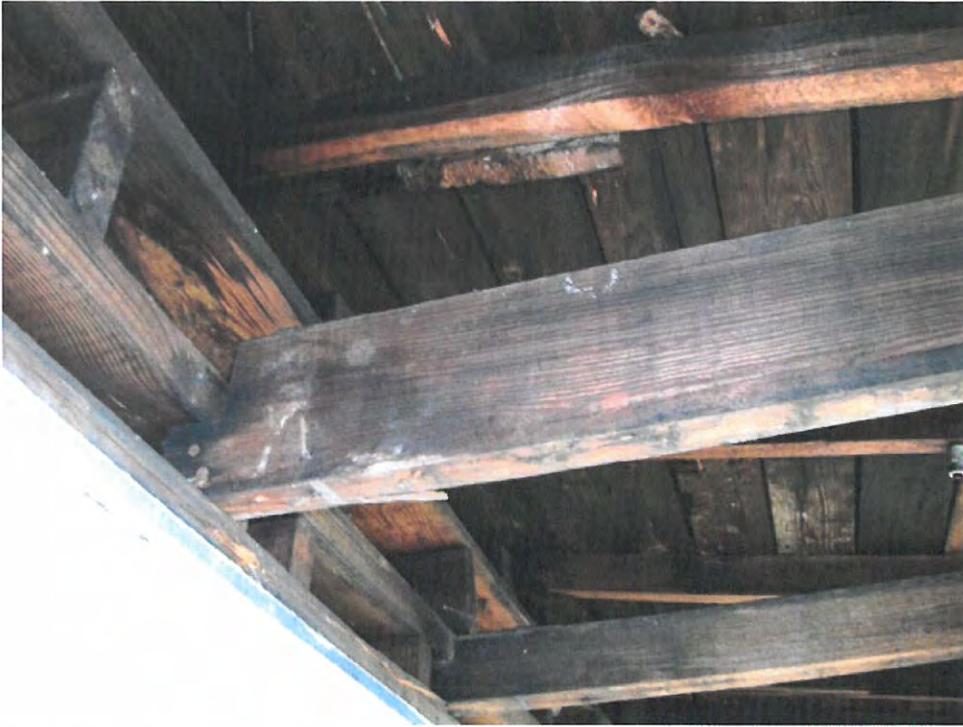
The existing ceiling joists are 2x6. These joists are not suitable for bearing the loads of finished space. The ceiling joists over the front porch are over-notched at the bearing location on the front wall of the residence (Photo 3). GEC recommends:

Photo 3: The ceiling joists are over-notched at the bearing on the front wall of the residence.

- For typical spans for floor joists for finished space, the 2x6 ceiling joists will need 2x8 sister joists for normal floor loads and 2-ply 2x8 sister joists beneath non-load-bearing partition walls and areas with tile floor covering.
- The 2x6 ceiling joists over the front porch need to be replaced.

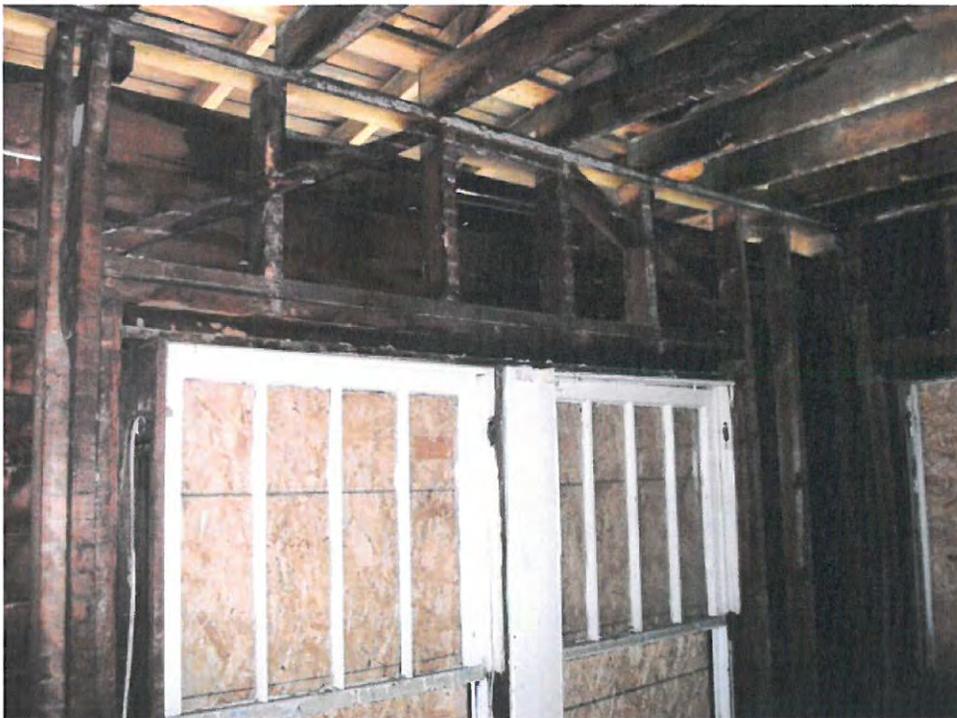
The exterior and interior load-bearing walls do not have headers above doorways and windows (Photos 4 and 5). The load-bearing walls do not have 2-ply top plates; therefore, studs must directly align with ceiling joists and/or rafters bearing on the walls, which they do not (Photo 6). GEC recommends:

Photo 4: View of exterior wall showing the absence of a header above the window.

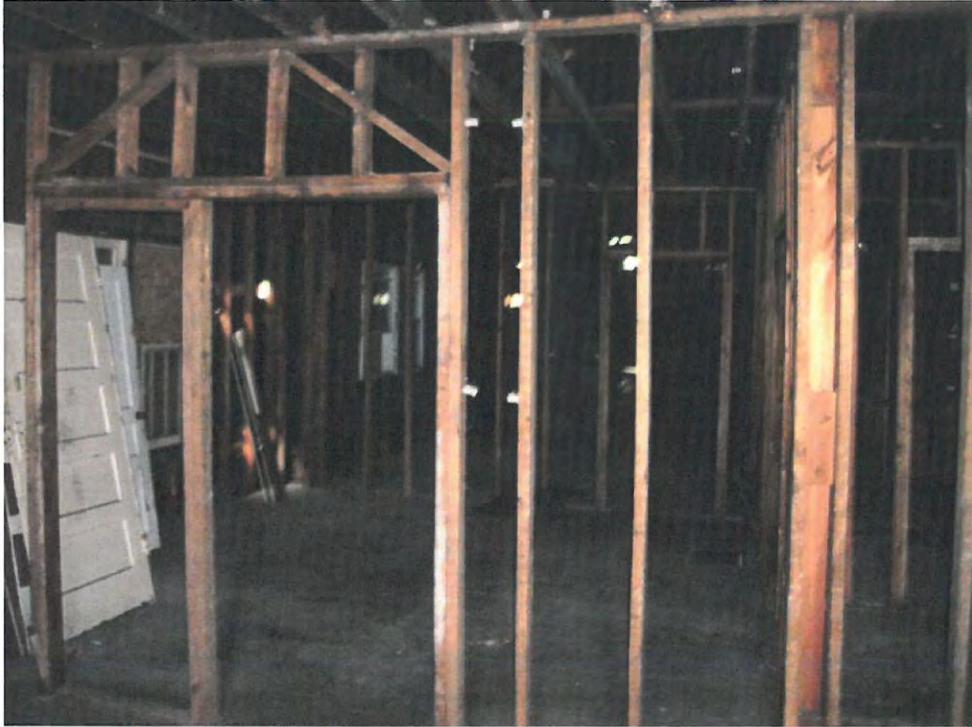
Photo 5: View of interior load-bearing wall showing the absence of a header.

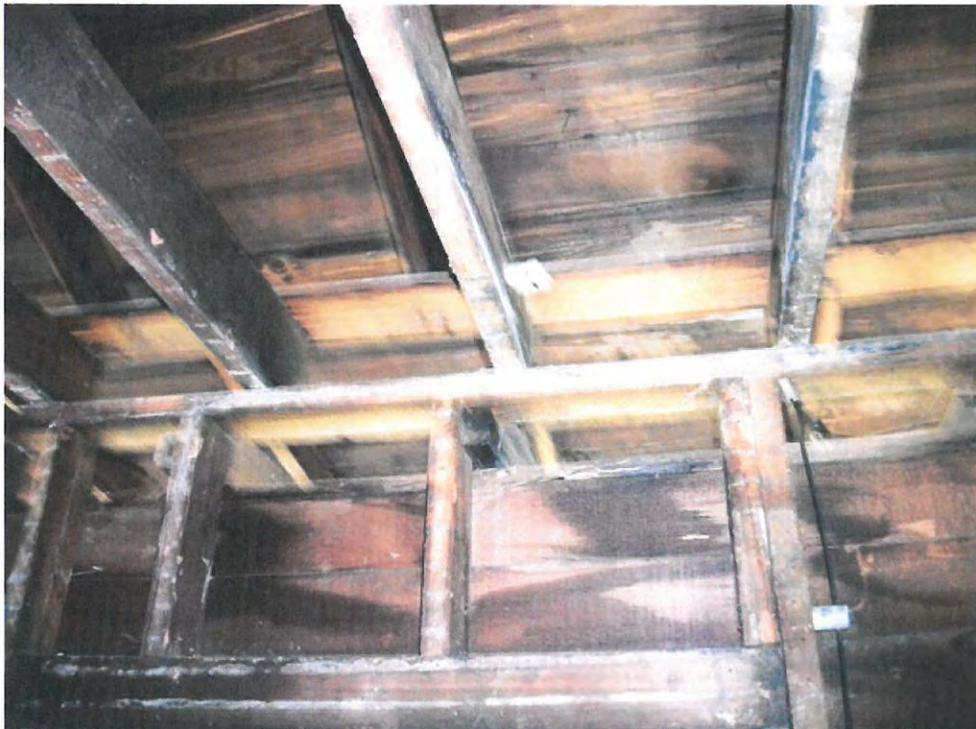
Photo 6: The ceiling joists do not align with the studs.

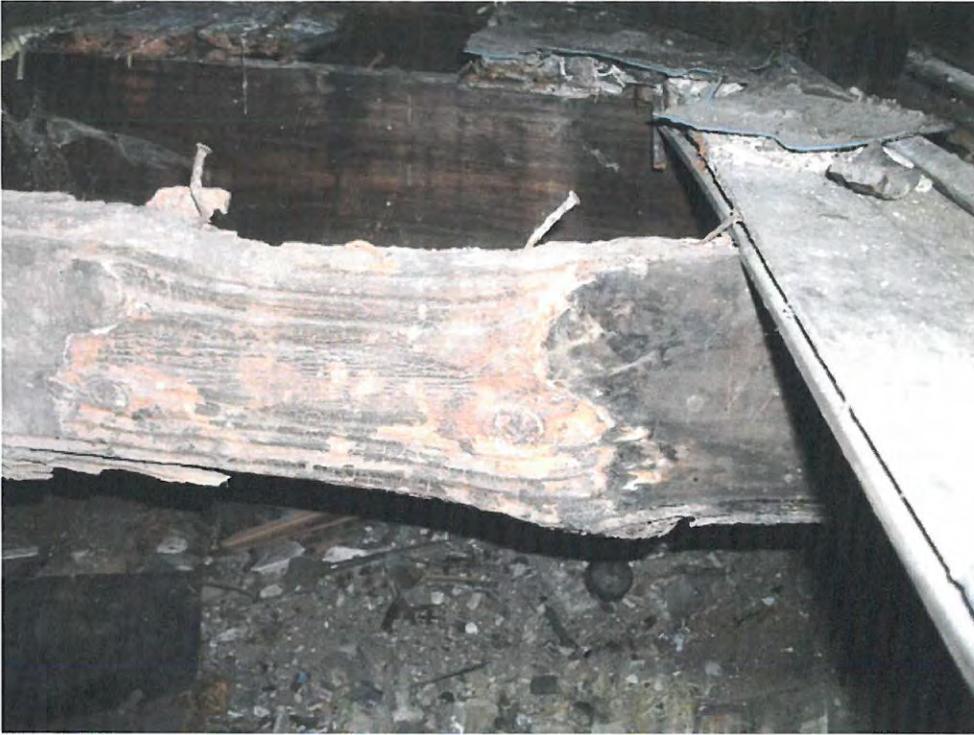
The subfloor framing has scattered termite damage and areas of extensive fungal growth (Photos 7 and 8). The fungal growth is the beginning stages of dry rot, which can structurally weaken the framing. Many of the framing connections are toe-nailed without support by a ledger board or joist hanger (Photo 9). The girders supporting the floor joists are over-spanned. Girders should also be supported by structural piers not cedar posts bearing on concrete blocks or the ground or thin-walled steel posts (Photos 10 through 12). GEC recommends:

Photo 7: The subfloor framing has scattered termite damage.

- Termite damaged wood should be repaired with same-size scabs extending at least 2-ft beyond the damaged area.
- Fungal growth needs to be treated before the wood is structurally weakened by dry rot.
- Toe-nailed framing connections should be secured with joist hangers.
- A 3-ply 2x10 girder should span about 6-ft supporting one-story of floor loads and 5-ft supporting two stories. A 2-ply 2x10 should span about 5-ft supporting one-story of floor loads and 4-ft supporting two stories.
- In general, structural piers are 6x6 lumber (cedar posts are acceptable), schedule 40 steel with ¼-inch thick walls, or concrete masonry block with mortared joints bearing on poured concrete pads with minimum dimensions of 24-inches by 24-inches by 8-inches thick.

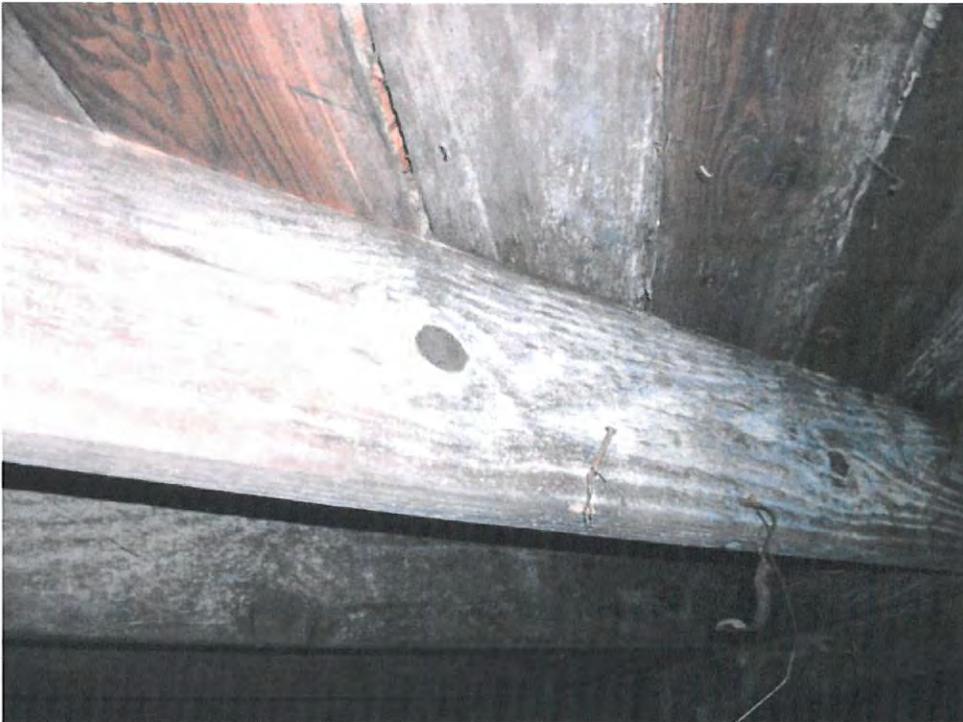
Photo 8: White fungal growth on subfloor framing is beginning of dry rot.

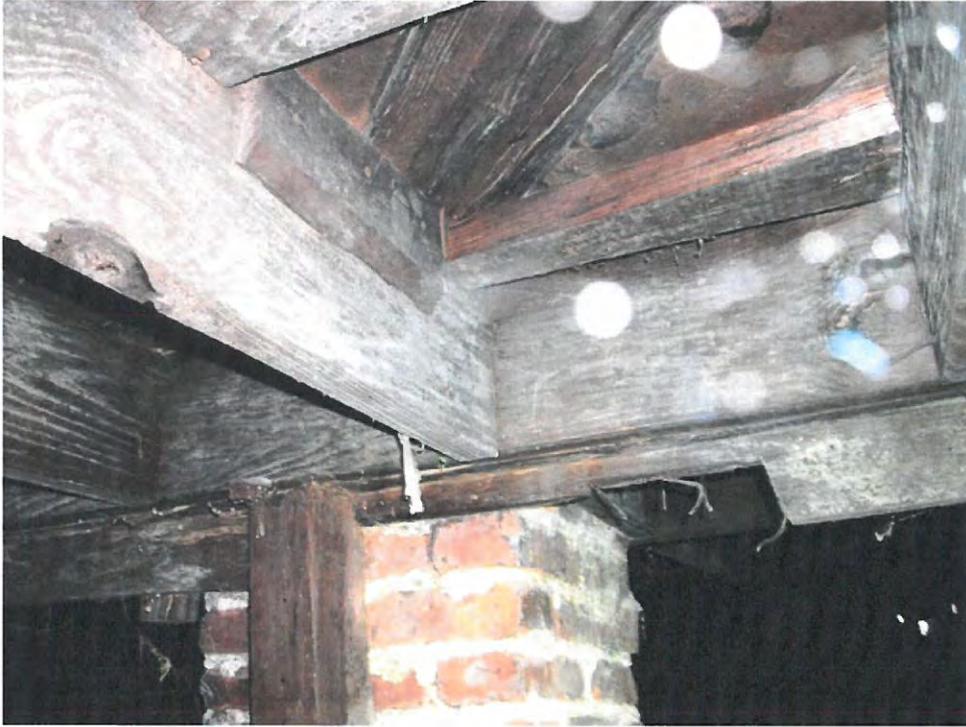
Photo 9: Framing connections without support by ledgers or joist hangers.

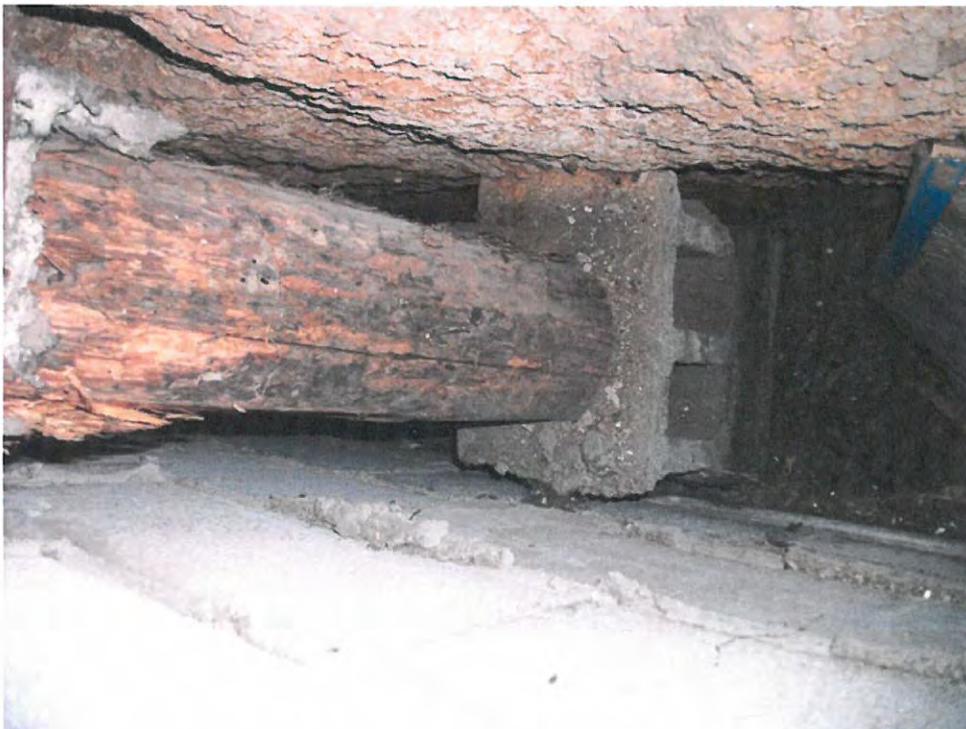
The dug-out basement does not have properly constructed foundation walls (Photos 10, 14, and 15). The block is non-reinforced hollow core and there is no structural footing. No drainage has been installed behind the wall and no fill has been installed to support the cut earth banks. GEC recommends:

Photo 10: Cedar post bearing on a hollow concrete block.

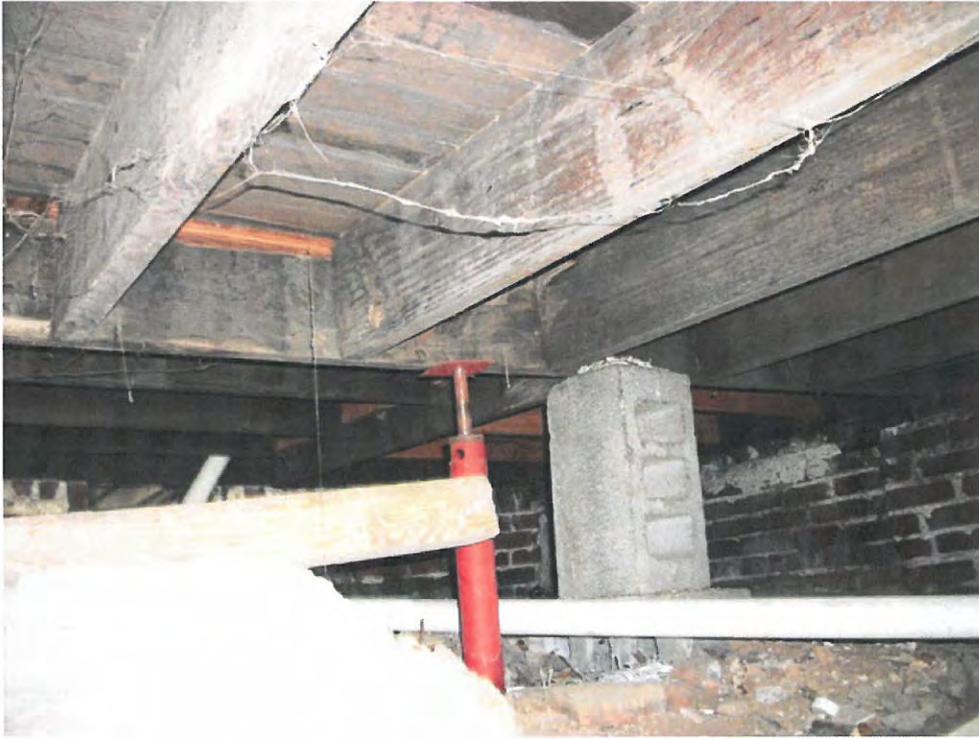
Photo 11: Thin-walled steel post and stacked block supporting framing.

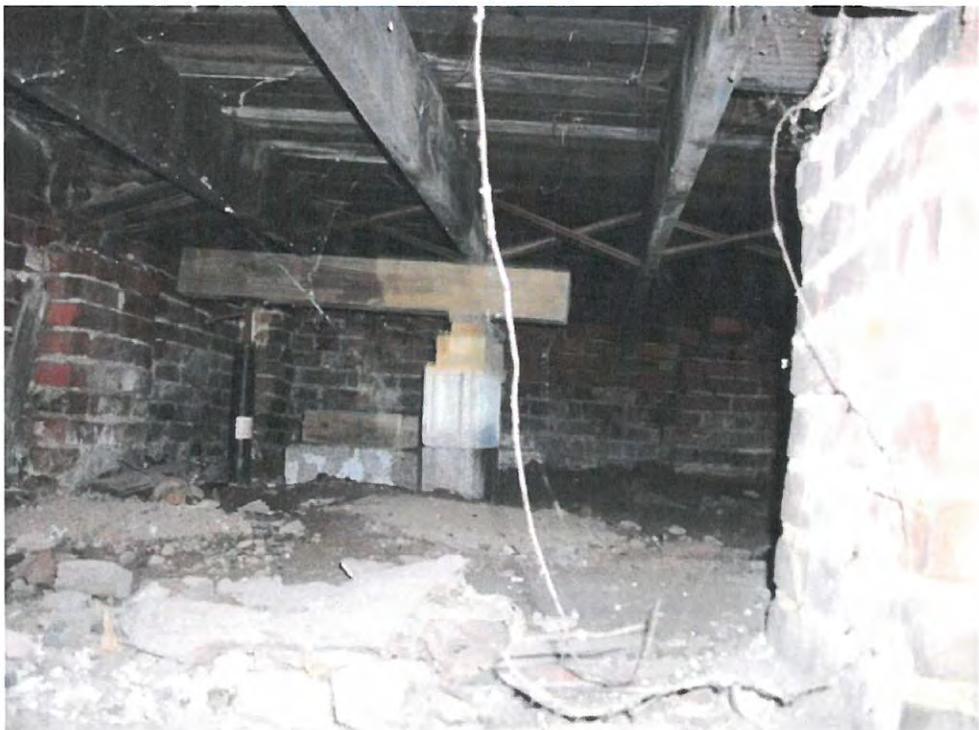
Photo 12: Thin steel and stacked block piers.

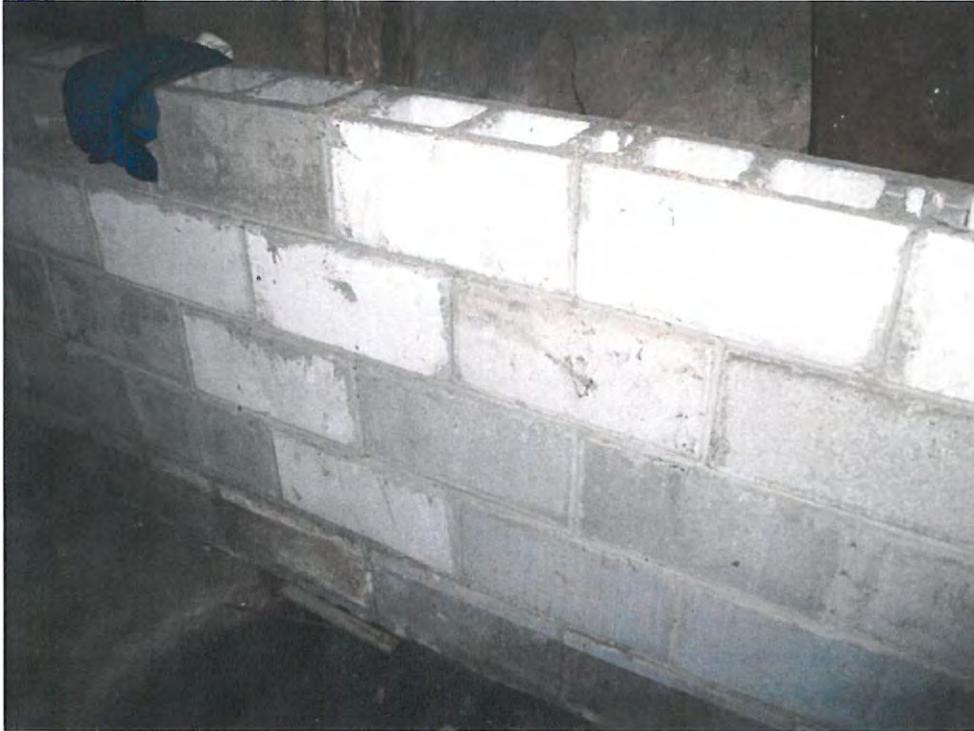
Photo 13: Hollow-core block dug-out basement foundation wall.

- The dug-out basement foundation walls need to be reconstructed with a reinforced poured concrete strip footing, steel reinforcement in the wall, a drainage system behind the wall, and backfill between the wall and the earth bank

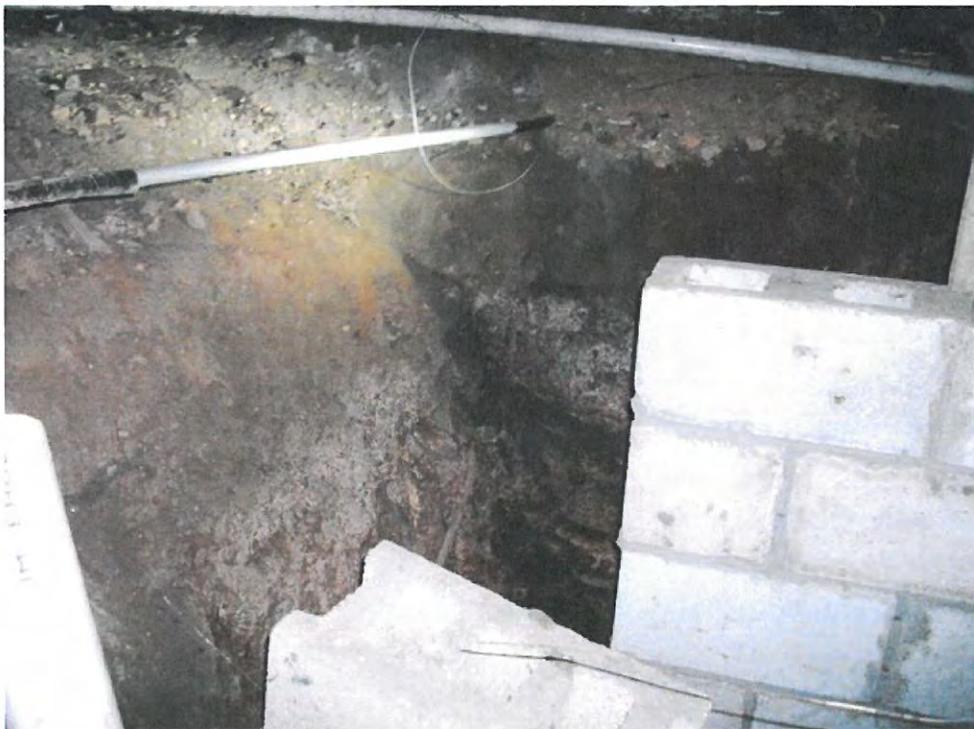
Photo 14: Hollow-core block dug-out basement foundation wall.

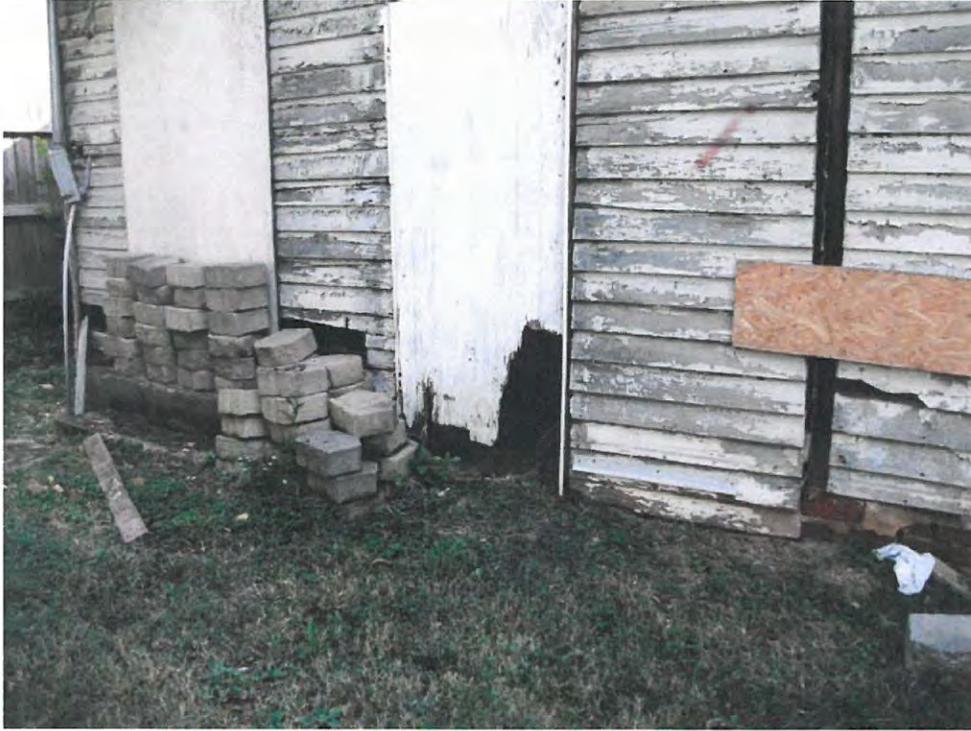
Wood at the right rear corner is in contact with the ground (Photo 15). Current codes require the non-wood foundation to extend high enough so there is at least 6-inches clearance between wood siding or framing and the exterior ground surface. The original foundation is pillar and beam with structural brick pillars bearing on the ground supporting the rim board. The single wythe of brick on the foundation wall between the pillars is not structural. On the right side of the residence, the foundation is leaning outward (Photo 16). GEC recommends:

Photo 15: Wood siding and framing within 6-inches of the ground

- The foundation at the right rear corner needs to be reconstructed so wood is not within 6-inches of the ground on the exterior and so non-pressure-treated wood is not within 18-inches of the ground in the crawlspace.
- The right foundation wall needs to be reconstructed with concrete masonry block on a reinforced strip footing or the brick pillars need to be replaced with structural piers constructed as previously described as long as the rim board can span between pillars when analyzed by current standards.

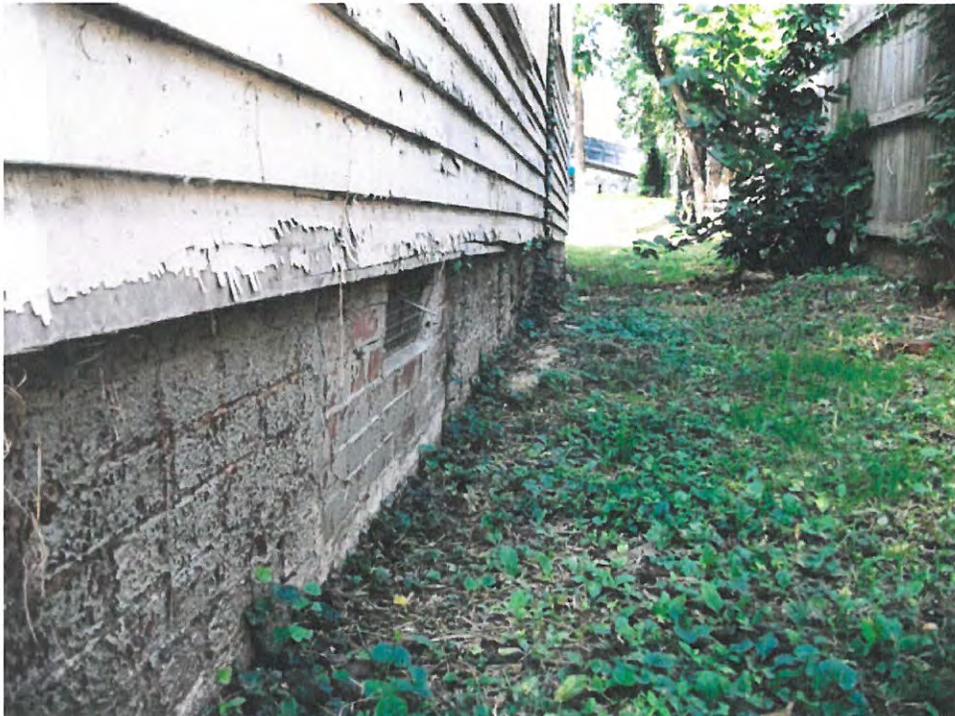
Photo 16: Leaning foundation walls on the right side.

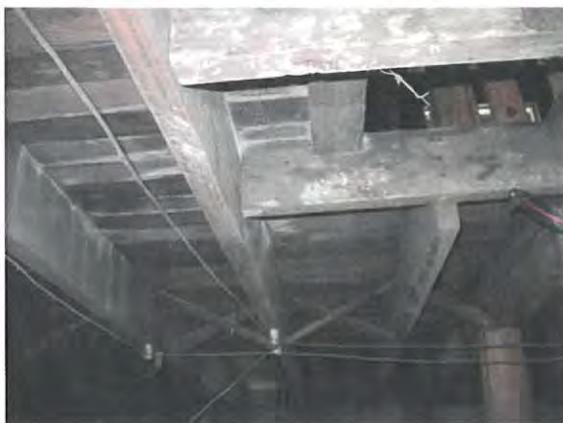
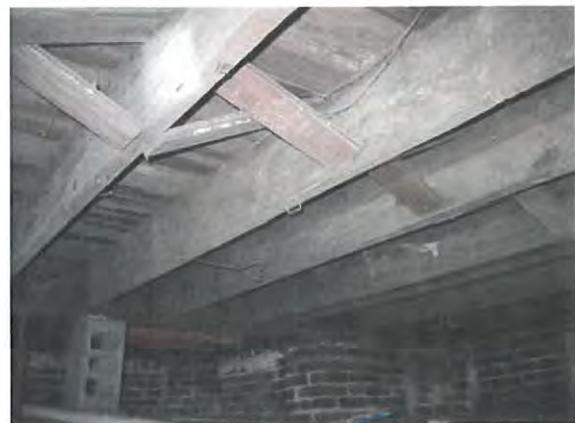
We should note that many of the floor joists and sub floor in the crawl space is also affected by dry rot and may need to be replaced even after the surface mold has been removed. The scope of work for this component is as follows:

Heavy Mold Residues on Floor Joists and Sub Floor

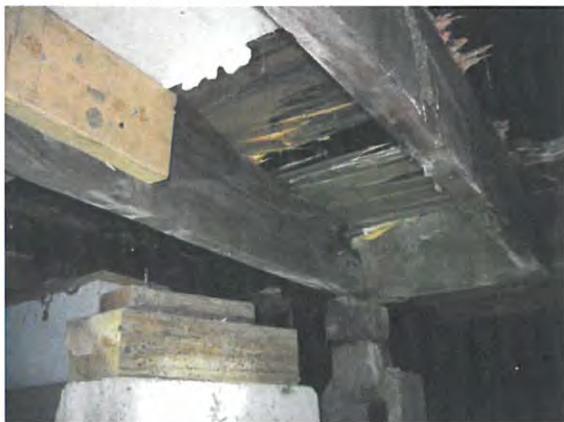
Floor Structures Affected by Dry Rot

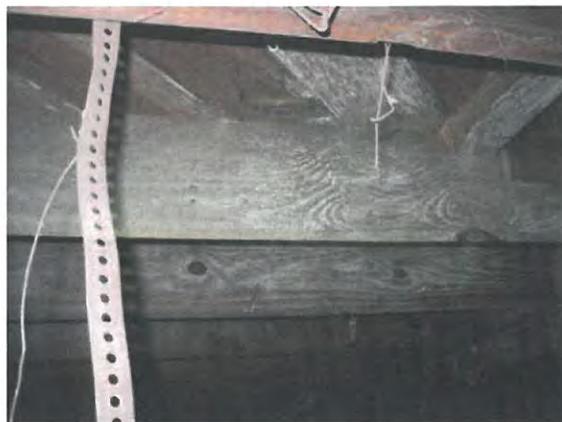
Active Mold on Floor Joists

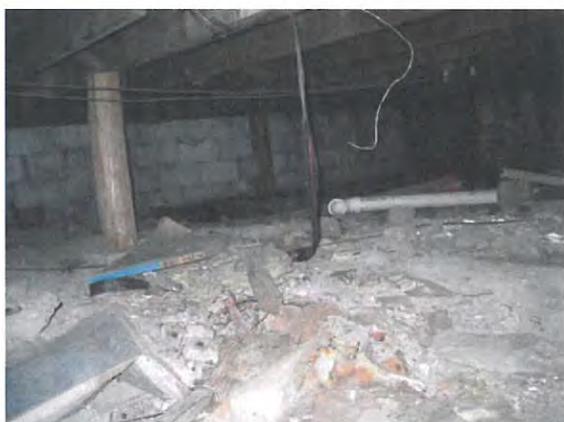
During our site visit we identified likely asbestos-containing insulation in the crawl space which was also damaged and exposed to further disturbance. This observation indicates that much of the debris in the crawl space is contaminated with asbestos dust.

Accumulated Debris in Crawl Space

In order to minimize the threat of airborne asbestos exposure, we recommend the following scope of work:

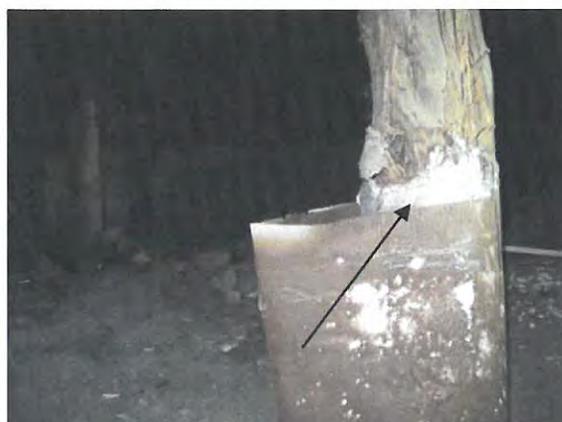
Suspect Asbestos Thermal Insulation

3. The work area will be placed under negative pressure to minimize the potential for any migration of asbestos particulates to other areas of the building.
4. We will spray a citrus based encapsulant over the dusty debris to minimize the amount of dust generated from the removal of the debris.
5. All waste materials taken from the crawl space will be placed in two layers of 6 mil polyethylene disposal bags and taken offsite for landfill disposal.
6. After the debris is removed, only soil should remain. We will remove the top inch of soil and take offsite for landfill disposal.
7. The remaining soil will be amended by another spray application of encapsulant.
8. The last step will be the installation of a 10 mil vapor over the entire ground surface and the center (cellar portion) of the crawl space.

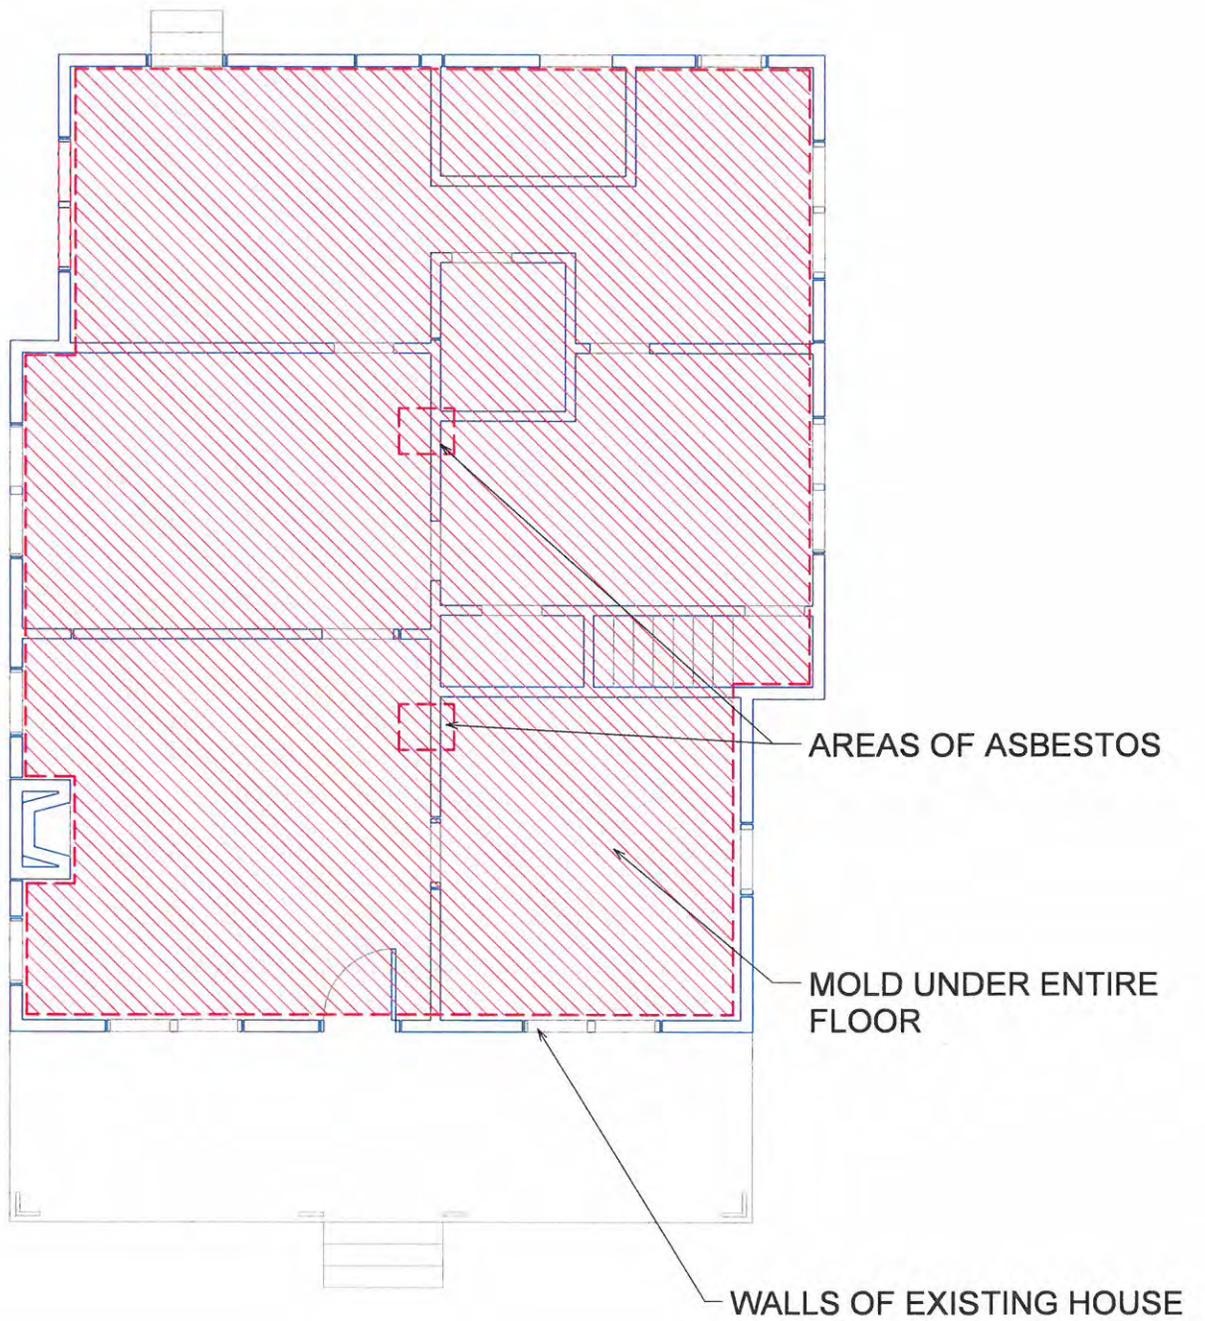
MOLD & ASBESTOS REMOVAL PLAN
1/8"=1'-0"

"HATCHED" AREA DENOTES
EXISTING EXTERIOR
FOUNDATION AREA WHERE
EXISTING DAMAGED
FOUNDATION IS REMOVED &
REPLACED WITH NEW
FOUNDATION

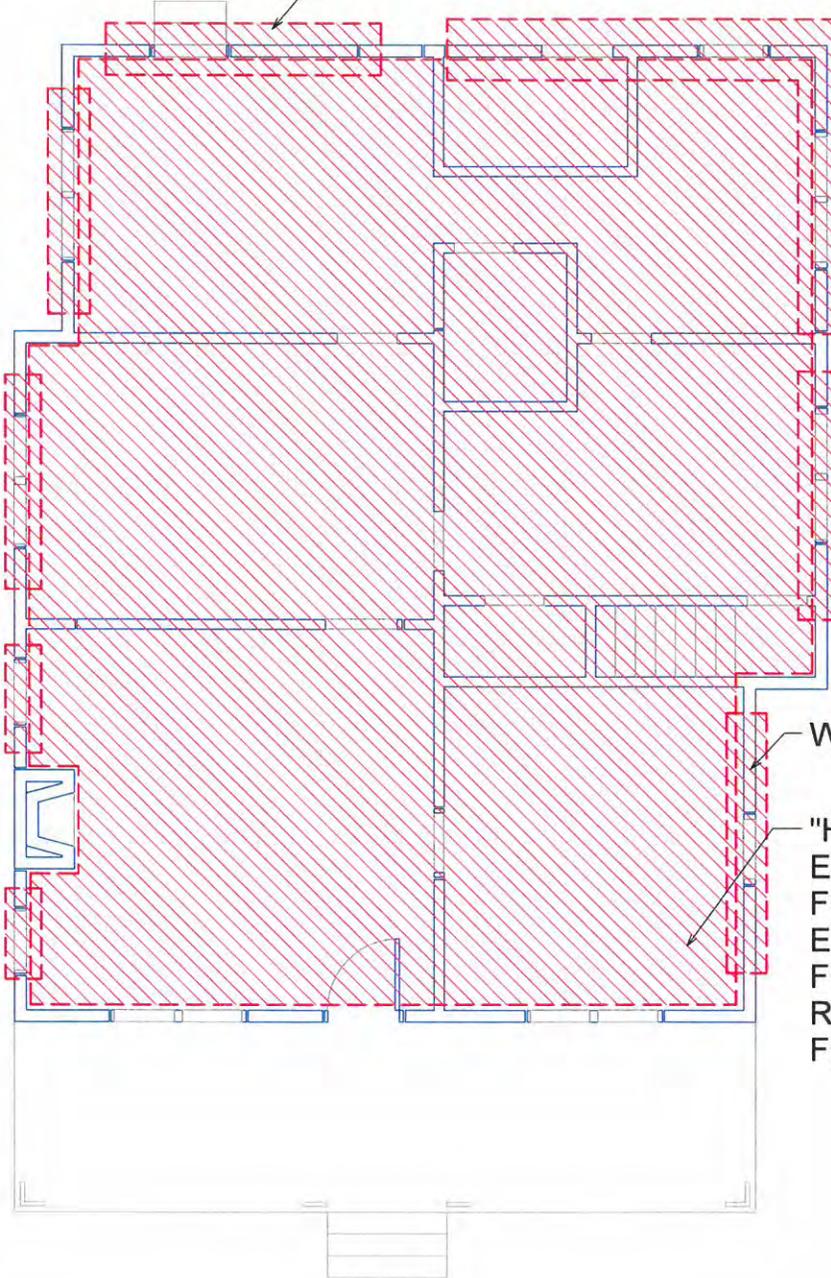
FOUNDATION DAMAGE REMOVAL & REPLACEMENT PLAN
1/8"=1'-0"

"HATCHED" AREA DENOTES
EXISTING INTERIOR
FOUNDATION AREA WHERE
EXISTING DAMAGED
FOUNDATION IS REMOVED &
REPLACED WITH NEW
FOUNDATION
