STAFF RECOMMENDATION
2306 Sunset Place
June 21, 2017

Application: Demolition
District: Hillsboro-West End Neighborhood Conservation Zoning Overlay
Council District: 18
Map and Parcel Number: 10415023000
Applicant: Metro Property Standards Division
Project Lead: Paul Hoffman, paul.hoffman@nashville.gov

<p>Description of Project: Demolition of a contributing building based on economic hardship</p> <p>Recommendation Summary: Staff recommends approval finding that demolition meets sections III.B.2.a. and b.</p>	<p>Attachments A: Photographs B: Order for Demolition</p>
---	--

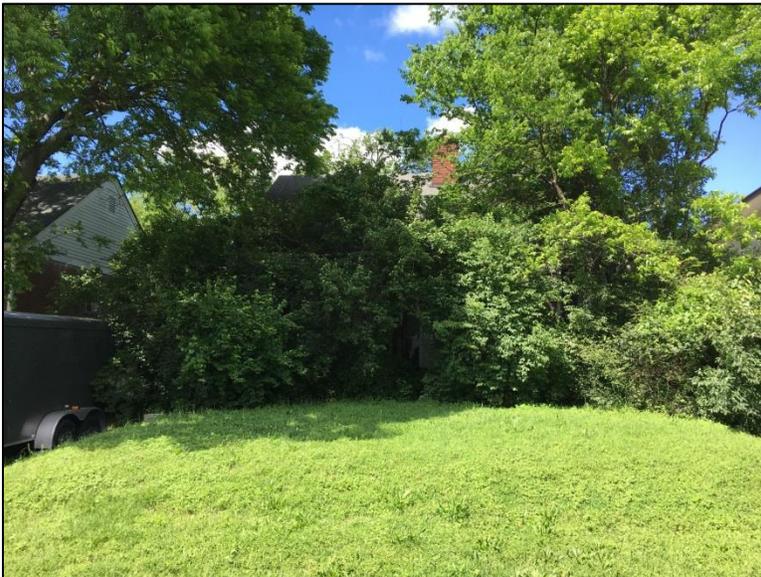
Figure 1. 2306 Sunset Place

The site is overgrown, the building is in poor condition and the property has been abandoned for an unknown amount of time. The Property Standards division of the Department of Codes and Building Safety has recorded a demolition order on the subject property (see Attachment B).

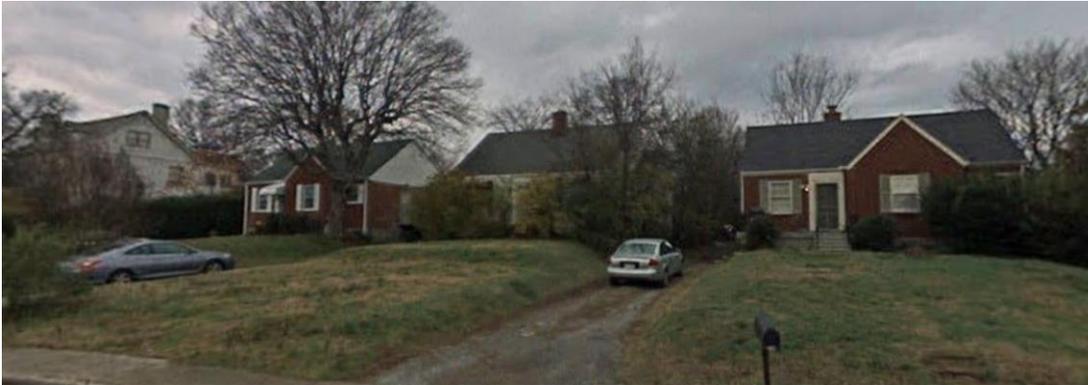
Figure 2: 2306 Sunset Place in 2007, already partially obscured by vegetation.

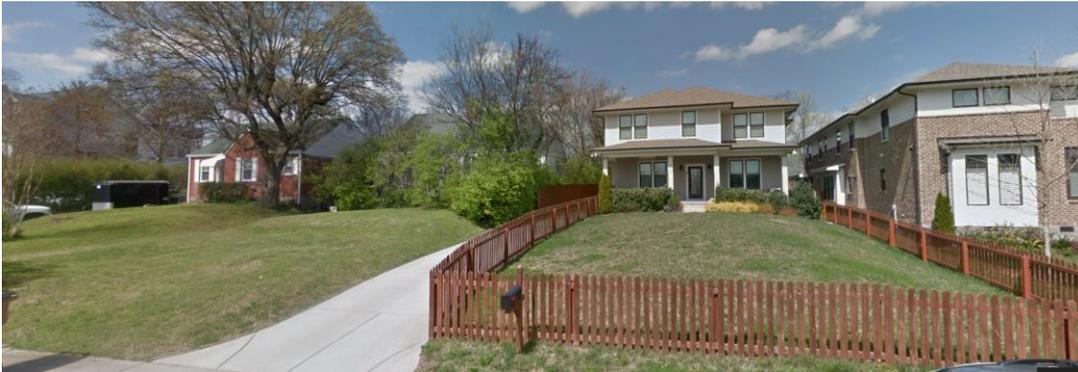
The building is on the very edge of the overlay with new construction to the right.

Figure 3: 2306 Sunset Place, obscured by vegetation in 2016. The new construction to the right is outside of the overlay.

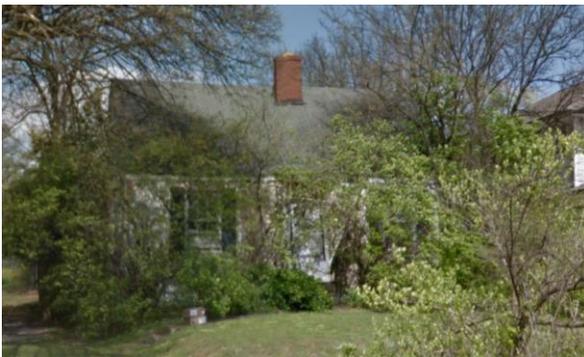
a minimal traditional form, a common form in certain areas of the neighborhood, constructed towards the end of the period of significance for the district. There is strong context for this form across the street; however, only one such building is left on the even side of the street. It is difficult to determine because of the overgrowth; however staff finds that many of the materials will likely need to be replaced, undermining the historic integrity of this very simple form with minimal detailing to distinguish it and continue to

represent its particular era of construction. See the assessment of condition. Based on the fact that the form is towards the outside of the period of significance, the building is located on the edge of the district, and the character defining features of the building have been undermined by neglect, staff finds that demolition will meet section III.B.2.b.

Figure 4: 2306 Sunset Place is a minimal traditional form.

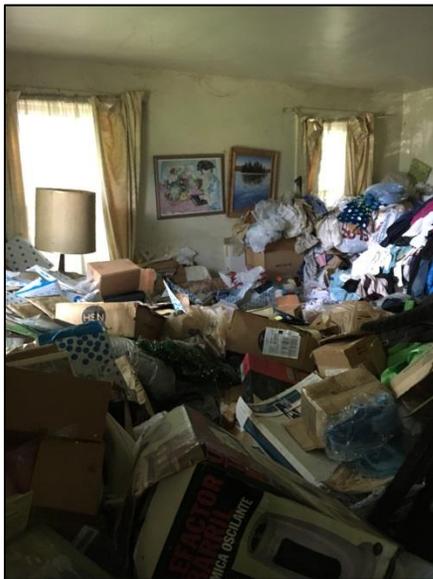
Figure 2. View of interior seen through front door

Interior: The interior was not available to be accessed as the entries are blocked by garbage and debris. The same conditions are visible throughout the house.

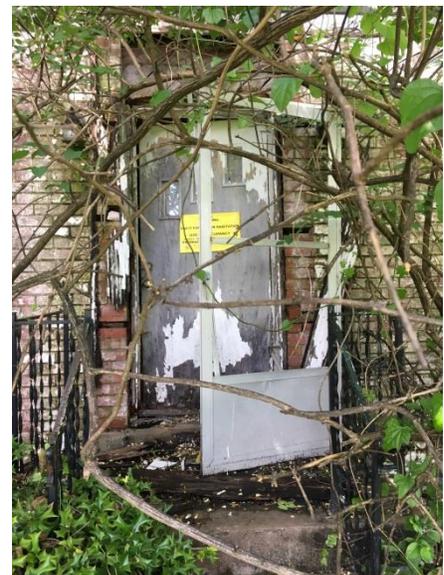
Figure 3. Front door and porch are overgrown

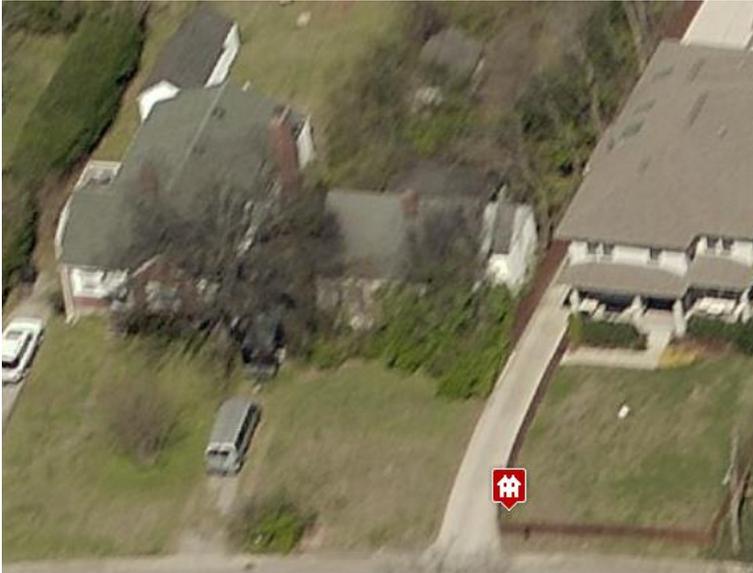
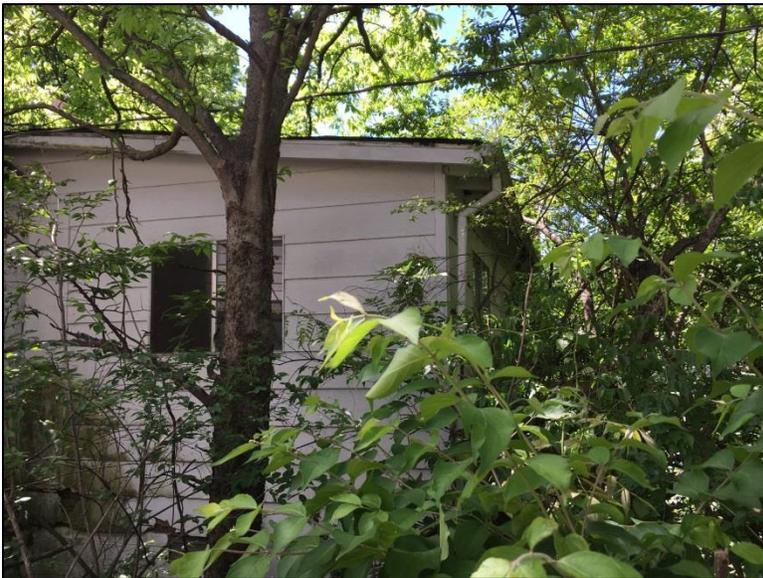
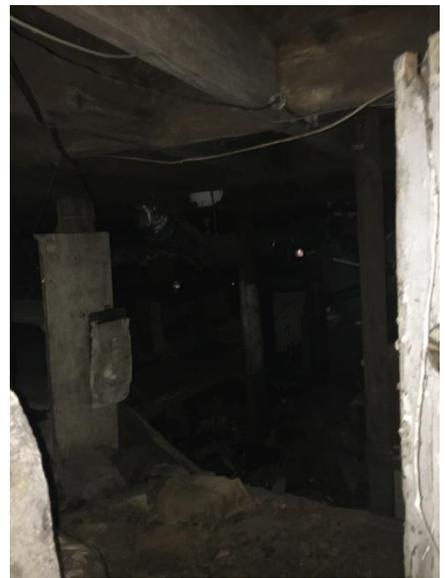
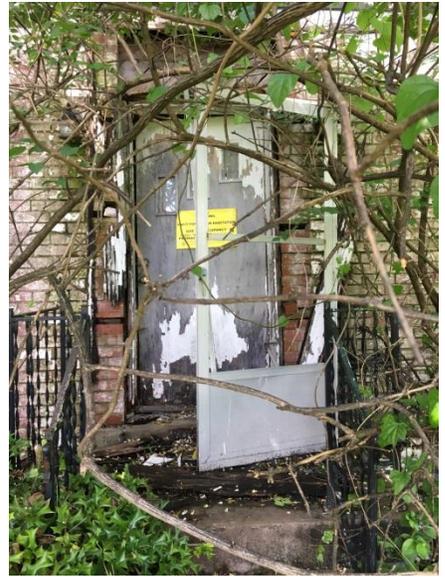
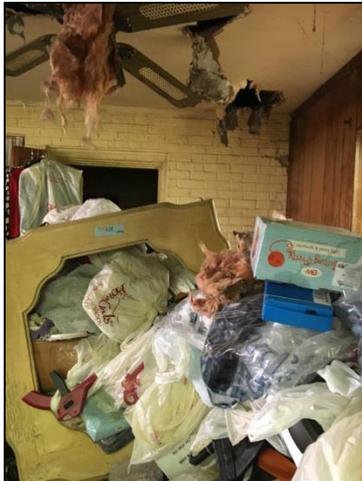
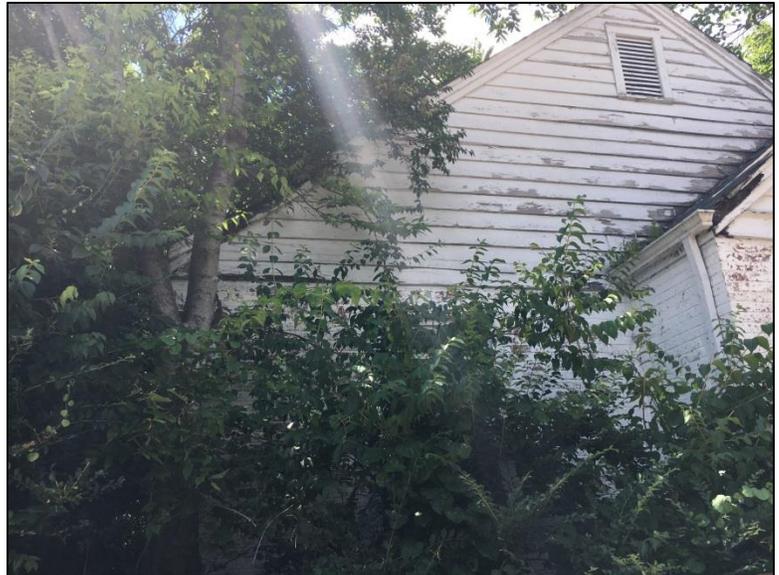
PHOTOS

Foundation: Staff was able to crawl under the structure a short distance. The perimeter foundation is a stone load-bearing wall that appears to be in good condition. Piers and jacks under the building show attempts at shoring it up at some point in the past. Farther under the structure, the subfloor, joists and beams have deteriorated and are in visibly unsafe condition. Water and possible termite damage was visible in at least fifty percent (50%) of the subfloor and joists, concentrated at the front of the building.

Roofing: The roofing is in poor condition and is in need of replacement. The rafters, decking and rest of the roofing structure were not able to be observed. Trees growing alongside the building have worn a spot through the roof several feet in length at the building's front right corner. Water has been able to intrude into the building for an unknown amount of time. Likely this is the source of the water damage visible underneath the building. Neighbors confirm that birds and rodents have entered the building here.

Staff recommends approval finding that demolition meets sections III.B.2.a. and b.
