STAFF RECOMMENDATION
2809 27th Avenue South
June 21, 2017

Description of Project: Demolition of a non-contributing structure.

Home Inspectors of Middle Tennessee LLC

| Date: 5/25/2017 | Time: 08:00 AM | Report ID: Revered2809A |

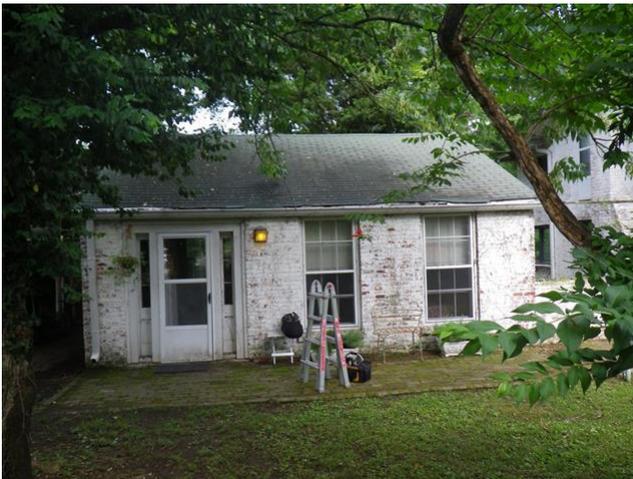
Figure 1. 2809 27th Avenue South

Background: 2809 27th Avenue South is a one-story brick structure built c. 1950.

Analysis and Findings: The applicant requests demolition of the building. The building was constructed as an accessory building to the older contributing home next door. The official date of construction is difficult to pinpoint; this property was not subdivided until 2014, and the Sanborn maps available fail to reach this area. A long-time neighbor stated that a previous property owner constructed the building c.1950 out of salvaged materials.

Demolition meets section III.B.2 for appropriate demolition as the building was constructed later than the district's period of significance. Character-defining features of surrounding buildings such as overhanging eaves and a stone foundation are not found on this structure. The roof slope of approximately 3/12 is lower than that found on contributing buildings in the district.

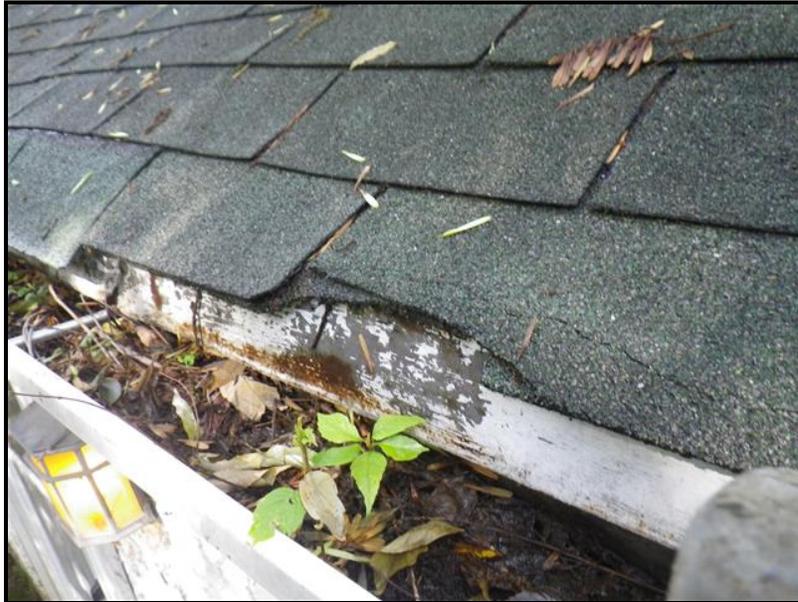
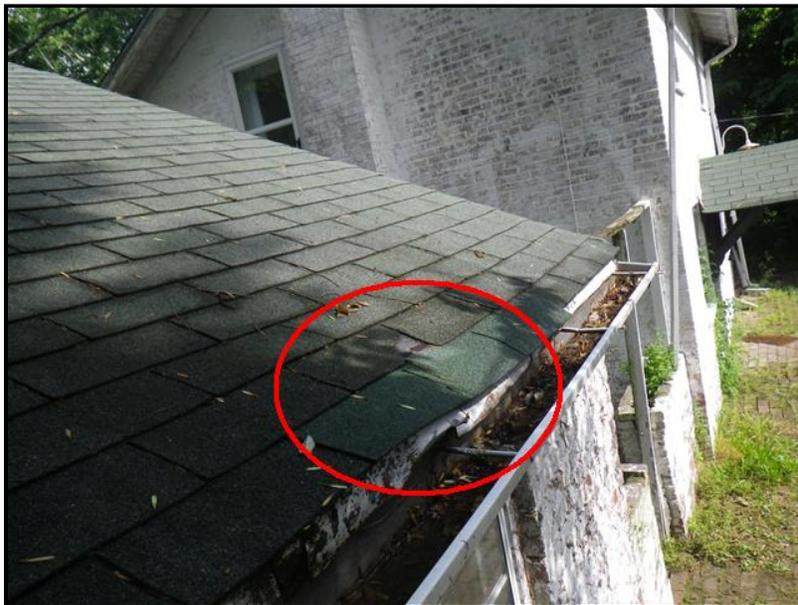
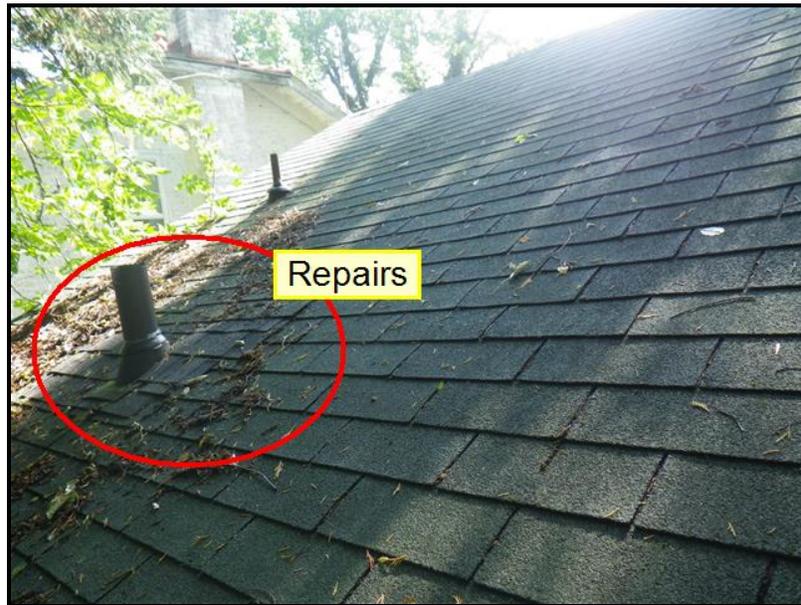
1.1 (Picture 1)

1.1 Torn, damaged, missing and deteriorated shingles exist throughout. Based on this observation I recommend a qualified roofing contractor evaluate further.

Roof covering was wet at time of inspection making evaluation very difficult.

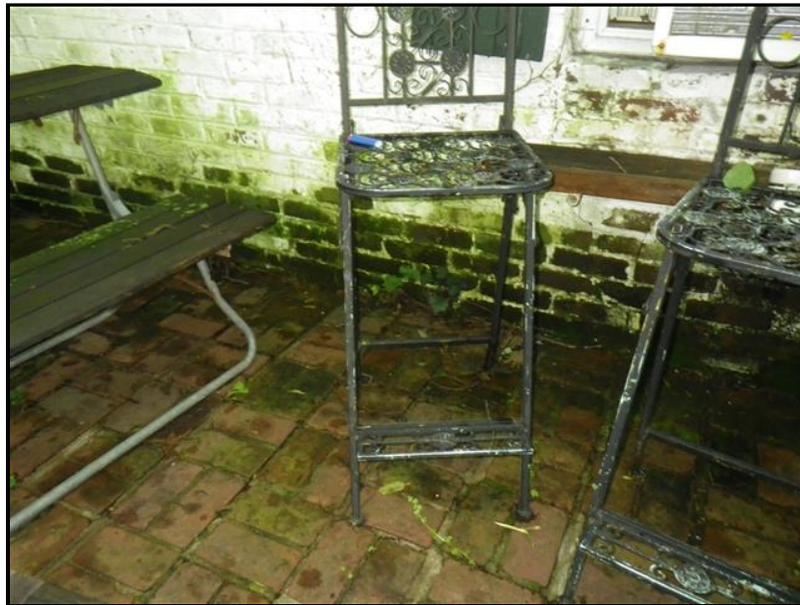
1.6 (Picture 1)

1.6 Rear of home needs gutters badly. At present runoff is landing on the patio and either filtering towards the house or towards the patio.

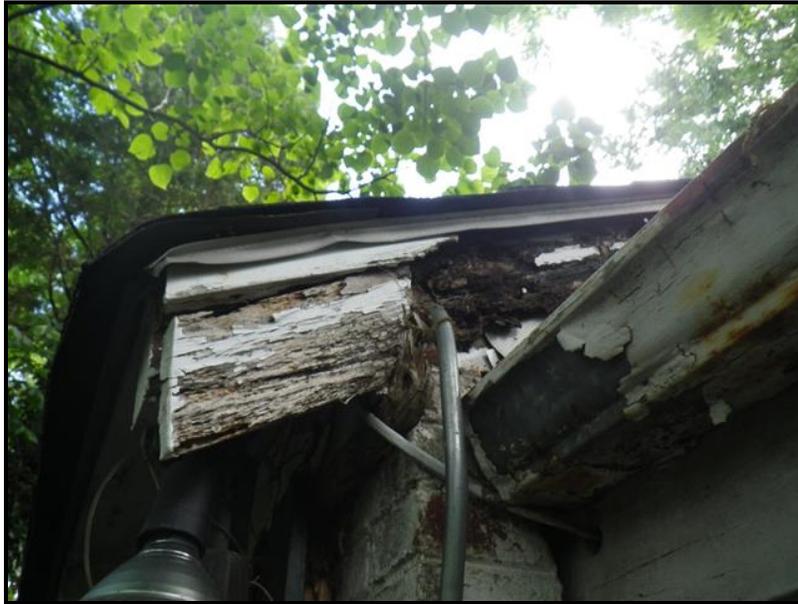
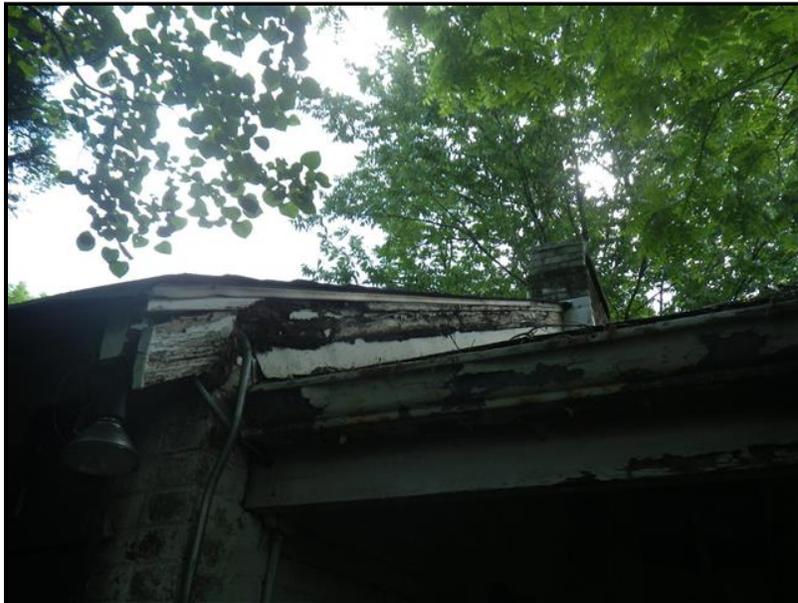
2.0 (Picture 1)

**2.0** most are in poor condition and simply need replacing.

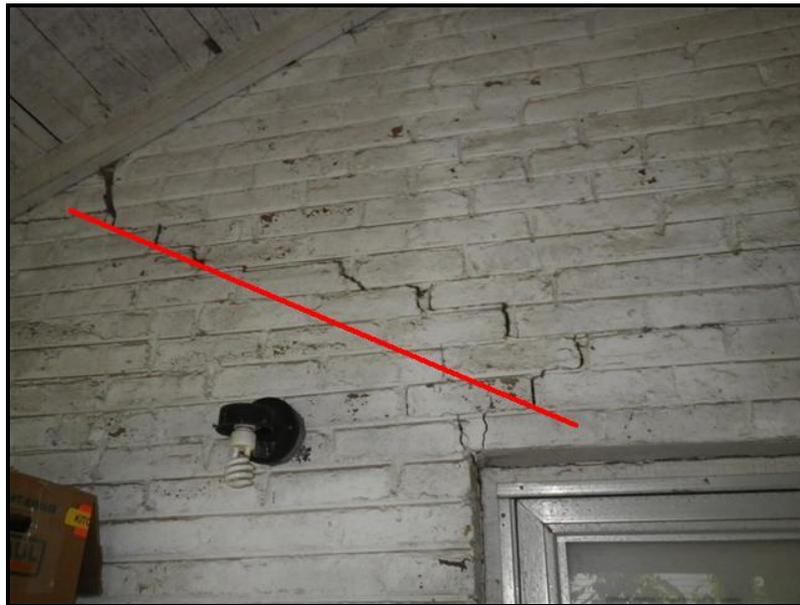
2.2 (Picture 1)

2.2 brick veneer settlement cracks exist at several locations which appear normal for a home this age and design.

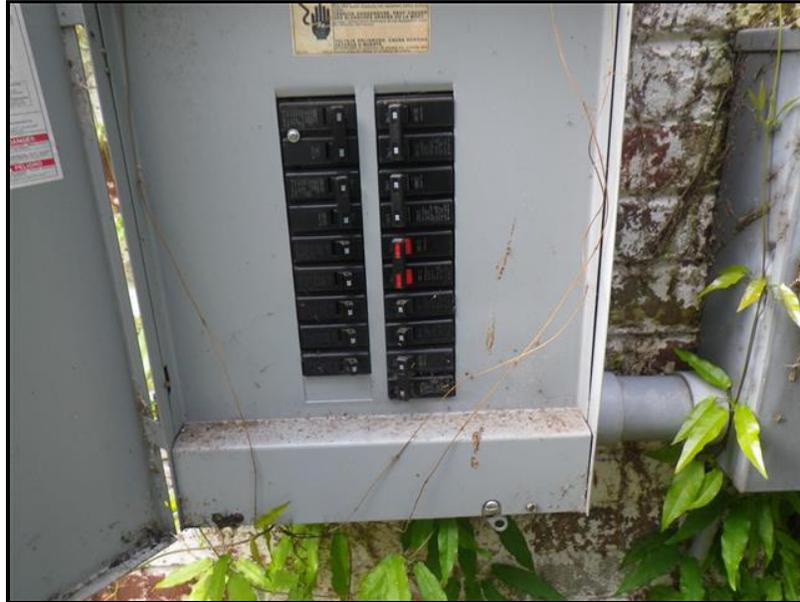
4.8 (Picture 1)

4.8 Main panel box is located at right side of home.

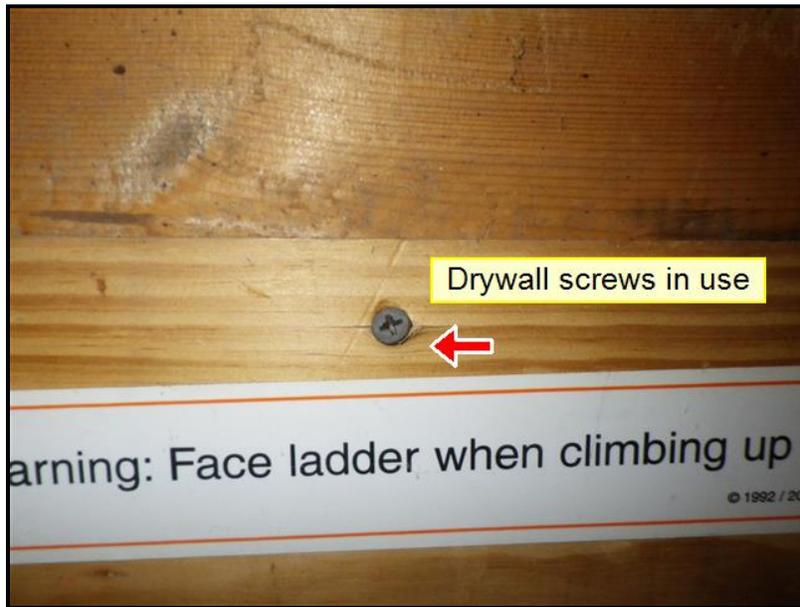
7.0 (Picture 1)

7.0 The entire attic area was not inspected due to limited and/or no accessibility in some areas.

Manufactures guidelines for attic pulldown stairs indicate mounting should occur with 16d nails or 1/4" X 3" lag screws. It appears non standard securing hardware has been used. Non standard hardware does not provide adequate sheer strength. Recommend proper hardware be installed.

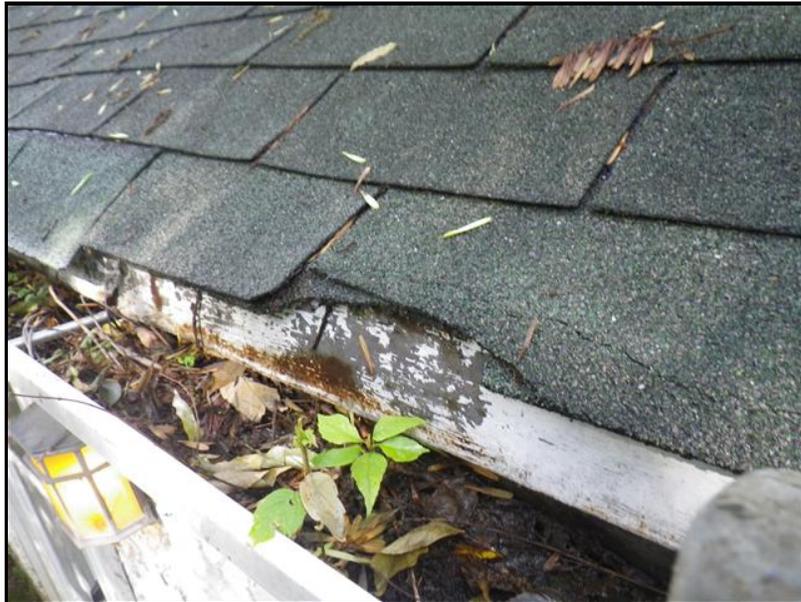
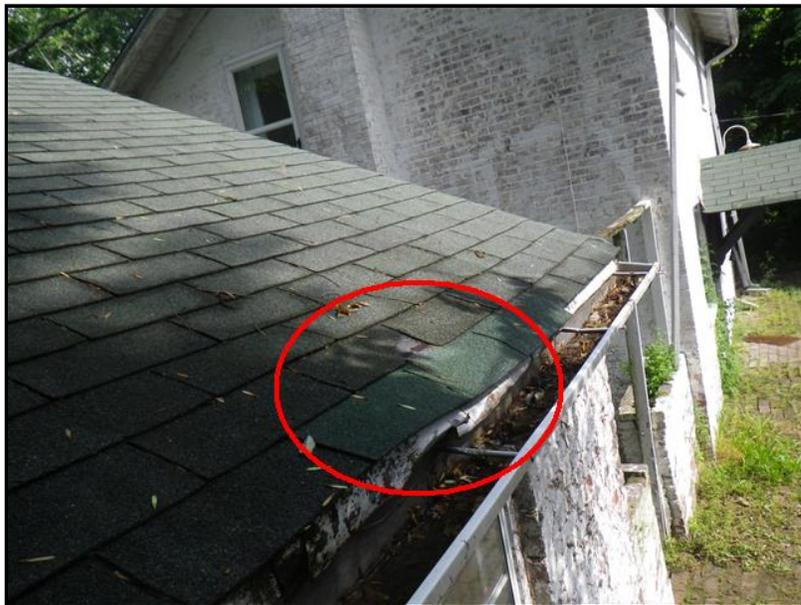
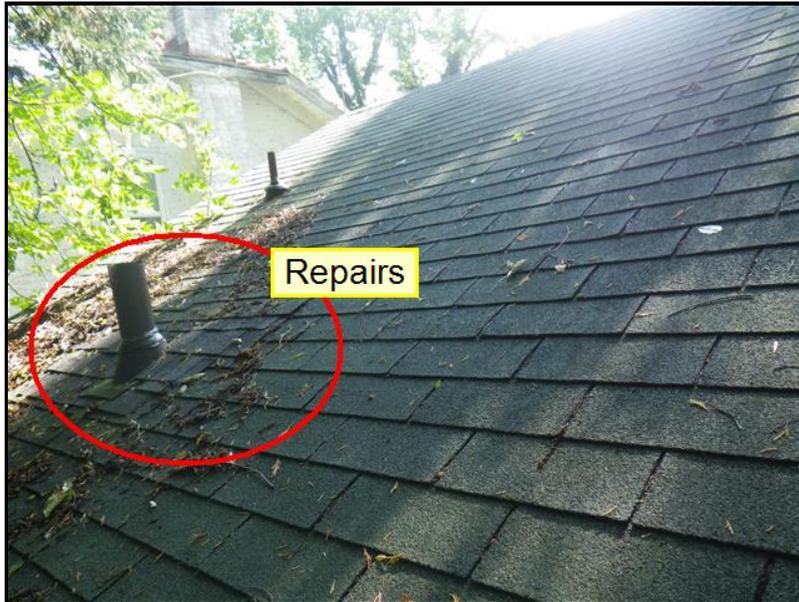
1.1 (Picture 1)

Torn, damaged, missing and deteriorated shingles exist throughout. Based on this observation I recommend a qualified roofing contractor evaluate further.

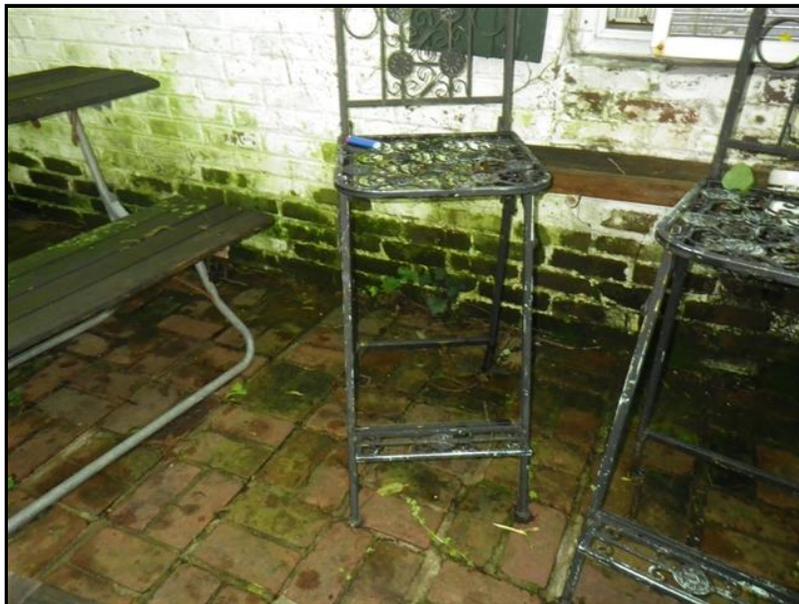
1.6 (Picture 1)

Rear of home needs gutters badly. At present runoff is landing on the patio and either filtering towards the house or towards the patio.

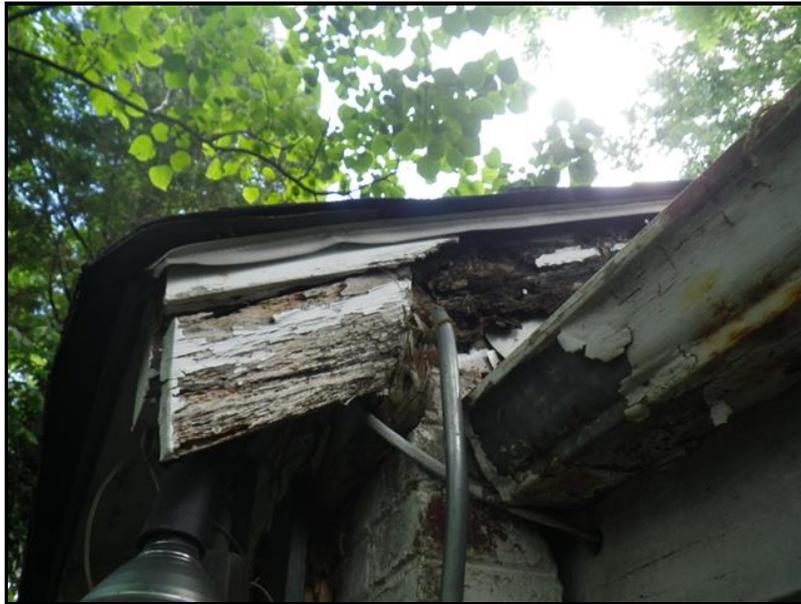
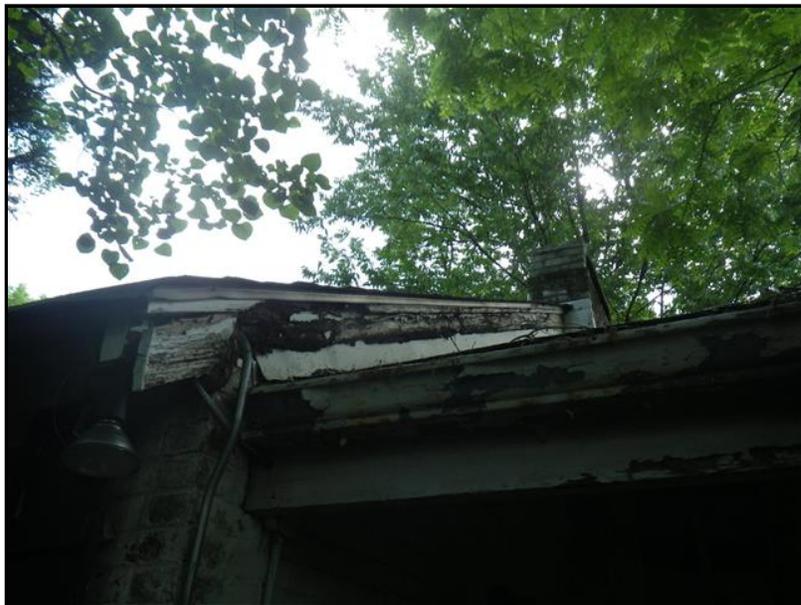
2.0 (Picture 1)

most are in poor condition and simply need replacing.

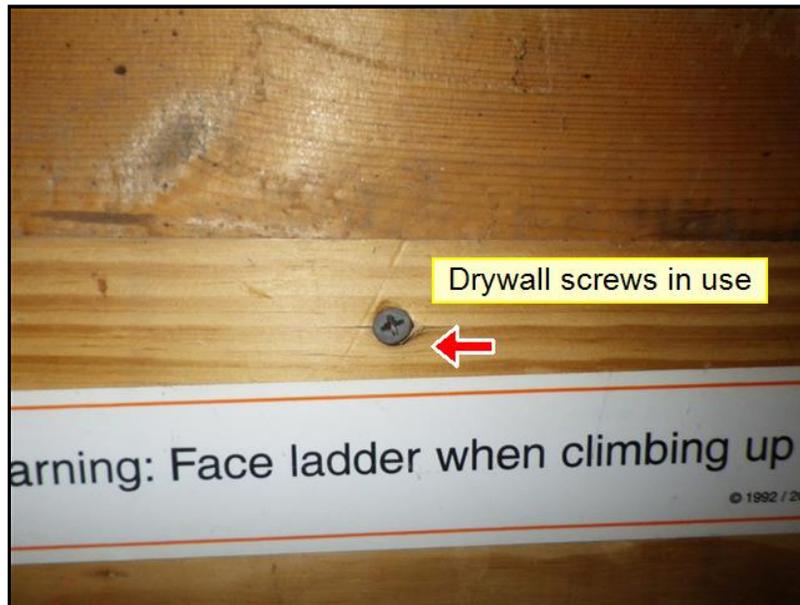
7.0 (Picture 1)

Manufactures guidelines for attic pulldown stairs indicate mounting should occur with 16d nails or 1/4" X 3" lag screws. It appears non standard securing hardware has been used. Non standard hardware does not provide adequate shear strength. Recommend proper hardware be installed.
