STAFF RECOMMENDATION
1600 10th Avenue North
February 19, 2020

Application: Neighborhood Landmark and Historic Landmark Recommendations for the Polk Street Day Home for Working Women’s Children

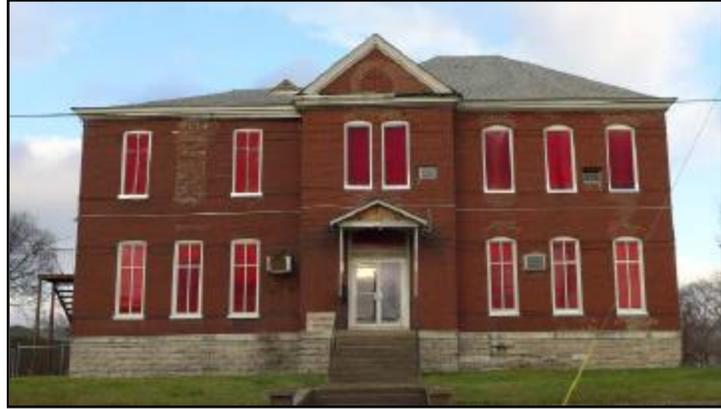
Figure 1: 1600 10th Avenue North

The Polk Street Day Home for Working Women’s Children is listed in the Buena Vista National Register of Historic Places historic district (1979) as a contributing building. It was constructed in 1892 and is described as a two-story brick building with terra cotta

ornamentation. The National Register nomination notes the building as an example of an institution which gave evidence of the concern for children and family in a suburban society.

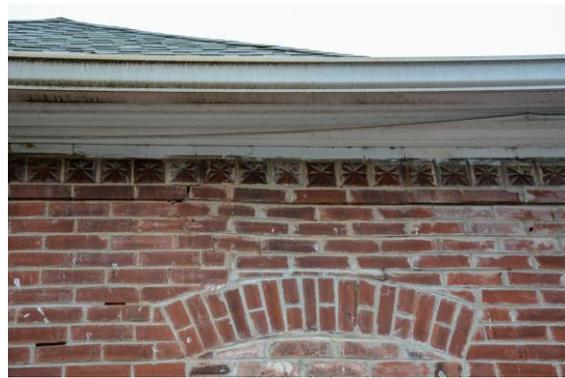
Figure 3: Terra cotta detailing, under the eave

In the early 1900s, a second wing was constructed to the north of the entry projection. This wing creates a fairly symmetrical façade with three bays of tall windows on both floors to match the existing south wing. The brickwork, terracotta detailing and stone foundation are replicated on this newer wing as well. The hipped roof has a lower ridge and shallower pitch than on the original wing. This

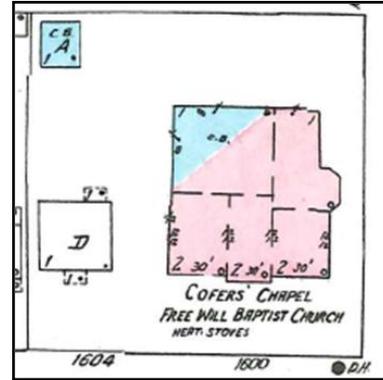
Figure 4: 1957 Sanborn footprint

From 1930 through 1965 the Cofer's Chapel Free Will Baptist Church owned all three lots and held services in the main building. In 1952, the congregation constructed a modest one-story parsonage next door to the main structure, on the unimproved lot 232. The L-shape of the main building was altered during the 1950s as well: The L was filled in with a one-story cinder-block addition resulting in a nearly rectangular footprint.

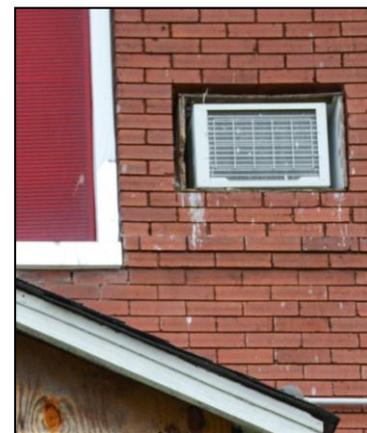
Figure 6: Example of later punctures to the historic masonry that will be refilled with brick.

Several openings on the front of the building will be bricked in, to restore original conditions. (See Figure 6.) Staff recommends final review of replacement brick.

There may be the possibility of salvaging brick in those areas where it will be removed.

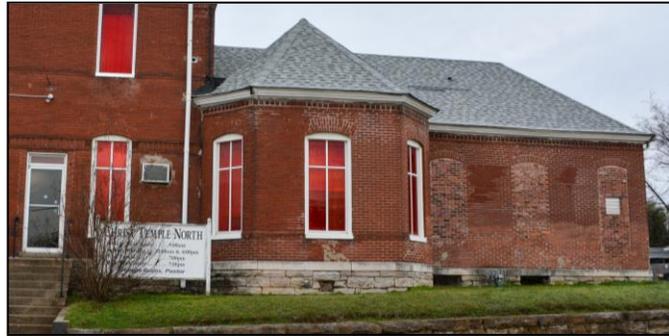
Figure 7: The right-side/rear addition is an example of window alterations. Two of the original window openings will be reconstructed and the third will become a door.

Several windows that have been bricked in will have the brick removed and new windows installed to restore original conditions. On the left-side/first floor the third window from the front will be turned into a door but remain an opening. On the right-side/first floor, an already bricked-in window of the rear wing will be turned into an entrance and the other two bricked-in windows will be windows again. (See Figure

7.) A window on the rear of the right wing/first floor, that is currently bricked-in, will be reestablished. Two enclosed windows on the rear of the upper level will become doors to a rooftop deck. The third window will be reestablished. The window/door alterations either restore original conditions or openings remain openings, albeit of a different type. Because original openings will remain openings and all changes are located on the rear and side, staff finds the alterations to be appropriate. Staff recommends review of brick, where new brick is needed. With this condition, the project meets section IV.A and B of the Historic Landmark design guidelines for demolition.

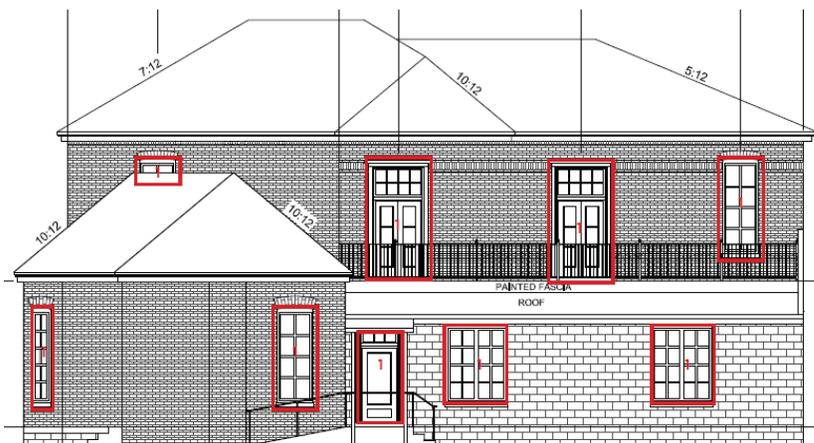
Figure 8: The rear plan shows a deck on top of the 1950s cinder block addition.

Massing, Form & Scale: The massing of the building will not change as no additions are planned. A portion of the roof of the 1950s cinder block addition will be used for an upper level deck, accessed from rear windows altered to doors. (See Figure 8.) Staff finds this alteration to be appropriate as the deck will be on a non-historic portion of the building and does not require new openings for access, just a revision to existing openings. (Also see discussion regarding partial demolition.) The project meets sections II.B.1 and 2 of the Historic Landmark design guidelines.

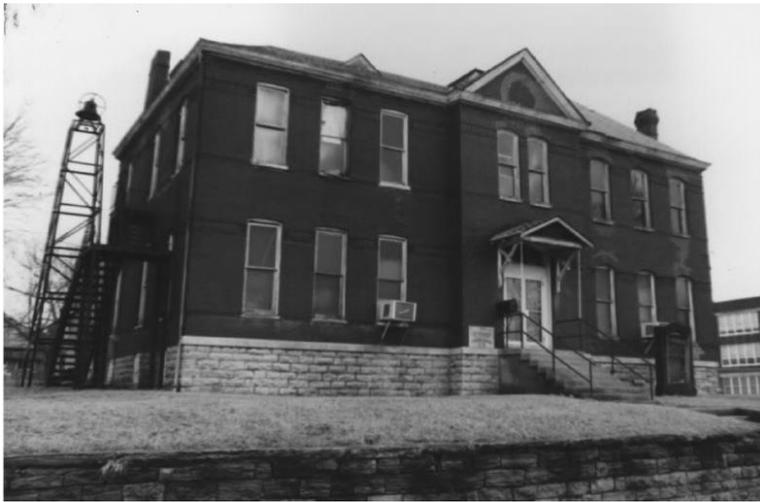
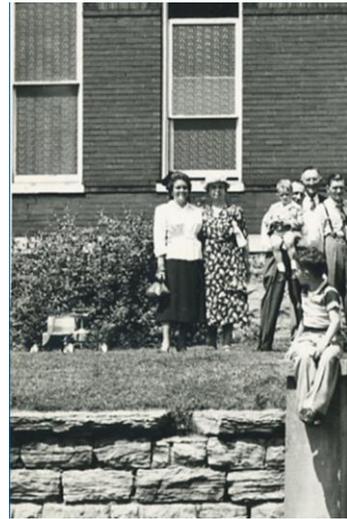
Figures 9 and 10: The 1970s photograph was taken at the time the National Register nomination was written. The 1940s photograph is on the Cofer’s Chapel website: <http://coferschapel.org/about-us/history-in-pictures>

Windows & Doors: The windows and doors are not original and are planned to be replaced, mostly with their original dimensions. (Also see discussion regarding partial demolition.) The windows are proposed to be multi-light operable aluminum clad single-hung windows with simulated divided lights. In 1979, the windows were one-over-one double hung windows with clear glass. (See Figure 9.) A photograph from the 1940s (Figure 10) shows double-hung windows with a clear textured glass. These are the earliest photos staff has found. Staff recommends that the windows be one-over-one single- or double-hung and with clear glass, with administrative review of the final materials, make and manufacturer unless the applicant has evidence of an earlier window design. This will prevent the addition of a “conjectural feature” which would not meet II.B.3.

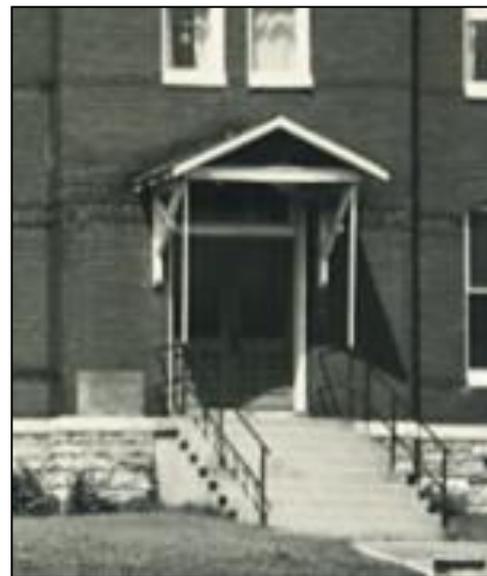
Figure 11: This photo from the 1930s or 40s shows a four-panel ¾ light double door.

The current main entrance appears to have the same door that was in place in 1979. The materials and the manner in which the door is installed are evidence that it is not original; therefore, replacement is appropriate. A 1930s or 40s photograph from the Cofer’s Chapel Free Will Baptist Church website shows the design of the original or early double-front door. (See Figure 11.) Staff recommends a new door of similar design to the earlier door be installed, rather than the multi-light door proposed.

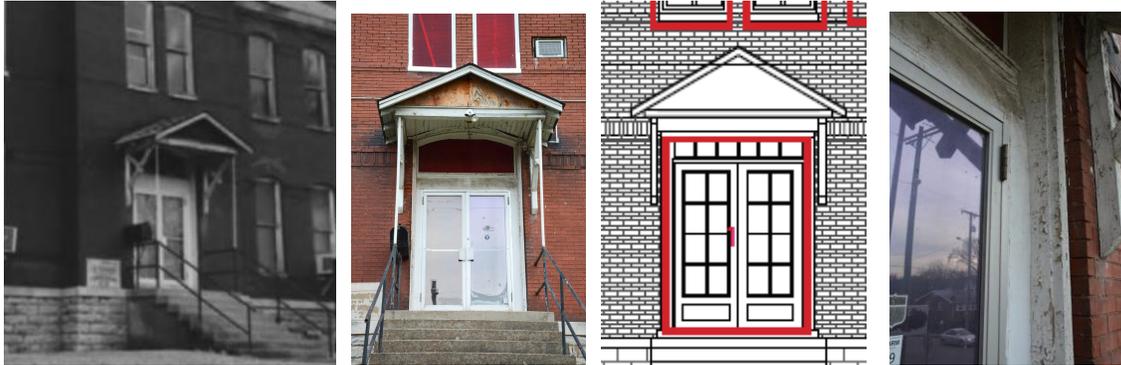
Figures 12-15: Figure 10 is the door as seen in 1970 and Figure 11 is the door as it looks today. Figure 12 shows what is proposed and Figure 13 shows how the current door is framed, which is evidence that it is not original.

The proposed drawings show a narrow straight transom rather than the semielliptical arch that is there now. (See Figures 12-15.) Staff recommends reconstruction of the original transom dimensions.

The new doors on the side and rear elevations are appropriate as they are not character defining entrances. With the condition that the transom dimensions are retained, and the new front entrance is similar to the historic entrance, the project meets section II.B.2 and 5 of the design guidelines.

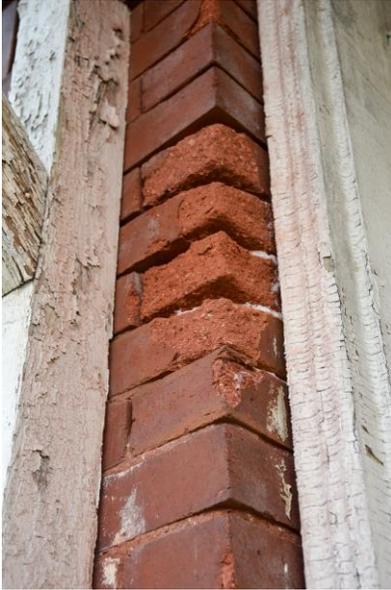
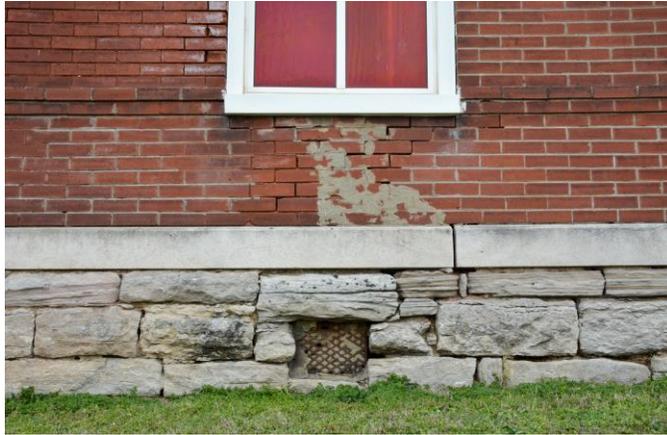
Masonry is planned to be cleaned and tuckpointed; however, more work than that may be necessary in some areas due to decay or previous inappropriate repairs. (See Figures 16 and 17.)

Figures 16 and 17: Figure 14 shows an area of significant brick decay near the front entrance. Figure 15 shows a poor repair that will need to be removed before new tuckpointing takes place.

Staff recommends review and approval of scope of work for masonry cleaning and repair prior to issuing a permit. With this condition, the project meets section II.B.2, 5 and 6.
