HISTORIC STRUCTURE REPORT

FORT NEGLEY

Nashville, Tennessee

FINAL REPORT (CORRECTED)
January 31, 2014

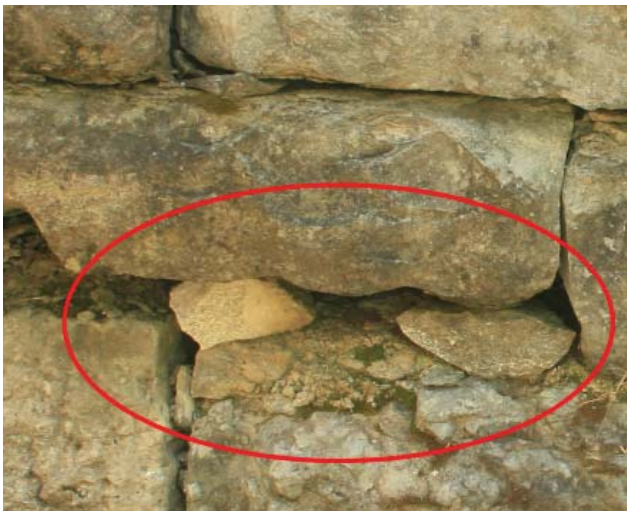
Figure 69. Chinking loss (JMA, 2013).

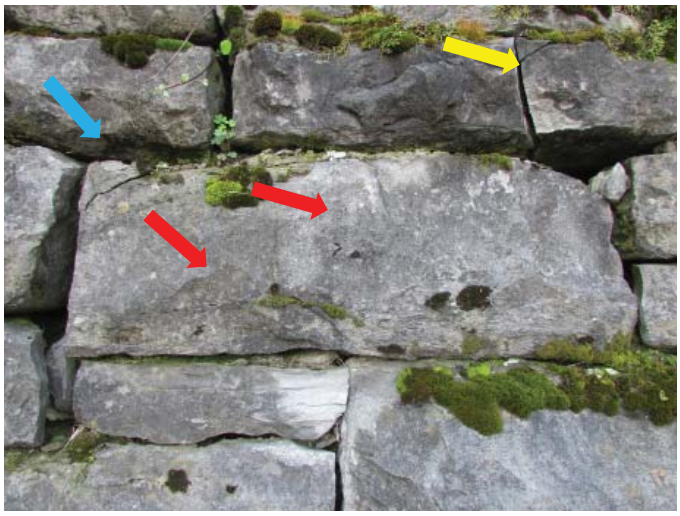
Figure 71. Vertical shear crack (yellow arrow), hairline vertical and horizontal fissures (red arrow) and spalled corner (blue arrow) (1200AE, 2013).

Note moss growth.

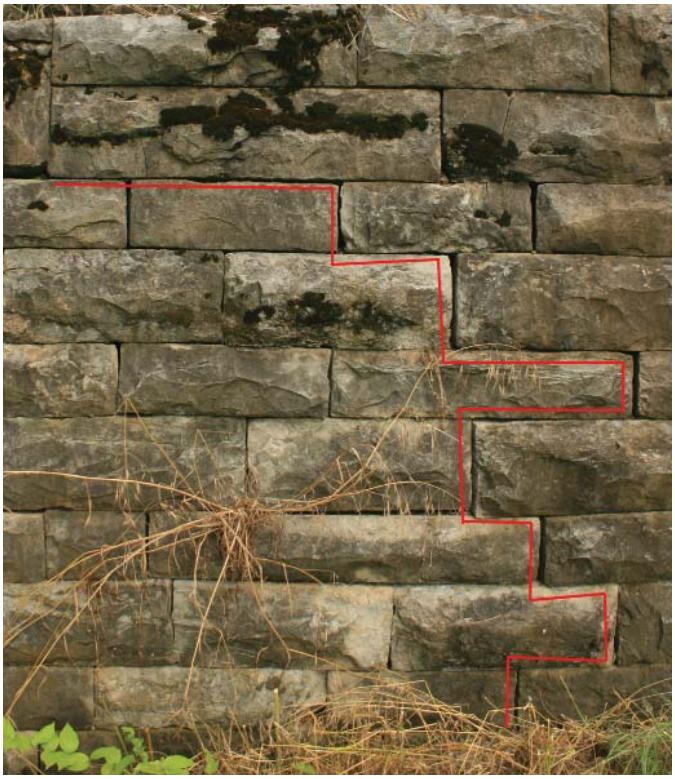
Figure 79. Step cracking indicating movement or "cold joint" between earlier construction and area of repair (JMA, 2013).

Figure 80. Open head joints (JMA, 2013).

Figure 81. Vertical joints aligned and plant growth in cracks (JMA, 2013).

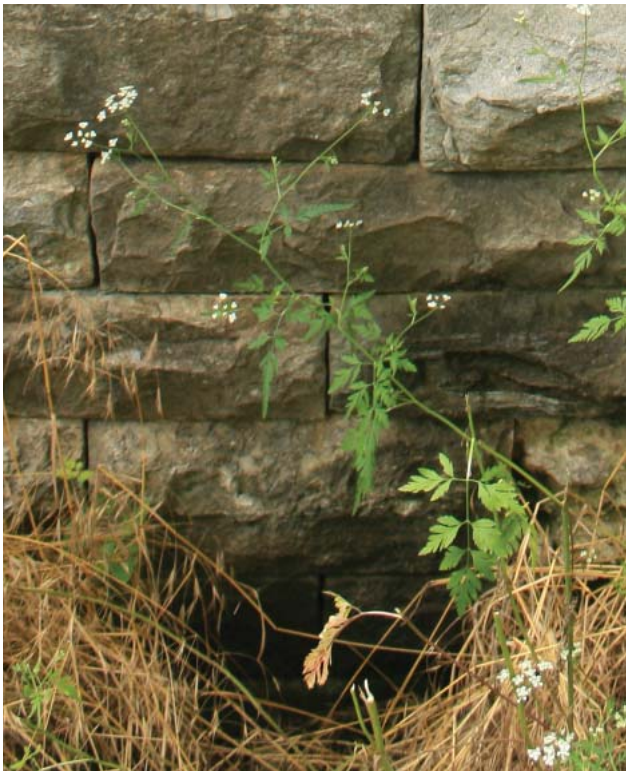
Figure 82. Animal burrow at base of wall (JMA, 2013).

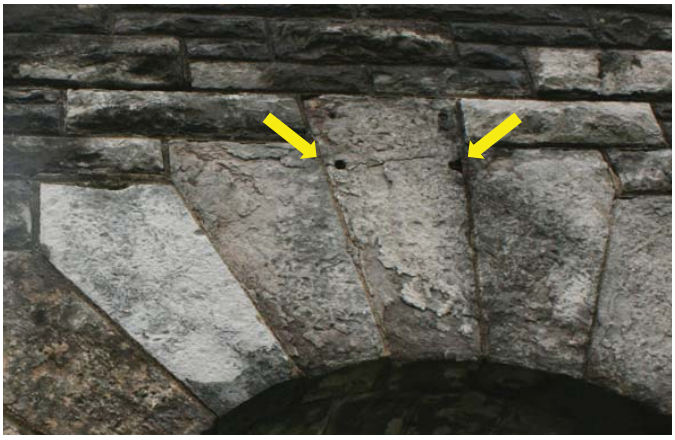
Figure 99. Drilled holes in face of stone in central arch of the entrance gateway (JMA, 2013).

Further investigation needed to determine whether there was a sign or plaque.
