STAFF RECOMMENDATION
2020 10th Avenue South
February 20, 2019

Application: Demolition-Partial; New Construction—Addition;
District: Waverly-Belmont Neighborhood Conservation Zoning Overlay
Council District: 17
Map and Parcel Number: 10509041200
Applicant: Tarl LaRocco
Project Lead: Melissa Baldock, melissa.baldock@nashville.gov

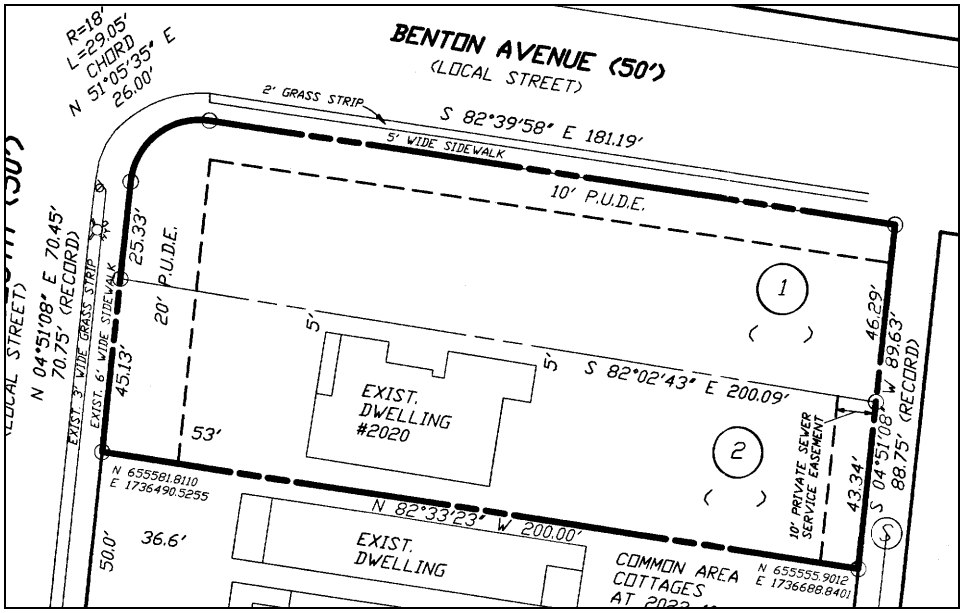
Until 2018, the house sat on a larger, wider lot. In 2018, Metro subdivided the lot into two parcels (Figure 3). As a result, the lot at 2020 10th Avenue South became narrower than typical lots in the area at approximately forty-five feet (45') wide at the front. MHZC approved new infill construction, with conditions, for the newly created parcel at 2018 10th Avenue South in July 2018. MHZC staff never received revised drawings

Figure 3. The plat showing the creation of two lots out of the previous larger lot at 2020 10th Avenue South.

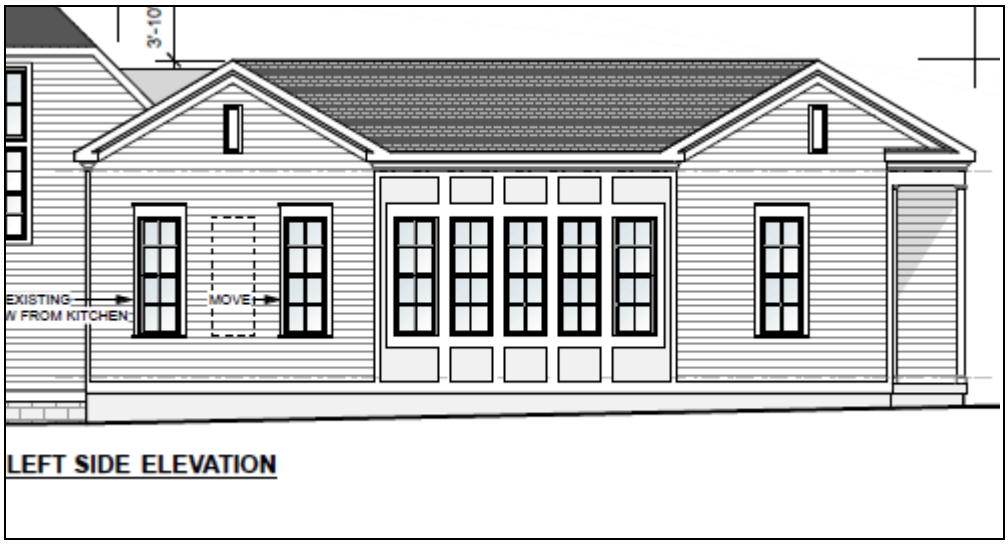
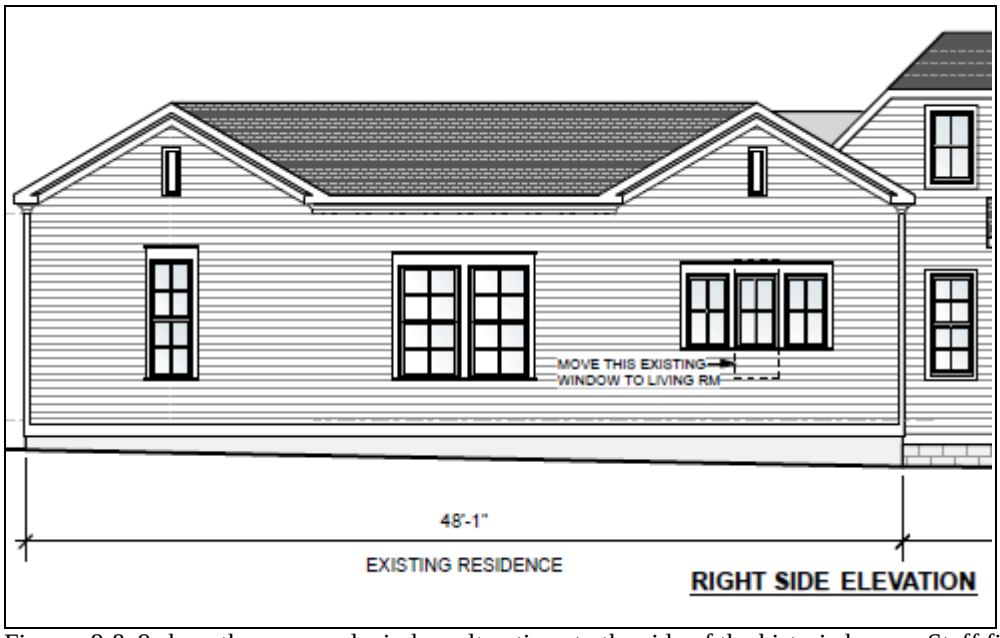
The applicant is proposing to alter window and door openings on the right and left facades towards the back. Alteration to window openings on the historic house is considered to be partial demolition. On the left elevation, the applicant is intending to move the existing window opening slightly to the right and to move the existing window opening from the back of the right elevation to this façade (Figure 8). The window opening on the right will be replaced with three shorter window openings (Figure 9). Because these window alterations are happening towards the back of the historic house and because the applicant intends to use the same casings and windows, staff finds these alterations to be appropriate.

Figures 8 & 9 show the proposed window alterations to the side of the historic house. Staff finds these alterations to be appropriate.

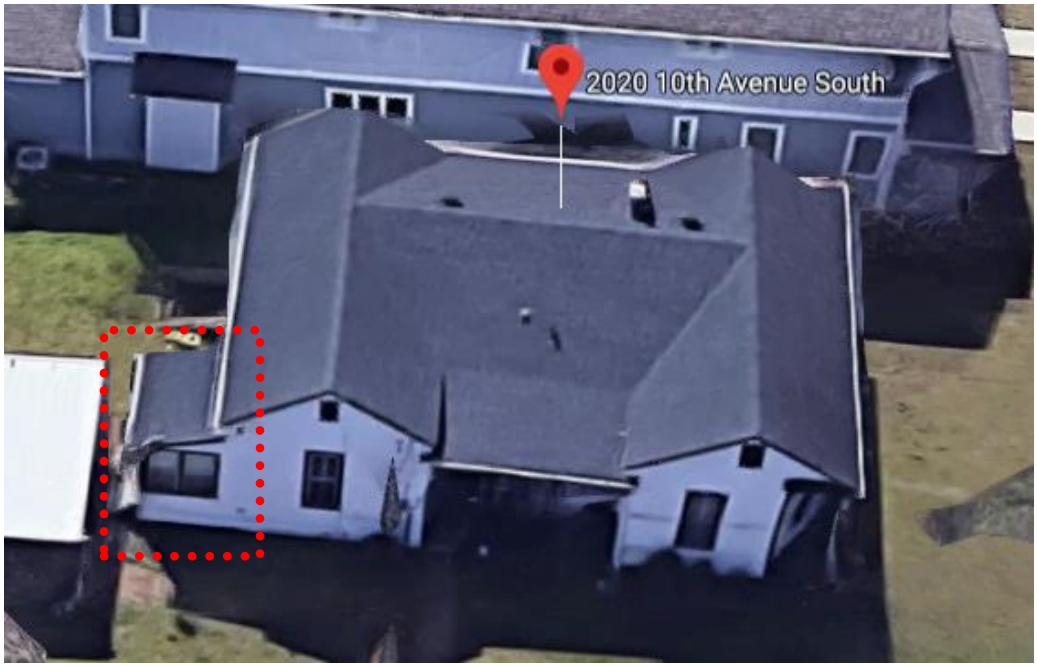
The applicant is proposing further to remove a small, rear porch portion of the house (Figure 10). The rear porch of the house is not seen in any of the older maps for the house and was therefore likely constructed after 1957. The structure has a separate roof form from the rest of the house, and staff finds that its date of construction, location at the rear of the house, and roof form do not contribute to the historic character of the house. Finally, the applicant is proposing to remove a detached rear carport and a detached garage (Figure 11). Neither structure appears on the 1957 Sanborn map, and neither contributes to the historic character of the house, the site, or the overall neighborhood. Staff therefore finds demolition of the rear porch, garage, and carport to be appropriate.

Figure 10. Staff finds that the removal of the appendage at the rear of the house to be appropriate.

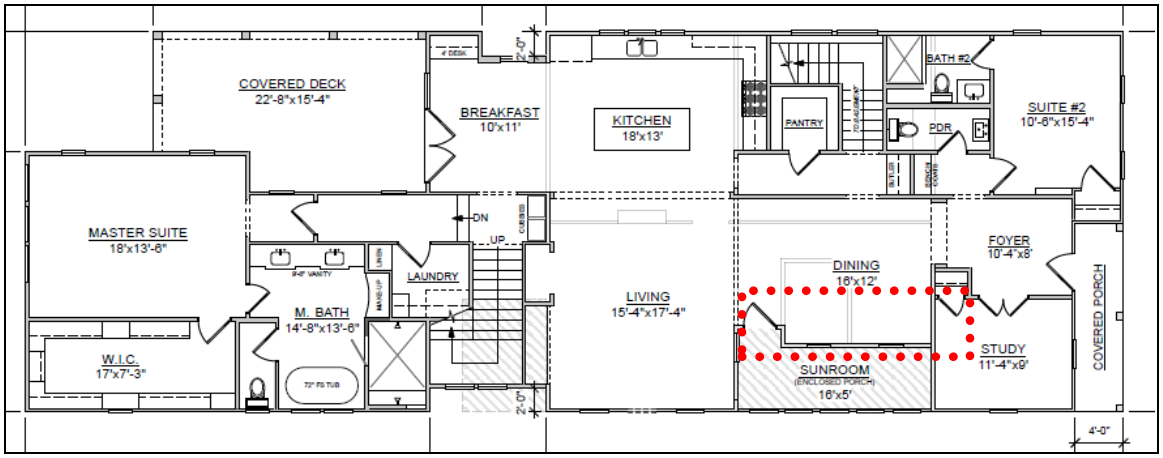
Design: Staff finds that the addition's height, scale, and taller roof form contrast greatly with the historic house at 2020 10th Avenue South. In addition, staff finds that the design of the proposed enclosure of the side porch is not appropriate (Figures 12, 13, and 14). Although the plans show that the exterior wall will remain, staff finds that the design of the enclosure lacks the transparency and openness required to indicate that this was once an open porch. The Sanborn maps from 1908, 1914, and 1957 all show that this area was always a side porch (Figures 15, 16, and 17). Staff finds the side porch configuration is a significant part of this historic house's form and should be preserved. Staff therefore recommends that the side porch element be designed to be more open in nature so – for instance all glass or screened – so that the exterior wall can still be read through the enclosed porch. The addition of posts to the enclosure would further help to make the element read more as an enclosed porch rather than a new wall.

Figures 13 & 14. The floor plan and elevation showing the area of the enclosed porch.

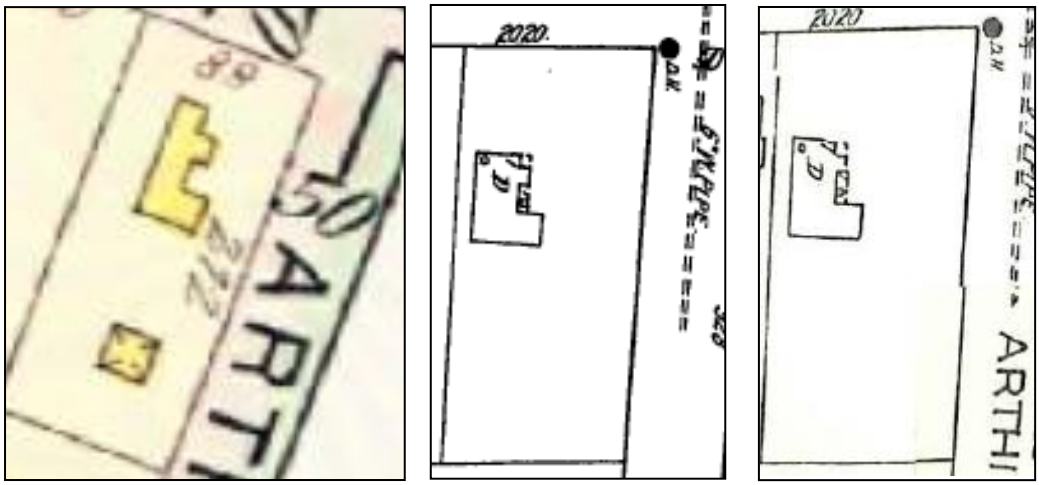
Figures 15, 16, and 17 show, left to right, the 1908, 1914, and 1957 Sanborn maps, which show the side porch element.
