STAFF RECOMMENDATION
3726 Richland Avenue
April 20, 2016

Application: Demolition; Reconstruction
District: Richland-West End Neighborhood Conservation Zoning Overlay
Council District: 24
Map and Parcel Number: 10409007300
Applicant: Gary and Lou Ann Brown
Project Lead: Paul Hoffman, paul.hoffman@nashville.gov

Description of Project: Demolition of a contributing building and reconstruction to the specifications and details of the existing building.

Structural Condition Assessment of 3726 Richland Ave., Nashville, Tennessee

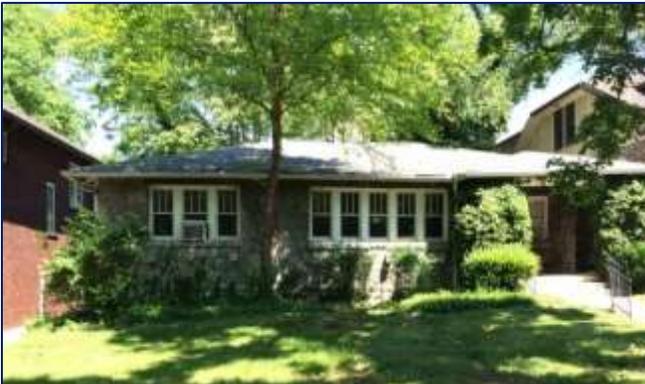
Figure 1. 3726 Richland Avenue

Demolition: There is settling apparent on first view of the building's front facade. The front porch shows a fall of two to three inches (2-3") over its twelve feet (12') from right to left. At an unknown date, the deterioration of the foundation wall was observed and remediation attempted with a new concrete block wall. This was laid adjacent to the front stone wall to a height of approximately seven feet (7') to support the stone wall. The new wall may have kept the stone behind it from fully collapsing. The engineer for the project observes that it also hid the problem, preventing the necessary repair:
