METROPOLITAN GOVERNMENT OF NASHVILLE AND DAVIDSON COUNTY

STAFF RECOMMENDATION
1515 5th Avenue North
August 15, 2012

Application: Demolition
District: Germantown Historic Preservation Zoning Overlay
Council District: 19
Map and Parcel Number: 08112041500
Applicant: SWH Residential Partners, LLC, John Tirill
Project Lead: Robin Zeigler, robin.zeigler@nashville.gov

<p>Description of Project: The applicant proposes to demolish non-historic buildings on half of the original Werthan Mill site in Germantown for future development.</p> <p>Recommendation Summary: Staff recommends demolition of buildings 1-5 on the Werthan complex, finding that demolition meets 7.2 of the design guidelines for the Germantown Historic Preservation Zoning Overlay.</p>	<p>Attachments A: Photographs</p>
--	---

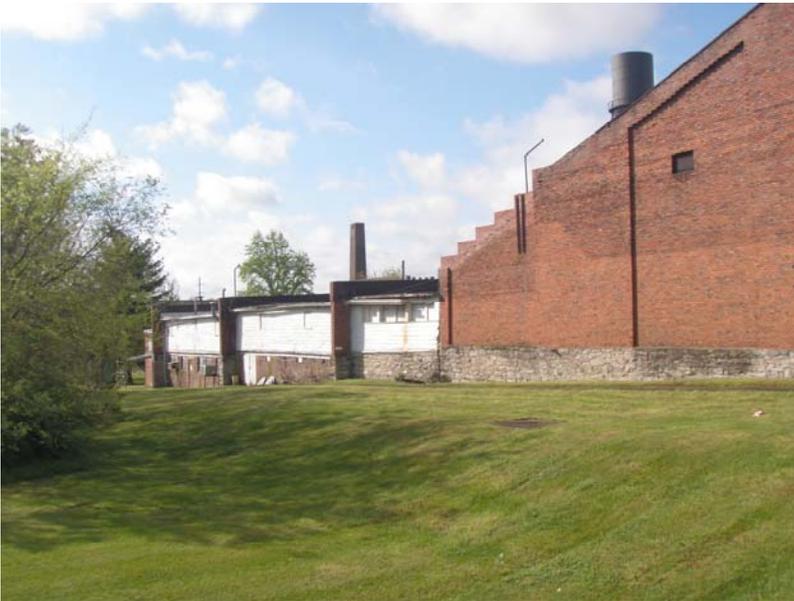
Picture #01
Exterior East

1. Building 1: (Located at the northwest corner of Parcel 415, along Hume Street)
 - Constructed in 1869, 1914 and 1955. West wall brick largely rebuilt following 1972 tornado.
 - 1-story brick building with basement having an area of Approx. 36,189 sqft.
 - Structure is damaged due to tornado damage and building is in poor condition due to lack of repair.
 - Request demolition for future planned mixed use redevelopment and site accessibility.

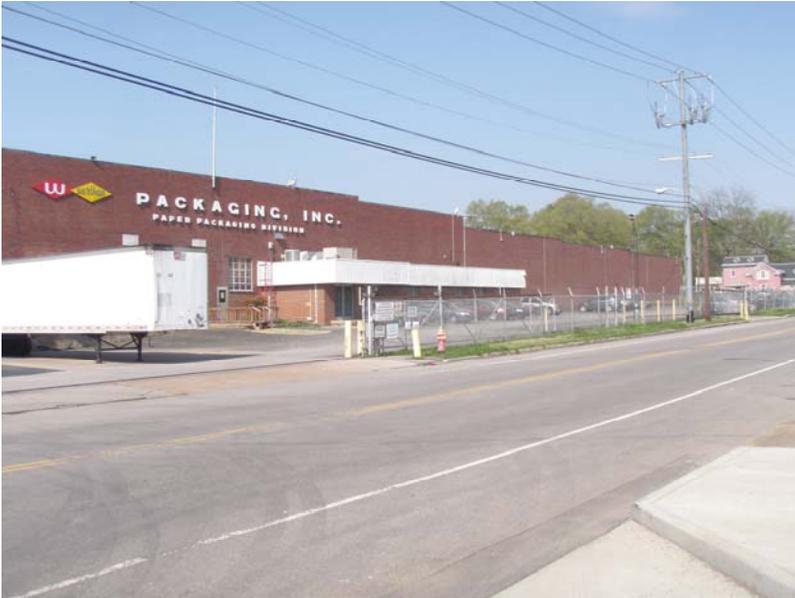
Picture #01
Exterior East

2. Building 2: (Located at the northeast corner of Parcel 415, along Hume Street and Fifth Avenue North)
- Constructed in 1953 and 1965.
 - 1 and 2-story brick building having an area of Approx. 132,245 sqft.
 - Request demolition for planned mixed use redevelopment and site accessibility.
 - Building is outside the period of any historical significance.

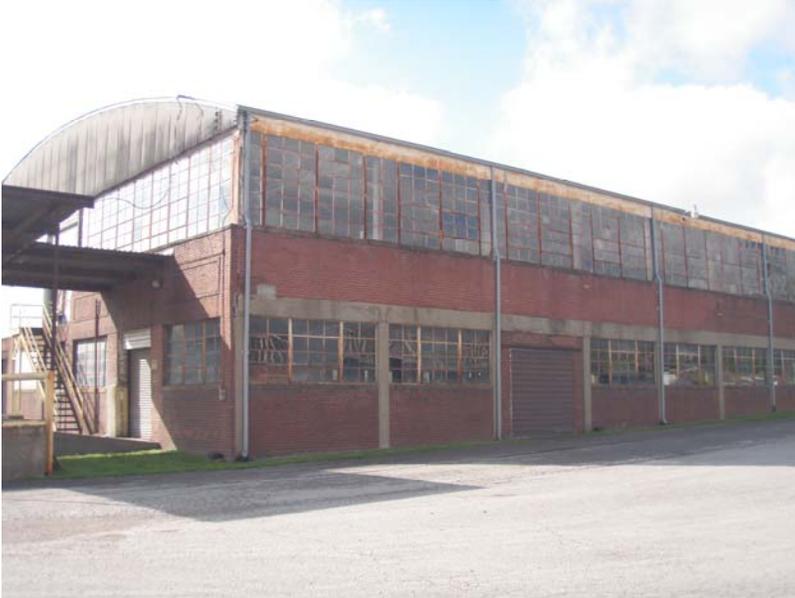
Picture #01
Exterior North East

- Constructed in 1941 and 1951.
- 2-story brick and metal building having an area of Approx. 65,770 sqft.
- Currently in use as Light Industrial
- 2.32 acres+/- will be leased backed to Werthan (Western half of building)
- Request demolition of Eastern half for future planned mixed use redevelopment and site accessibility
- Eastern half of the building is outside the period of any historical significance (1951)

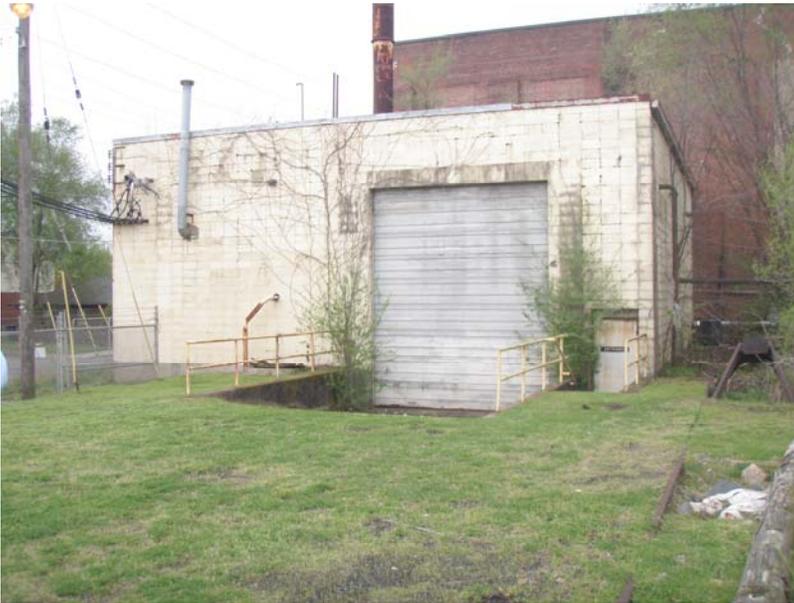
Picture #01
Exterior East

- Constructed in approx 1971
- 1 story concrete block building having an area of approx. 2,287 sqft.
- Request demolition for mixed use redevelopment accessibility to site
- Building is outside the period of any historical significance (1971)
