STAFF RECOMMENDATION
1203 Forrest Avenue
May 16, 2012

Application: Demolition
District: Lockeland Springs-East End Neighborhood Conservation Zoning Overlay
Council District: 06
Map and Parcel Number: 08309009400
Applicant: Neil McGlothlin/ Paragon Group LLC
Project Lead: Robin Zeigler, robin.zeigler@nashville.gov

**Re: Structural Review of Integrity of Residence
1203 Forrest Avenue
Nashville, TN 37206
AJDS Project No. 12-0421-000**

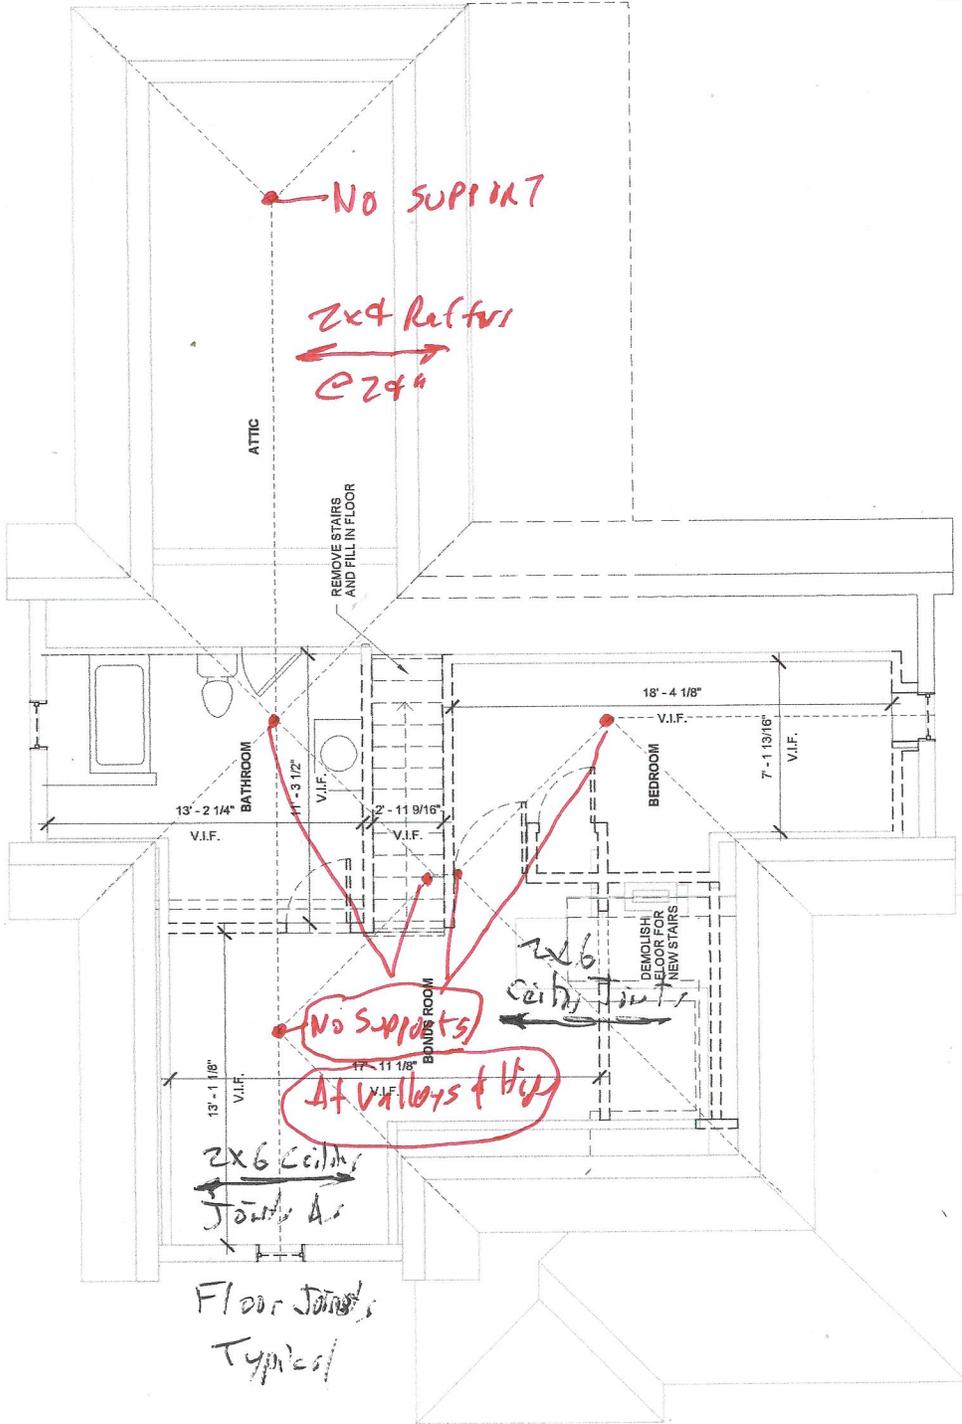
EXISTING SECOND FLOOR PLAN
 1/4"=1'0"

Second floor joists are actually only original 2x6 ceiling joists that also show signs of past charring from fire. Walls only have single top plates and no headers over windows. Rafters rest on ribbon board on top of ceiling joists.
