STAFF RECOMMENDATION
1614 Benjamin Street
March 20, 2013

Application: Demolition of contributing building
District: Eastwood Neighborhood Conservation Zoning Overlay
Council District: 06
Map and Parcel Number: 08306003300
Applicant: Bill Franklin, Owner
Project Lead: Sean Alexander@nashville.gov

STRUCTURAL EVALUATION OF RESIDENCE

1614 Benjamin Street
Nashville, Tennessee
Project #213022

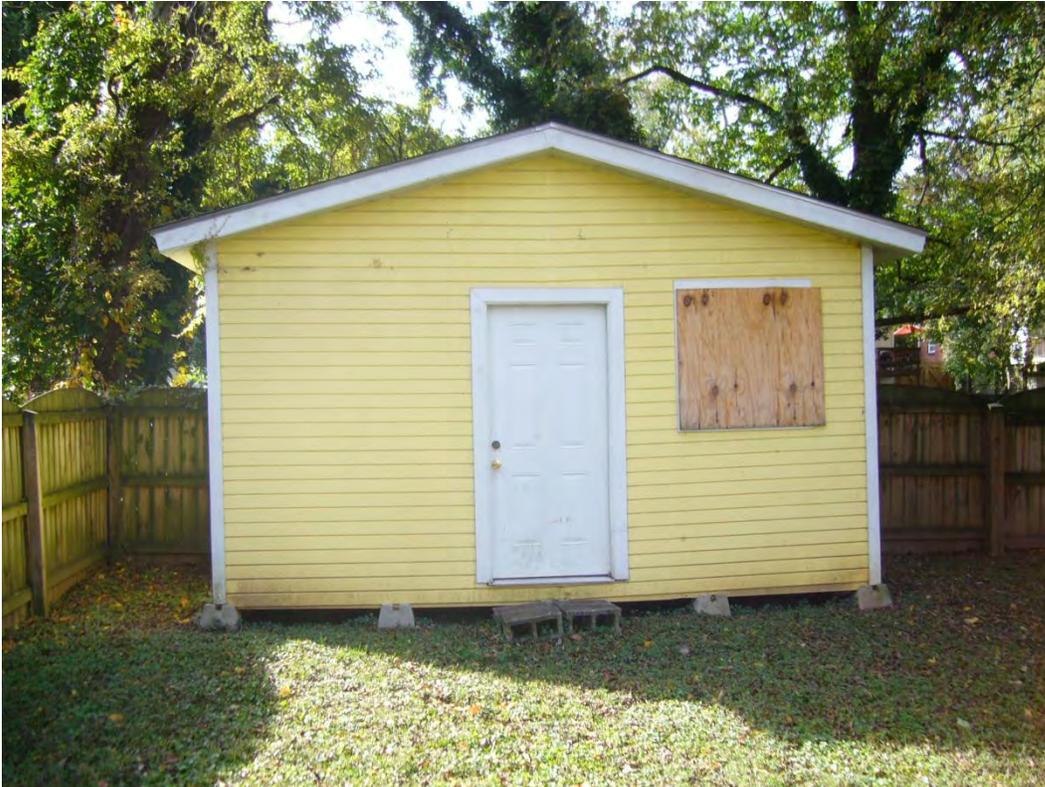
1614 Benjamin Avenue, Accessory Building

The applicant proposes to demolish the house and accessory building. Demolishing the accessory building meets guideline III.B.2.b for appropriate demolition because it is not historic and does not contribute to the historic character of the district.
