STAFF RECOMMENDATION 1810 Ashwood Avenue January 15, 2013

Application: Demolition
District: Belmont-Hillsboro Neighborhood Conservation Zoning Overlay
Council District: 18
Map and Parcel Number: 10416007800
Applicant: Andrew Oeltmann, owner
Project Lead: Robin Zeigler, robin.zeigler@nashville.gov

LIMITED STRUCTURAL INSPECTION

1810 Ashwood Avenue
Nashville, TN

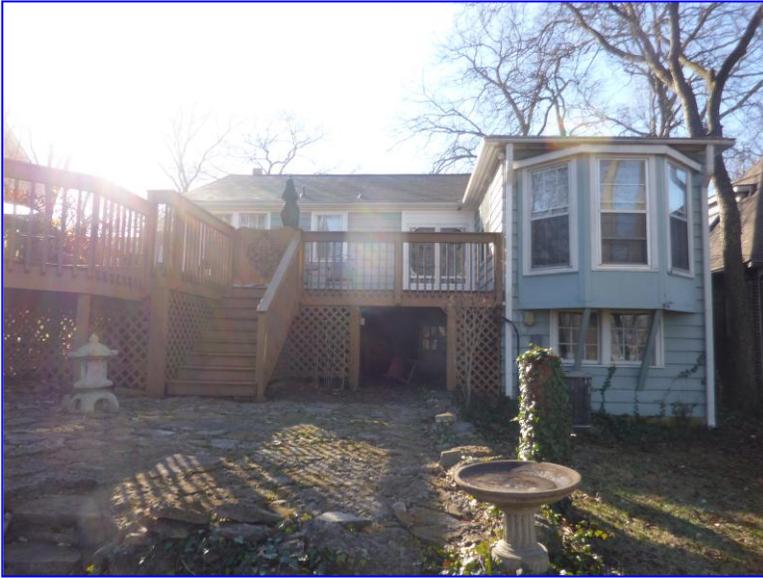
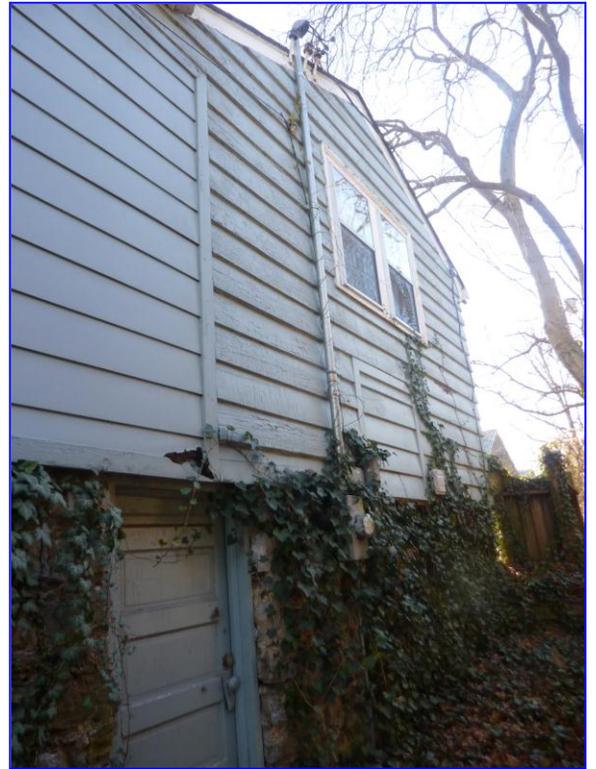
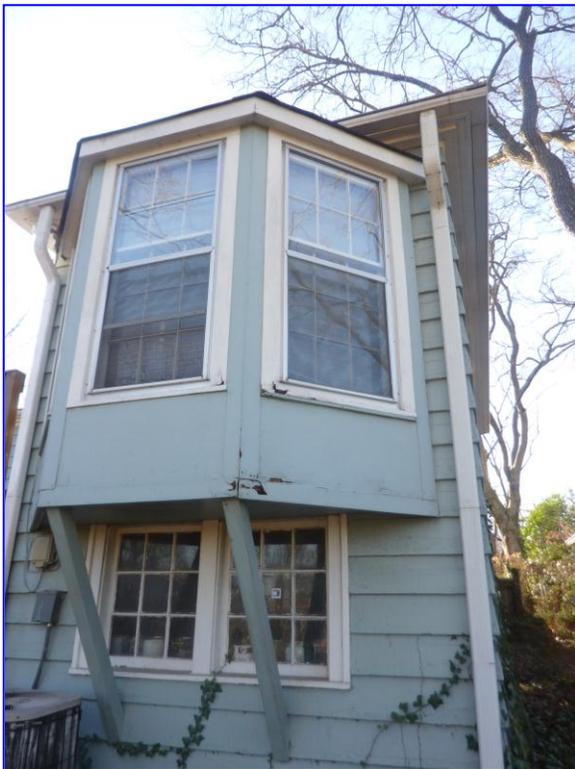
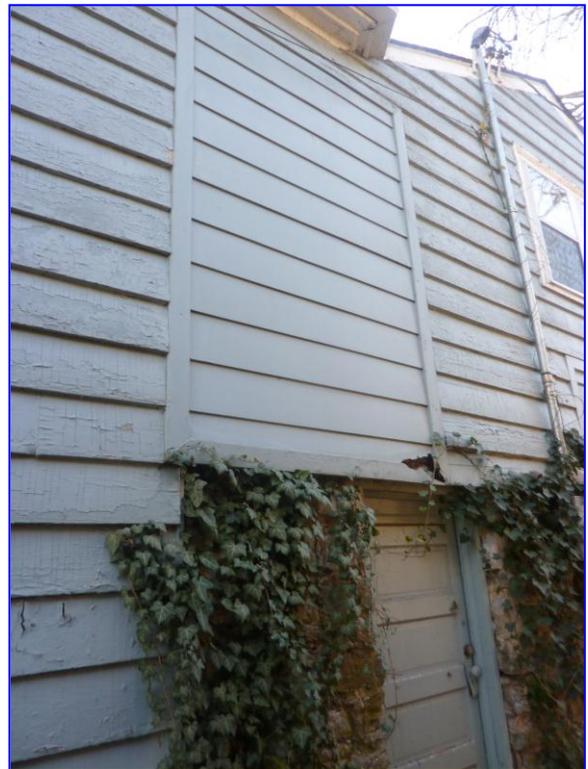
Rear Addition

The only portion of the building in need of structural repair is the rear left addition and there are two supports needed for the historic portion of the home. The report provides recommendations for these two supports that would be relatively easy to accomplish without replacing the entire foundation and the use of temporary foundation supports, as described in the Adler estimate. In addition, if the applicant did not wish to make the repairs necessary to stabilize the rear addition, the design guidelines would allow for its removal.

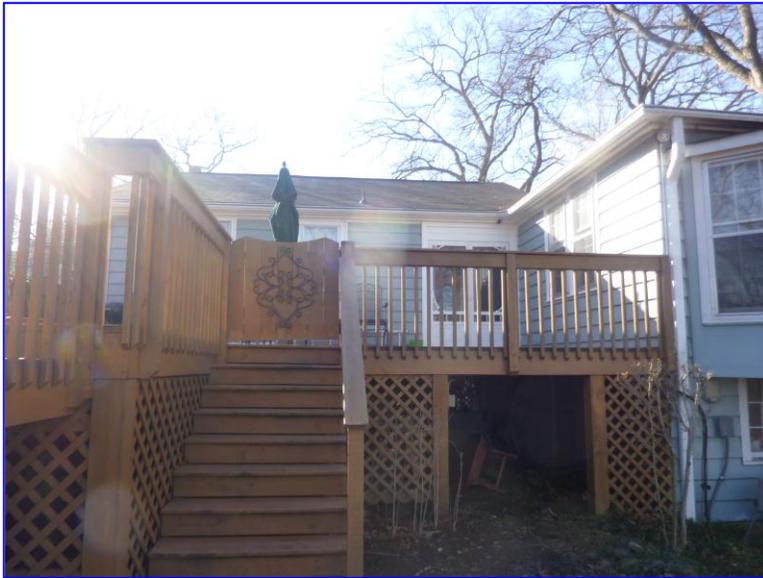
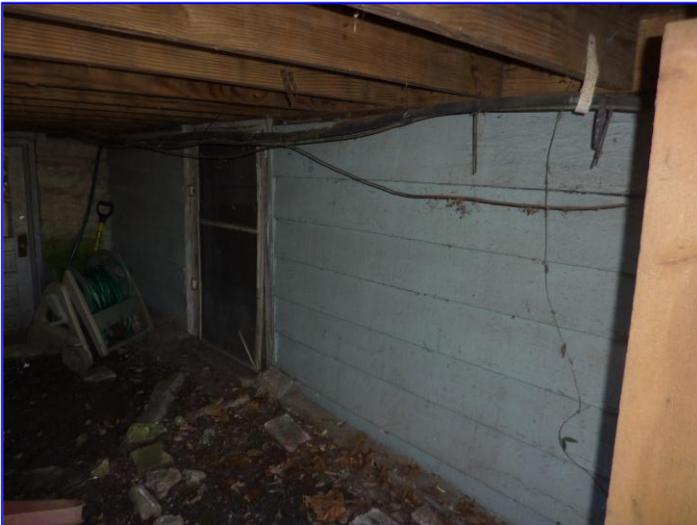
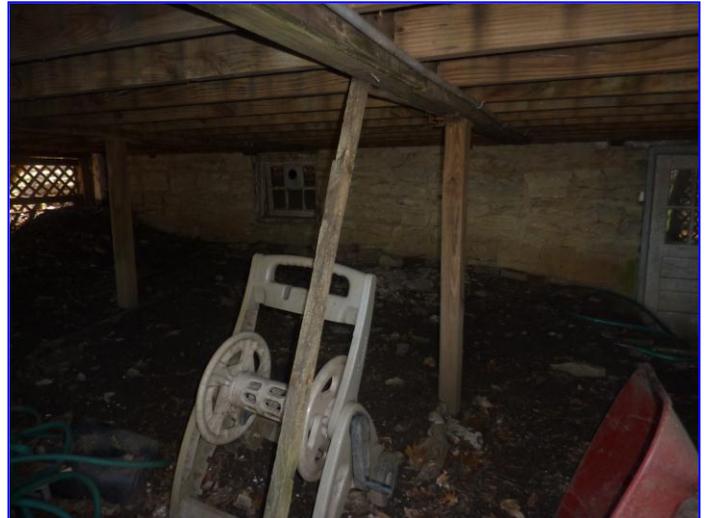
Rear Deck

The rear deck was not secured properly when constructed and the report stated that it should be "bolted to the structure." The only other item of repair noted in the report is the replacement of the basement stairs. These are not structural issues that render the home inhabitable.
