METROPOLITAN GOVERNMENT OF NASHVILLE AND DAVIDSON COUNTY

STAFF RECOMMENDATION 128 Second Avenue North August 19, 2015

Application: Violation
District: Second Avenue Historic Preservation Zoning Overlay
Council District: 19
Map and Parcel Number: 09306207900
Applicant: Nancy Jones, Possum Legend, LLC
Project Lead: robin.zeigler@nashville.gov

Description of Project: This application is for alterations made that do not match the permit and/or design guidelines. The applicant would like to request approval of the alterations.

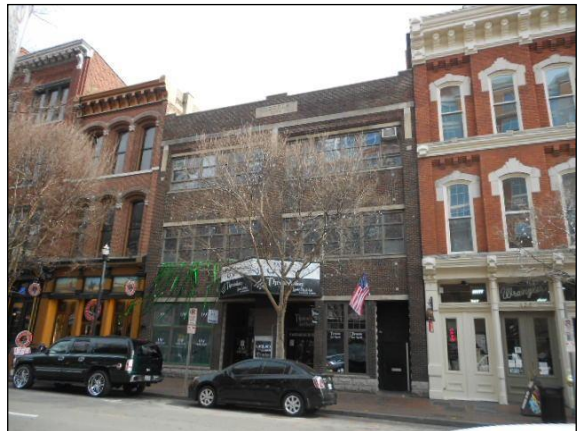
The Hooper Building located at 128 Second Avenue North was constructed in 1924. This building is three stories tall facing Second Avenue and four stories on First Avenue due to a change in grade.
