METROPOLITAN GOVERNMENT OF NASHVILLE AND DAVIDSON COUNTY

Metropolitan Historic Zoning Commission
Sunnyside in Sevier Park
3000 Granny White Pike
Nashville, Tennessee 37204
Telephone: (615) 862-7970
Fax: (615) 862-7974

STAFF RECOMMENDATION
128 Second Avenue North
August 19, 2015

Application: Violation
District: Second Avenue Historic Preservation Zoning Overlay
Council District: 19
Map and Parcel Number: 09306207900
Applicant: Nancy Jones, Possum Legend, LLC
Project Lead: robin.zeigler@nashville.gov

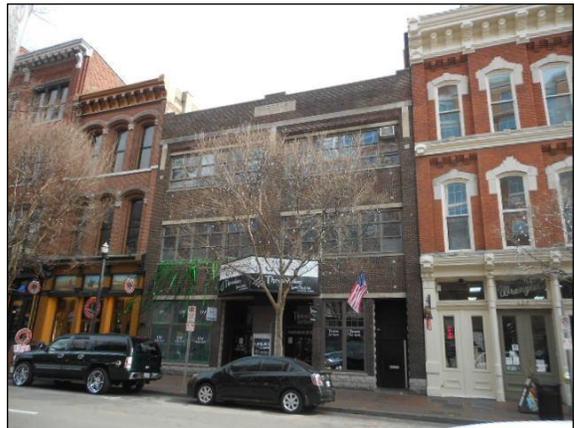
The Hooper Building located at 128 Second Avenue North was constructed in 1924. This building is three stories tall facing Second Avenue and four stories on First Avenue due to a change in grade.

1. Storefront windows have been replaced on the Second Avenue façade;
2. Inappropriate masonry added to front façade;
3. Roll-up doors added to the First Avenue façade, which also changed the dimensions of the opening;
4. The rooftop bar no longer meets the 10’ setback requirement; and,
5. A small wall sign was added to the First Avenue elevation.
