STAFF RECOMMENDATION 1107 Boscobel Street August 17, 2016

Application: Demolition
District: Lockeland Springs-East End Neighborhood Conservation Zoning Overlay
Council District: 06
Map and Parcel Number: 083130171.00
Applicant: Chris Seay
Project Lead: Paul Hoffman, paul.hoffman@nashville.gov

**RE: 1107 Boscobel Street / Nashville, Tennessee
EMC Project No. 16674**

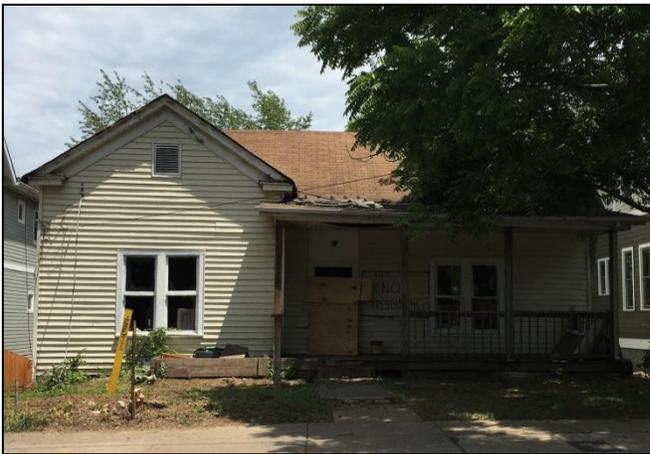
Figure 1. 1107 Boscobel Street

Background: 1107 Boscobel Street is a contributing structure in the Lockeland Springs-East End district. 1107 Boscobel dates to c.1900 and can be identified on the 1908 Sanborn map. The earlier Sanborn map, which dates to 1889, stops one block west of the site. The lot was platted as a part of the East Edgefield subdivision in 1875.

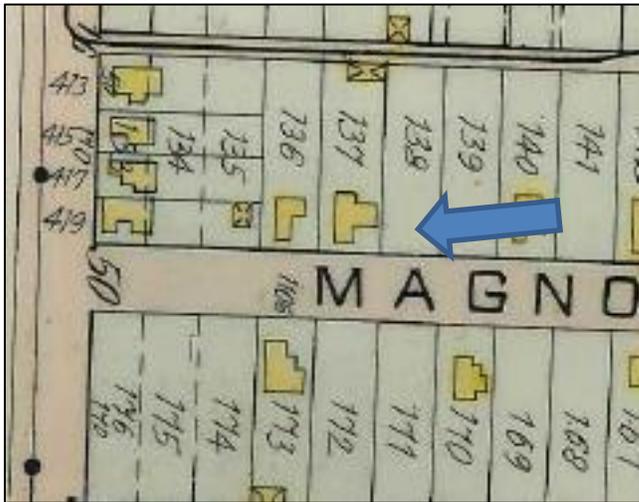
Figure 2. 1908 Hopkins map shows the approximate footprint of the current structure (Magnolia Street became Boscobel Street at a later date)

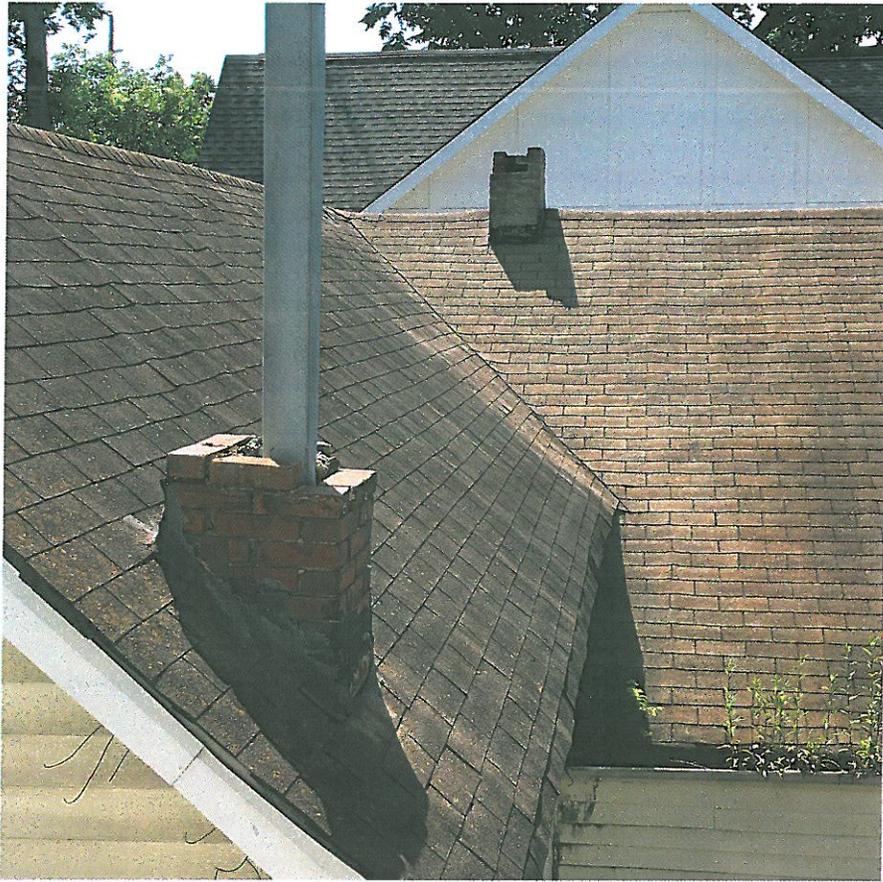
The masonry on the central fireplace/chimney on the main floor has cracked and settled. There is water staining on the floor joists and boards around the fireplace that indicates water is entering the building through the chimney. There is little mortar remaining in the brick joints in the chimneys above the roof. This is likely the channel through which water enters the chimneys (photographs 19 and 20).

Photograph 20: Deteriorated chimneys.

5. The existing 1x spaced roof sheathing boards must be removed and replaced with 5/8" APA-rated sheathing.
6. The fireplace/chimneys must be reconstructed.
