STAFF RECOMMENDATION 1712 Fifth Avenue North September 20, 2017

Application: Addition and Alterations - violation
District: Salemtown Neighborhood Conservation Zoning Overlay
Council District: 19
Map and Parcel Number: 08205003400
Applicant: Saint Petka Serbian Orthodox Church
Project Lead: Melissa Sajid, melissa.sajid@nashville.gov

Description of Project: A cupola addition was constructed, windows replaced and brick cladding removed without a Preservation Permit.

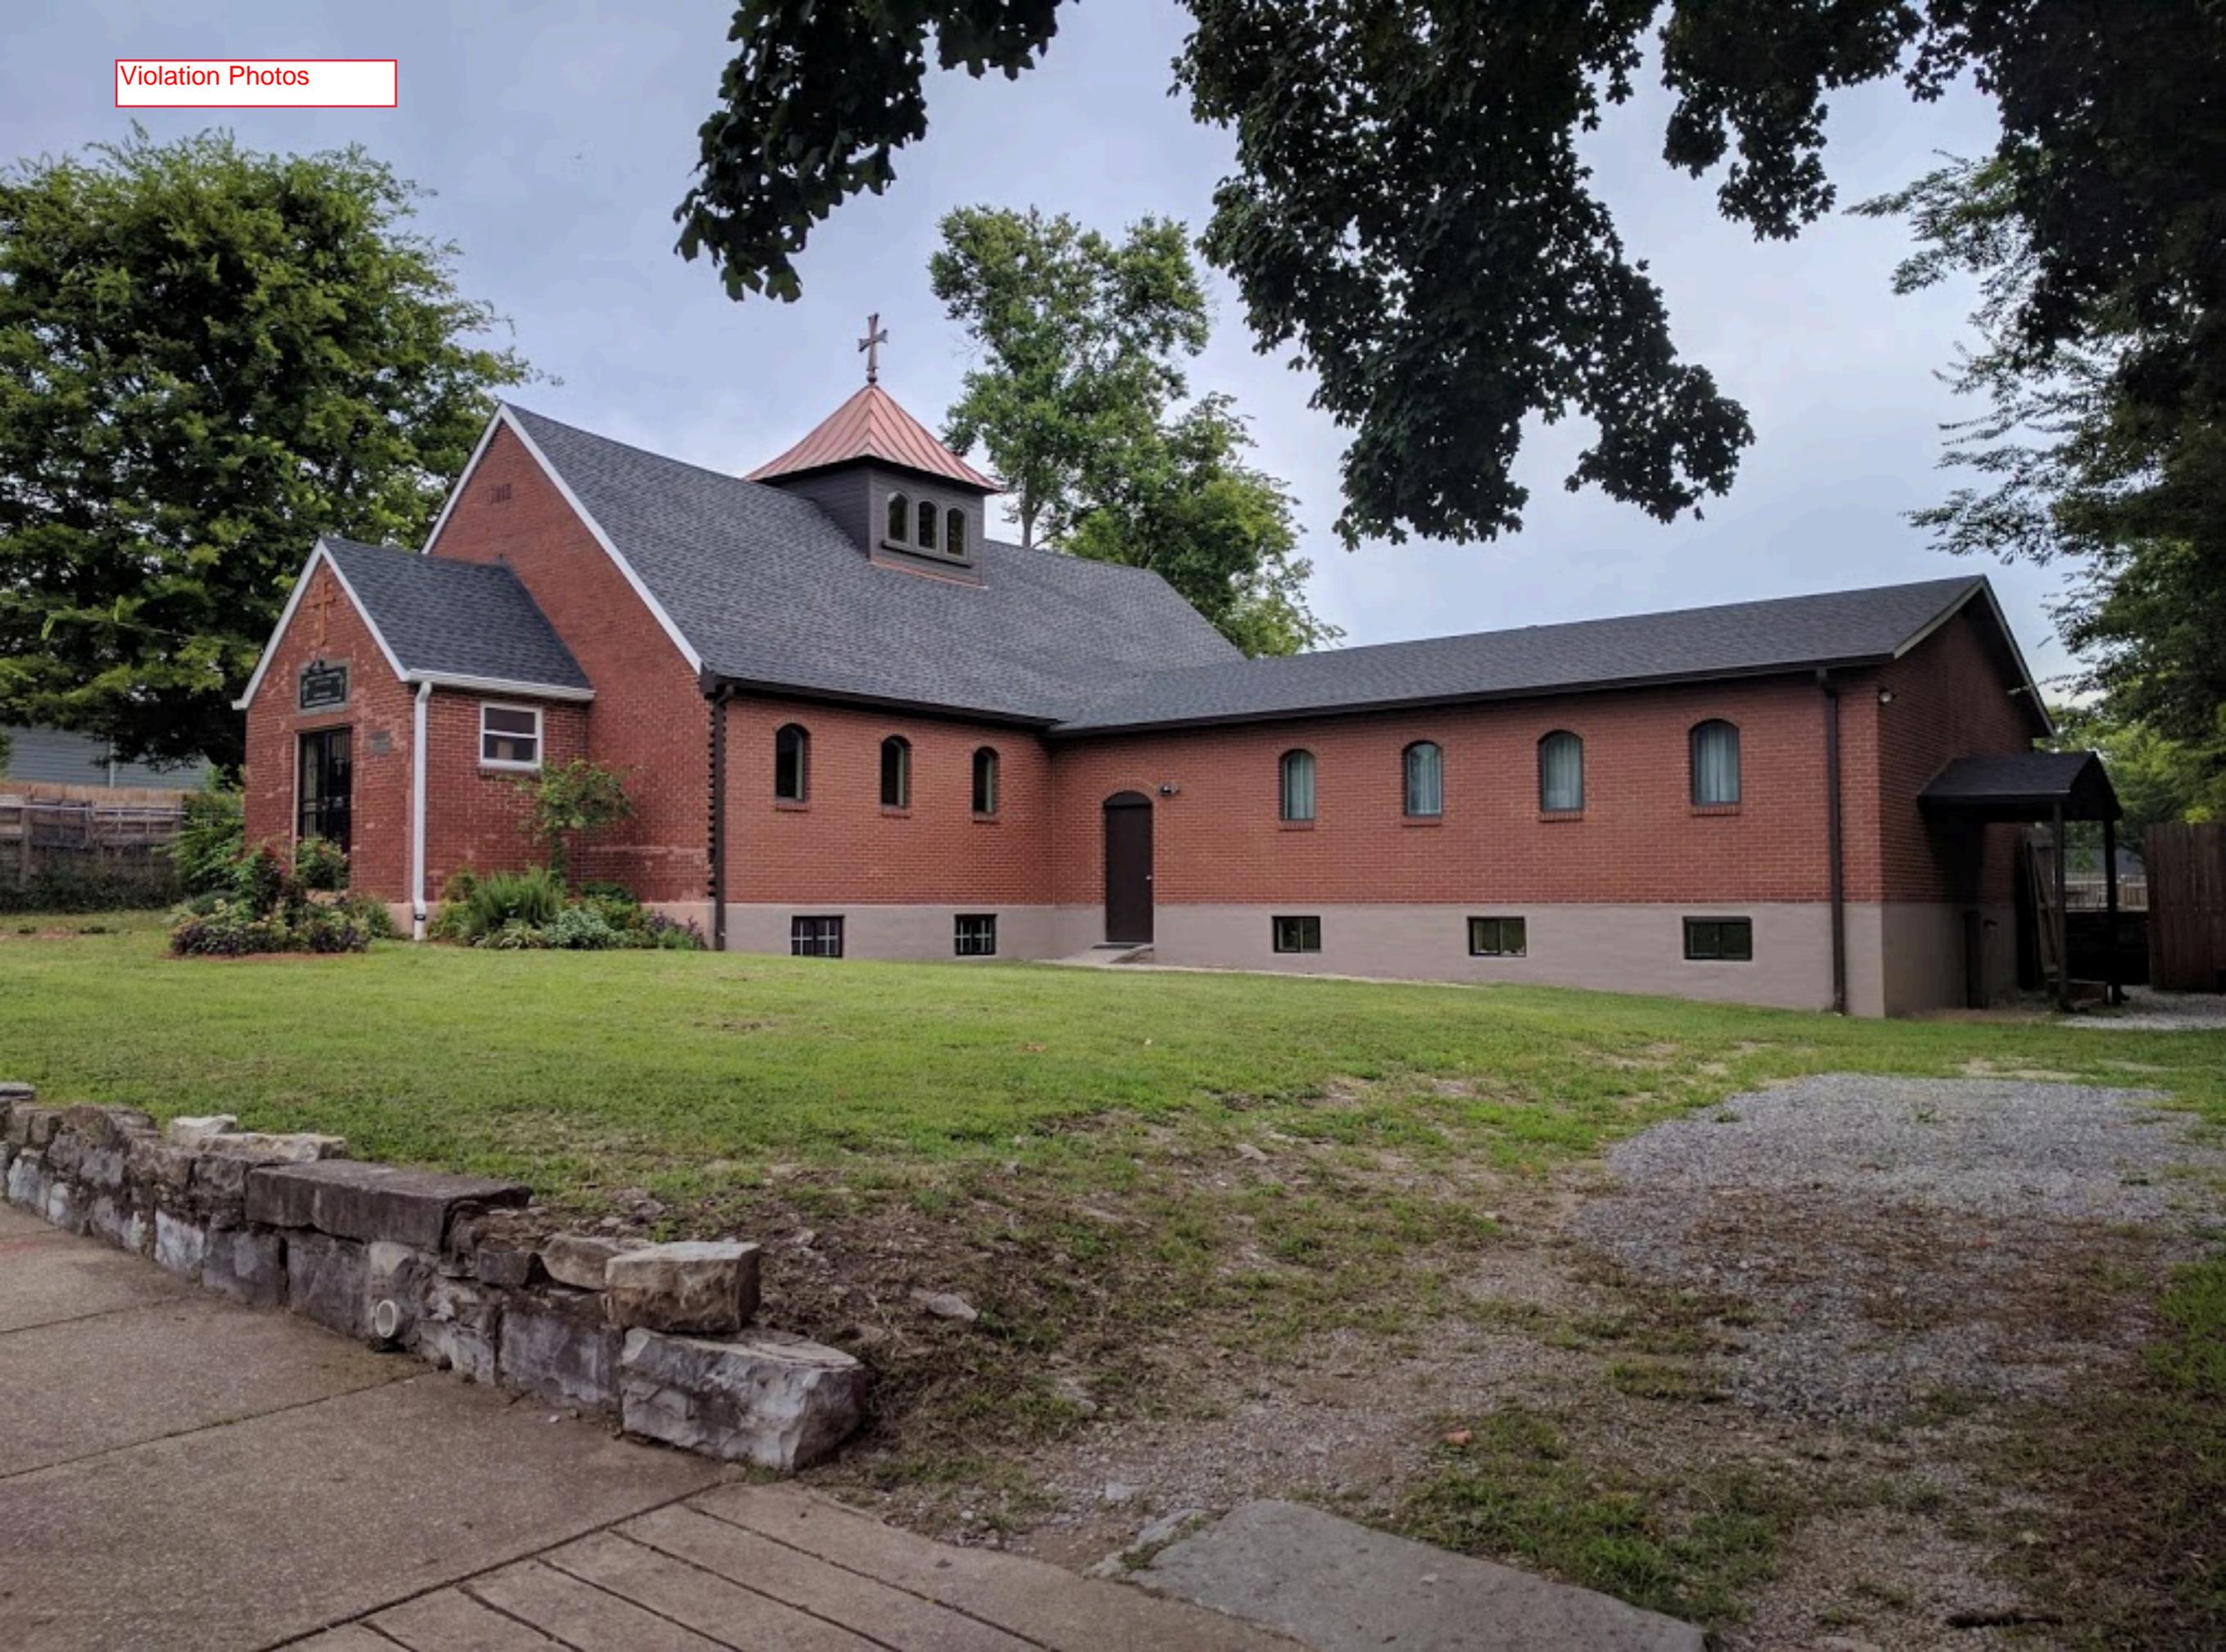
Violation Photos

The applicant has removed the historic brick on the historic portion of the church and it no longer exists, therefore it cannot be reinstalled (Figure 5). In addition the entire left façade was removed. On the non-historic portion of the church, the applicant replaced the existing T-1-11 siding with brick. There have been no changes to the cladding on the rear of the building.

According to the engineer’s report, wall frame rot and deterioration were discovered during the window replacement, and the brick on the left side of the historic building tilted outward during the window replacement, causing the roof framing to fail. It is not clear as to whether the scope at that time was for window replacement as permitted or for alteration of window openings, which was not permitted. The applicant then proceeded to repair the structural damage that was discovered by removing the brick on the left side of the façade (Figure 6) and did not inform MHZC.

applicant did not apply for a preservation permit for this work. When the masonry was replaced, the brick work on the corners of both the left and right façades was not completed (Figures 7 and 8). Since the original brick no longer exists, staff recommends that the two sides of the historic portion of the church be altered so that the vertical stretchers that were located at the bottom of the brick wall (see Figure 5) and above windows is reinstalled.

Staff recommends that the original window locations, dimensions, design and materials be reinstalled. The applicant shall submit drawings showing the original window dimensions and locations as well as information about materials for staff review, prior to making the change.
