STAFF RECOMMENDATION
628 Shelby Avenue
December 19, 2018

Application: Demolition
District: Edgefield Historic Preservation Zoning Overlay
Council District: 17
Map and Parcel Number: 09304004000
Applicant: Crystal Love
Project Lead: Paul Hoffman, paul.hoffman@nashville.gov

Structural Observance for 628 Shelby Ave., Nashville, TN 37206

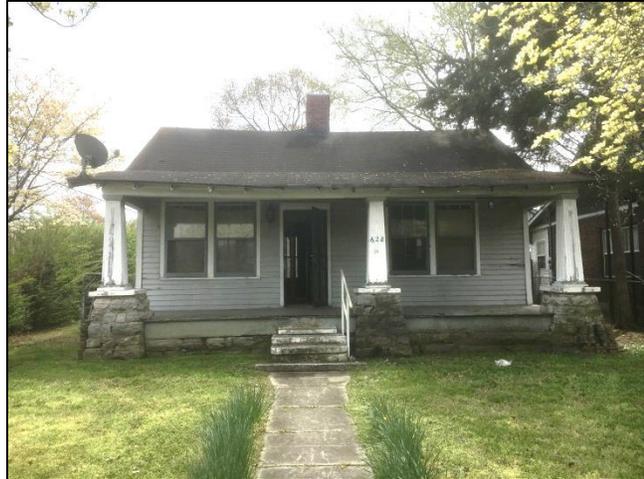
Figure 1. 628 Shelby Avenue
