STAFF RECOMMENDATION
1501 Fatherland Street
January 15, 2020

Application: Demolition
District: Lockeland Springs-East End Neighborhood Conservation Zoning Overlay
Council District: 06
Base Zoning: R6
Map and Parcel Number: 08313041400
Applicant: Laura Magliochetti
Project Lead: Paul Hoffman; paul.hoffman@nashville.gov

Structural Observance for 1501 Fatherland St., Nashville, TN 37206

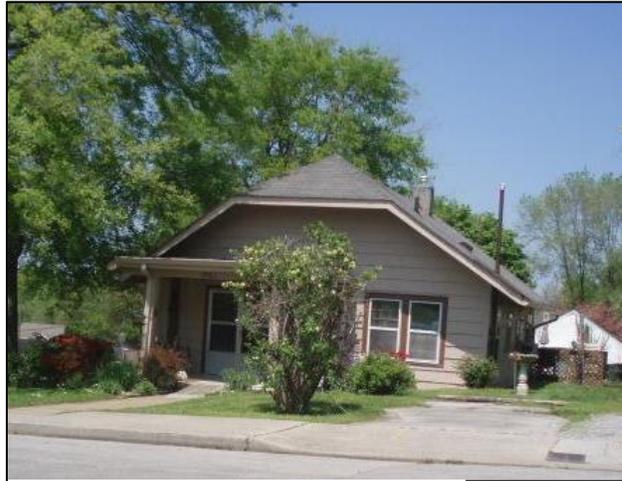
Figure 1: 1501 Fatherland Street.

Background: 1501 Fatherland Street was built circa 1930 and is a contributing building in the Lockeland Springs-East End Neighborhood Conservation Zoning Overlay (Figures 1 and 2).
