METROPOLITAN GOVERNMENT OF NASHVILLE AND DAVIDSON COUNTY

STAFF RECOMMENDATION
215 Broadway
March 18, 2020

Application: New Construction - Violation
District: Broadway Historic Preservation Zoning Overlay
Council District: 19
Base Zoning: DTC
Map and Parcel Number: 093 06 4 043.00
Applicant: Broadway Hotel, LLC
Project Lead: Jenny Warren, jenny.warren@nashville.gov

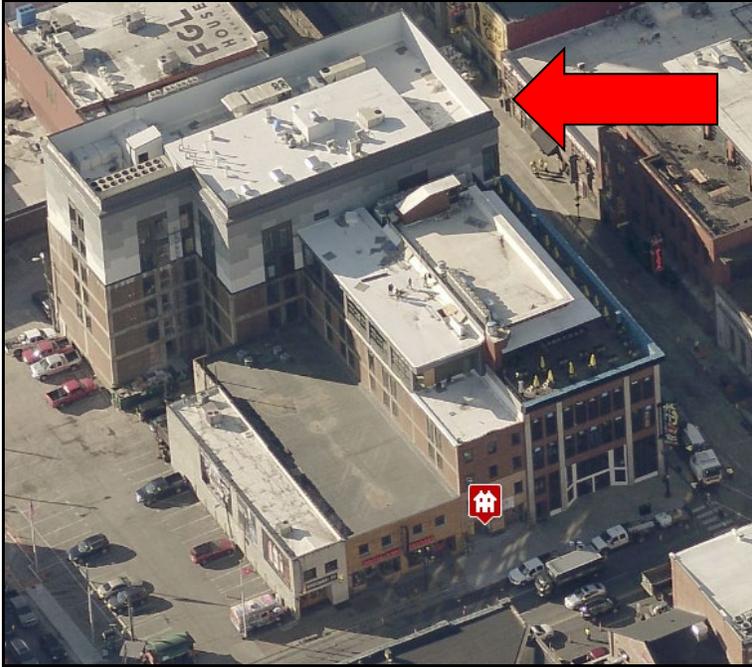
Figure 5: Aerial picture. 215 Broadway indicated by pin. The entrance to the Moxy Hotel is in a separate but connected building, along 3rd Avenue, North.

In addition to not meeting the design guidelines for new construction, the ATM does not meet the policy the Commission established in 2004 that only allows for ATMs inside a building, where it would not be reviewed, or “in an alcove not on the primary facade.” This ATM is in a recessed primary entry rather than an “alcove,” and it is located along Broadway, one of the most highly visible streets in the district. The Moxy Hotel occupies the property today and operates out of this historic building and a second building behind it, which faces onto 3rd Avenue, South. While the Moxy has their primary entrance on 3rd Avenue, Broadway is still the primary façade for this historic building. Therefore, an ATM along this primary façade is not appropriate.

Staff recommends disapproval of the current storefront configuration including the ATM, finding that it does not meet Section II of the design guidelines for rehabilitation, Section III of the design guidelines for new construction and the MHZC policy for ATMs. Staff suggests that the doors and transoms be installed into the left side of the storefront, as per the plans approved in 2014 and the ATM be removed within the next 60 days.
