**METROPOLITAN GOVERNMENT OF NASHVILLE AND DAVIDSON COUNTY**

**STAFF RECOMMENDATION**  
**215 Broadway and 110 3<sup>rd</sup> Avenue South**  
**July 15, 2020**

**Application:** New Construction - Violation  
**District:** Broadway Historic Preservation Zoning Overlay  
**Council District:** 19  
**Base Zoning:** DTC  
**Map and Parcel Number:** 09306404300  
**Applicant:** Broadway Hotel, LLC  
**Project Lead:** Jenny Warren, jenny.warren@nashville.gov

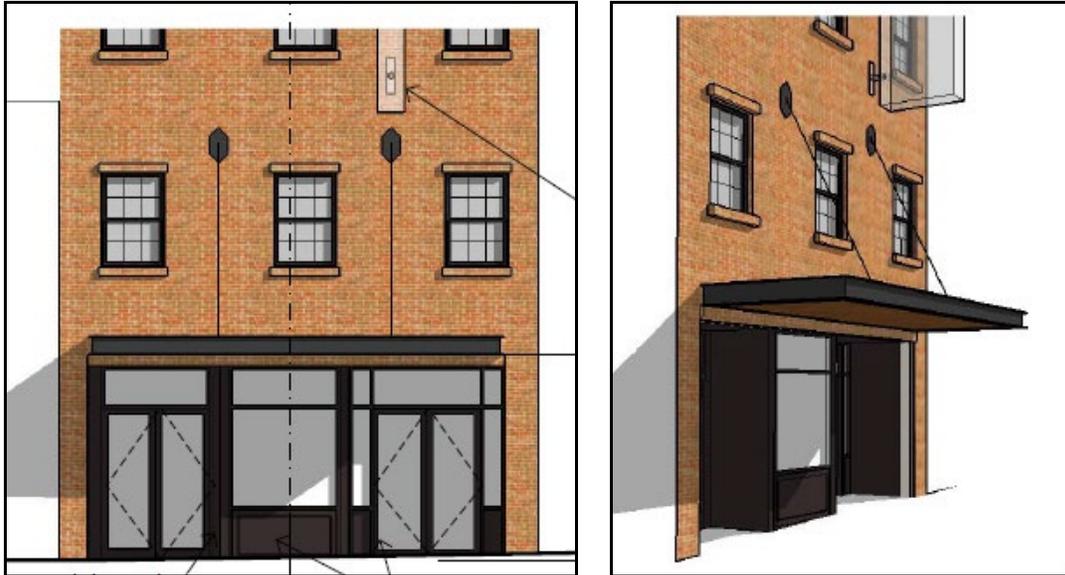
revised on 4/22/2016, after the expansion of the overlays, shows a storefront with a projecting central bay and recessed double doors with transoms on either side (Figures 2 & 3). This was constructed as per the permitted plan on the right side, with full-light doors, and in the central bay. However, the left side was not built out according to the permitted plans (Figure 4). Instead of installing double glass doors with a transom, a solid wall was constructed with two nearly solid doors and no transom. An ATM was also installed here.

Figures 2 & 3: Storefront as approved in 2014

Staff finds the current configuration to be inappropriate, as it does not match the permit and does not comply with General Principles, Section II of the design guidelines which state “Replacements of street-level facades should be in keeping with the style and period of the building.”

Staff recommends that the doors and transom be installed into the left side of the storefront, as per the plans approved in 2014, which would also result in removal of the ATM installed without a permit.

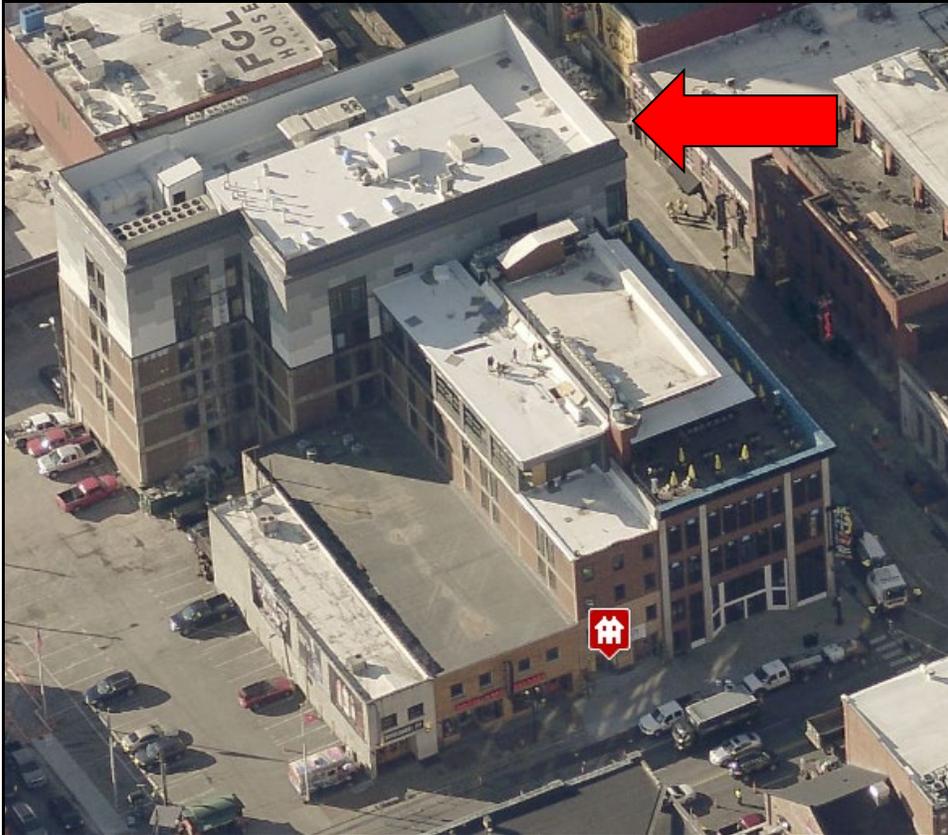
If the revised interpretation of the design guidelines is agreed upon, the violation at the 3<sup>rd</sup> Avenue South entrance would meet the guidelines. The ATM is located within a deep recess (approximately 6' 2" deep) on the façade and is stepped back from the exterior wall by more than one foot (1'). It is installed in a new side-wall so did not require removal of any historic features. It measures approximately fifteen inches (15") wide, which would meet the three foot (3') wide maximum. The signage is located on the machine itself. No additional lighting or signage has been added or is proposed.

If the Commission finds that the 2004 interpretation is still valid, the ATM meets the design guidelines due to its location. The interpretation the Commission established in 2004 does not allow for ATMs on primary facades. Although this entrance appears as a primary façade, this part of the building is a later addition to the Broadway facing building and is non-contributing and so could be considered a secondary façade.

Figure 6: Aerial picture. 215 Broadway indicated by pin. The entrance to the Moxy Hotel is in a separate but connected building, along 3<sup>rd</sup> Avenue South.
