5246 Brick Church Pike Culvert Replacement

Existing Conditions

Proposed Conditions

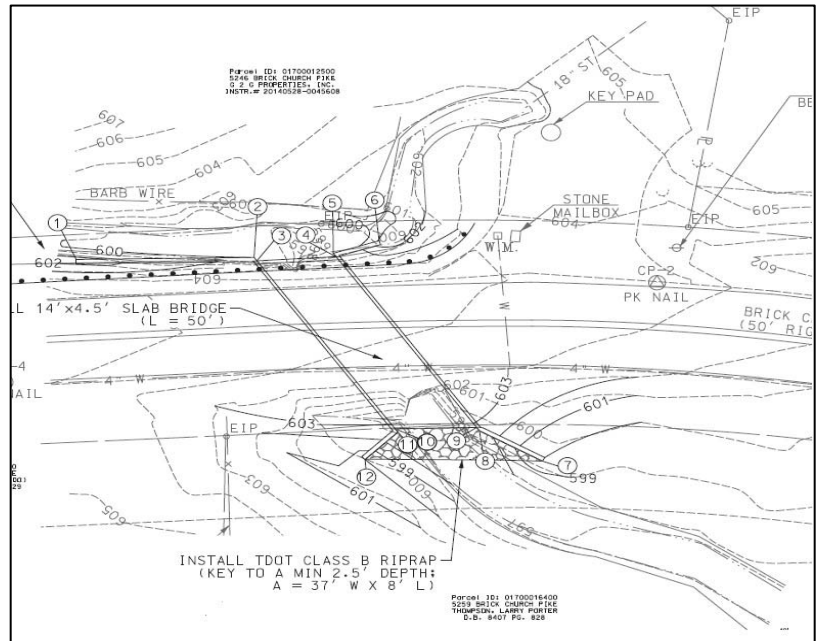
Project Plan View

The proposed culvert construction will include a 14.5'x5' reinforced concrete slab bridge, the installation of guardrail, roadway reconstruction, and site restoration to ensure proper functionality. Due to the depth and width of construction, the road will need to be closed to through traffic throughout the duration of the project. The project has been scheduled while school is out for summer in order to have the least impact on the community.
