7425 Harper Road Culvert Replacement

Existing Conditions

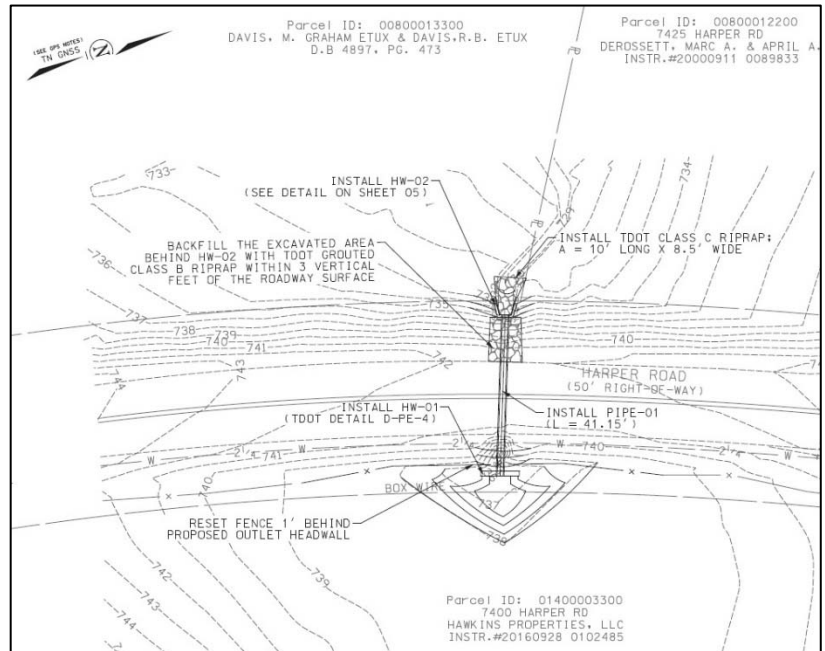
Project Plan View

The proposed culvert construction will include an 18" RCP with reinforced concrete headwalls as well as the installation of erosion control measures, roadway reconstruction, and site restoration. The project will require a road closure through the duration of the project due to depth of excavation and the narrow roadway prevents the contractor from safely maintaining a lane of traffic.
