4578 Little Marrowbone Road Culvert Replacement

Existing Conditions

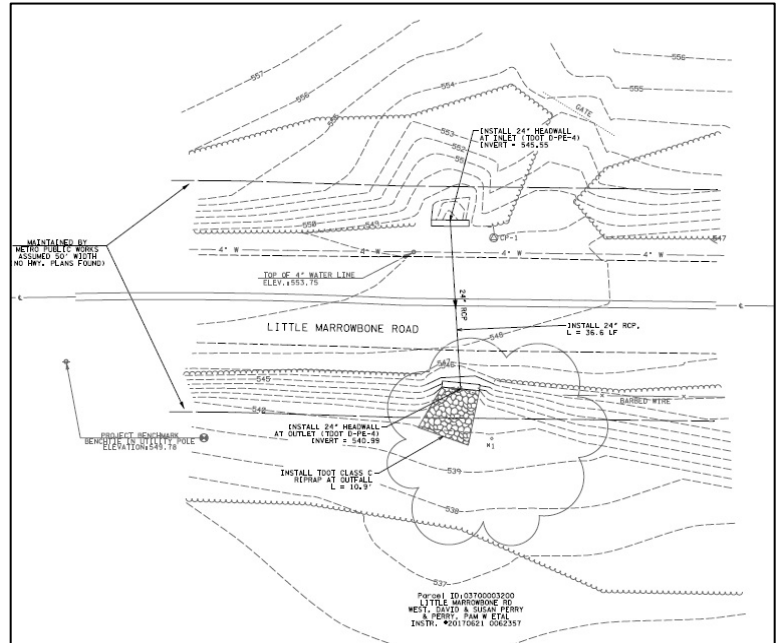
Project Plan View

The proposed culvert construction will include a 24" RCP with reinforced concrete headwalls, roadway reconstruction, and site restoration to ensure proper functionality. The project shall be completed under intermittent lane closures. Both lanes of traffic will be open at the end of each workday and access to all properties shall be maintained throughout the project duration.
