4884 Brick Church Pike Culvert Replacement

Existing Conditions

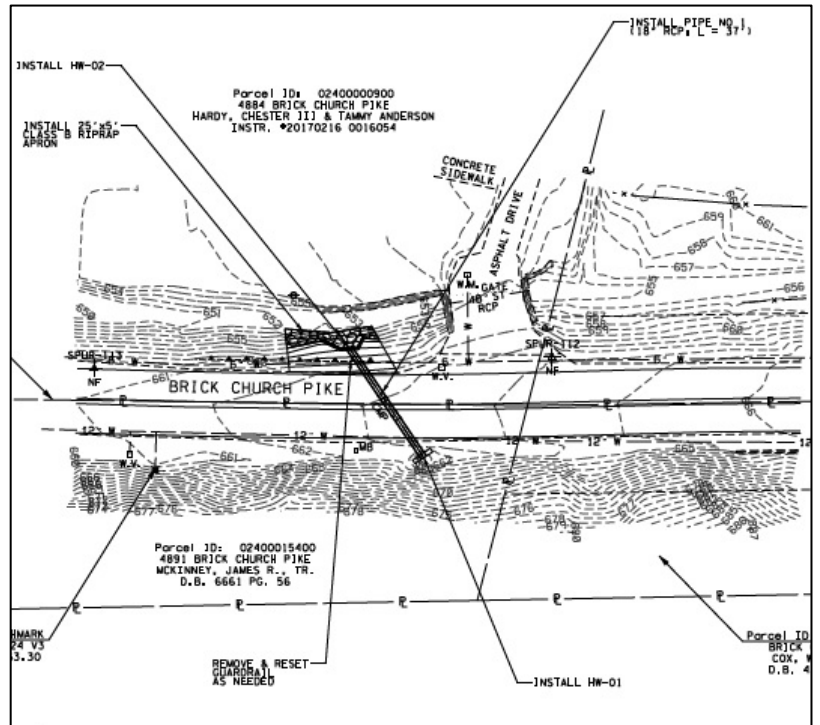
Project Plan View

The proposed culvert construction will include an 18" reinforced concrete pipe, reinforced concrete headwalls, roadway reconstruction, and site restoration to ensure proper functionality. Additionally, due to the sheer roadside embankments, guardrail shall be installed along the east side of Brick Church Pike for approximately 250'.
