5357 John Hagar Road Culvert Replacement

Existing Conditions

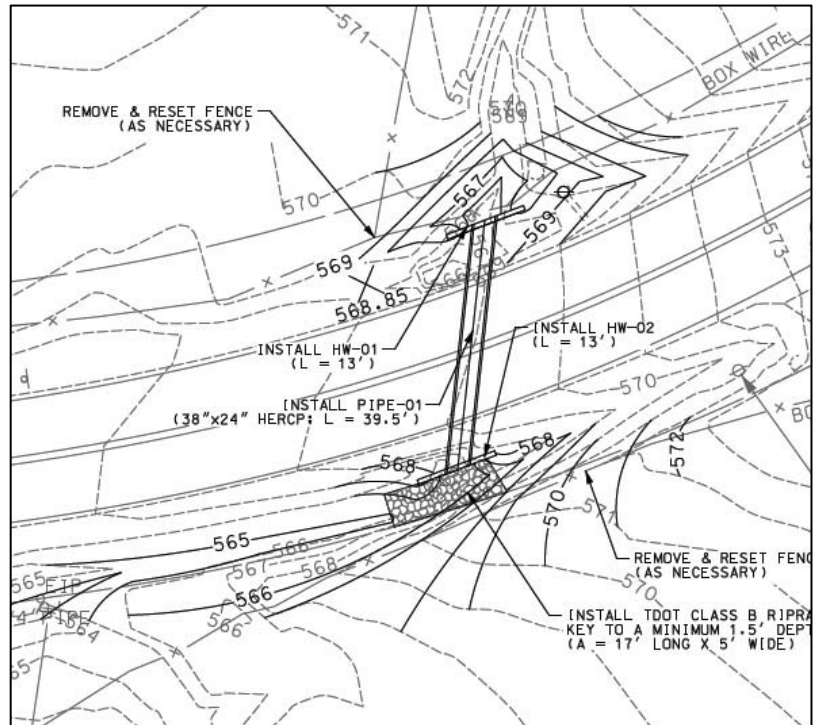
Project Plan View

The proposed culvert construction will include the installation of a 38"x24" reinforced concrete pipe, reinforced concrete headwalls, roadway reconstruction, and site restoration to ensure proper functionality.
