# Facility Condition Assessment

April 3, 2017

## Nissan Stadium

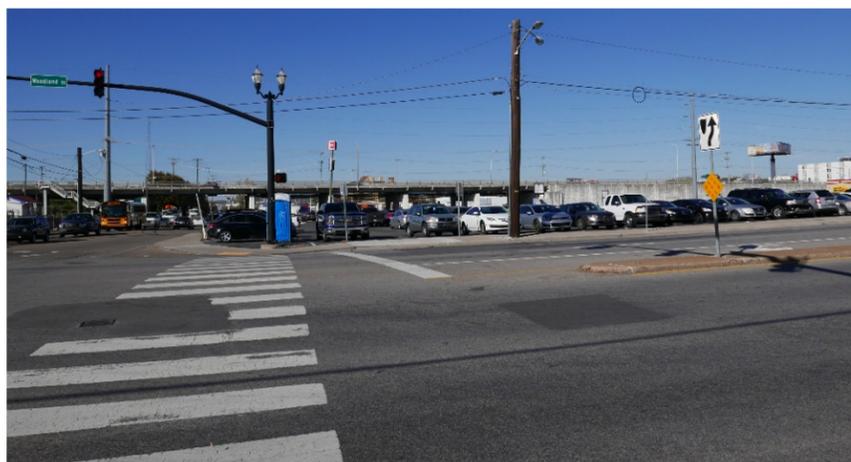
### Parking Lot F

Lot F is located north of the stadium, across Woodland Street, which is a very busy street on event days. Lot F is characterized by insufficient landscaping and a poor pedestrian route to the stadium. The entry to lot F is not aligned with Lot E across 1<sup>st</sup> Street, which can lead to traffic congestion.

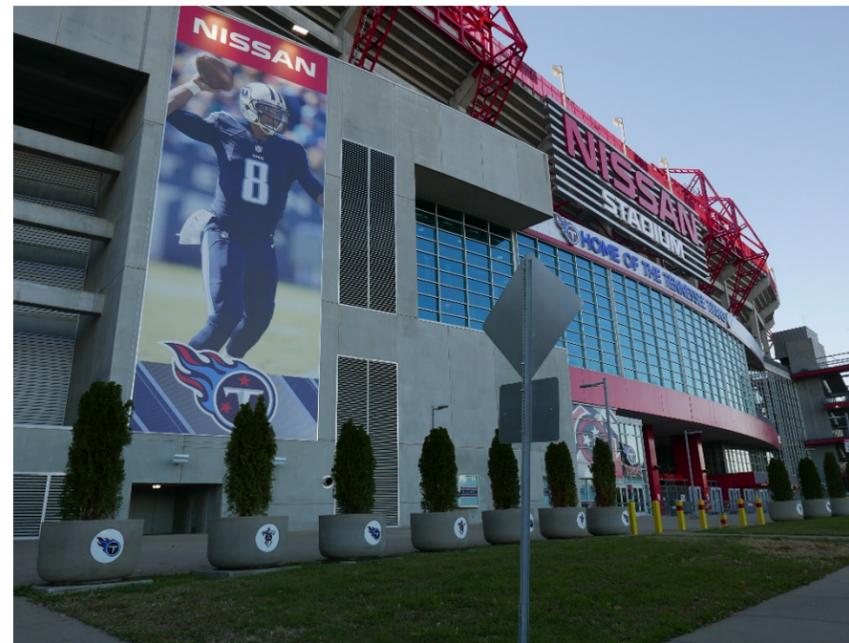
Nissan Stadium is characterized by large amounts of exposed precast and cast-in-place concrete, concrete masonry units, red painted exposed steel structural elements, and curtain wall glazing at the east and west sides. While the overall appearance of the stadium is clean and contemporary, when compared to more recent NFL stadiums, it could be described as stark, less finished, or less impressive. Short of a major addition that created new exteriors (as in Miami or Kansas City), an interim solution to this issue would be to consider recladding precast concrete portions of the exterior with newer materials, such as concrete or terra cotta exterior panels (for example).

A current strategy in use at Nissan Stadium is to wrap large exterior elements completely with printed graphics. This approach is not recommended. Printed graphics have a relatively short life span and will require frequent replacement, and the use of printed graphics over an entire exterior building

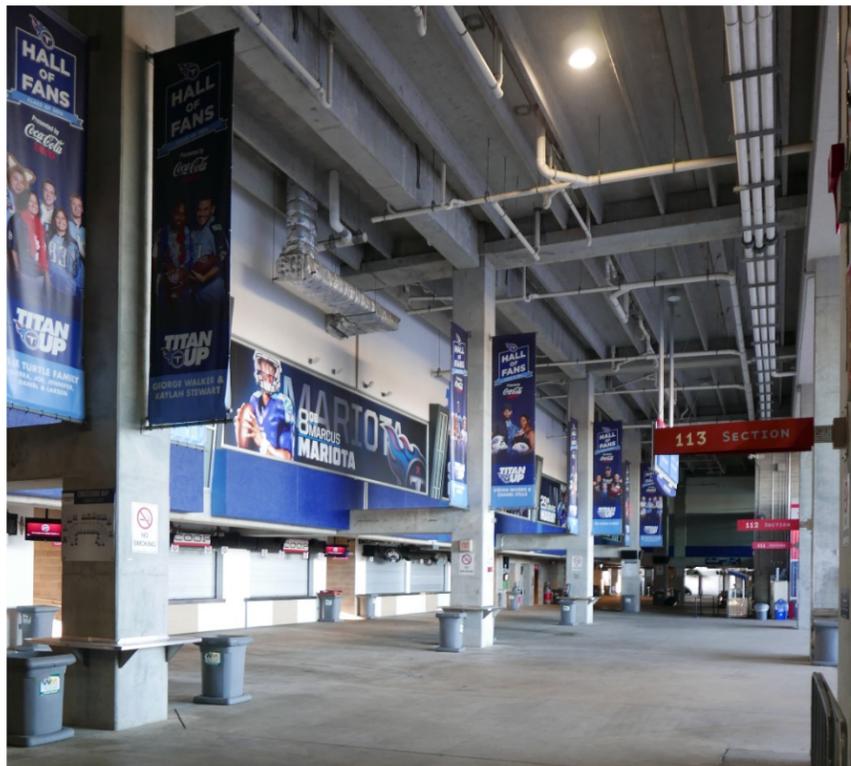
The overall impression of the main concourse is of unfinished or under finished space. This is primarily due to the extensive use of exposed unpainted concrete masonry units (of no special color) to construct many of the walls at this level. While colored CMU is often used to create durable and economical concourse walls, plain CMU is seldom used because of this unfinished effect. The floor finish in the concourse is generally plain concrete. Visible cracking in the concourse floor was limited.

Some doors and frames in high traffic areas are showing signs of wear and should be refurbished as part of routine maintenance.

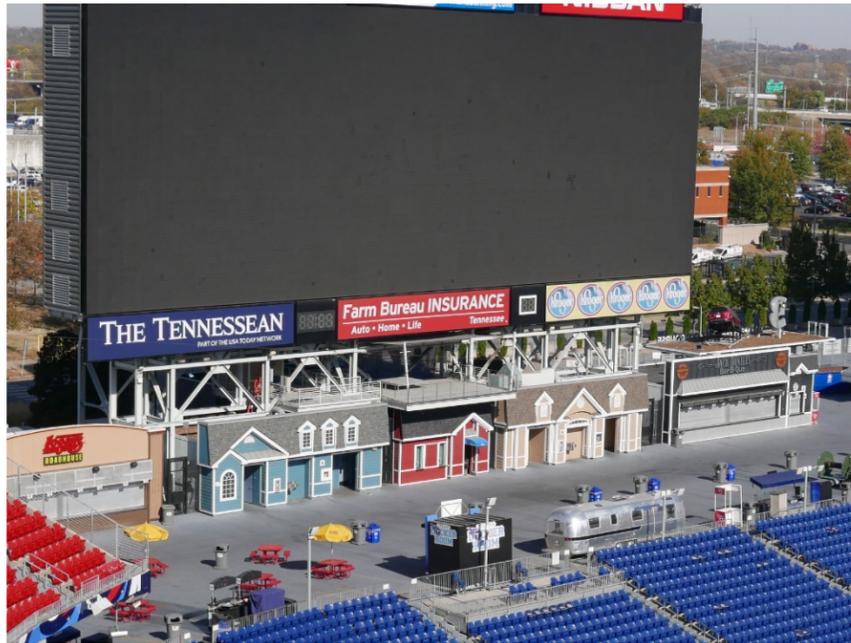
A collection of themed storefronts line the concession areas in each end zone under the scoreboard. While vaguely reminiscent of the scenic design of the Grand Ole Opry, these themed areas seem out of place at the otherwise starkly contemporary Nissan Stadium, and have proven difficult to repurpose without significant investment. The entrance to the Mother's Lounge is especially forbidding and should be reworked.

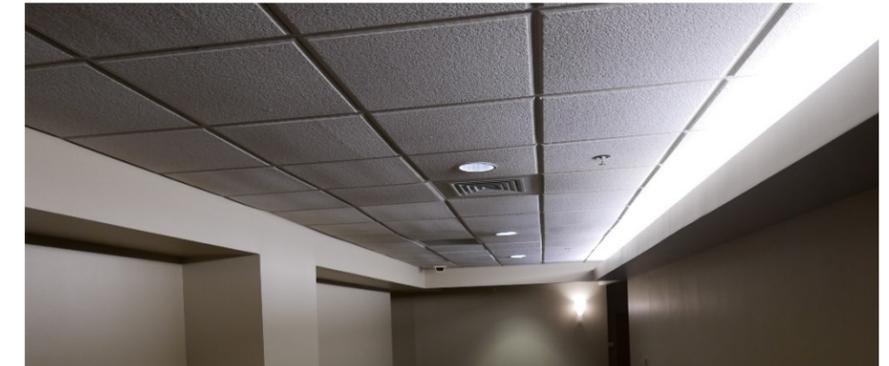
Sagging acoustical ceiling tile was observed in enclosed spaces at this level. This condition likely occurs due to the poor insulation allowing in outside air resulting in humidity to rise to ambient (outdoor) levels.

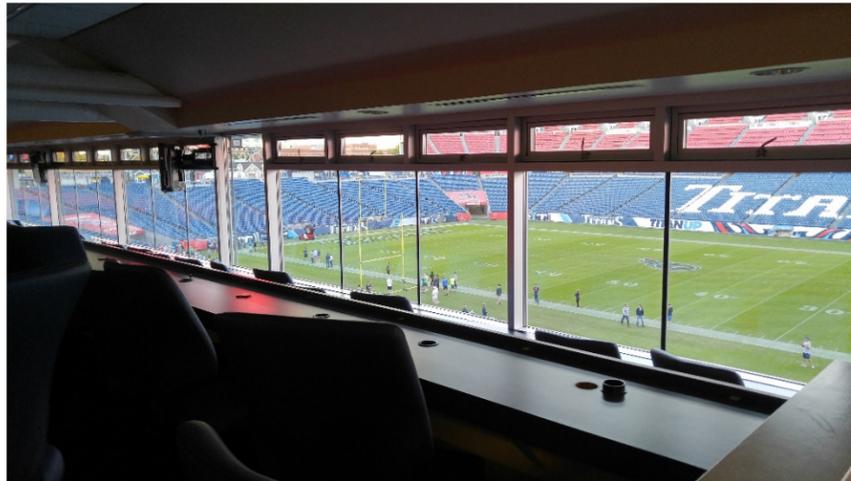
The writing press window to the field uses a curtainwall glazing system with vertical mullions that create partial obstruction of views of the playing field. Replacement of this glazing with fully butt-glazed insulated glass should be considered in the future. Chairs for the writing press are too large for the space available and should be replaced with smaller (though not necessarily narrower) chairs.

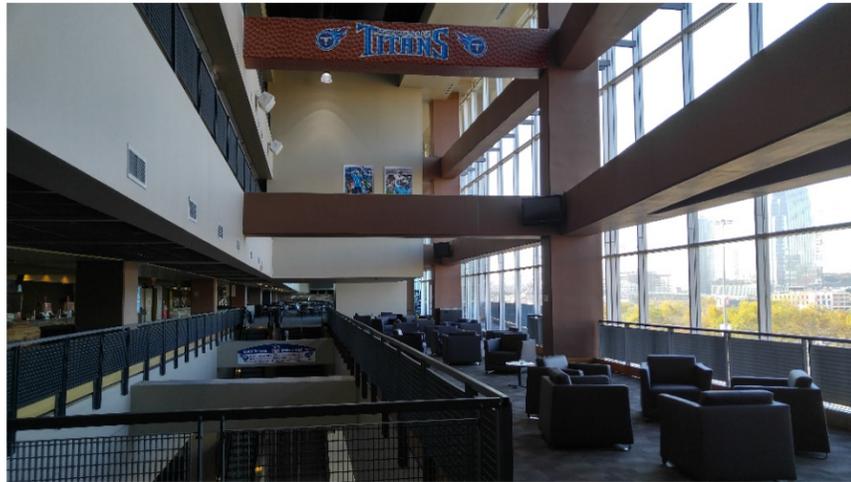
Printed sign at team store is not appropriate for upscale club lounge area. Likewise, some of the wayfinding signage (e.g., for restrooms) appears amateurish and not appropriate for the upscale environment. Concession areas lack overhead signage.

27. Replace printed retail signage on club level with dimensional signs. Replace wayfinding signage with appropriately designed dimensional signage system. Add overhead dimensional signage at headers above concession stands.

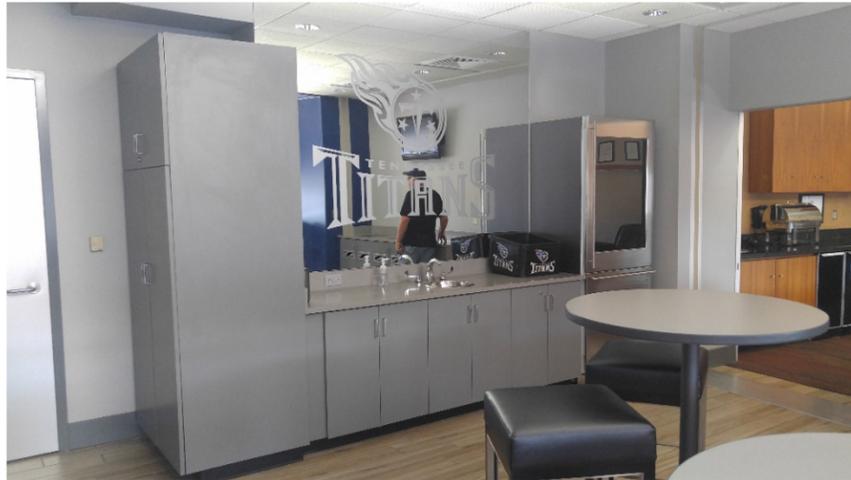
- Consider using a larger television monitor above the buffet—expectations are moving rapidly towards larger screens.
- Corduroy look ceiling tile appears to be a holdover from the previous implementation and should be replaced. This ceiling tile has been around since the early 1980s and appears quite dated. Make sure ceiling tile has high resistance to humidity and sagging.
- Consider adding protection to outside corners of plastic laminate casework where exposed to cart traffic and other abuse.
- Carpet tile in updated suites should be something other than building standard.

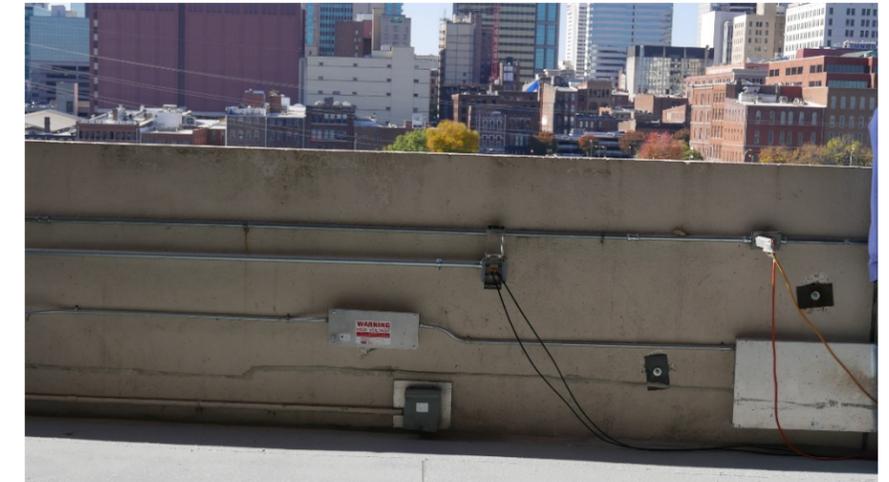
Some parts of the guardrail at the upper concourse are flat on top, allowing guests to rest food and drinks on it. Some portions of the guardrail effectively form a wall preventing views to spectators on the concourse. In some locations, concrete guardrail has accumulated an undesirable accretion of electrical conduit in a disorganized pattern.

45. Add large scale wayfinding graphics to upper concourse.
46. Add angled trim to flat guardrail tops to discourage resting food or drinks on guardrail. Lower height of precast cladding from approximately 10 feet to 4 feet (with sloped top) where spectator views are possible. Replace electrical conduit on precast guardrail to minimize visual impact.

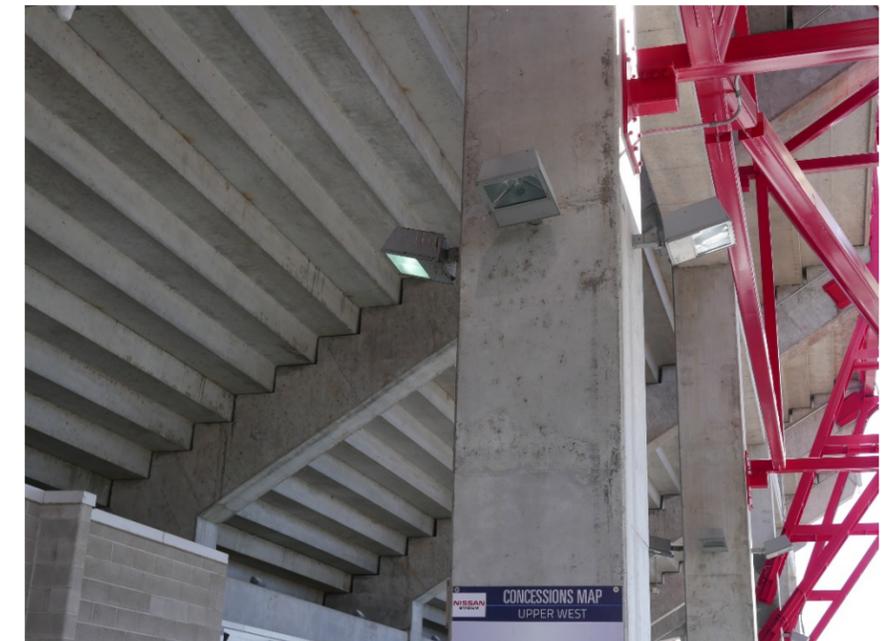
Lighting at the upper concourse is via HID floodlights. While efficient from a lumen per watt viewpoint, this lighting contributes to a lowest-cost ambience.

47. Replace HID floodlights at upper concourse with a decorative light fixture with similar output characteristics.
48. Replace printed signage at any retail area on the upper concourse with dimensional signage similar to permanent concession stands.

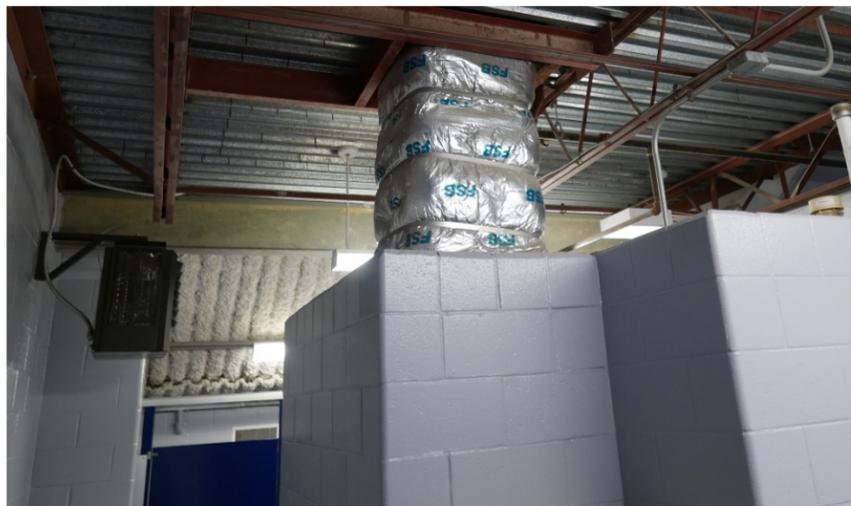
The restrooms have been updated as on the upper concourse; however, exposed fireproofing on the sloped ceilings detracts considerably from their appeal. The roof deck and structure within restrooms were never painted.

49. Add permanent, moisture-resistant surface at sloped ceiling area of upper concourse restrooms. Paint inside roof deck and all visible roof structure of restrooms.

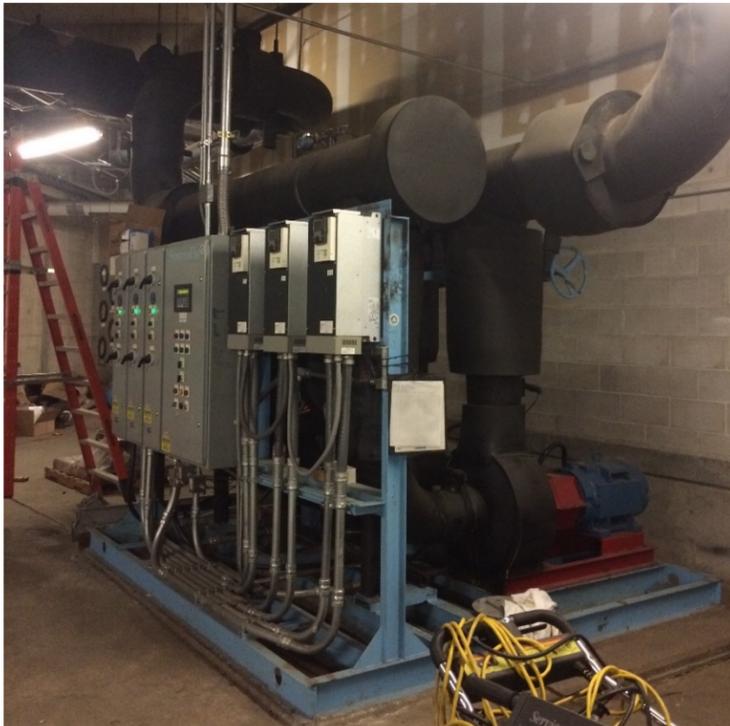
Primary Chilled Water Pump Skid

The chilled water system is original to the building and appears to be in moderate working condition considering its age. Purchased, district chilled water is supplied to the stadium by NDES for all cooling requirements. The chilled water system is not decoupled from the district loop system, meaning there are no heat exchangers that separate the building from the city loop. Because there are no heat exchangers, there is no equipment that requires maintenance or replacement other than pumps. The chilled water pumping system is served by three (3) variable-speed primary pumps sized for what appears to be 50% of the total flow for full redundancy. The pumps are each 50 HP end suction type. While the system may be sized for full redundancy at 3,600 gpm, the pumps are only able to produce on a peak day around 2,300 gpm. This in large part due to the additional scale build-up within the pipes from corrosion.

The chilled water system was designed to maintain a temperature difference between the supply and return lines of 14 degrees; however due to the restrictions, the system is only able to maintain around a 20 to 25-degree temperature rise. All the pumps appear to be in fair condition, given their age. The pumps are showing signs of wear. Pump condition is as follows:

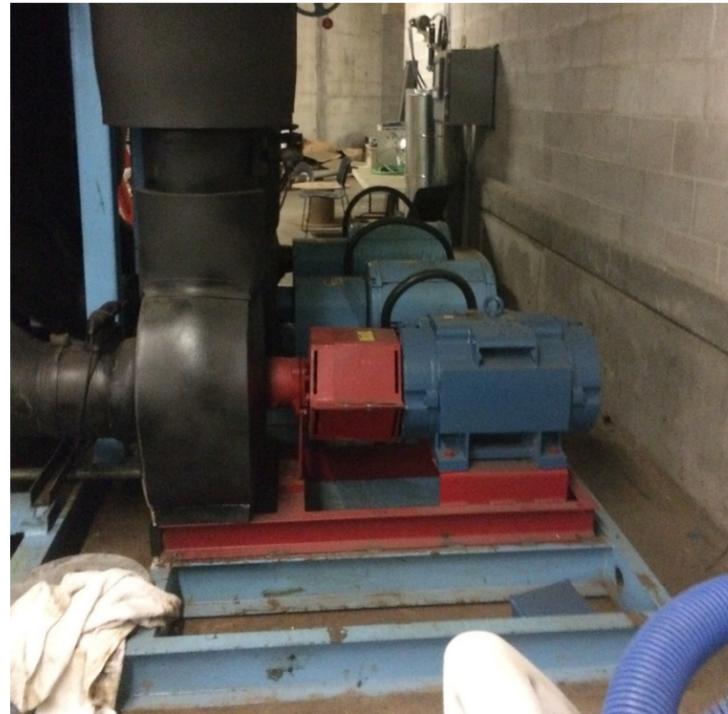
Primary Chilled Water Pumps

- Chilled Water Pump, P-1: Motor replaced 1 year ago
- Chilled Water Pump, P-2: Bearings and seals replaced four years ago
- Chilled Water Pump, P-3: Bearings and seals replaced three years ago

The median useful life of the chilled water pumps is between 20 and 21 years. All of this equipment may outlive, or already has outlived its useful life due to maintenance, but should be considered for replacement soon.

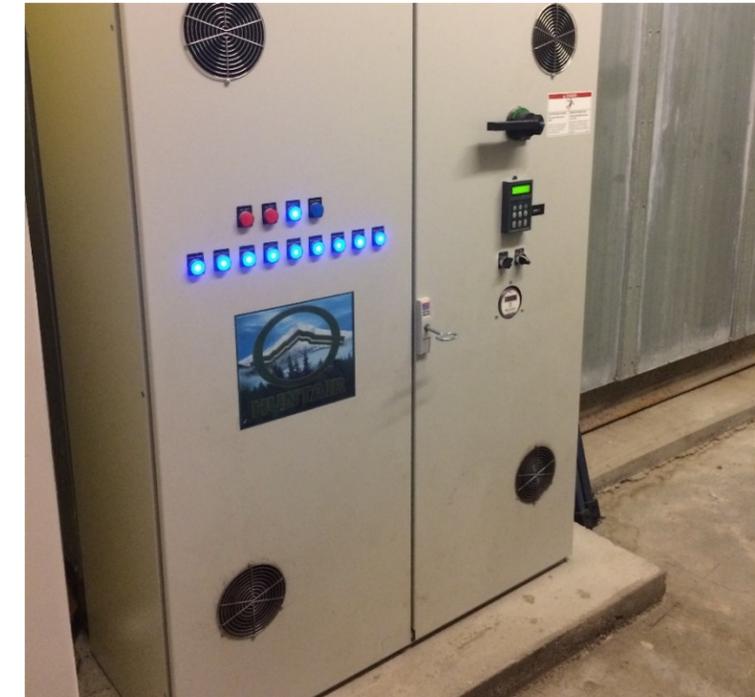
Club AHU Supply Fan Array VFD

Typical life span for a custom air handler is around 15-20 years. Hydronic coils are expected to last about 15 years, and fans reach their end of life around year 25. All this equipment may outlive, or already has outlived its useful life due to its good maintenance, but should be considered for replacement soon.

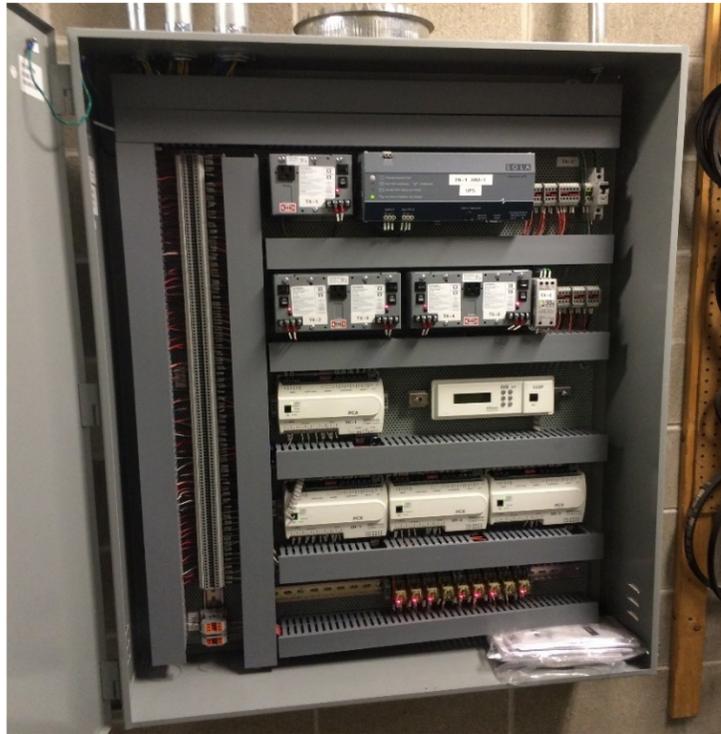
Siemens Control Panel

This system is the original BAS system with minor upgrades to the system, other than software updates. Most control issues are being addressed by maintenance staff. The software updates have ended, therefore causing the control system to be out of date. All building automation system components appear to be in good working order given the age of the system.

The staff currently is using the system for a troubleshooting tool and a means to control equipment on and off. While this is a vital piece of the building automation system, there are no schedules or trending in place to optimize the system, or provide any means of energy savings.

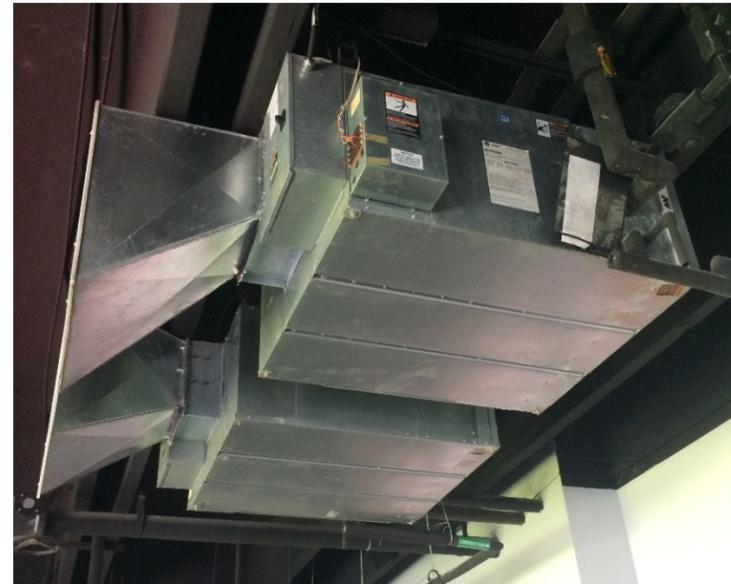
Fan Coil Unit in Suite

There are approximately 238 Trane blow through fan coil units located around the building. Each is equipped with a pre-filter, chilled water cooling coil, electric reheat coil, supply fan, and discharge air plenum. All equipment appeared to be in a reasonable condition, considering almost all fan coil units are original to the building.

One of the major concerns is that all FCUs are provided with an isolation valve on the chilled water supply line but no isolation valve on the return line. This prevents the staff from replacing units without shutting down the entire chilled water system. Considering the location of most FCUs and the age of the equipment, this is a major problem.

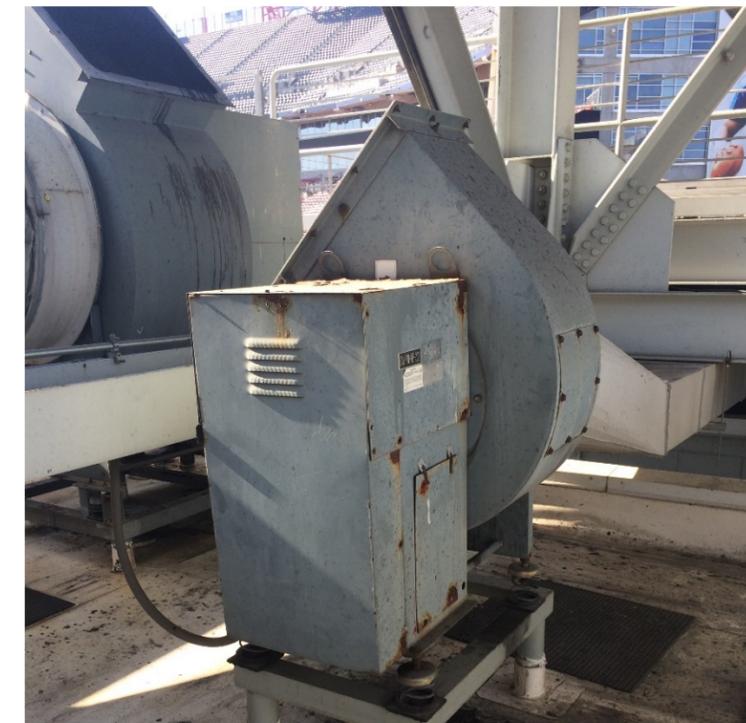
The grease fans during a full cooking mode are not able to eliminate all the smoke produced under the kitchen hood; this can be caused by the kitchen hood not being properly cleaned or a grease build up the ductwork which creates a low flow situation.

Grease Fan on Low Roof

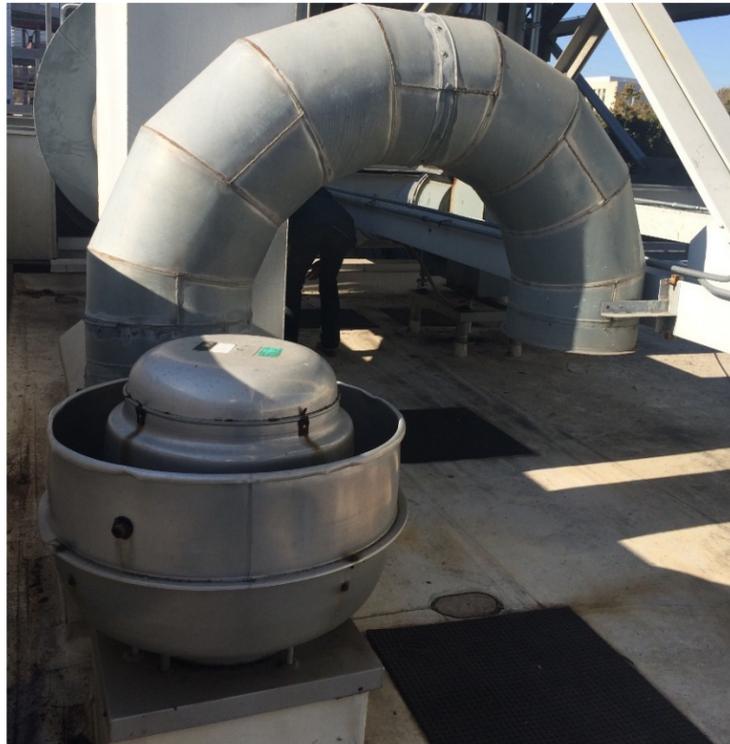
All equipment appears to be in a reasonable working condition, considering almost all exhaust fans are original to the building. The life span of a general exhaust system should be between 15 and 30 years, depending on the frequency of use and preventative maintenance.

*General Exhaust Fan on Low Roof*

19. We recommend that the exhaust fans be replaced on an as needed basis with the motor being the main area of concentration. The replacement motor should be a premium efficient motor. At the time of replacement, consideration should be given to direct drive fans instead of the belted fans for reduced maintenance.

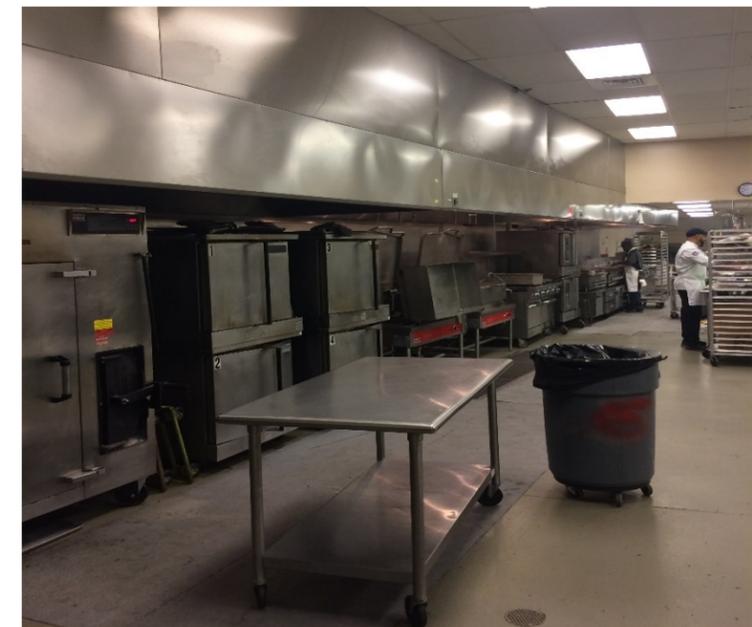
*Main Kitchen Exhaust Hood*

through, though only one area had cooking activity. We recommend adding all kitchen hoods and exhaust fans to the BAS so that the operations staff can monitor and turn off equipment when not required to be operational.

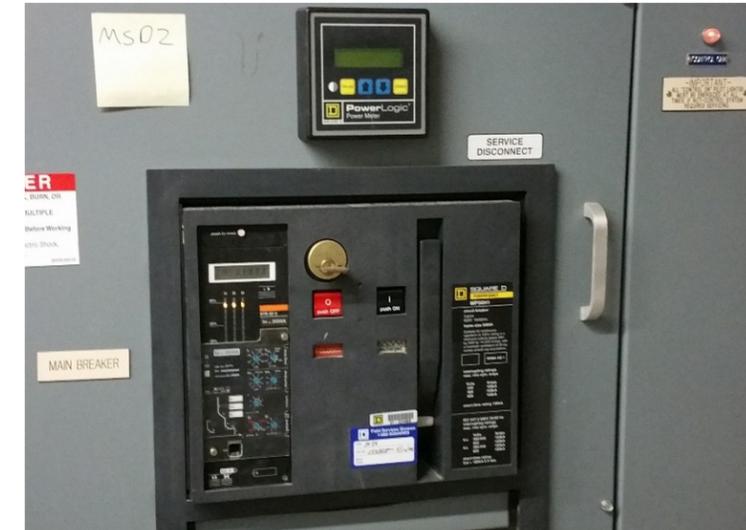
The main switchgear analog meter was observed to be turned 'OFF' on some of the main switchgear and is not connected to the stadium's central building monitoring system.

*Main Breaker and Analog Meter*

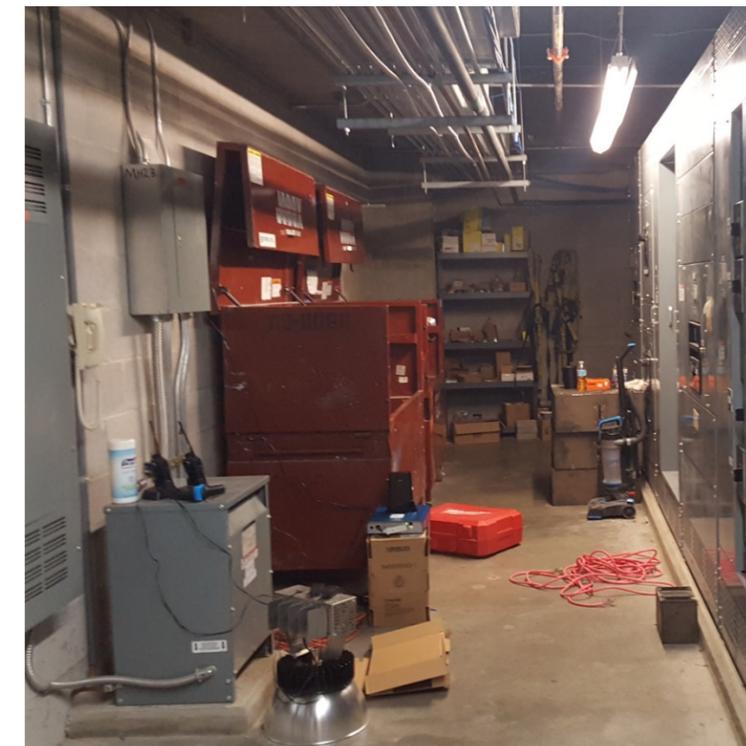
*Main Electrical Room Utilized for Storage*

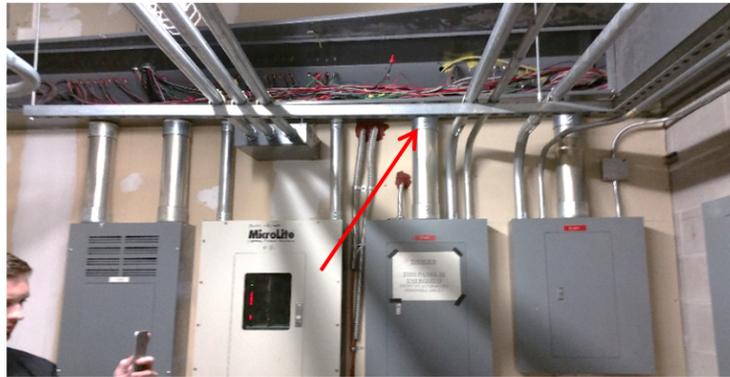
Normal and Emergency Circuits run in the same wireway which is missing the cover

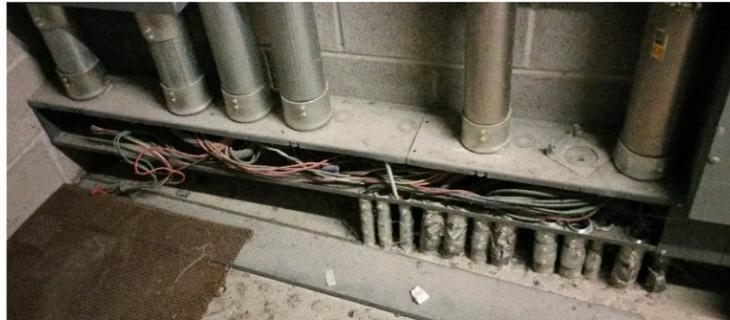
Open Wireway

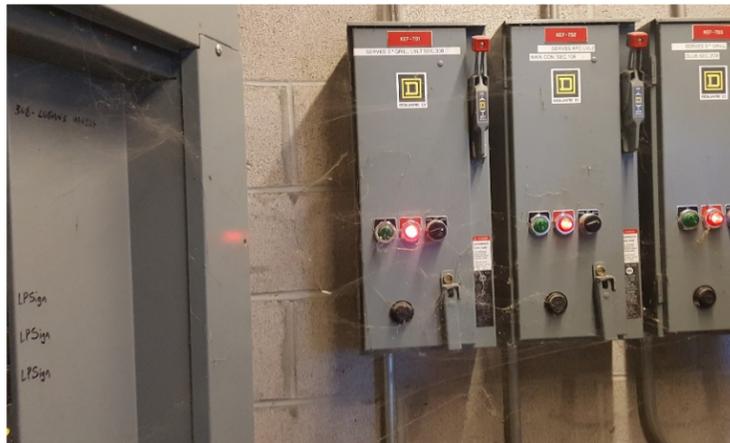
Cobwebs in Upper Concourse Electrical Room

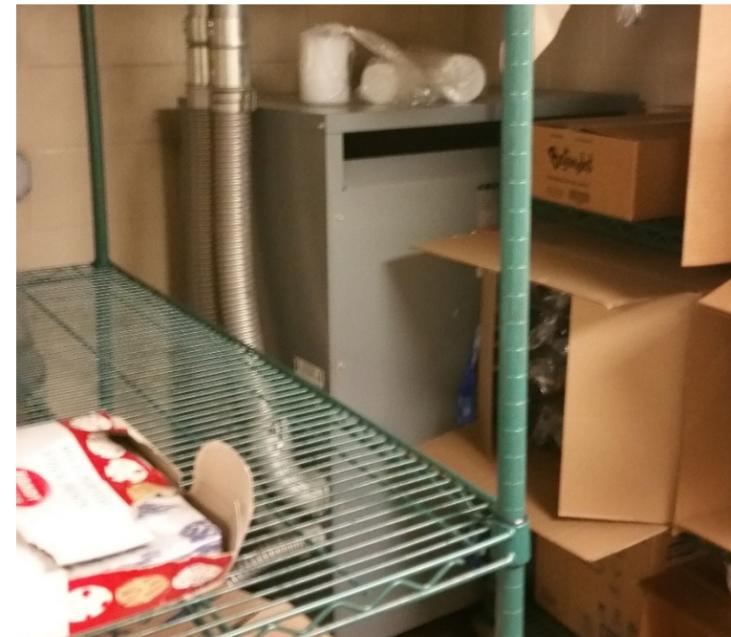
The concession transformers were observed to not have adequately maintained clearances or were being utilized for shelving.

Concession Transformer with Improper Clearance

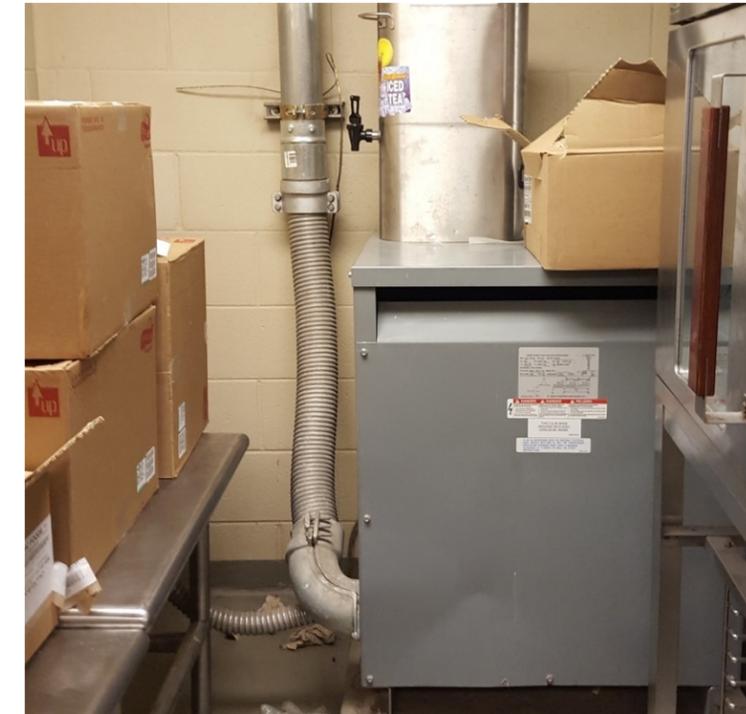
Concession Transformers

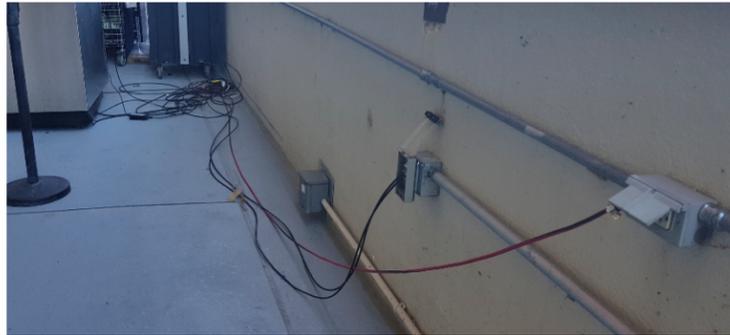
The main concourse portable cart power at each end zone and the upper concourse appeared to not have an adequate quantity of power connections for the current portable concessions

needs. During the assessment, multiple extension cords were observed being utilized to distribute power to multiple carts, which is shown.

Upper Concourse Portable Carts Serviced by Extension Cords

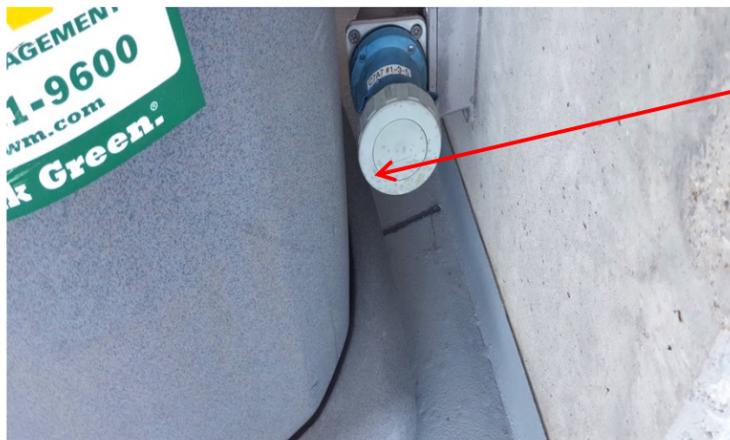
Damaged Portable Cart Connection

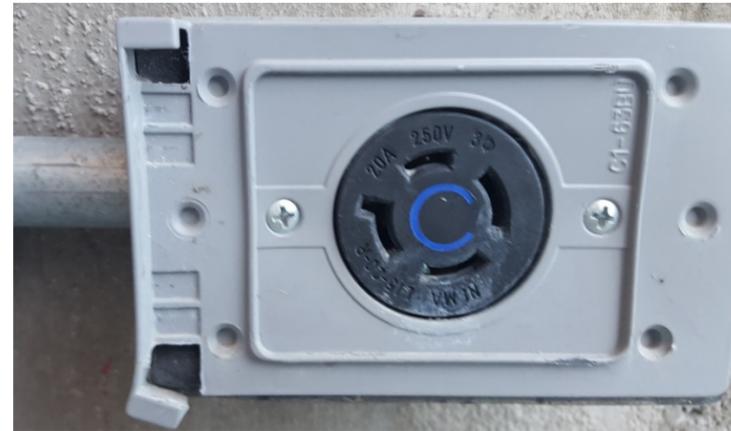
Upper Concourse Cart Receptacle Missing Cover

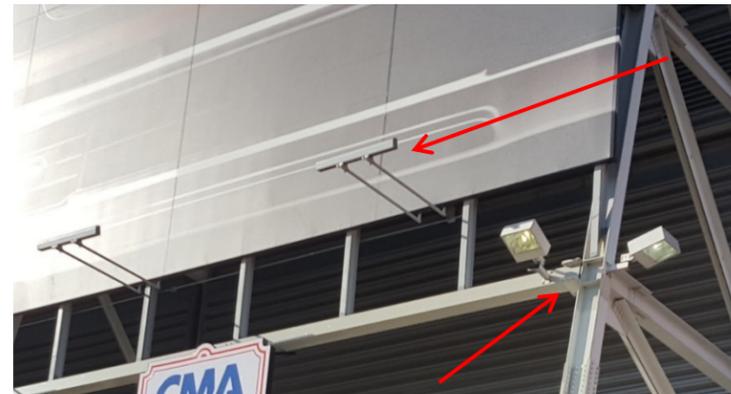
Metal Halide and LED Luminaires (on during the day)

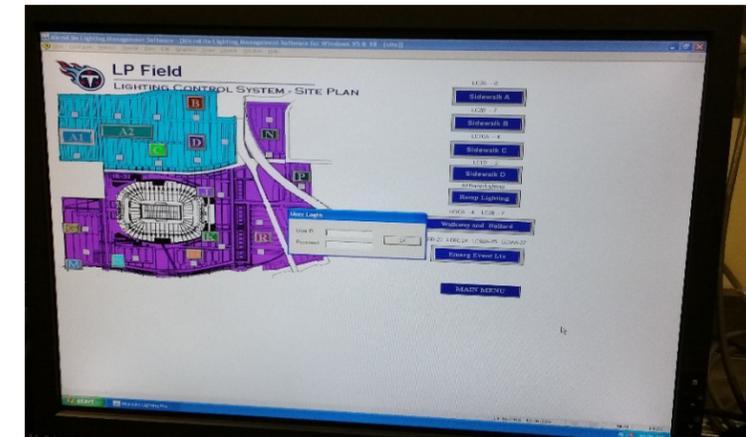
The original MicroLite main control touchscreen panel located above the PC screen was observed to be no longer functional. The maintenance staff is having difficulty finding replacement parts for the system since the product is no longer manufactured.

MicroLite Lighting Control Master Station

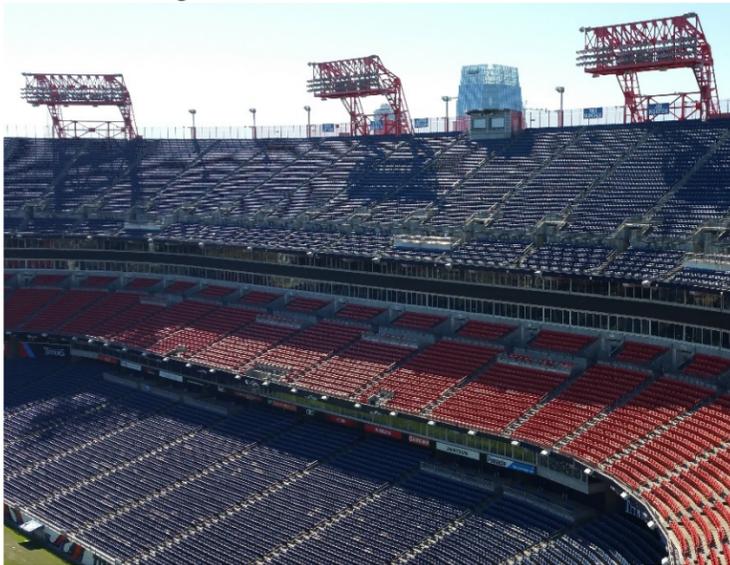
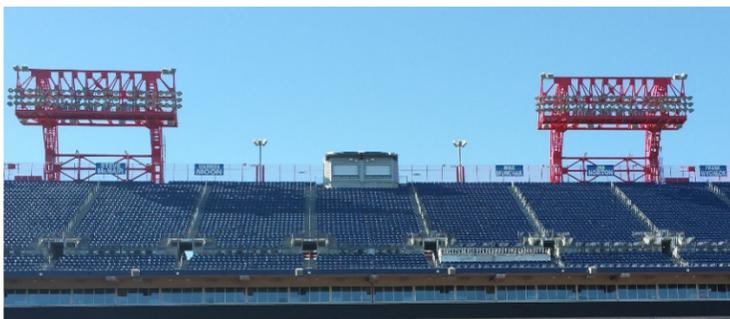
Sports Lighting Banks

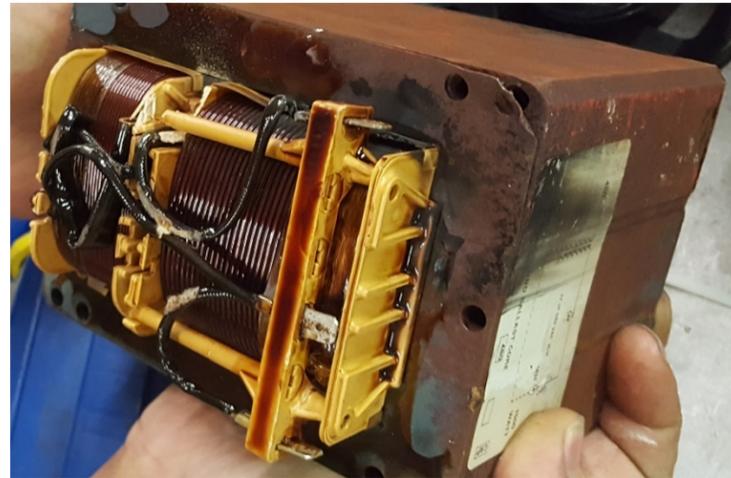
It was noted that the sports lighting ballasts have started to fail on a more regular basis.

Failed Sports Lighting Ballast

26. Replace existing sports lighting fixtures with LED fixtures, which in the next few years will become more prominent within stadiums of this size and usage. Advantages of LED sports light fixtures include the ability to instantly turn fixtures ON/OFF and much greater flexibility within the control system, including various scene settings. LED source also allows for better control

27. Institute a program of group re-lamping of existing sports lighting fixtures to maintain proper lumen output. The re-lamping time should be based on the lamp manufacturer's recommendation, but in general, it is approximately at 75% of lamp life. Metal halide lamps in this type of application typically have a life span of approximately 10,000 – 12,000 hours.
28. Replace the existing head-end fire alarm control panel and have the system recertified.
29. Continue to implement the existing preventative maintenance plan and service records for the fire alarm system in accordance with the NFPA-72 and the local A.H.J. requirements.

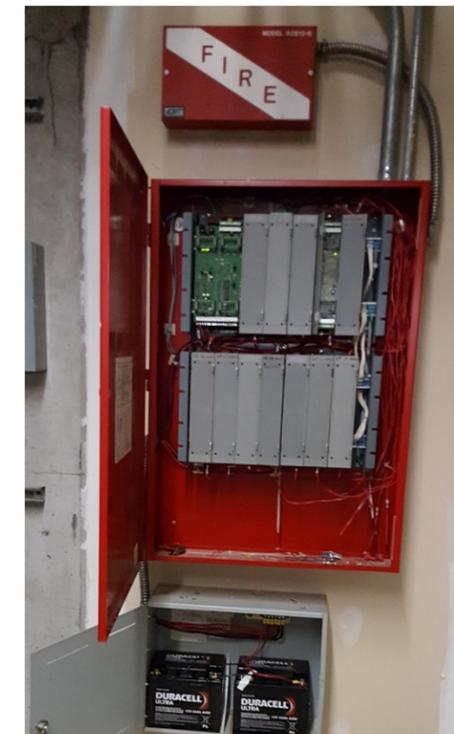
The fire alarm riser panels located in the electrical riser rooms were observed to be in excellent condition.

Fire Alarm Riser Panel

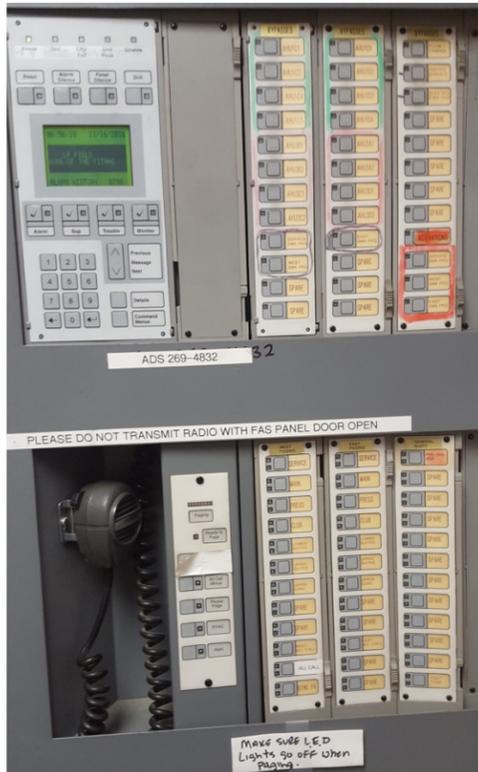
Maintenance staff noted that strobe synchronization has not been able to be accomplished with the existing fire alarm panel.

Fire Alarm Control Panel

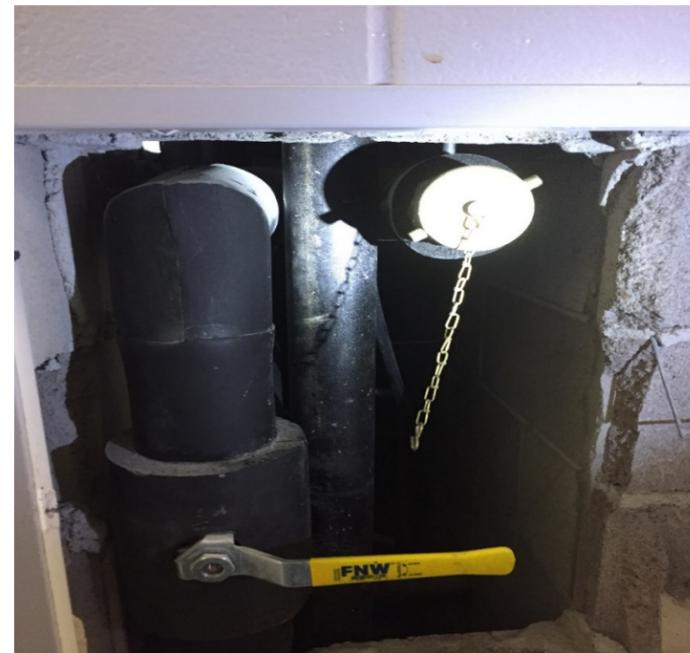
The galvanized coating inside all of the cold water piping has deteriorated over the years, and now the piping is oxidizing at an accelerated rate. Currently the maintenance staff is flushing the entire cold water piping system four (4) days before an event. (Example: Flush Thursday before a Sunday Titans game.) The staff has installed flushing ports at the event level and upper concourse level. These flushing ports consist of a 2 ½-inch valved hose connection. There are four (4) on the low-pressure zone system at the event level and six (6) on the high-pressure zone system at the upper concourse level.

Domestic Water Flushing Port – Upper Concourse

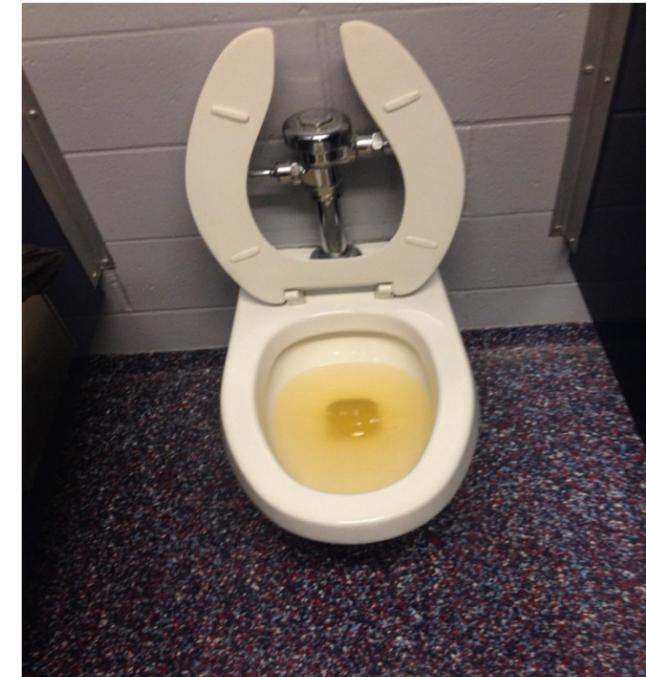
Water Closet Upper Concourse – Discolored Water from Corrosion

This observation was performed Wednesday and Thursday after a Titans game on the previous Sunday afternoon. After flushing the water closets and urinals in one of the men's restrooms on the upper concourse for approximately 5 minutes, we began to see evidence of additional buildup of corrosion in the domestic cold water main. The flushing procedure requires two (2) technicians dedicated to this effort for 8 hours each time. As the corrosion continues, more time may be necessary to flush the system until clear water is present in all fixtures at all levels of the stadium.

1. The galvanized cold water pipe and fittings should be replaced. In addition to the ongoing cost for regular flushing, the condition of the inner wall is a potential breeding ground for bacteria and viruses such as legionella. Suggested replacement piping materials would be type "L" copper, stainless steel, Schedule 80 CPVC or Aquatherm. Victaulic type fittings could be used for either copper or stainless steel.

2. An option for consideration would be to replace the larger main sizes that are 4-inches through 12-inches with one of the suggested piping materials. There are contractors that specialize in lining existing piping within existing walls and chases. This is usually limited to pipe sizes 3-inches and smaller. The liner is typically an epoxy, plastic or glass product and would need to be NSF approved. The lining is applied after the interior wall of the existing piping has been cleaned/prepped for the application of the liner. This method minimizes demolition and rebuilding of wall cavities and chase walls.

3. We wouldn't recommend draining the cold water system down in the future until the piping could be replaced as previously discussed. Several maintenance issues occur during the refilling of the system that requires replacement of flush valve diaphragms, removal of some water closets to remove debris from the rim water supply channel, and replacement of lavatory faucet "O" rings and aerators. Draining the system allows more oxygen into the piping system. This only promotes increased oxidation.

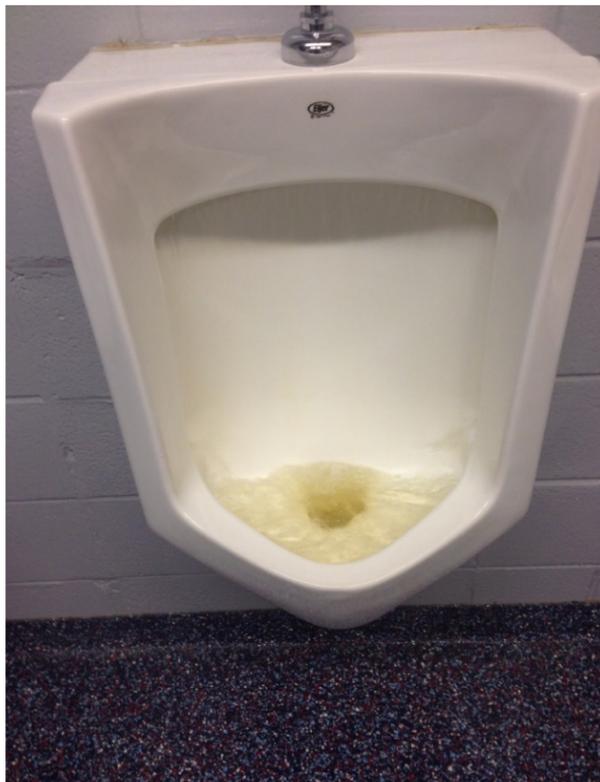
*Urinal Upper Concourse – Discolored Water from Corrosion*

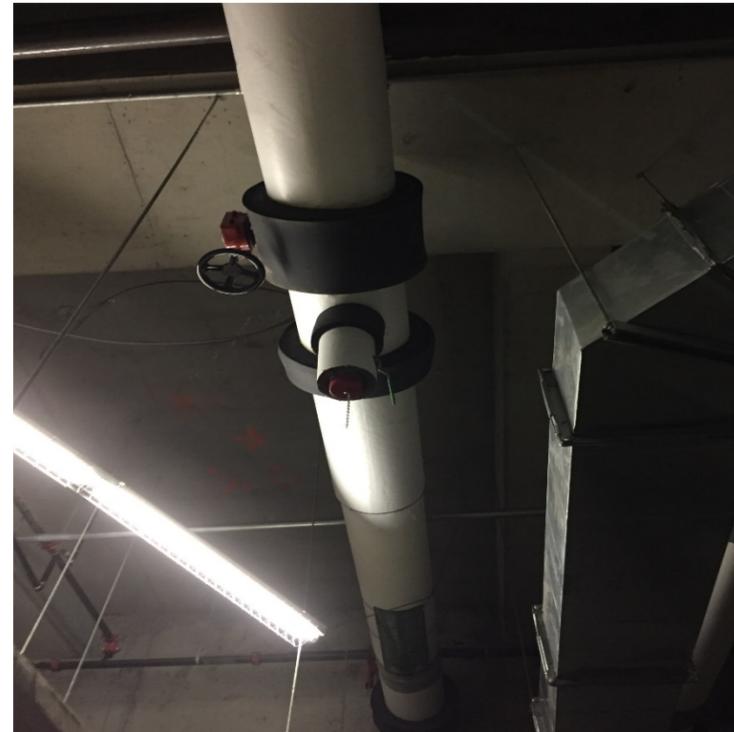
The domestic cold water system has been drained down over the last (3) years. Drainage connections with isolation valves have been provided in the system that allow for a 2 ½-inch drainage hose connection.

*Domestic Water Drainage Port – Event Level*

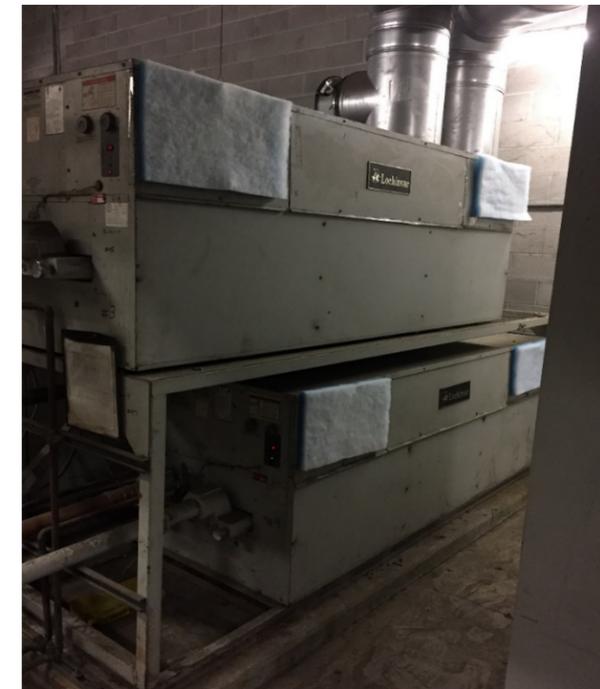
*Water Heaters – Event Level*

4. The natural gas fired domestic water heating equipment serving the event and main concourse fixtures is original to the building. Both the tanks and all four (4) heaters are at or near the end of expected service life. This equipment could be replaced with new smaller and more energy efficient equipment. An analysis of the connected fixtures and load would need to be performed to determine how much small equipment could be used. As a minimum, a phased replacement schedule of the existing heaters and tanks should be considered.

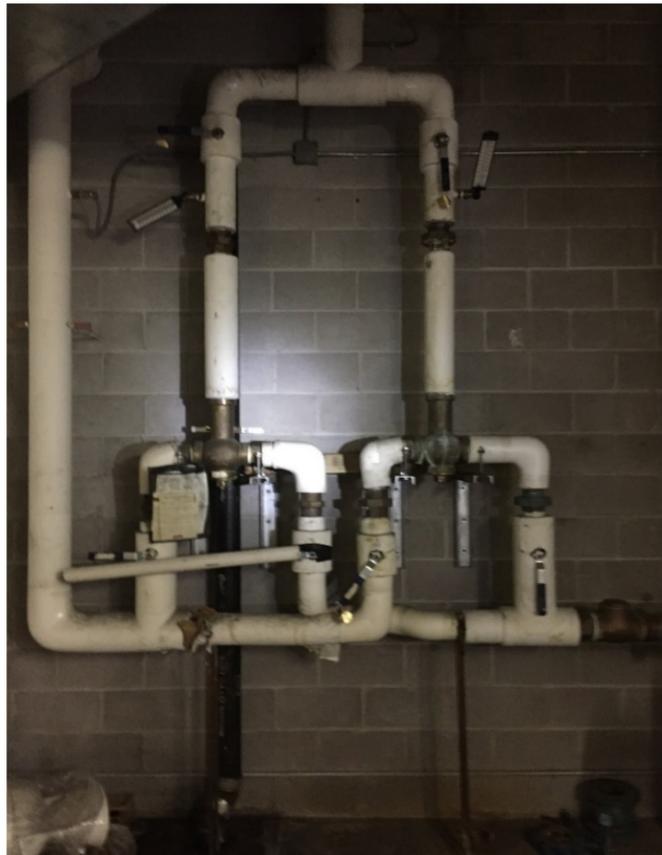
*Holby Mixing Valve Station*

5. The existing Holby mixing valve station is near the end of its expected service life. There are two (2) valves at this location. The piping was originally designed incorrectly to allow for operation of both valves. After one valve was isolated with the remaining valve in service, it was discovered that only one valve is required to satisfy the hot water load. We recommend replacing with newer technology that allows for variable flow conditions and a system that can communicate with the building automation system.
