# Facility Condition Assessment

April 3, 2017

## Nissan Stadium

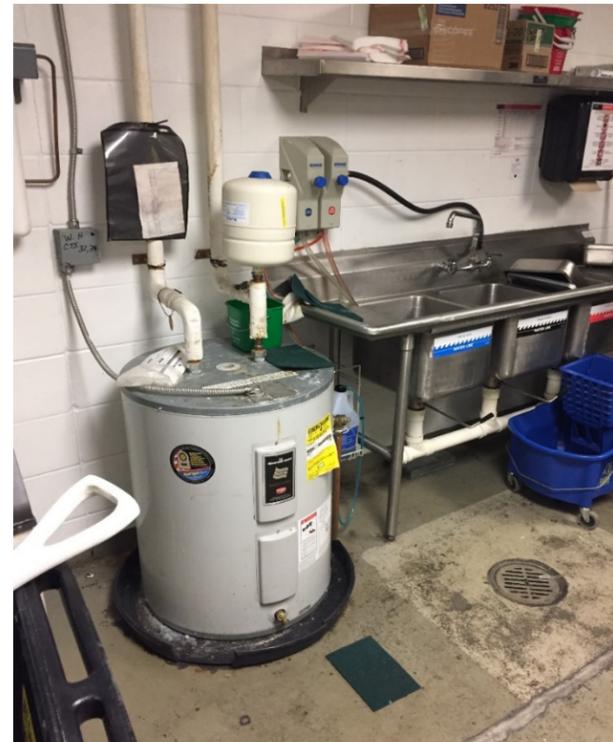
The electric heaters provided in the concession stands appear to be undersized. Typically, a 40 or 50-gallon heater has been provided. The 3-compartment sink in the concessions is the hot water user in the concession stands. This fixture will use all the available hot water to fill all three compartments when a 50-gallon heater is used, leaving no hot water for hand washing until the electric heater has recovered.

*Concession Water Heater*

6. Replacement of the existing multiple electric water heaters should be on an as needed basis. Consideration should be given to increasing the size of the heaters in the concessions to provide adequate hot water quantities at temperatures the health department may require.

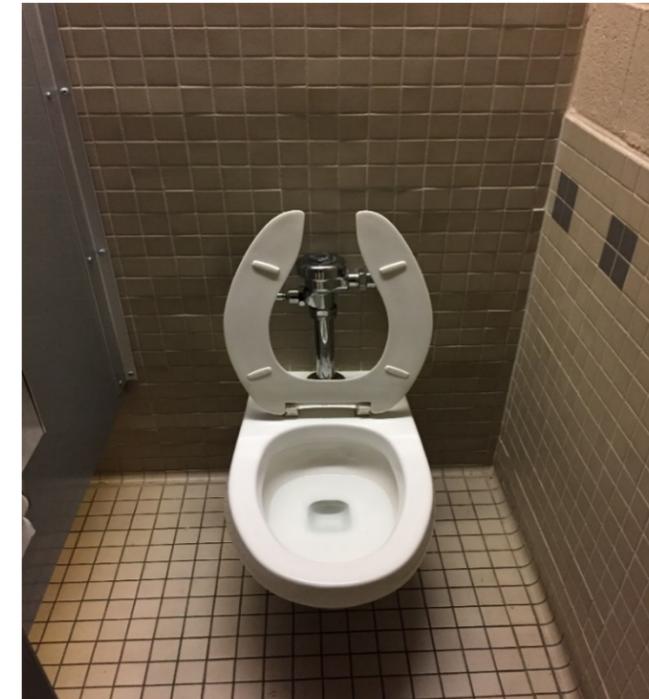
Water closets are 3.5 Gallons Per Flush (GPF). They are wall hung type but use a 3-bolt pattern wall carrier. Currently there are only two (2) fixture manufactures, Kohler and American Standard, that still can provide fixtures with this bolt pattern.

*Typical Flush Valve Water Closet*

7. The three bolt water closet carriers are going to present a problem. As manufacturers phase out this product, the stadium will need to begin a program of replacement. This will involve demolition and rebuild of the chase walls where the fixtures are installed. When the fixtures are replaced, we would recommend replacement with a 1.28 GPF fixture as this uses 64% less water than the current water closets. There are 772 water closets in the stadium.

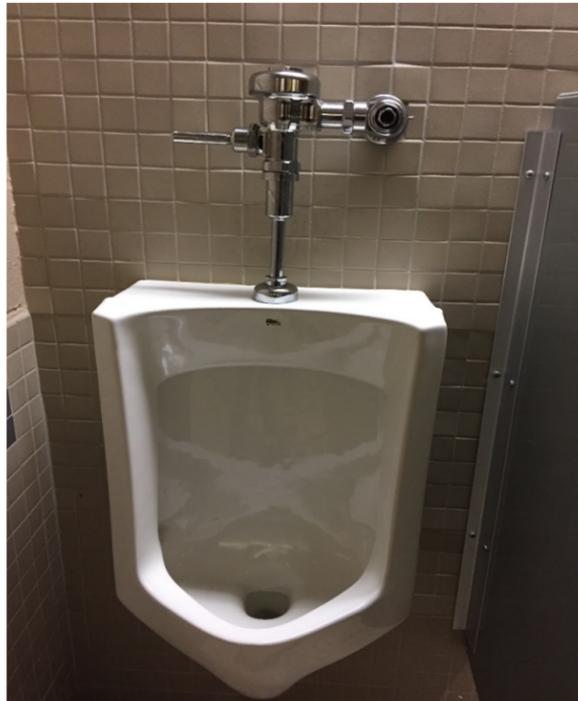
Flush valve urinals are 1.0 GPF. Lavatory faucets are currently being replaced and are assumed to be units that allow for only 0.5 GPM flow rated. Original faucets remaining in service are assumed to be 2.0 GPM each.

*Typical Flush Valve Urinal*

8. We recommend replacement of the existing 1.0 GPF urinals with pint flush urinals. Each urinal will save 7 pints of water each time the fixture valve is operated. There are 346 urinals. If all 346 urinals were flushed at the same time, they would use 346 gallons of water. If they are replaced with pint flush urinals, only 43 gallons of water is used to flush all 346 urinals.

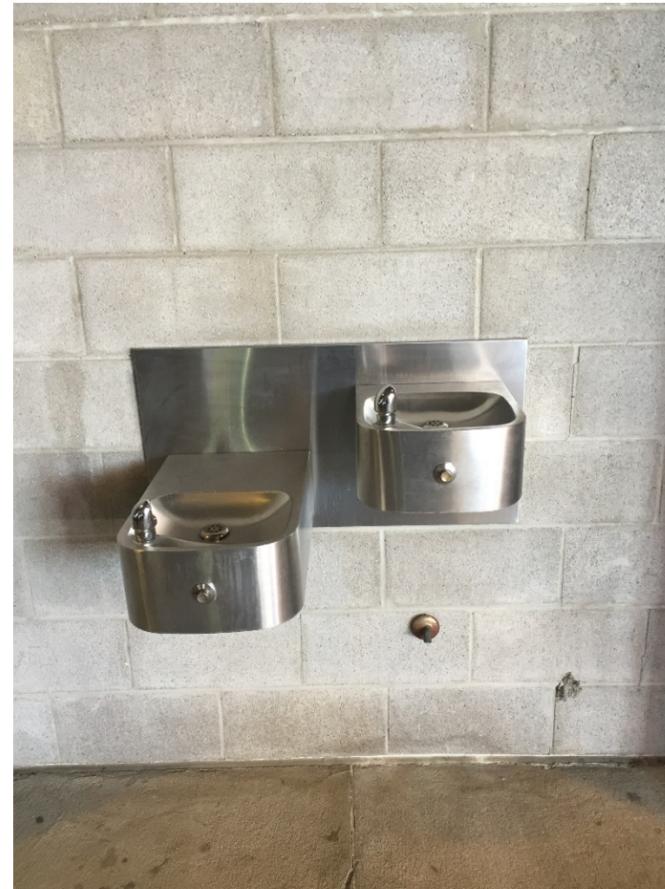
Electric water coolers are provided along the main and upper concourses. The refrigeration units serving these fountains are manufactured by Halsey Taylor or Sunroc and located in a closet behind the fountains. Parts are becoming scarce for these units. The fountain is a stainless-steel product and appears to be in good condition.

*Stainless Steel Drinking Fountain*

9. We recommend continued replacement of lavatory faucets. Replacement units should include 0.5 GPM aerators.
10. We recommend replacing all refrigeration units with a manufacturer that can provide replacement parts in the future; removing the refrigeration feature to convert the electric water coolers to non-refrigerated drinking fountains; or replacing the existing fountains with new drinking fountains. The plumbing code doesn't require public drinking water to be refrigerated.

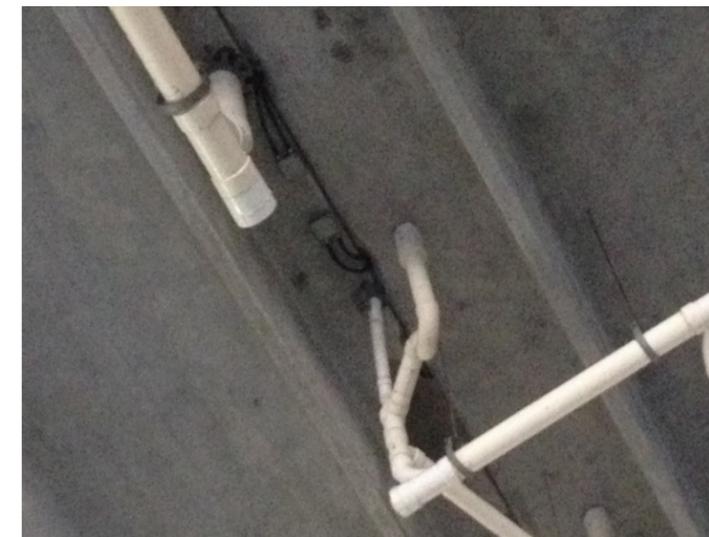
*Exposed Floor Drain Trap*

11. Shower valves could be rebuilt as a minimum but should be considered for replacement due to length of existing service.
12. Add heat trace cable and insulation on exposed floor drain traps to reduce maintenance, and trap replacement should be considered.

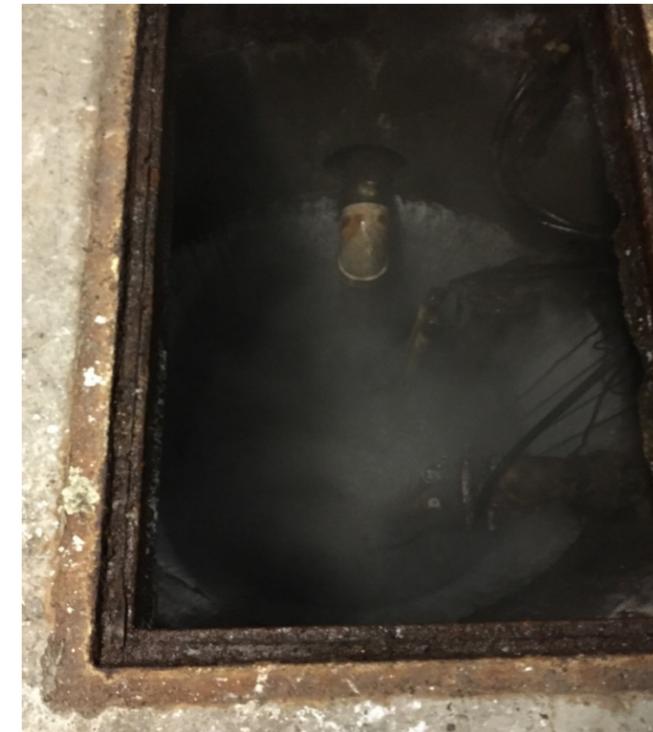
Open Sewage Lift Pump Pit

13. The existing sewage pumps are original, and a phased replacement of the pumps, valves, controls and control panels is recommended.
14. Debris including cigarette butts, peanut shells and paper should be cleaned from all drain locations. Several cigarette butts and peanut shells were noted in the trench drain system serving the playing field.

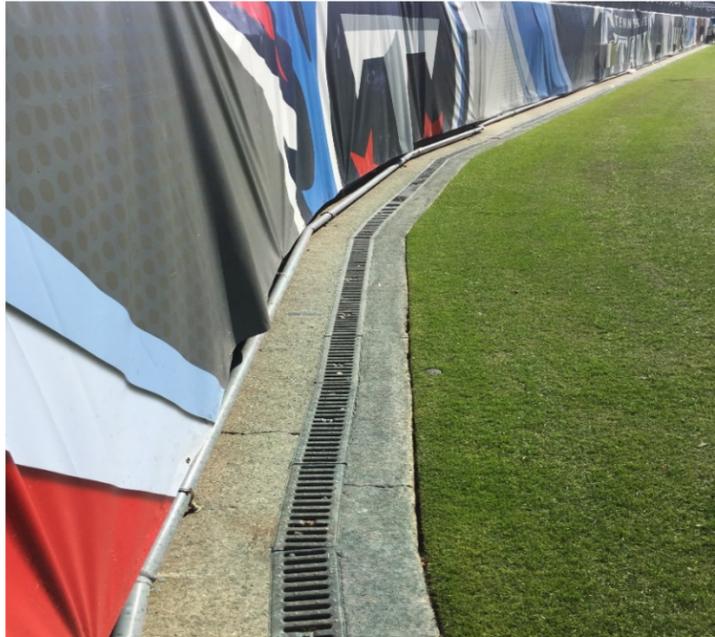
Playing Field Trench Drain

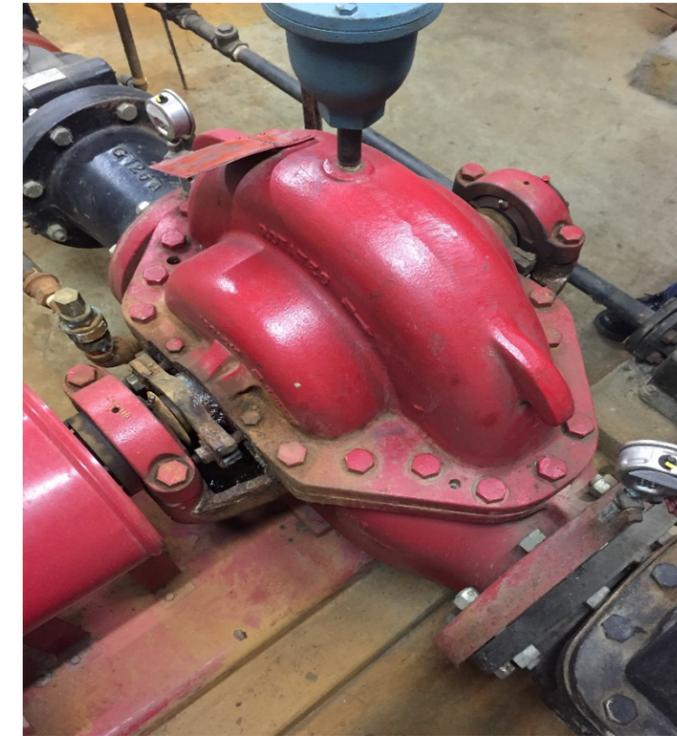
It was observed that the fire pump casing is showing only minimal amount of corrosion build up for the age of the pump.

*Fire Pump Casing*

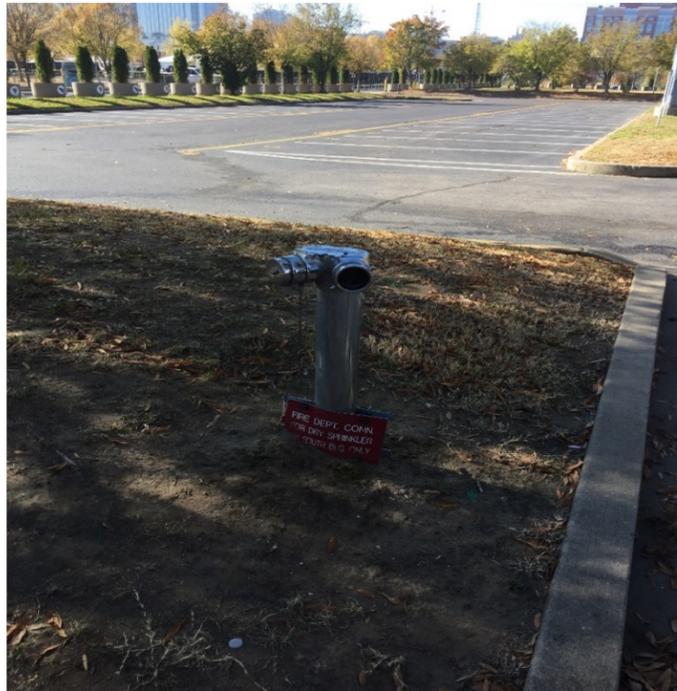
Caps with chains are missing from both fire department connections. The missing caps and chains should be replaced to prevent intrusion of foreign materials. Both fire department connections are within the acceptable distance from a city fire hydrant.

*Fire Department Connection South End Zone Missing Caps and Chains*

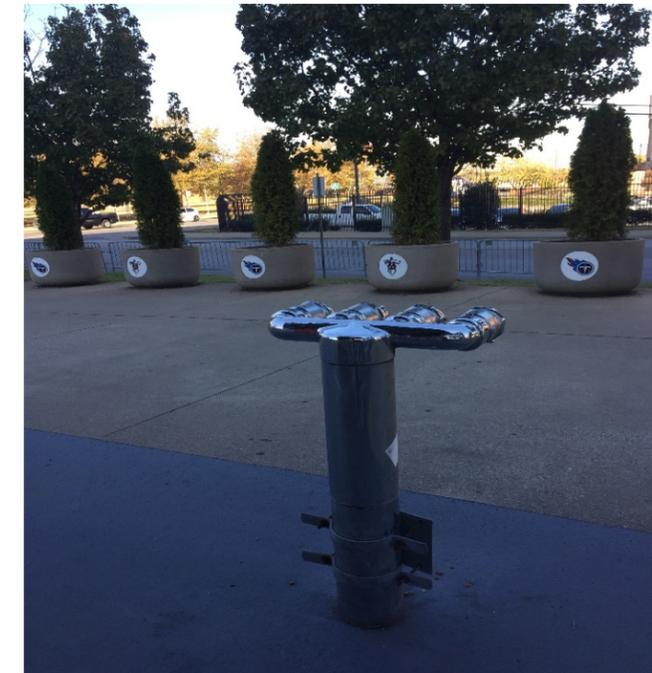
*Fire Department Connection West, North and East Sides Missing Caps and Chains*

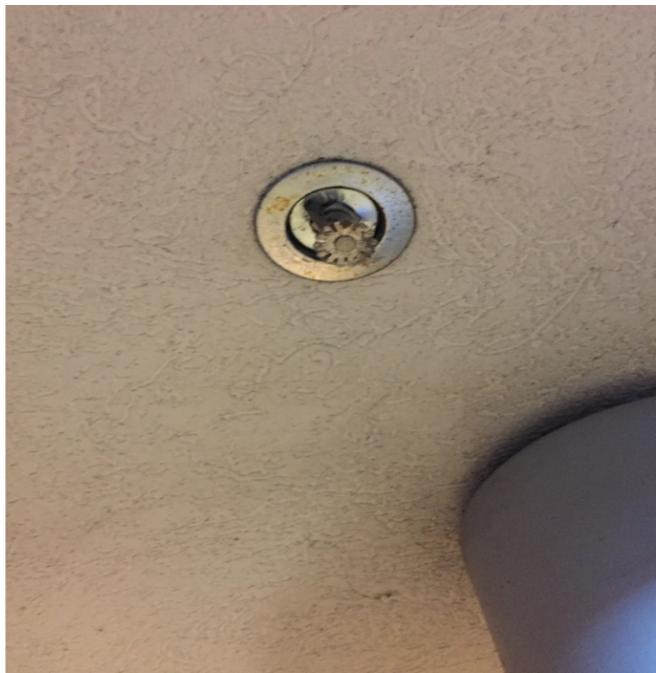
There are multiple dry pipe systems that serve exterior spaces and concessions on both concourse levels. We noted several sprinkler heads located in exterior areas where rust is beginning to accumulate. The sprinkler operation or performance shouldn't be affected; however, the 2008 Edition of NFPA 25 Standard for the Inspection, Testing and Maintenance of Water-Based Fire Protection Systems states that dry pipe sprinklers that have been in service for 10 years shall be replaced, or representative samples shall be tested every 10 years (5.3.1.1.1.5). Paragraph 5.3.1.2 outlines an acceptable test procedure.

*Automatic Sprinkler Head Corrosion*

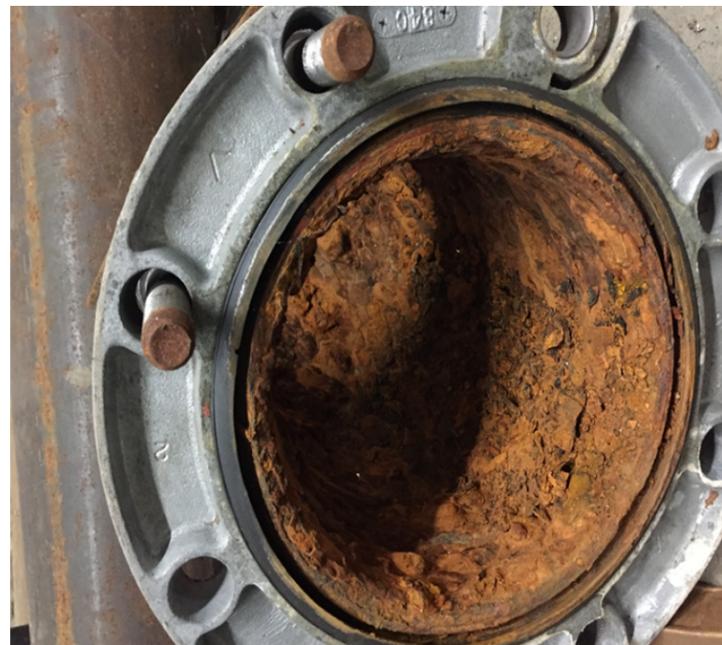
We observed interior corrosion of fire protection piping sections that had previously developed leaks and required replacement. Buildup of corrosion appears to be acceptable for the age of the piping.

*Interior Pipe Corrosion*

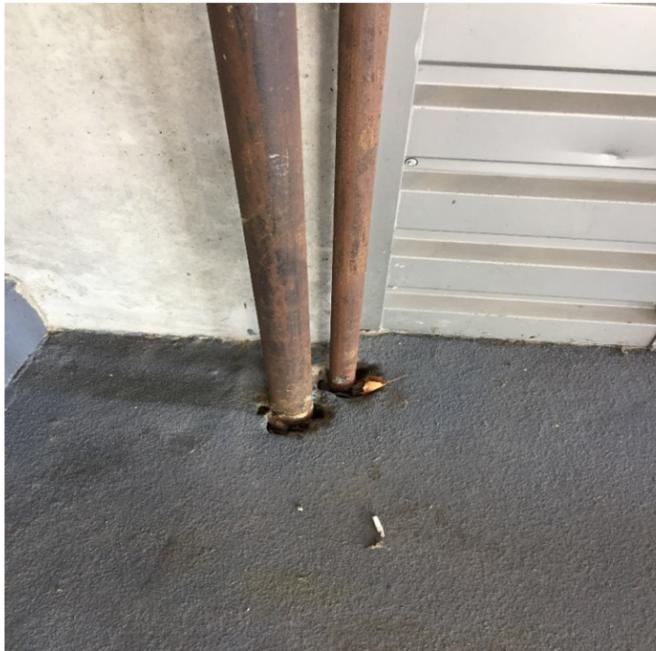
*Piping Missing Floor Supports*

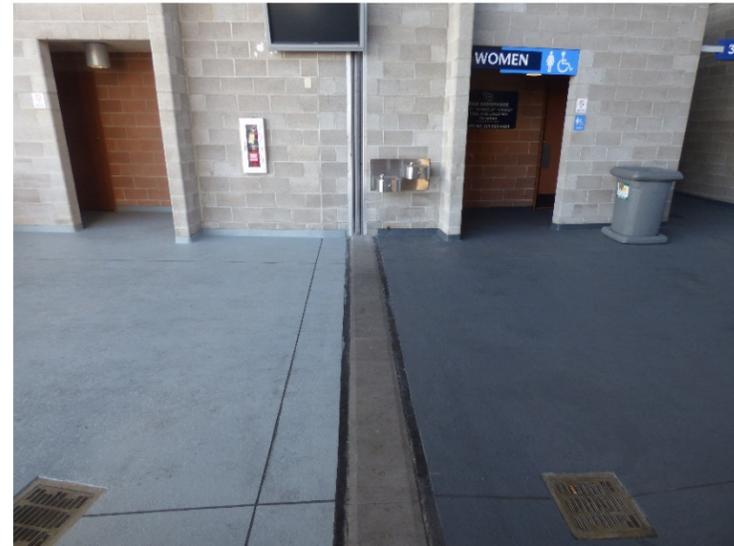
Expansion Joints: The header material on the new expansion joints installed on the upper level concourse on the East side of the stadium exhibited minor damage.

Overall view of new expansion joint on upper concourse

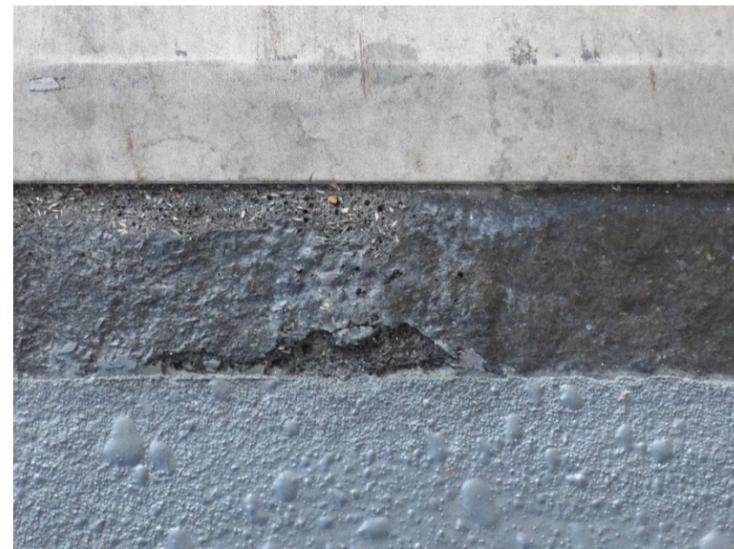
Damage of header material for expansion joint

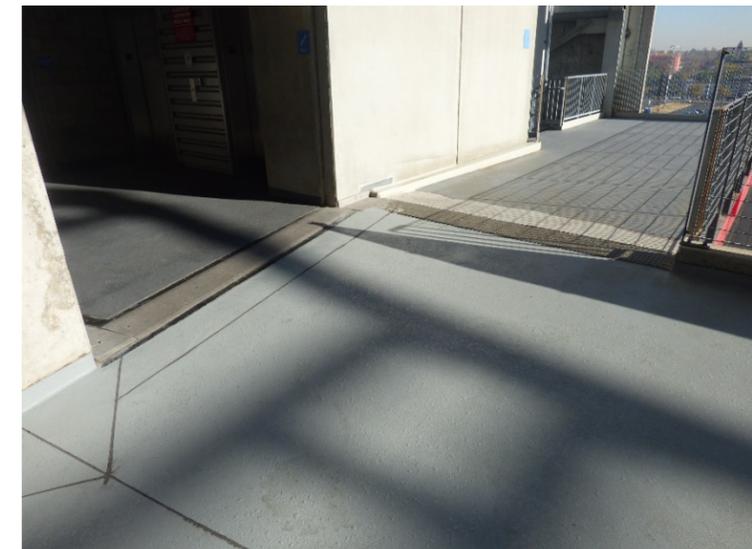
Sealants at older expansion joints, the joints between concourse perimeter walls, and the joints in the topping slab on the main concourse slab appear to have reached the end of their service life and had failed.

Overview of older expansion joints

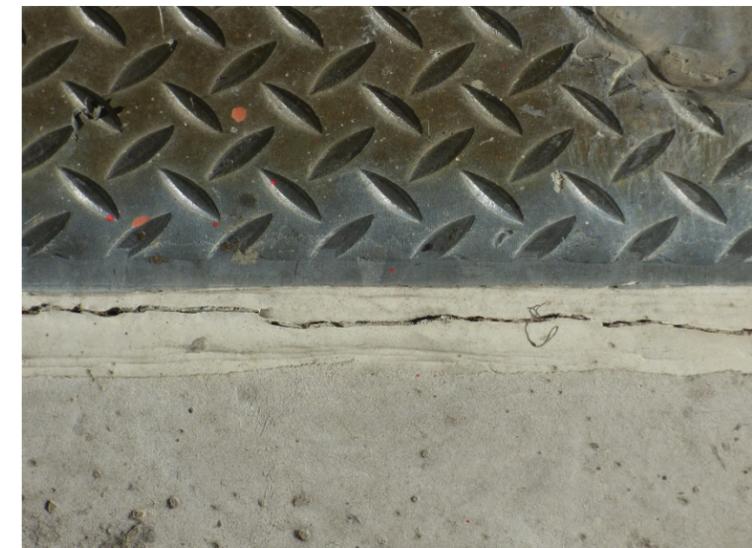
Failed sealant on perimeter of plates over older expansion joints

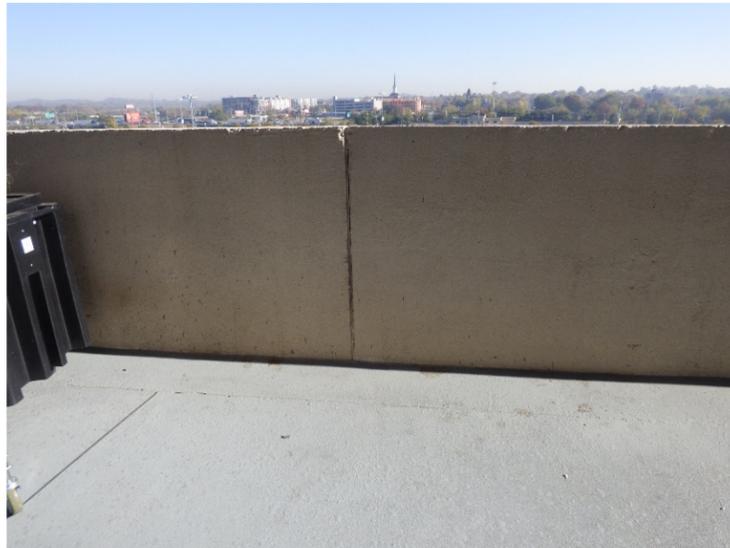
*Vertical joint between concrete perimeter walls*

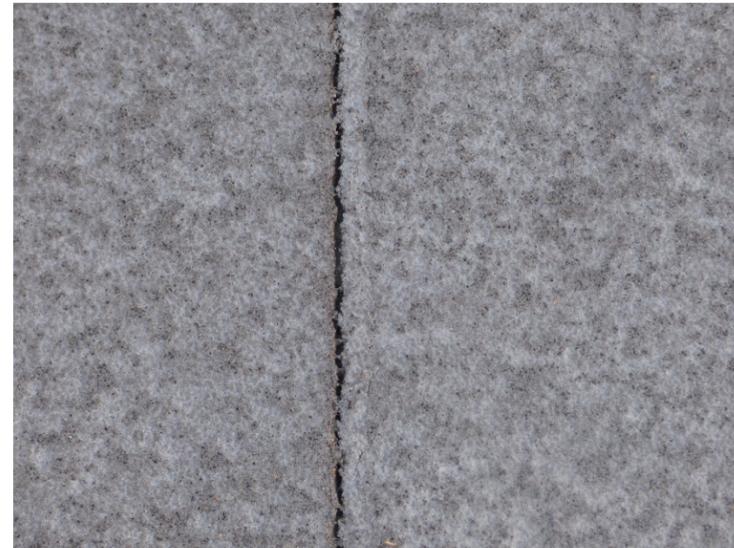
*Failed sealant at topping slab joints in the Main Level concourse*

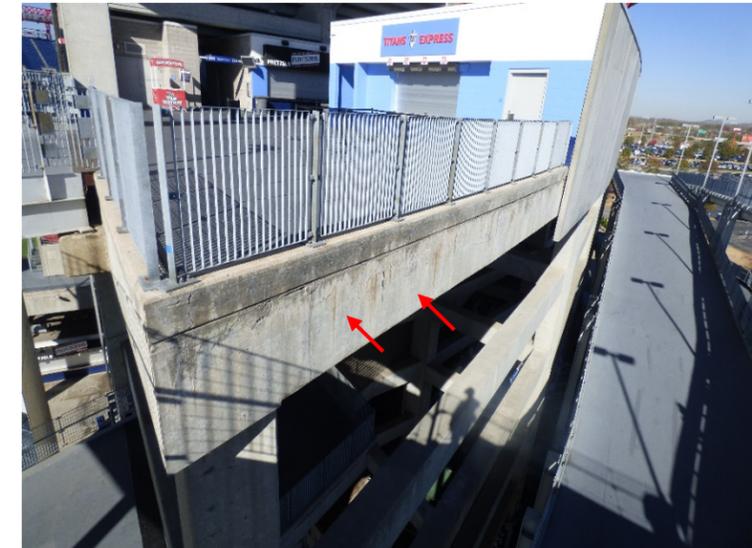
*Concrete spalls and delamination on face of beam and slab*

Concrete spalls and delaminations on face of slab and beam on southeast corner of upper concourse level, on the flanges and stems of double tees at various locations throughout the stadium, and on one column on the Main Level concourse. The delaminations and spalls do not appear to be caused by overloading of the structure, but rather by either corrosion of the reinforcing steel, reinforcing steel with low concrete cover, or damage during construction in the case of precast members.

3. Replace missing nuts and bolts on railing in club level seating.
4. Repair concrete spalls following ICRC guidelines.
5. Replace broken CMU blocks and repoint cracked joints.

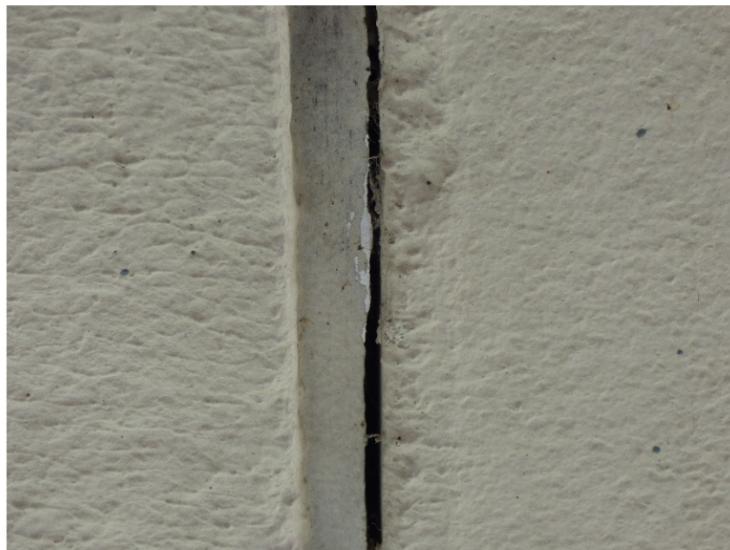
*Failed sealant at joint between perimeter walls*

10. Replace deteriorated concrete steps.
11. Replace failed expansion joints.
12. Replace all failed sealants.
13. Perform concrete repairs per ICRI guidelines and replace deteriorated coating in seating areas.

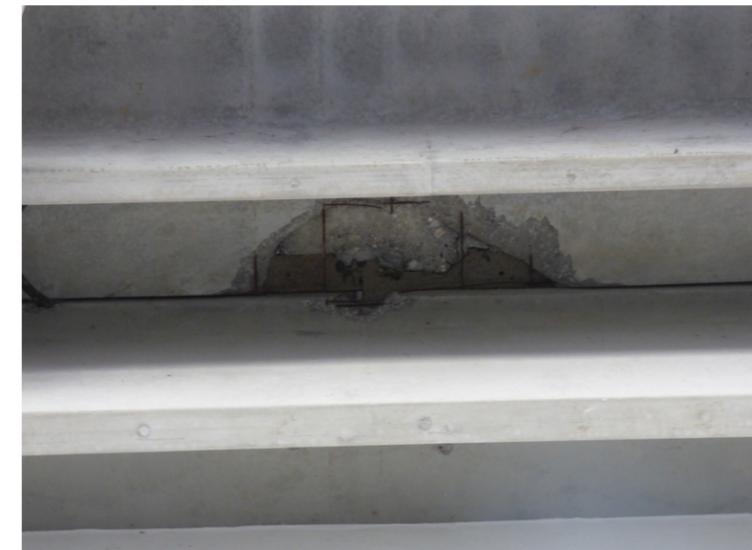
*Concrete spall on double-tee flange on the underside of press level, southwest corner of stadium*

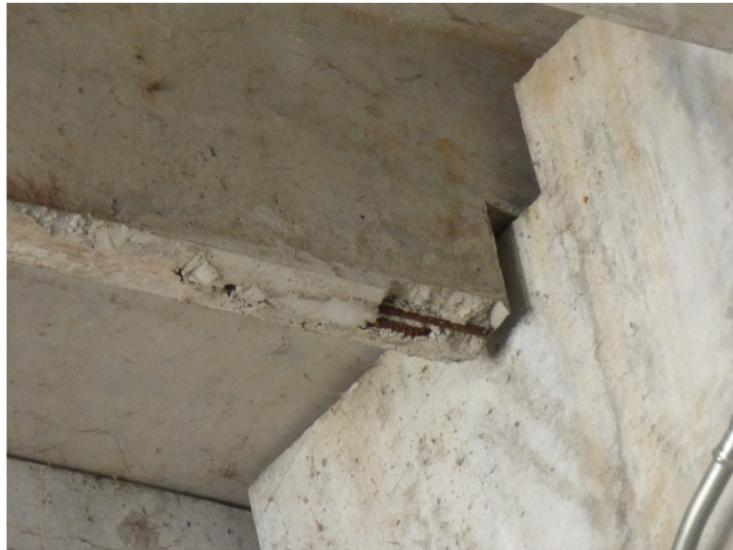
Concrete spall on double-tee stem

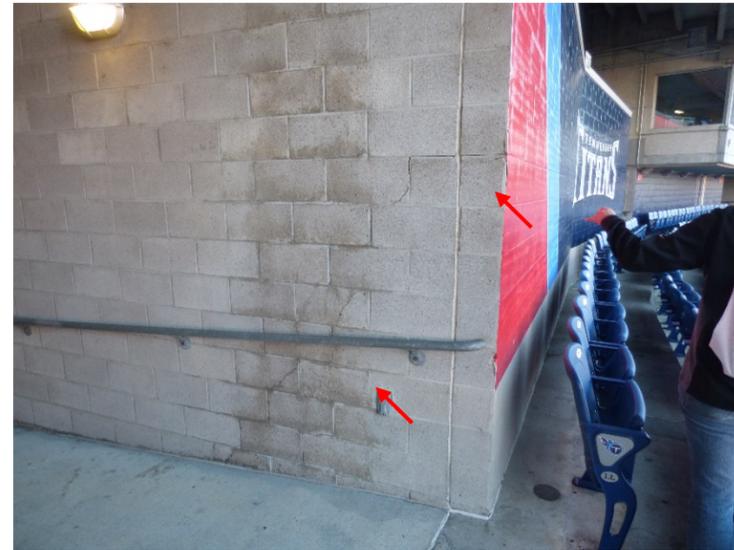
Cracks in concrete masonry units (CMU)

Cracking of concrete masonry units (CMU) at two locations on the stadium. The CMU walls are not part of the main structural system for the stadium, but are part of the bathroom and concession facilities. Cracking does not appear to be of structural concern, but repairs are recommended to prevent further deterioration.

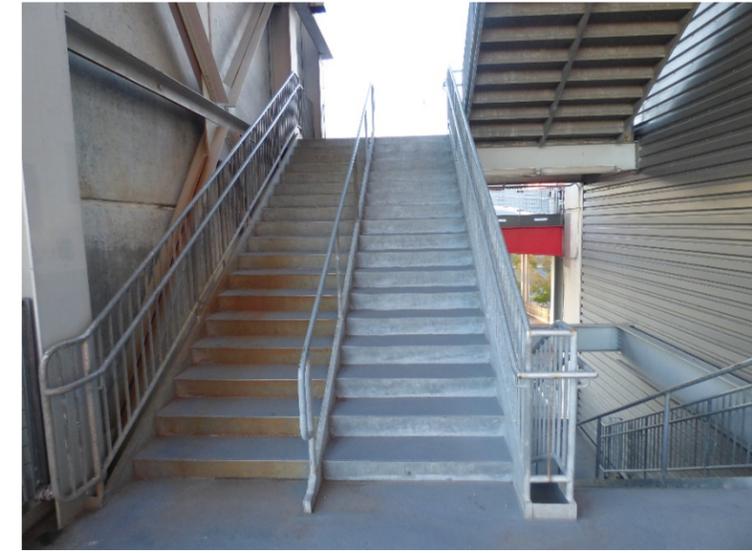
Rust staining of horizontal surfaces below open-ended tubes

The ends of vertical and horizontal tubes at the east and west stair towers are unsealed, allowing water inside the tubes, which has resulted in corrosion of the interior of the tubes and in rust staining on stair surfaces below. The corrosion inside the tubes appeared to be limited to surface corrosion with no apparent section loss of the tube.

6. Seal the ends (top and sides) of the tubes with a steel cap plate. Bottom end of the tubes shall remain open to allow water to exit the tube.
7. Repair deteriorated concrete and perform localized subgrade replacement, if required.

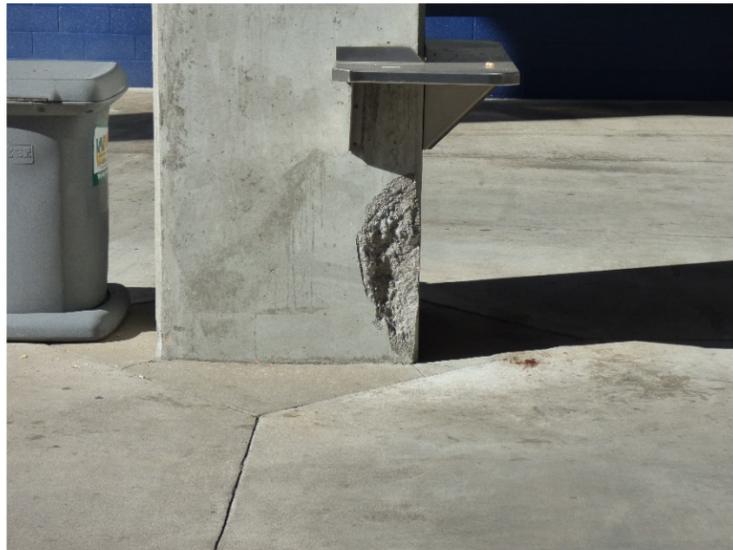
Concrete spall on column at Gridline 10 on main concourse level

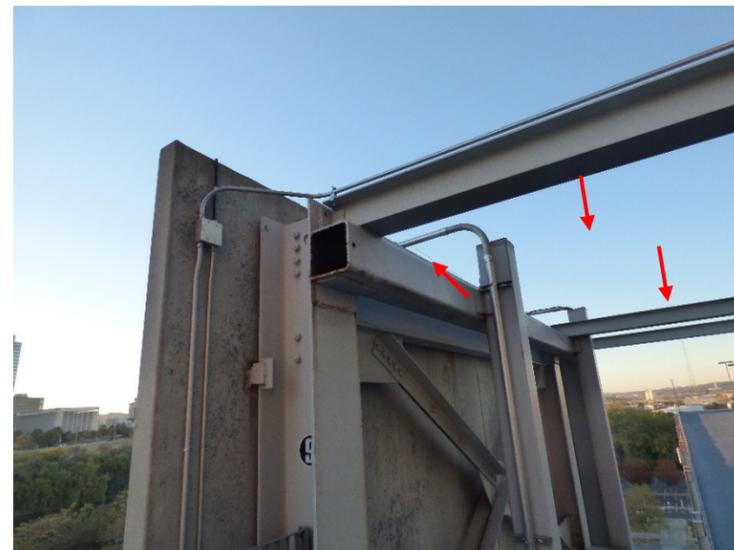
Open ends of steel tubes

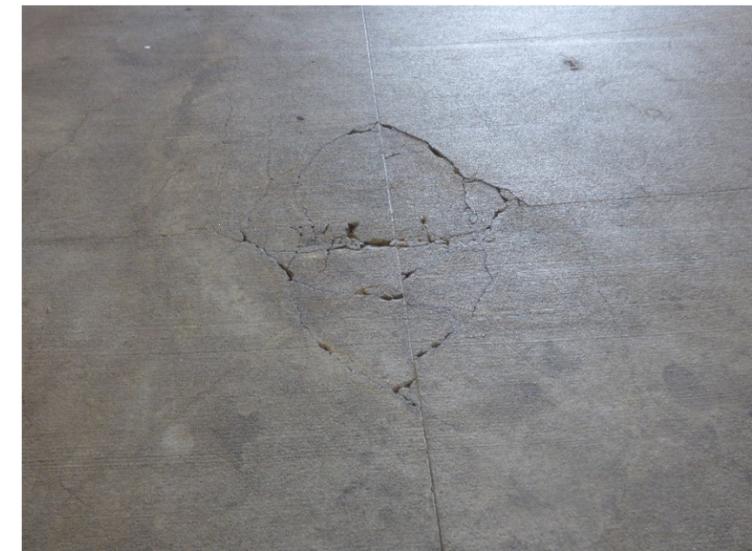
Cracks and spalls on slab-on-grade at service level. Typical cracking on slab-on-grade is of no structural concern. Cracks could be a result of localized overload or localized failure of the subgrade which resulted in loss of support of the slab.

Concrete spalls on slab-on-grade

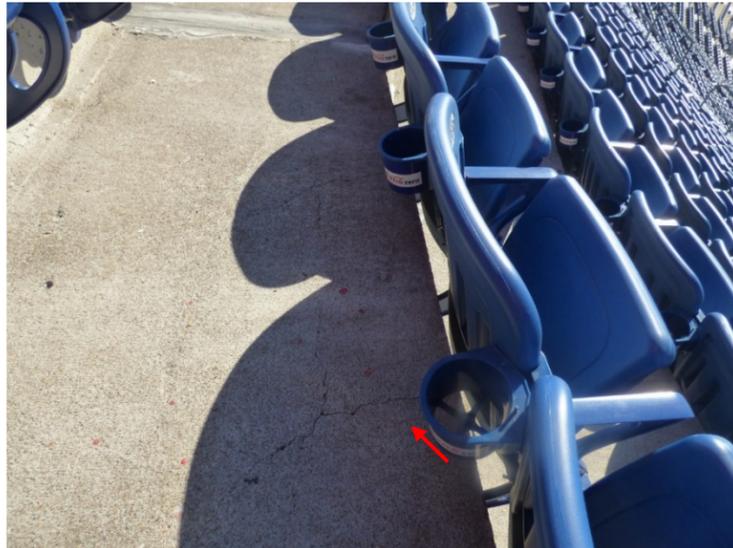
Cracks on top surface of precast seating risers do not appear to be caused by overloading of the structure but rather by volumetric changes due to shrinkage of the concrete or expansion/contraction due to changes in temperature.

*Cracks on seating risers*

8. Cracks greater than 1/32-inch should be routed and sealed to prevent moisture intrusion that could lead to corrosion of the reinforcing steel.
9. Remove delaminated patches and install approved concrete repair material following ICRI guidelines.

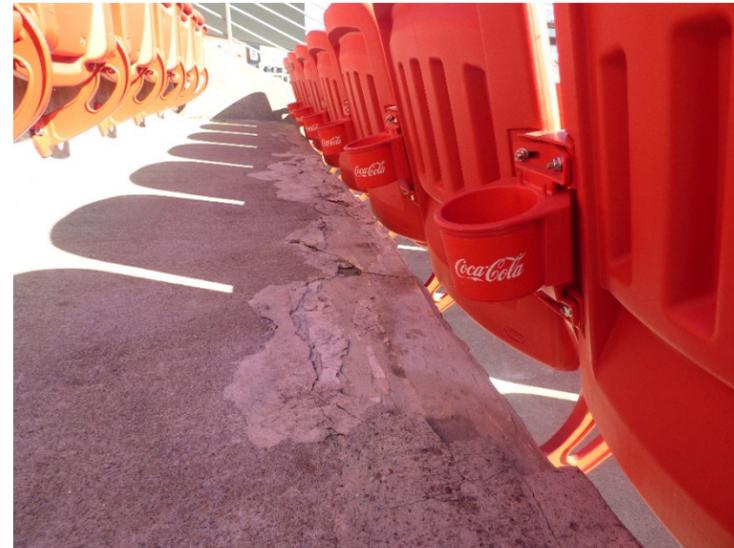
Failed concrete patches on west club level seating risers. The concrete repairs do not appear to have been performed following ICRI criteria.

*Failed concrete patches on seating risers*

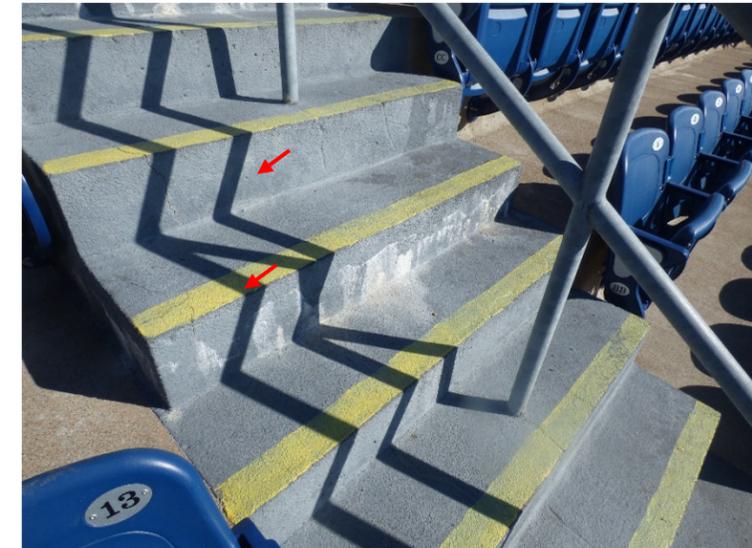
Cracking and leaching on concrete steps was evident, and it appears that some of the cracks had been sealed prior to the application of the waterproofing membrane; however, additional cracks have formed since then and are reflecting through the existing waterproofing membrane. It is our understanding that testing has been performed on the steps and that evidence of alkali-silica reaction was found which explains the leaching observed. Replacement of steps on the lower rows of the Upper Level had been recently completed.

*Cracks and leaching in concrete steps*

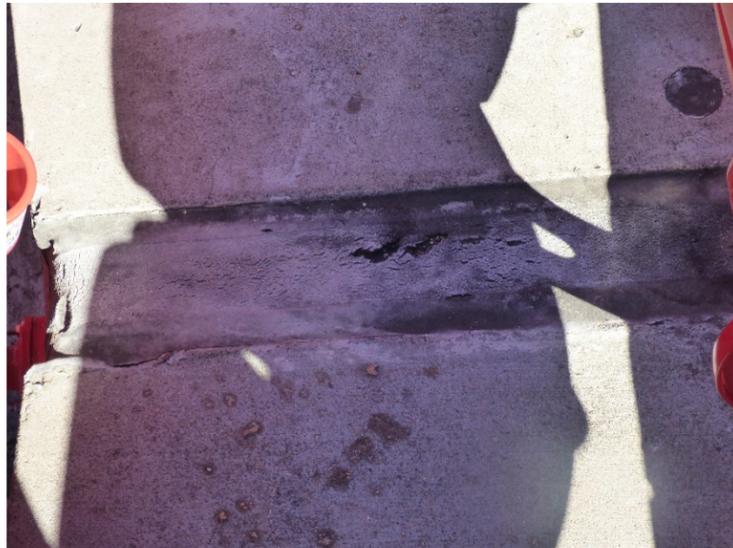
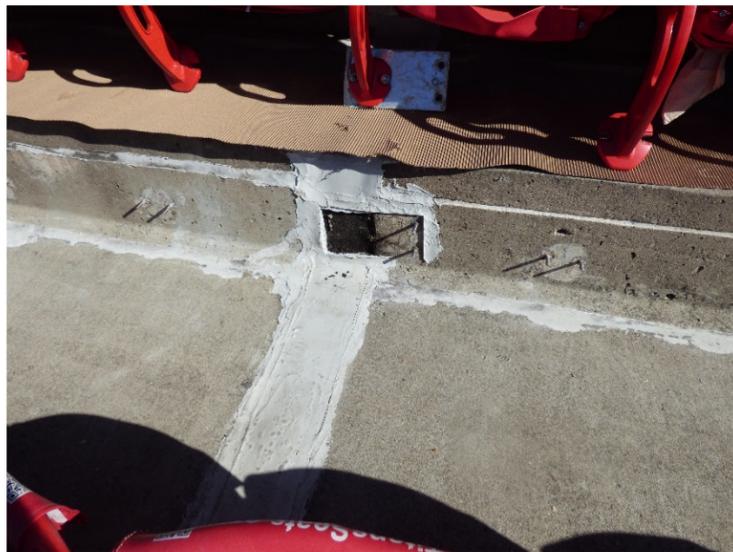
Failed expansion joint covers on seating areas. The existing expansion joint covers appear to be a premolded joint. In areas above occupied space, the joints have been covered with sealant to prevent water intrusion into the occupied space below. It is our understanding that the expansion joints have been recently replaced in the lower rows on the upper level and are currently scheduled for replacement on the east side of the club level.

*Failed expansion joint on seating areas*

*Expansion joint covered with sealant*

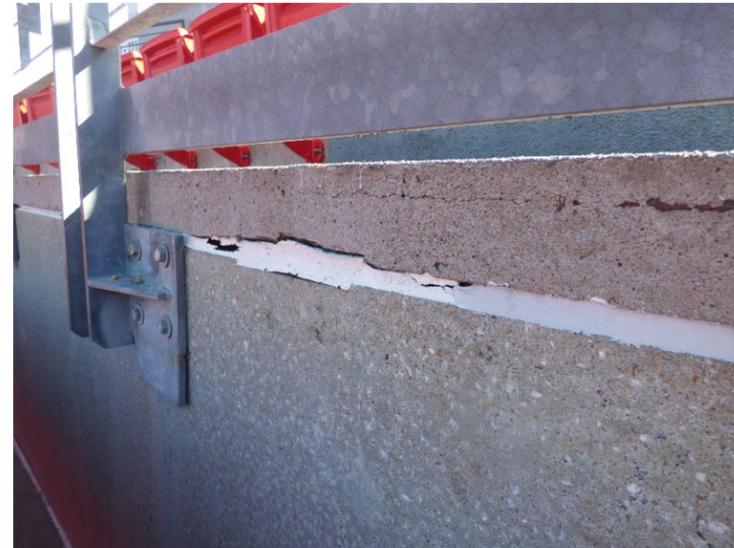
Failed sealant at horizontal joints on precast seating risers. Sealant had been recently replaced on the lower rows on the upper concourse level and was in the process of being replaced on the east side of the club level.

*Failed horizontal sealant on precast seating riser*

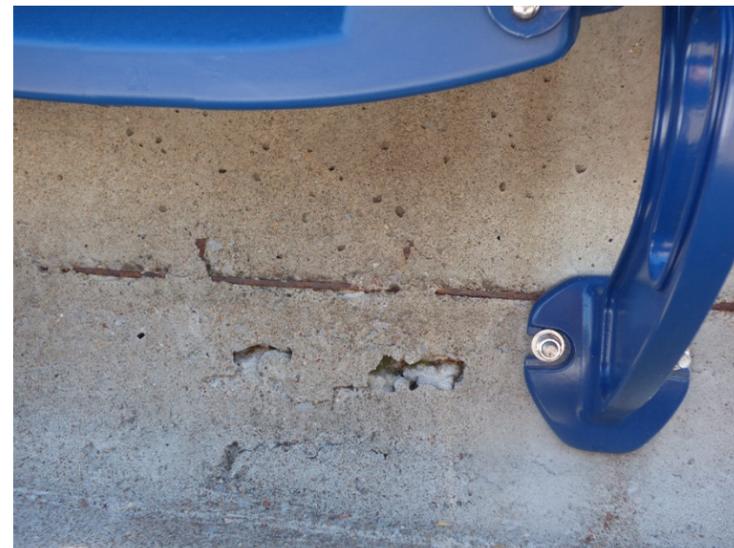
Exposed wire mesh on precast seating risers, which appears to be a result of very low concrete cover and inadequate consolidation of the concrete. The exposed wire mesh is not of structural concern and does not appear to be negatively affecting the structural member. At this time, no correction measures are recommended.

*Exposed wire mesh on precast seating riser*

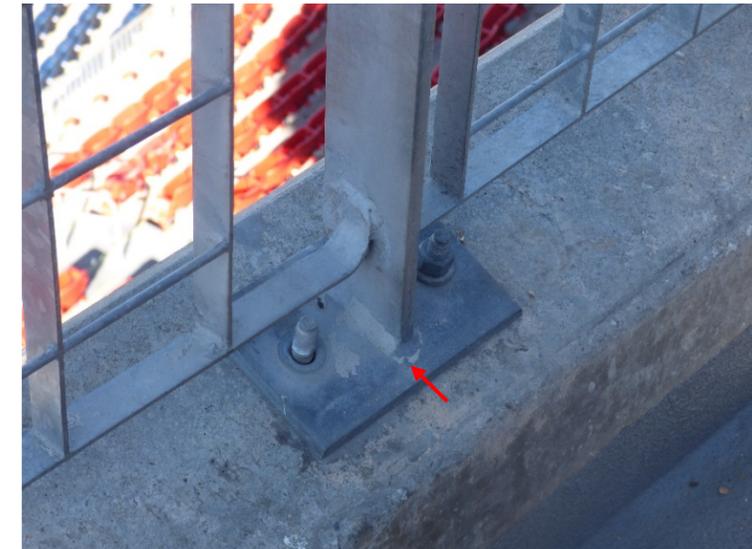
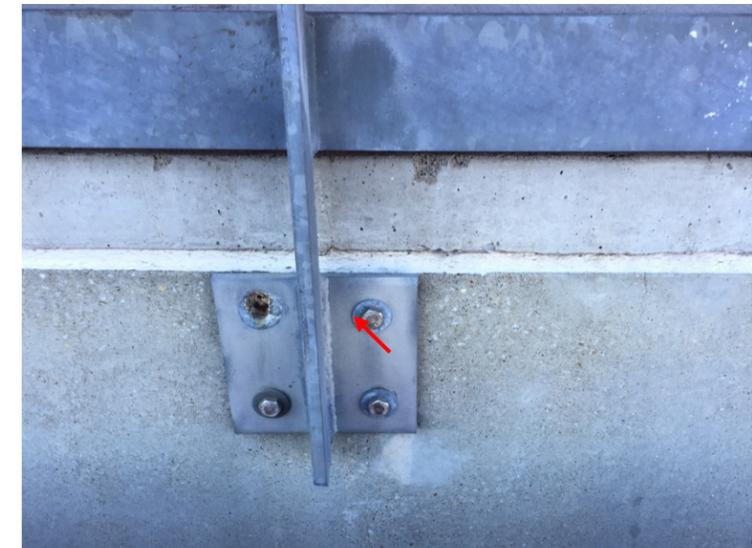
Missing nuts on the base plates for the guardrails on the seating areas were observed at two locations. Missing anchors on the guardrail attachments were noted in two locations at the club level.

*Missing nut on handrail base plate on club level*

*Missing bolt on handrail anchorage plate in club level*

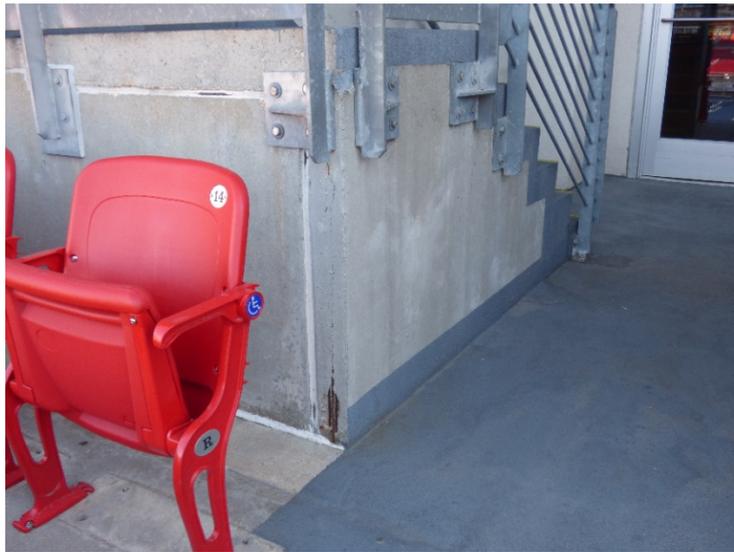
Cracks and spalls were observed at the corner of precast concrete stairs on the club level. In some cases, corroded reinforcing steel was also observed. In the cases where the reinforcing steel was visible, it appeared to have very low concrete cover which might have led to cracking of the concrete and subsequent corrosion of the steel, which resulted in the concrete spalls.

*Cracks and spalls at corner of precast stairs*

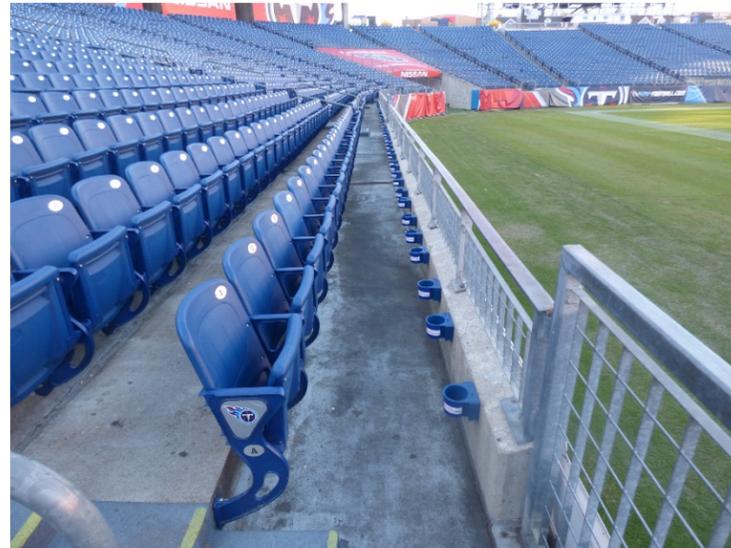
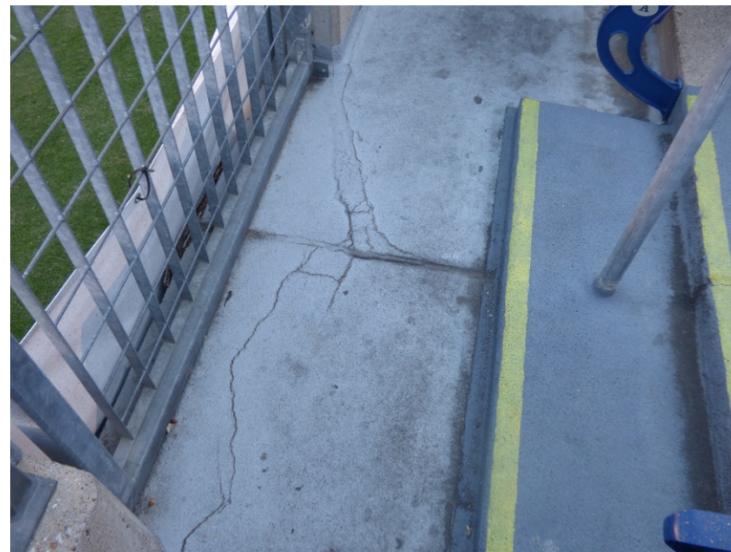
Deteriorated coating and concrete delaminations on the first row of the Lower Level seating areas.

*Deteriorated traffic coating*

*Concrete delaminations on first row of lower level seating area*

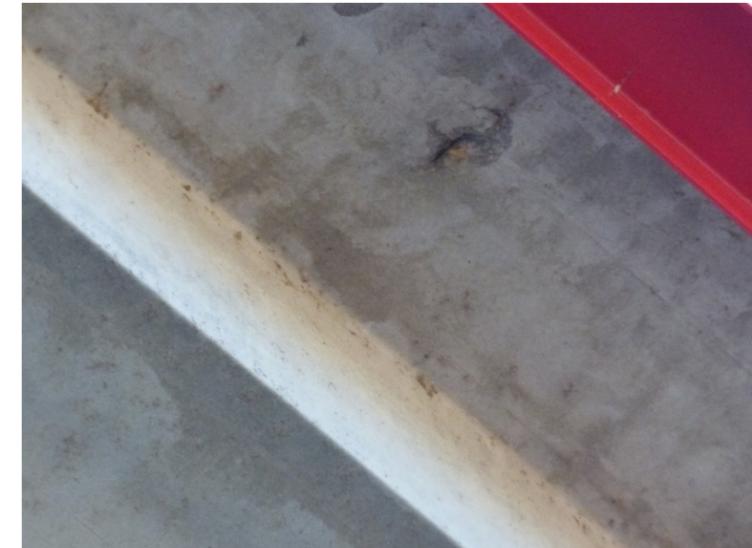
Spalls on underside of precast seating risers. The spalls appear to be a result of low concrete cover, and in some cases, corrosion of the embedded reinforcing steel.

*Concrete spall on underside of seating riser.*

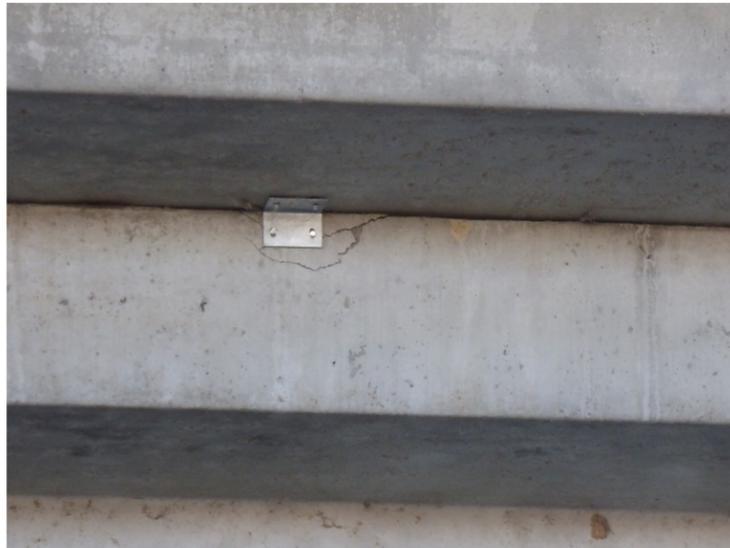
Delaminations at clip angles on the underside of precast seating risers. It is our understanding that as part of a recent renovation, these clip angles were installed at locations where concrete had spalled at locations of welded connections between precast seating risers. The welds were ground off, and the new clips were installed. The documented delaminations may be caused by differential movement between the precast seating risers that causes stresses at the connection points.

*Concrete delamination at clip angle location*

14. Review deterioration at clip angles between precast seating risers by original designer.
15. Replace broken connection on ribbon board.

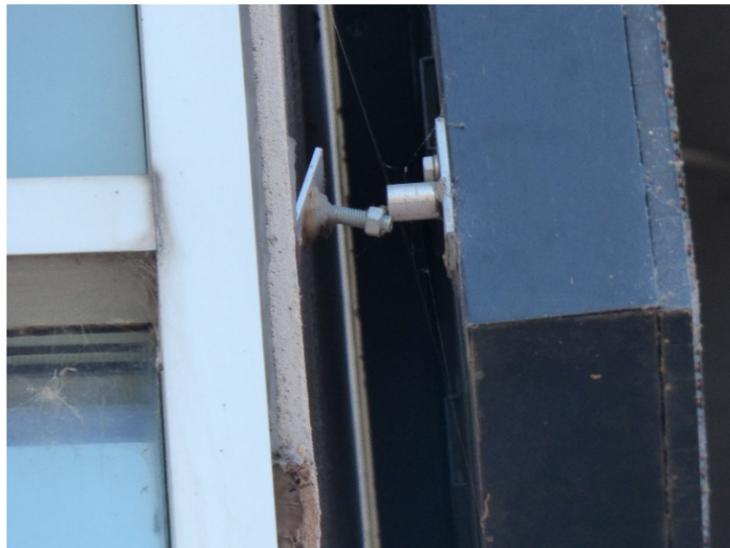
One of the connections of the ribbon board on the northeast corner of the club level seating area had failed.

*Loose connection of ribbon board*

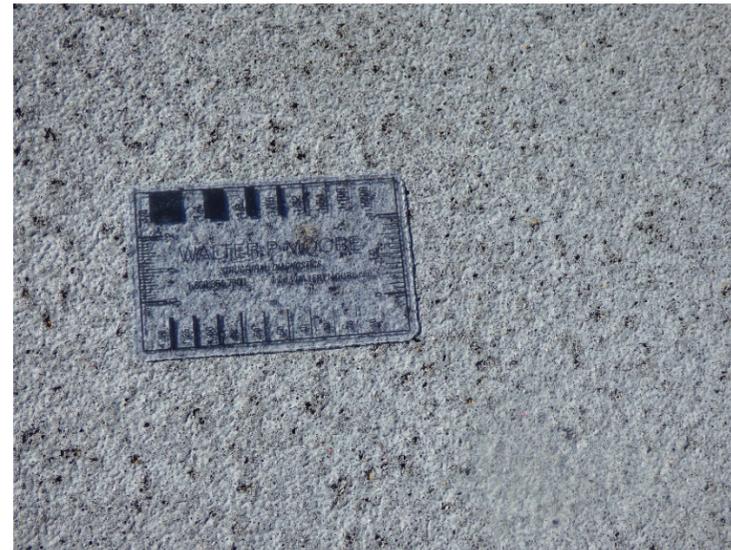
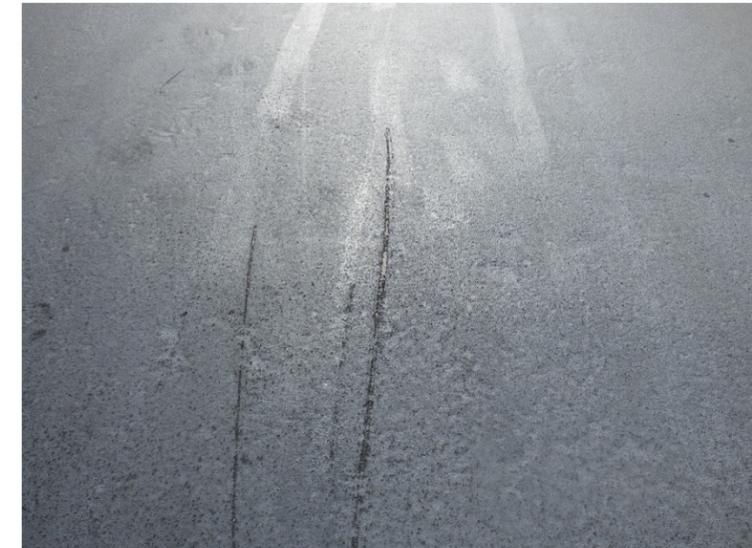
The traffic coating on the pedestrian ramps that provide access to the upper levels is aged and has been damaged by vehicles and other equipment. Traffic coatings typically require recoating every 5 years, and replacement once the base coat shows excessive deterioration.

*Aged traffic coating on pedestrian ramps*

*Damaged traffic coating on ramp*

16. Recoat traffic coating with replacement at isolated locations on pedestrian ramps.
17. On pedestrian ramps, remove all corrosion products and coat with a high-performance coating. At isolated locations, installation of supplementary sections of deck may be required.
