# Facility Condition Assessment

April 3, 2017

## Nissan Stadium

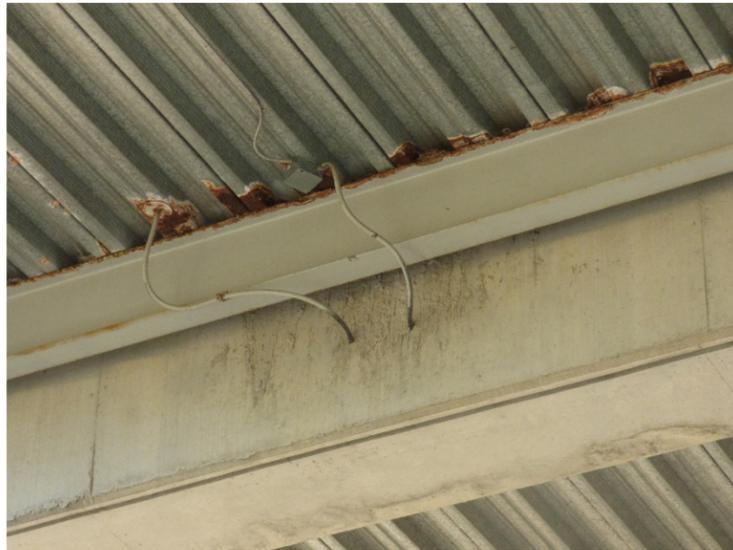
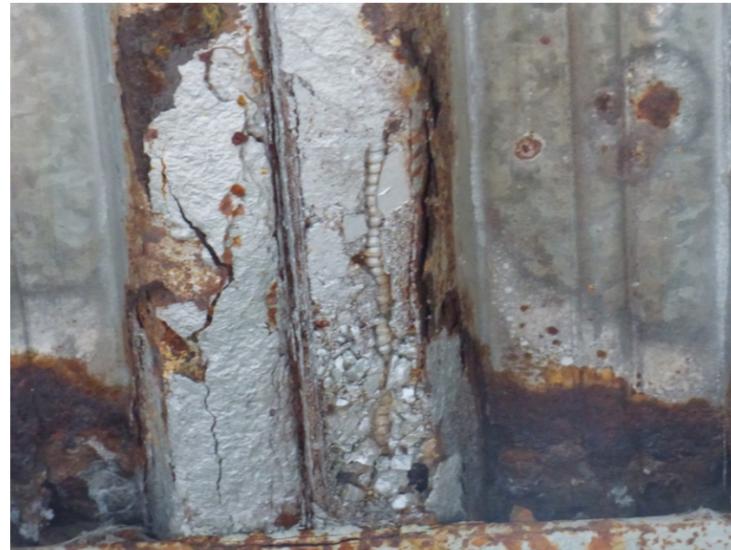
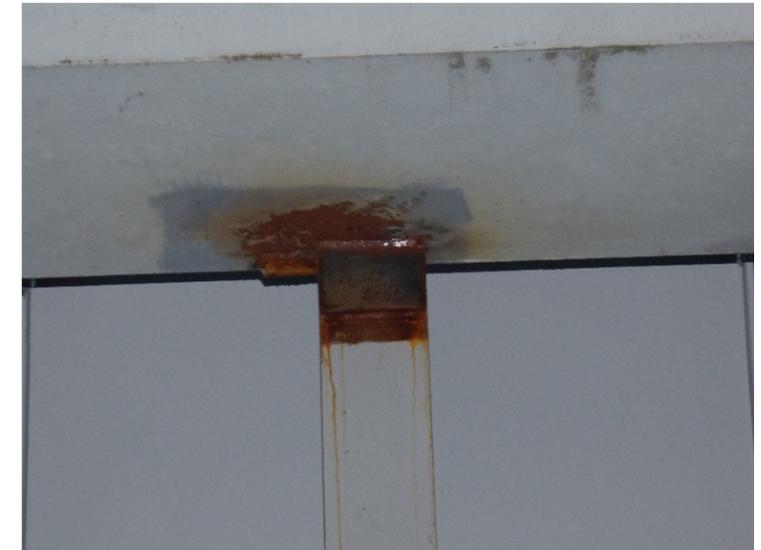
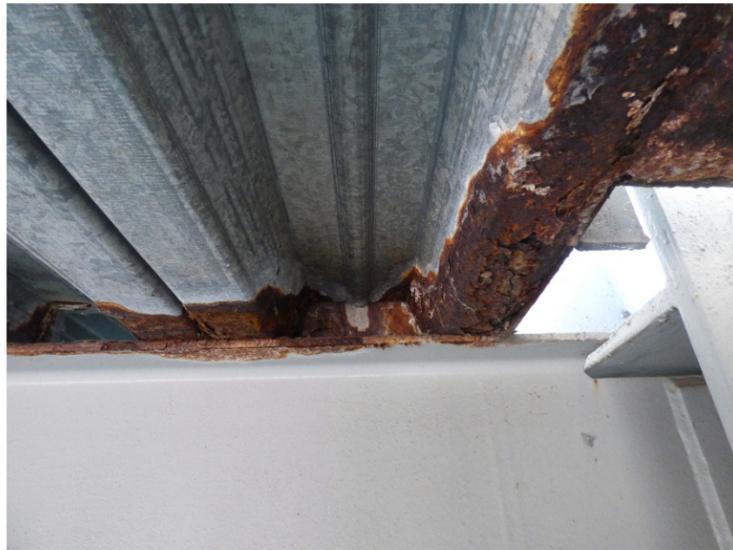
Corrosion of the metal deck and structural steel beams on the pedestrian ramps. It appears that the corrosion is a result of water intrusion from the top of the ramps through the side, which did not have cove sealant originally. Cove sealant appears to have been installed along with the traffic coating on the top surface of the ramps. However, significant corrosion of the metal deck and minor corrosion of the top of the beams has occurred. In one area, the corroded metal deck had been coated; however, it appears that the corrosion products were not removed prior to coating.

*Corrosion of metal deck on pedestrian ramp*

*Corroded metal deck which has been painted over at exterior, visible from exterior of stadium sidewalk*

*Corrosion of clip angle*

*Close up of metal deck damage due to corrosion*

16. Recoat traffic coating with replacement at isolated locations on pedestrian ramps.
17. On pedestrian ramps, remove all corrosion products and coat with a high-performance coating. At isolated locations, installation of supplementary sections of deck may be required.

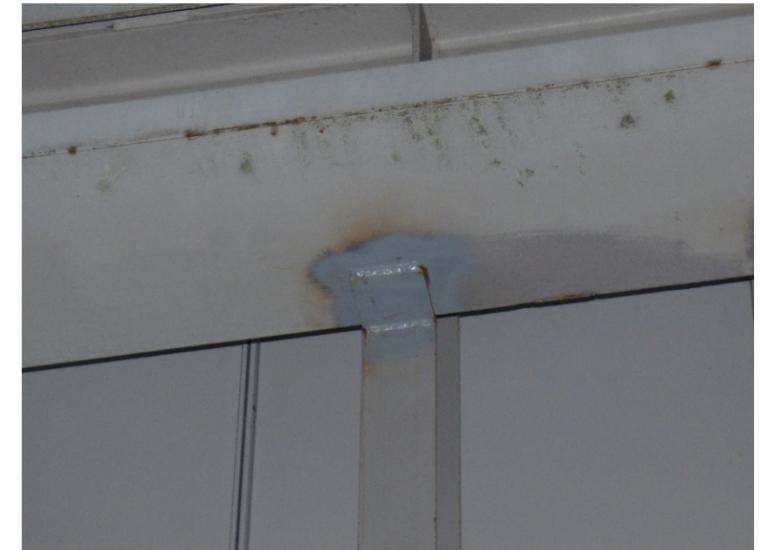
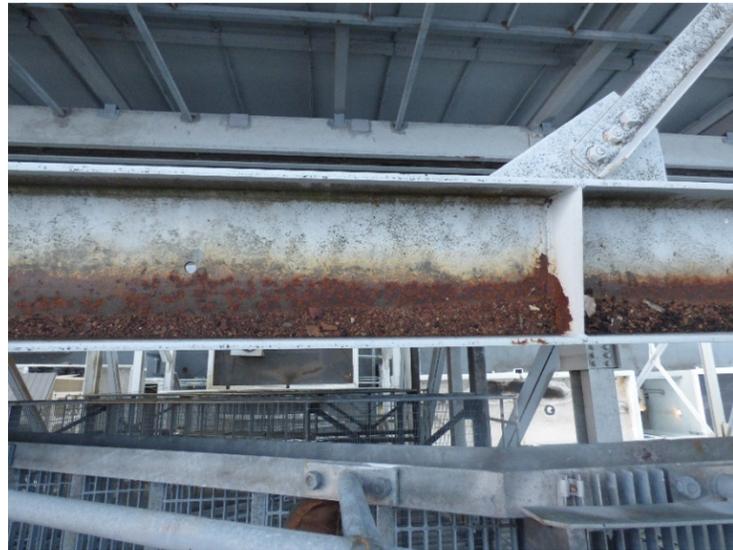
Corrosion of clip angles and structural steel beams on scoreboard structures. Some of the clip angles had been previously recoated; however, evidence of rust was also observed on these angles as shown. Some of the structural steel I-beams had been installed with the web at a slight angle from the horizontal direction which causes water ponding on top of the web. Even though holes had been drilled on the web, they were not located in the low spot.

*Evidence of rust on previously coated clip angle*

Corrosion of web on structural steel beam. View looking down.

18. Remove all corrosion products on scoreboard structures and coat with a high-performance coating. On the structural steel beams, add holes at the low spots to prevent water ponding, or install caps over the beams.

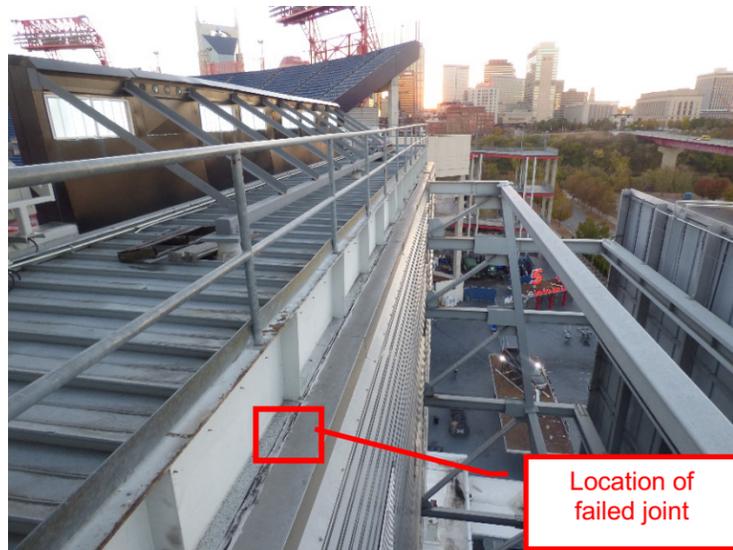
Location of failed joint

Failed sealant at joints between exterior elements of scoreboard structure

View of back side of scoreboard

19. Replace failed sealants on exterior of scoreboard structures.
20. Repair deteriorated exterior concrete and perform localized subgrade replacement, if required.

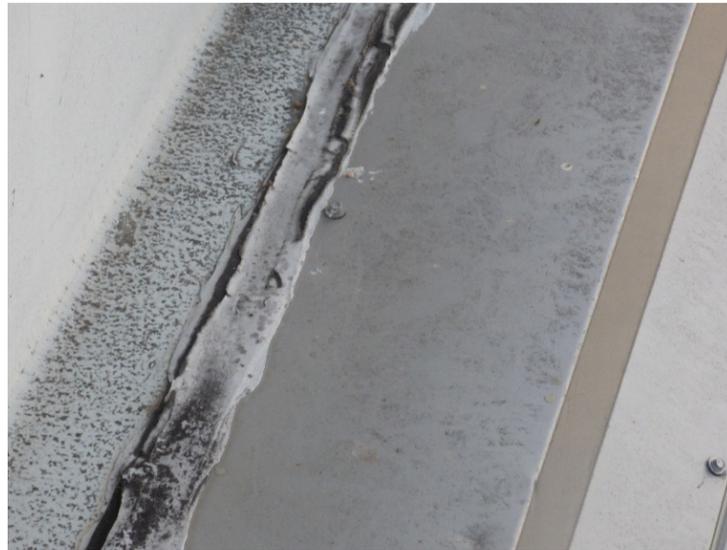
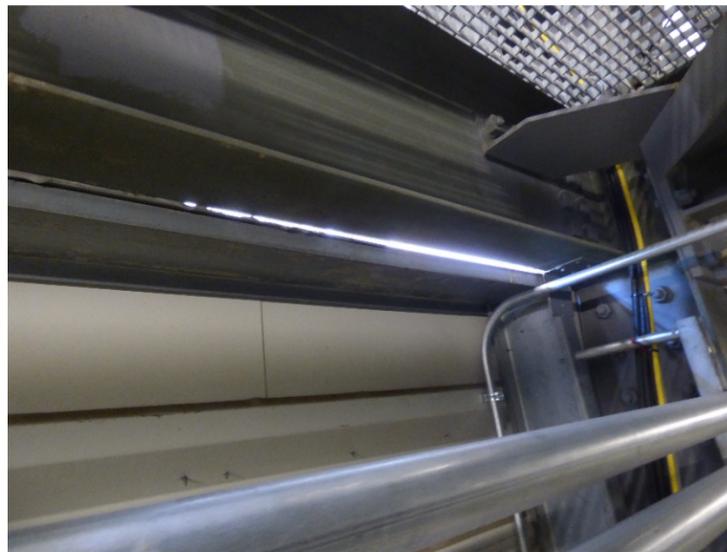
Deteriorated sealant at joint on scoreboard elements

Evidence of failed sealant between elements of scoreboard elements (notice daylight through joint)

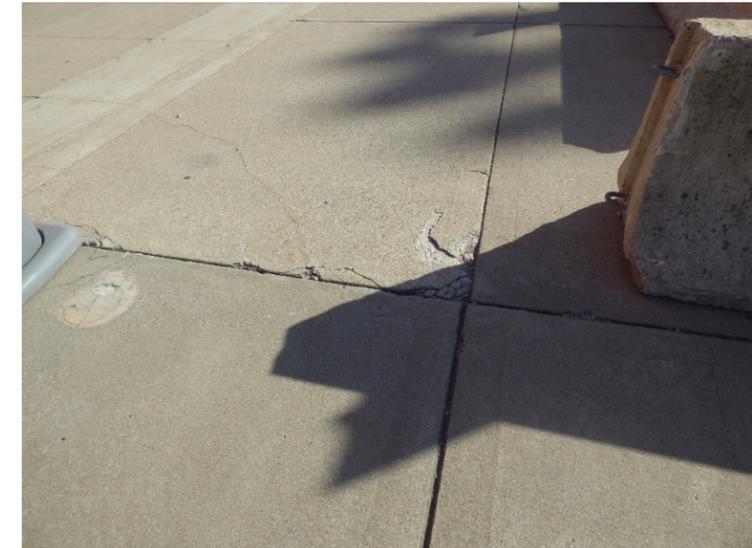
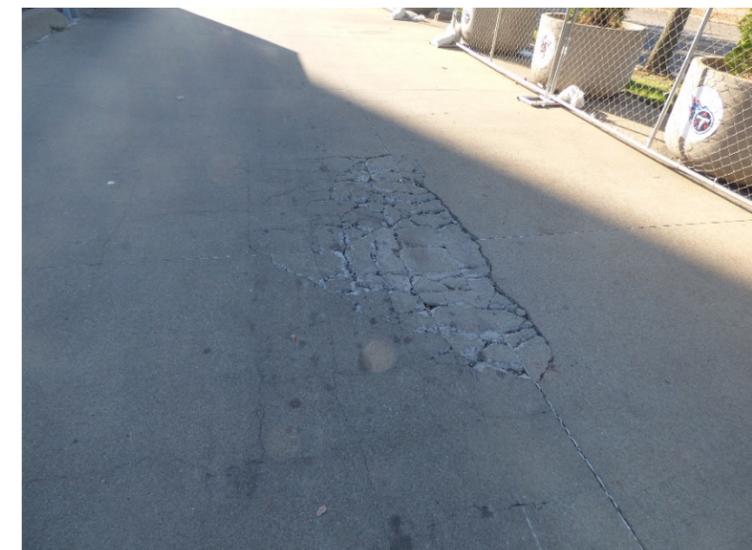
Concrete cracks and spalls on slab-on-grade. Typical cracking on slab-on-grade is of no structural concern. Concrete damage could be a result of localized overload or localized failure of the subgrade which resulted in loss of support of the slab.

Delaminated concrete in slab-on-grade

Severely damaged concrete in slab-on-grade

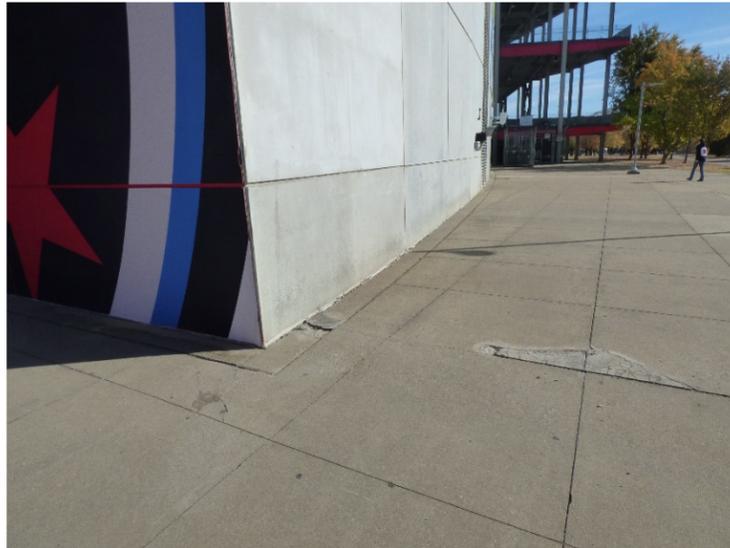
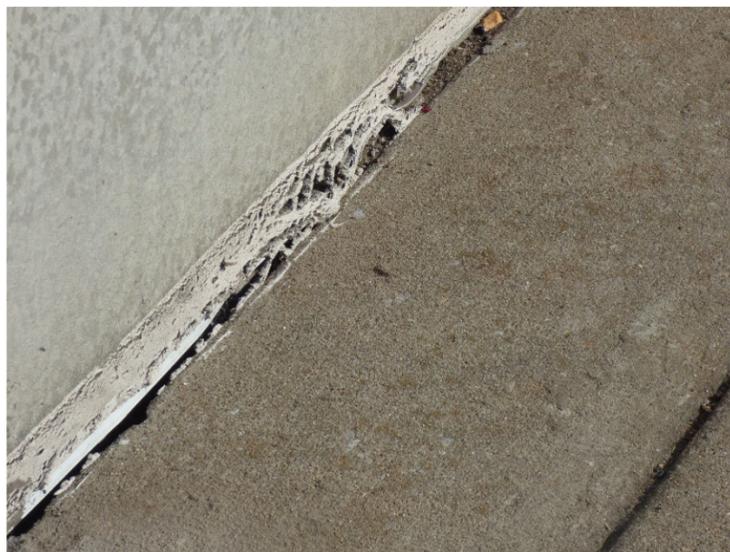
Failed cove sealant along the perimeter of the building. The sealant appears to have reached the end of its service life and requires replacement.

*View of exterior wall location of failed cove sealant*

*Failed cove sealant at exterior wall*

21. Replace failed cove sealant along perimeter of stadium.
22. Repair spalled concrete on the perimeter per ICRI guidelines.
23. Install grout at base of precast concrete walls.

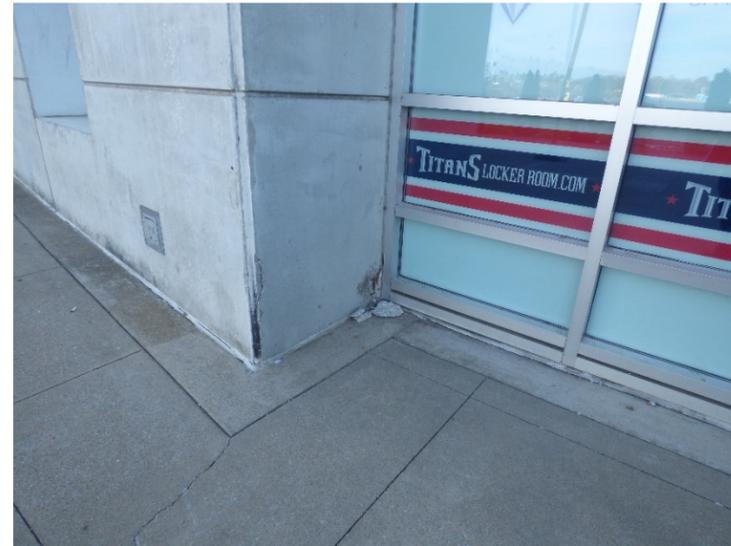
Concrete spall on precast concrete wall panel. The spall was observed on one of the exterior wall panels but does not appear to be of structural concern. Spall may have been caused by minor damage during construction that with time resulted in the spall observed.

*Concrete spall on precast wall element*

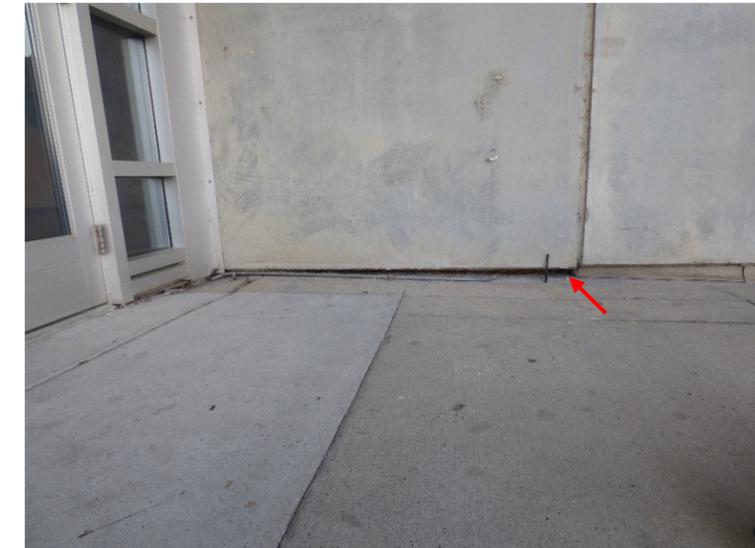
Missing or loose grout at base of precast concrete walls. The grout originally placed at the base of precast concrete walls on the perimeter of the building was either missing or completely loose and could be removed by hand. It does not appear that the grout is used to support the walls, as they are typically attached directly to the columns. However, the grout will prevent water from penetrating into the structure.

*Missing grout below exterior precast wall panel*

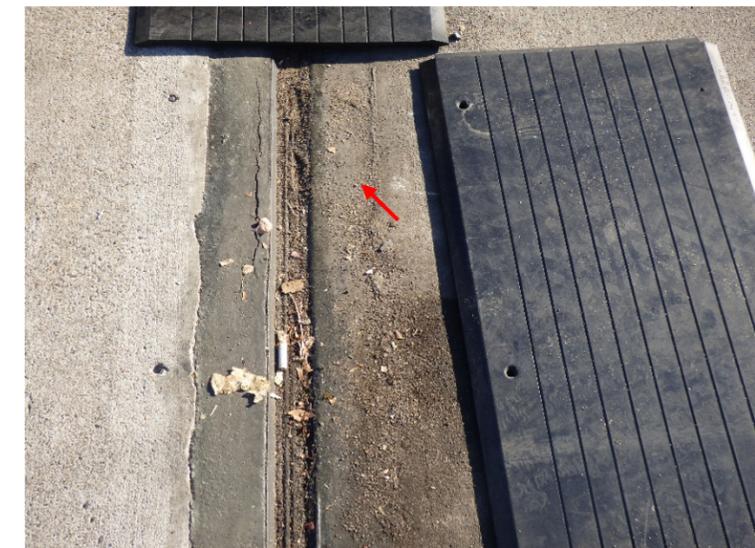
Damage to header material on exterior expansion joint located over loading dock.

*Damage to header material on exterior expansion joint over loading dock*

24. Replace deteriorated header material on exterior expansion joint cover.
25. In surface parking lots, seal cracks and replace pavement in heavily damaged areas. In areas with severe weathering, an overlay will be required. In areas with minor weathering, we recommend application of a seal coat.

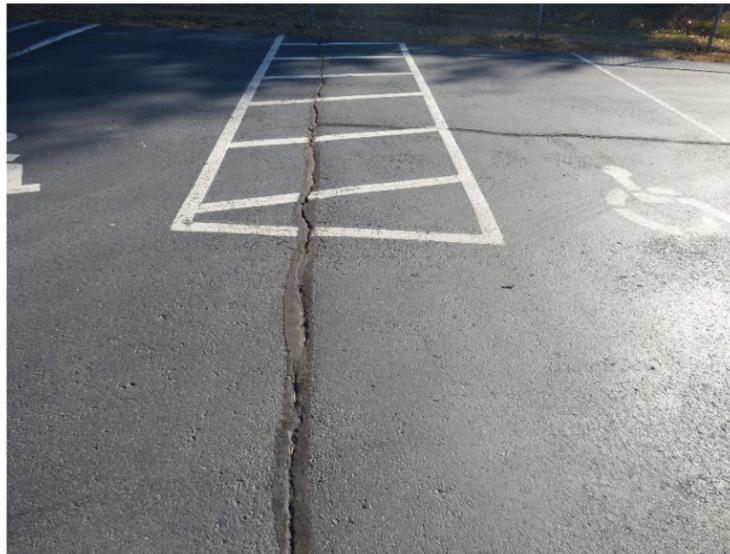
The surface parking lots were in fair condition. We observed cracks in the pavement. Some of the cracks had been previously sealed but had cracked again. We also documented isolated locations of significant pavement distress which could have been caused by overload or subgrade deterioration. The degree of weathering of the pavement varied throughout the different lots.

*Previously sealed pavement crack*

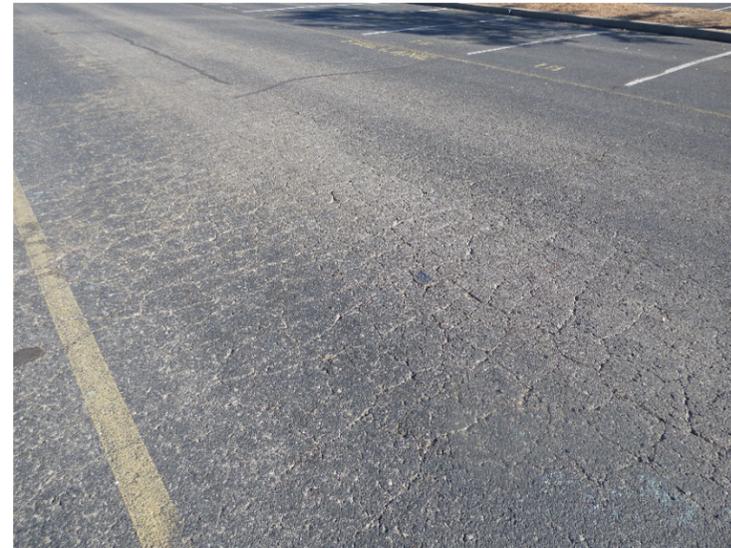
*Severe pavement deterioration*

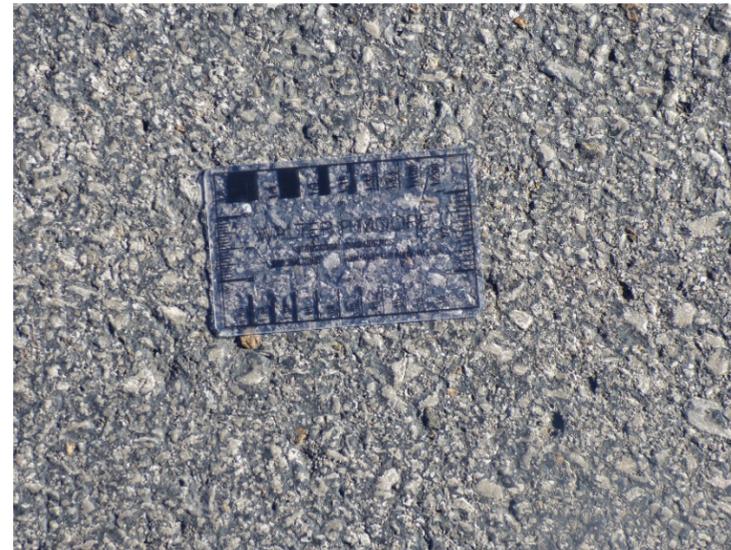
*Weathering of pavement*

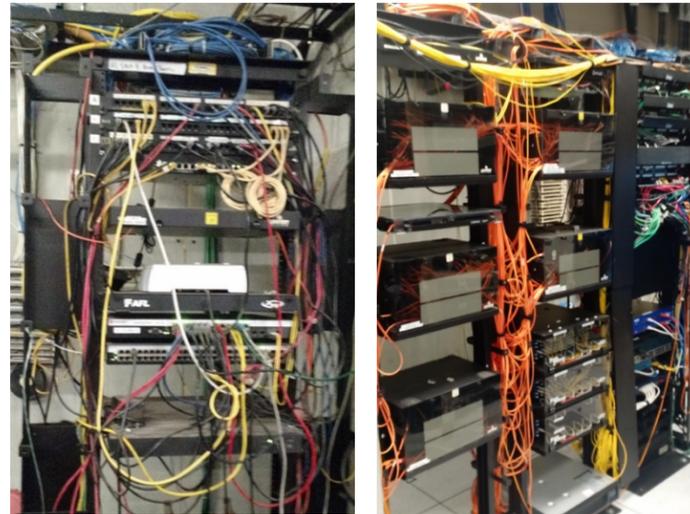
The structured cabling system infrastructure, spaces and pathways, are primarily the results of the initial construction of the stadium and are generally in accordance with current guidelines and standards: Building Industry Consulting Service International (“BICSI”), American National Standards Institute (“ANSI”) and Telecommunications Industry Association (“TIA”). To further achieve compliance with published guidelines and standards, minor housekeeping is recommended to address cable management/routing/support issues in the IDFs (intermediate distribution frame/telecom room).

*Telecom Spaces - Cabling Management*

1. To further achieve compliance with Structured Cabling System guidelines and standards, minor housekeeping effort is recommended to address cable management/routing/support issues in the IDFs and IT Main Equipment Room.

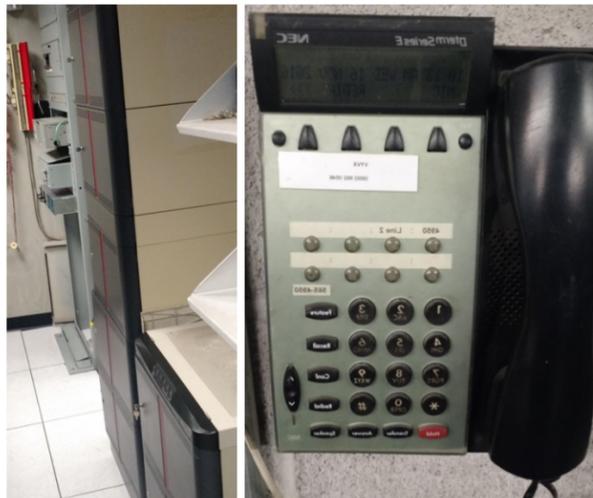
The phone system is a legacy phone PBX, NEC NEAX 2400 IMS. The manufacturer announced End of Support of the PBX as of March 31, 2014. Support and refurbished parts availability is becoming more difficult to obtain. We recommend upgrading the PBX within the next 1-2 years to an enterprise Voice-over-IP (VoIP) PBX solution.

Legacy Phone System

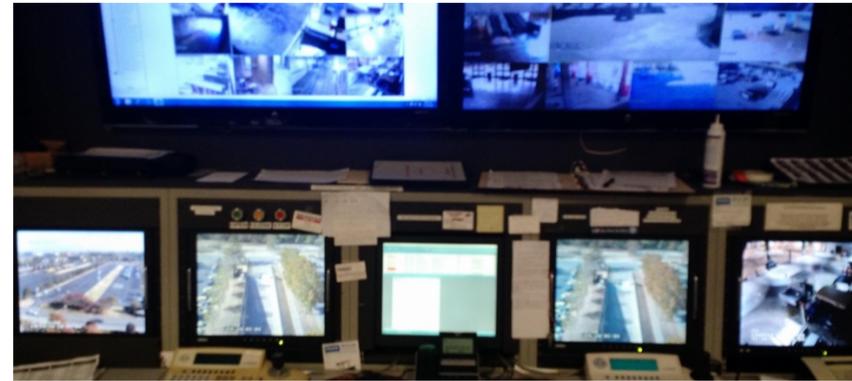
The security technology in the control room includes some upgraded components, and many outdated components. It is recommended that the viewing monitors be upgraded when the video management system (VMS) is upgraded.

*Security Control Room*

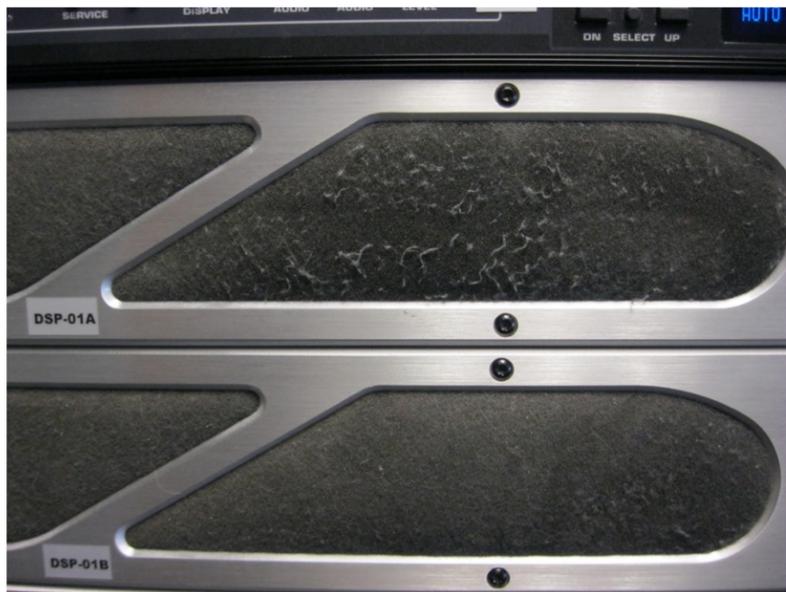
General cleaning of amplifier and processor air intake filters is recommended as many are loaded with dust. This is a time consuming task, but easily accomplished.

Dirty processor filters

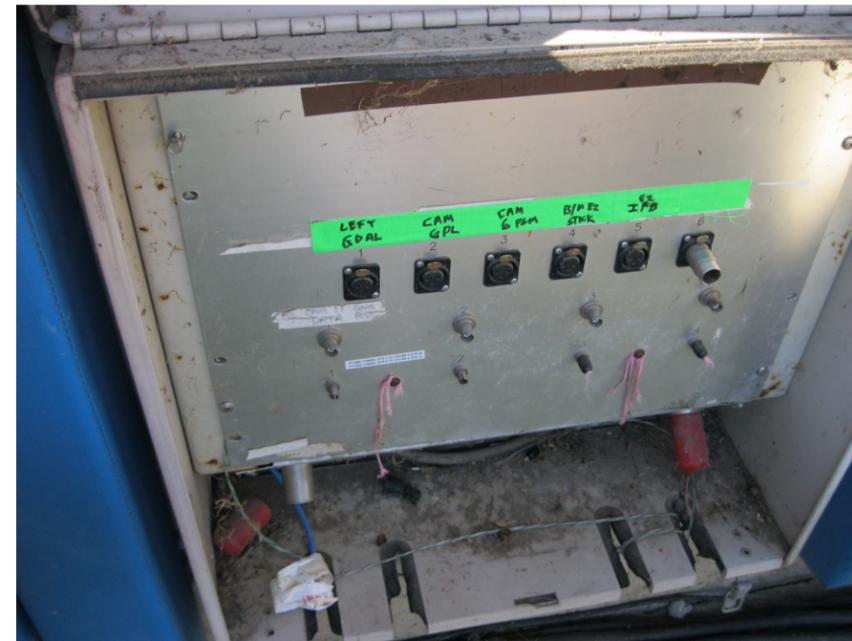
Field Audio Cabling and Panels – The audio cabling routed to the field wall is original to the building except for the portion damaged in the 2010 flooding. The original design as well as common practice is to route this cabling from origin to destination without splices. The flood remediation work installed splice points in the field cabling which eventually will lead to service issues due to corrosion or failing contacts. The connectors at the field wall panels show considerable corrosion and should be replaced. It would also be prudent to replace and upgrade the field wall enclosures to stainless steel when any cabling and panel repairs are made.

Field wall panel example

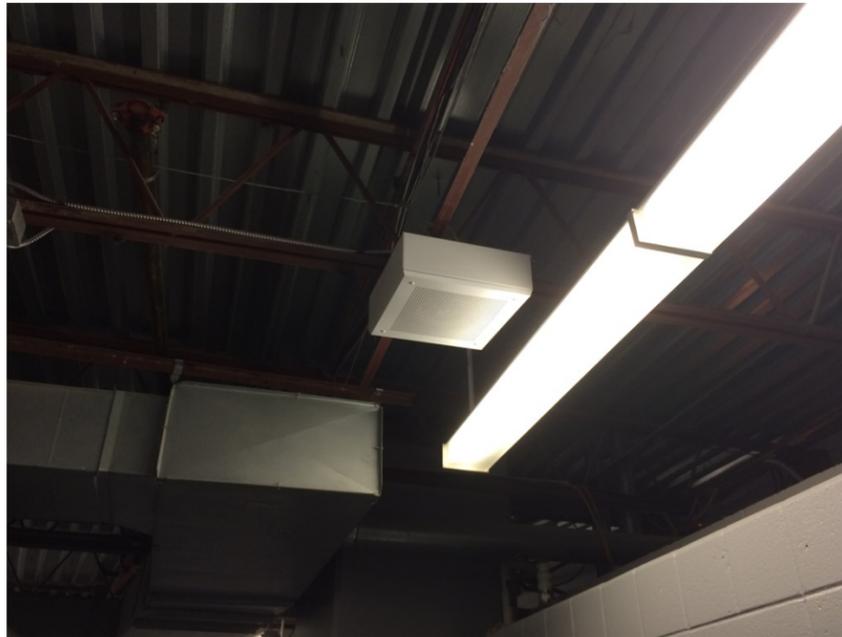
There are two restroom zones on the upper concourse level and in the North end zone of the main concourse where the speakers are not operating properly and need to be serviced as soon as possible. This is likely a wiring issue caused by construction work conducted over the years and not associated with the sound system.

*Typical Restroom Speaker*

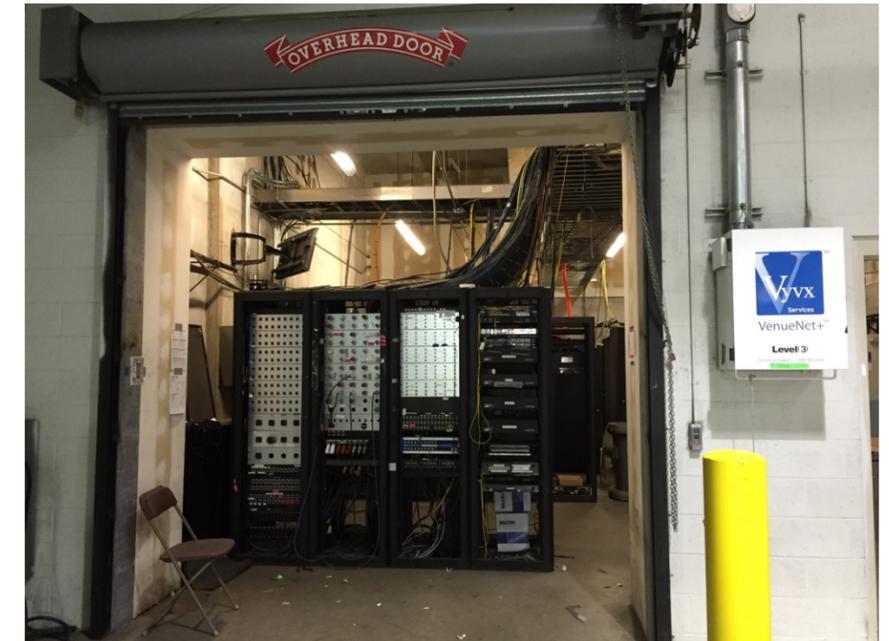
The broadcast cabling system is provided for national and regional TV broadcasters to connect their production trucks to the building and gain access via cabled locations around the facility. This system is largely original to the construction of the stadium and needs service.

TV Truck Connection Area

The overall system is in poor condition, thus causing the facility to be inadequate for today's NFL broadcasting requirements. Many of the issues have to do with the following:

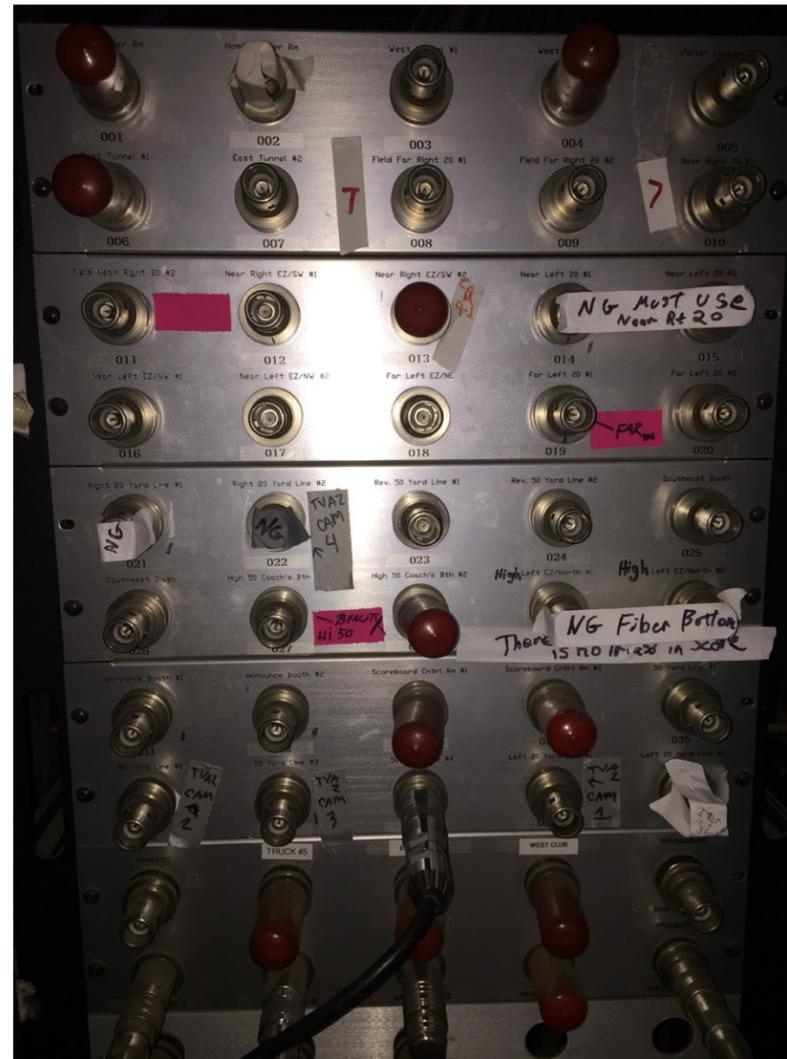
- At the TV truck connection, there are 50 triax camera connectors of which eight were observed to be labelled as unusable.
- Corrosion was observed on most the panel mounted connections at the field wall.

TV Truck Connection Triax Panel

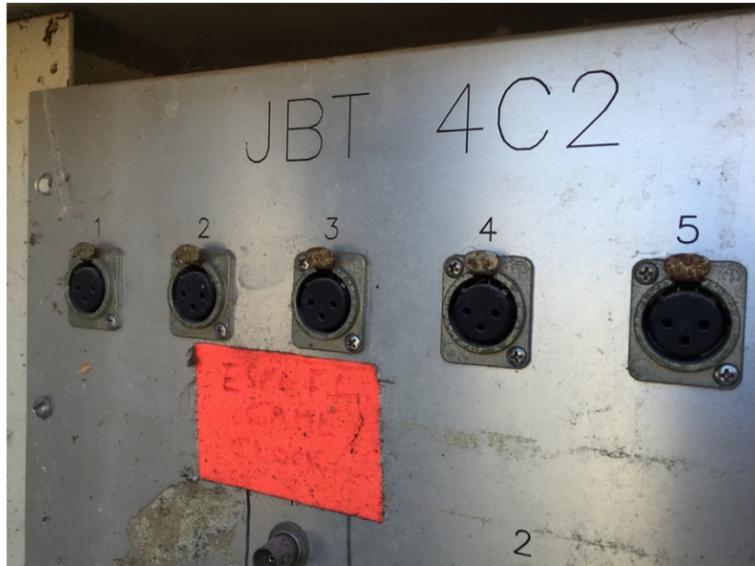
Close Up of Corroded XLR Connectors (Typical of Most)

1. Replace entire broadcast cabling plant to meet current TV broadcast requirements.
2. With the facility being short on broadcast fiber optic cabling, it is recommended that single-mode fiber optic cable gets added to meet current TV broadcast requirements. This fiber cabling could be installed separately, although it would be most practical to install fiber while replacing other damaged cabling.
3. Since the overall broadcast cabling plant has damage to it and does not align with systems being installed currently, full replacement is recommended. At a minimum, sweep tests

should be conducted of all connection points and connectors or cabling repaired or replaced at deficient locations.

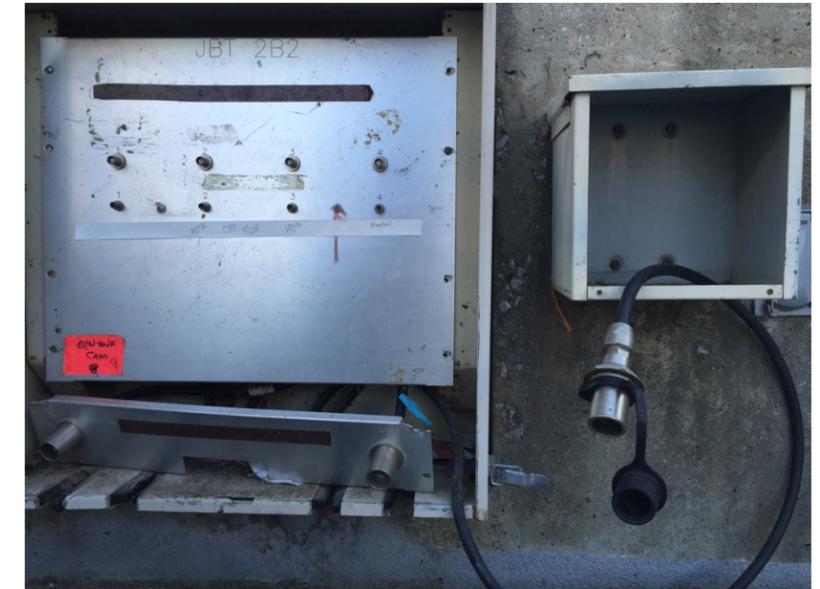
Triax with panel mount connector but not connected to panel

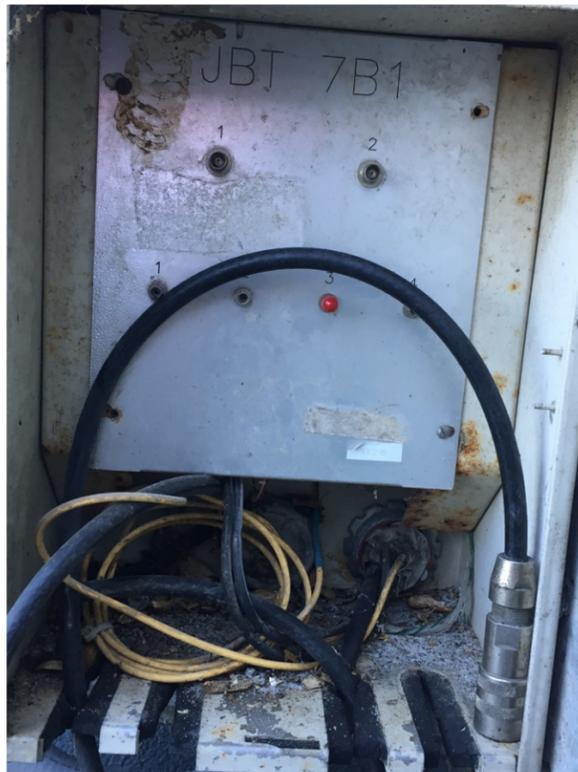
Close Up of Corroded Coax and Fiber Connectors and non-panel terminated triax.

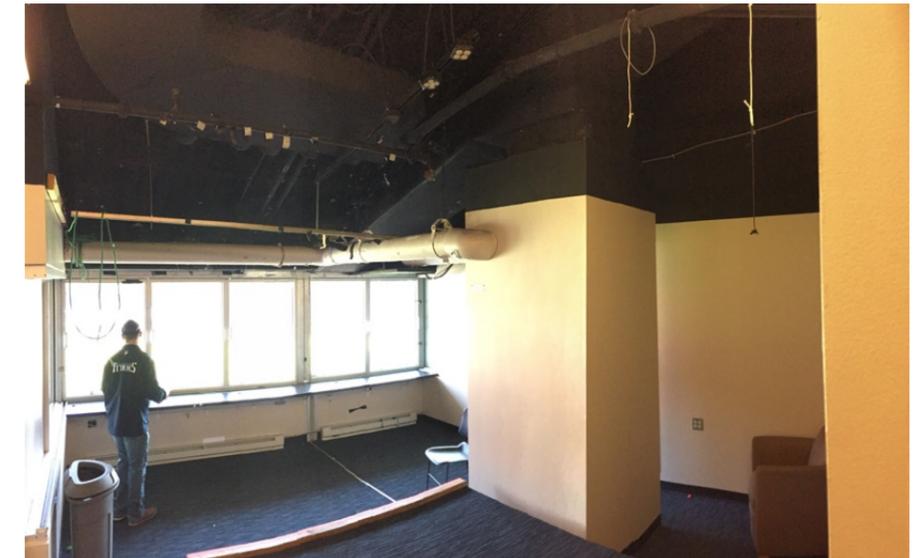
Main TV Broadcast Booth

- The Main TV Broadcast booth is deficient on the following:
    - Lack of useable lighting grid.
    - A stage/platform that is configurable. It needs to be in smaller pieces in order to fit the size of the room. Now, it is not able to breakdown at all.

- Fiber to the TV truck
    - Audio to PR/Writing Press
  - TVs are set on the counters, taking away counter space from the talent. Most facilities have these mounted to the ceiling corners.

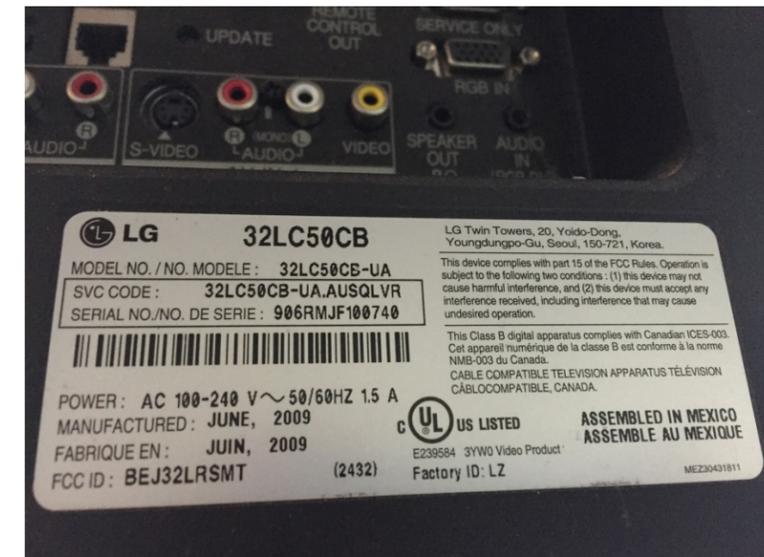
Older Model LG Television

The televisions are manufactured by LG and NEC and varies in deployment dates from 2009 and 2012. The units deployed in 2009 are quickly reaching their end-of-life. and frequent failures can be expected.

2. Television replacement is typically served by a repair or replace as needed on an occurrence basis. The televisions past the typical 8-year life span should be considered for replacement.

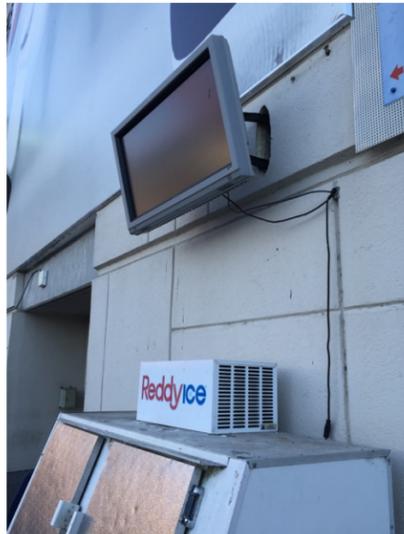
Exterior Sunbrite Television

Sunbrite televisions have been deployed in exposed outdoor locations. These televisions are out of warranty and will be difficult to support.

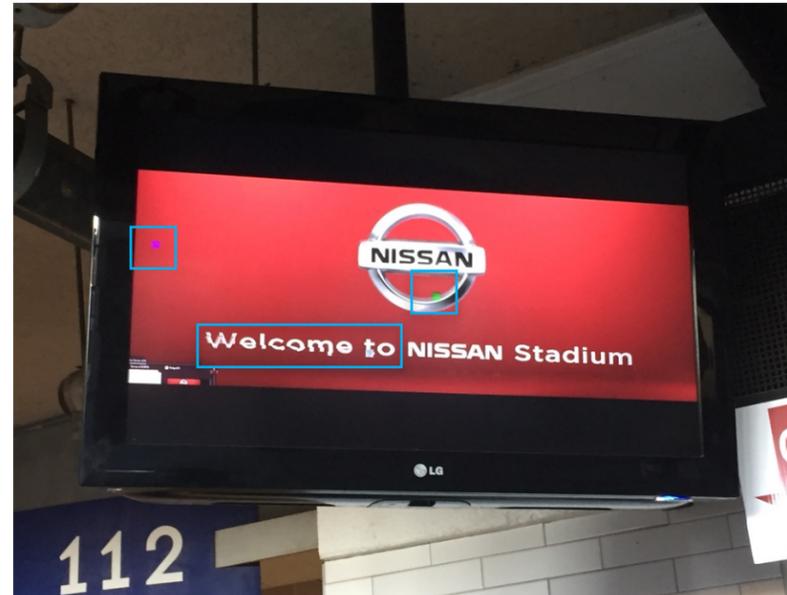
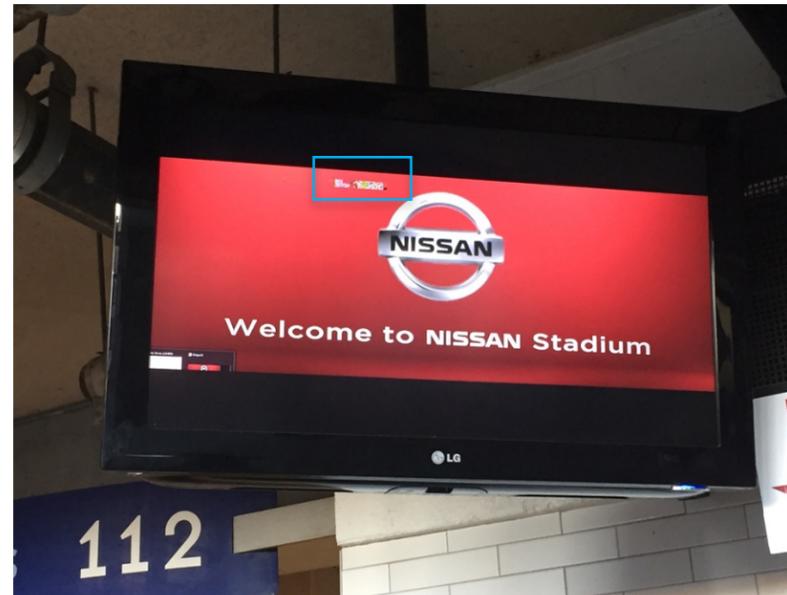
Certain TV locations are experiencing artifacts in some of the content. We believe this is a product that the distance limitations of the coaxial based trunk and tap system have.

Example of TV Location with Artifacts

Example of Same TV Location with Different Artifacts

3. To extend the life of the system, it is recommended that the system cabling and connectivity be sweep tested and measured to make sure signals are operating within industry parameters.

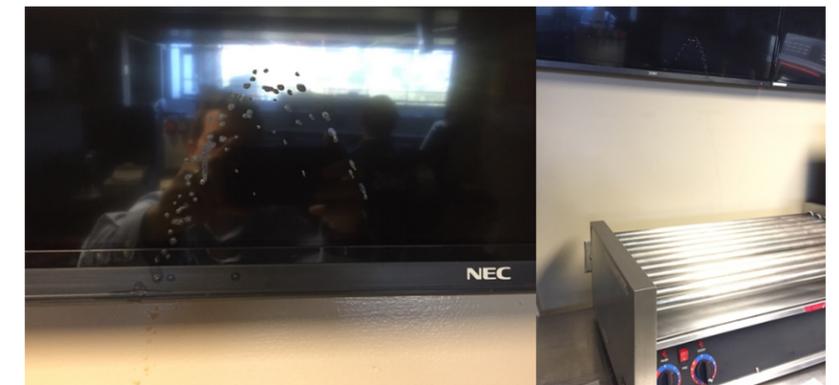
The location of some of the concession televisions can cause damage due to the food prep equipment as shown in the photo below.

Concession Location with TV Damage from oil splatter

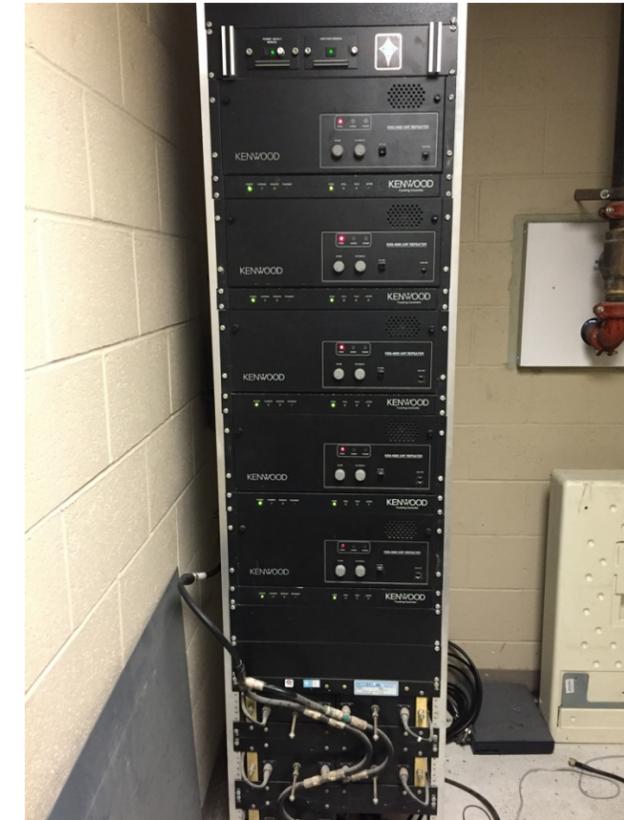
At 20 years, the system is quite out of date and lacking the features required in a modern system. Parts are also unavailable. Some of the features of new systems:

*Repeater System in Room 7.56.03*

1. Due to age, the radio repeater system should be planned for replacement.

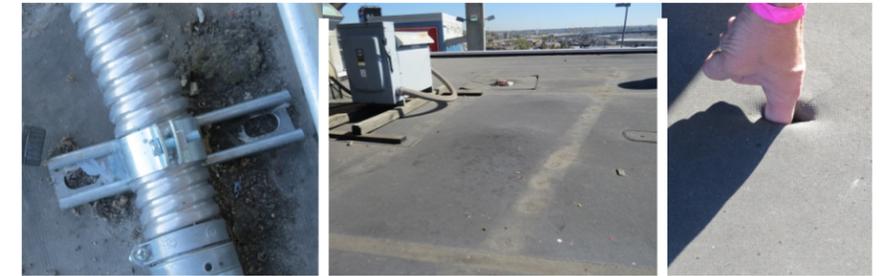
During our inspection, we noted a hole of approximately 1½ inches in diameter through the EPDM roof membrane. The puncture appears to have been caused either by falling debris or possibly by workmen on the roof. The puncture is wide open to moisture infiltration/damage.

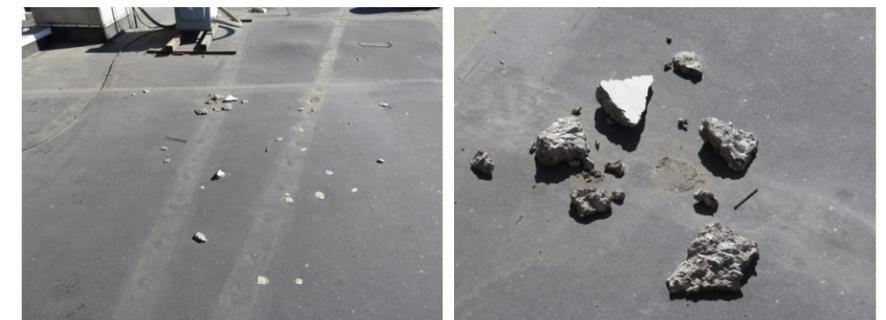
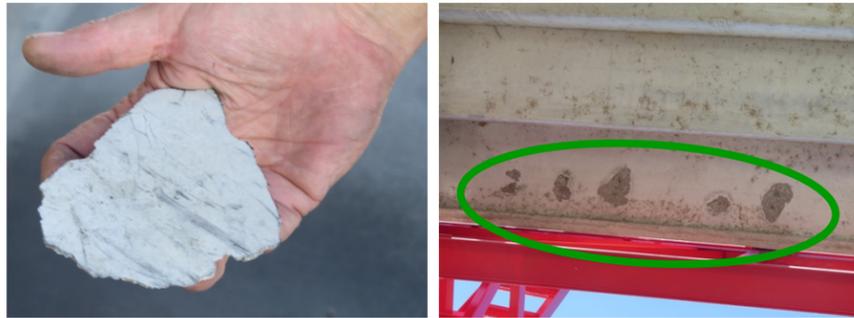
Fragments of concrete were found lying on the roof surface in many areas (photos above and at top left of next column), having spalled and fallen onto the roof from the underside of precast concrete sections of the upper seating bowl (photo at top right of next column). In some areas, the concrete fragments may have fallen up to 40 feet directly onto the thin, vulnerable EPDM roof membrane. The jagged/sharp-edged concrete fragments may damage/puncture the roof membrane, causing leakage/moisture damage. This condition was noted in several areas around the stadium beneath the upper seating bowl.

During our inspection, we also noted several areas where fragments of concrete, from the precast seating bowl structures above the roofs, are spalled and falling directly onto the unprotected roof membrane, potentially damaging/puncturing the roof membrane. We noted more than 25 such fragments of spalled/ fallen concrete throughout the facility.

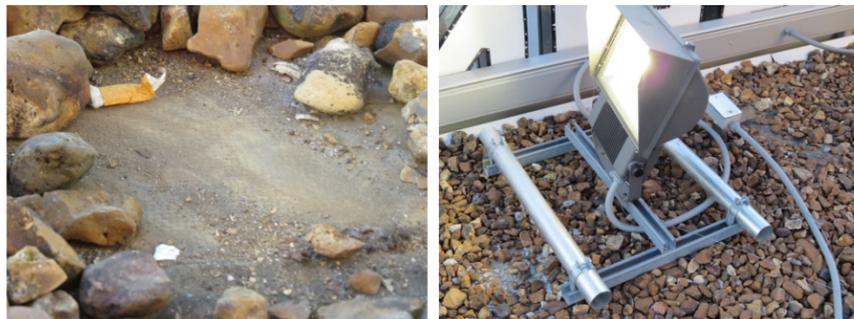
Several roof areas utilize EPDM single-ply membrane roof covering systems on which the roof membrane and underlying roof insulation are loose-laid atop the metal roof deck and ballasted with washed river stone (above). On only a couple of these areas, a ply of polyester filter fabric is installed atop the EPDM roof membrane beneath the stone ballast (above left). The fabric helps protect the roof membrane from damage/abrasion by the stone ballast and fines in the stone. In several places, equipment is installed directly atop the stone ballast (above right); additional weight atop the stone may cause damage to the underlying EPDM roof membrane.

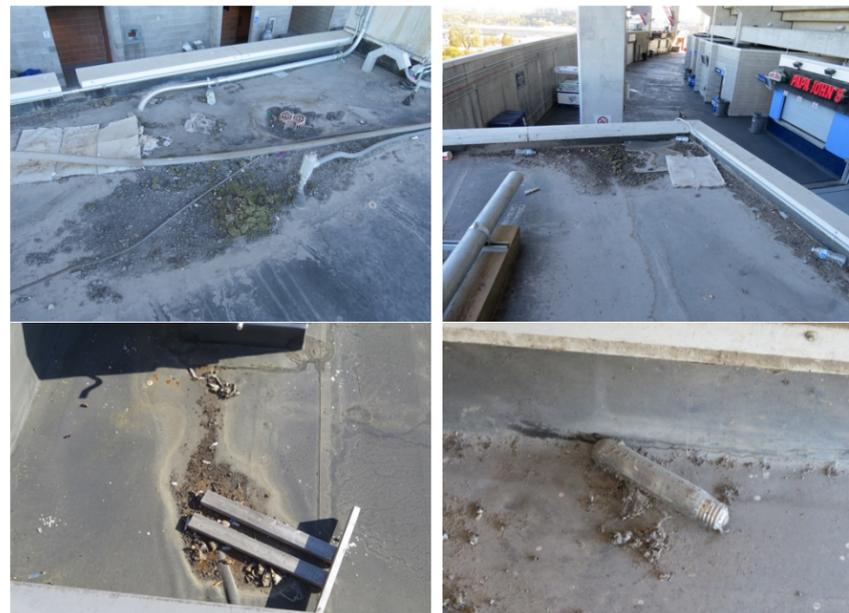
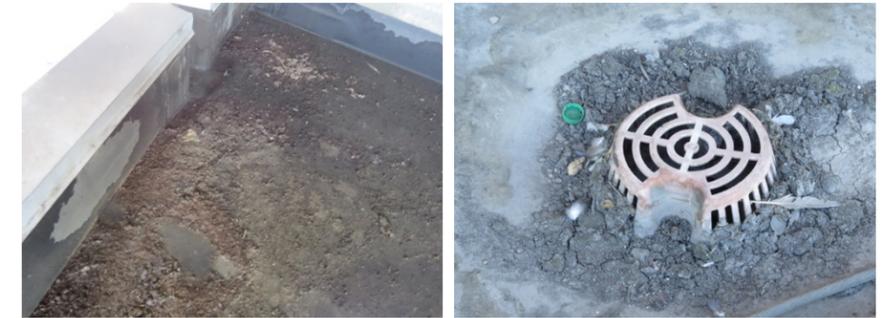
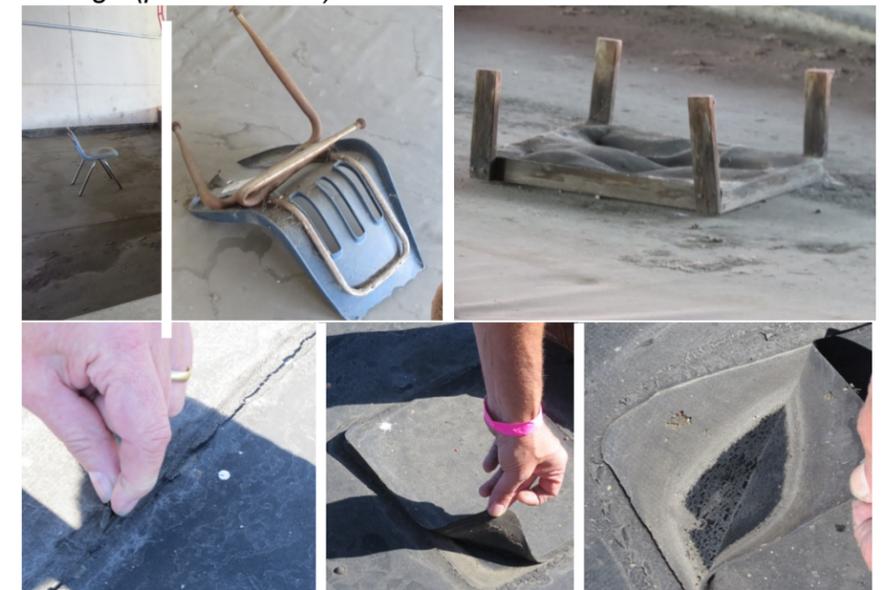
There are numerous areas with excess accumulated dirt/debris on the roof surfaces. Debris on the roofs, if stepped upon, may potentially damage/puncture the thin EPDM roof membrane, causing leakage and moisture damage. We noted at least one instance of a chair with thin metal legs sitting directly on the EPDM roof membrane, and the chair legs may easily puncture the membrane if a heavy person sits on the chair as it is.

Loose dirt/debris was also noted in the drainage elements in several areas; dirt/silt/debris can potentially clog drainage elements and/or storm drainage plumbing, and may result in retention of water on the roofs. It generally appears as if the roofs have not been thoroughly cleaned for at least several years.

Debris is accumulated on roof surfaces in many areas throughout the facility. Debris on the roofs may cause damage to the EPDM roof membrane (particularly if sharp-edged debris or broken glass is stepped upon), and dirt/silt/debris may clog roof drains and/or storm drainage plumbing (photos above). Pieces of broken furniture on the roofs can also cause cuts, punctures, or other damage to the roof membrane, causing leakage (photos below).

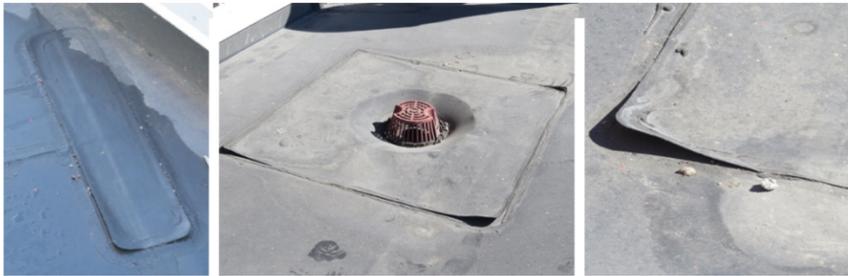
Lap seams in the roofing/flushing membrane are failing, delaminating, and non-watertight in many places throughout the facility. This condition was more common in areas with more exposure to the elements. It appears that adhesives utilized in the seams are badly deteriorated, and many patches and sections of flashing membrane are delaminating, particularly at outside corners in the membrane.

**Membrane Seam Failure:** Throughout the facility, many lap seams in the roofing/flashing membrane are failing, and more frequently on roof areas with direct exposure to the elements. Dozens of lap seams are delaminated, particularly at outside corners of patches/flashing membrane; many corners are upturned, allowing moisture infiltration into the seam. Moisture enters beneath open membrane seams and freezes/expands, further delaminating the seam until, eventually, the seam will leak.
