# Facility Condition Assessment

April 3, 2017

## Nissan Stadium

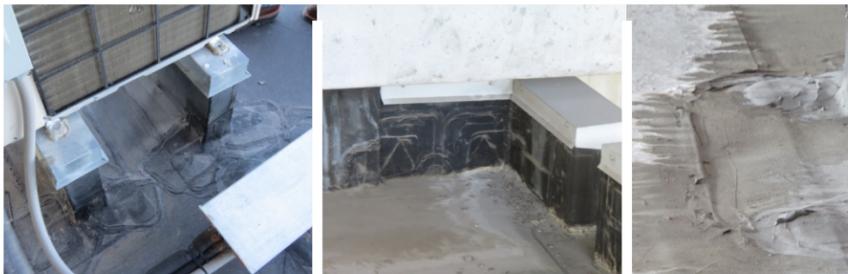
The existing EPDM-covered roof covering systems appear to have been repaired in very few locations. Most of the repairs appear to have been properly installed and tied-into the existing EPDM roofing/flashing membrane (above left and center); however, one poorly installed patch that was noted does not appear to be properly tied-into the existing membrane system, and is dependent upon sealant for water tightness (above right). The sealant utilized around the repair/patch is poorly installed.

**Membrane Repairs:** There are very few visible repairs/patches on the existing EPDM membrane throughout the facility. Generally, the membrane patches/repairs that we noted appear to be properly installed, functional, and watertight; however, we saw one patch that was poorly installed, and is dependent upon sealant for watertightness.

It should be noted, as mentioned above, there are numerous failing seams in the existing EPDM roofing/flashing membrane throughout the EPDM-covered roofs, most of which could be patched/repaired to restore the roof covering system to a watertight condition and help prolong the service life of the roof covering system. It generally appears that the roofs and drainage elements have not been cleaned in recent years, and roof repair work has generally been aimed at finding and repairing known leaks that cause visible interior moisture damage.

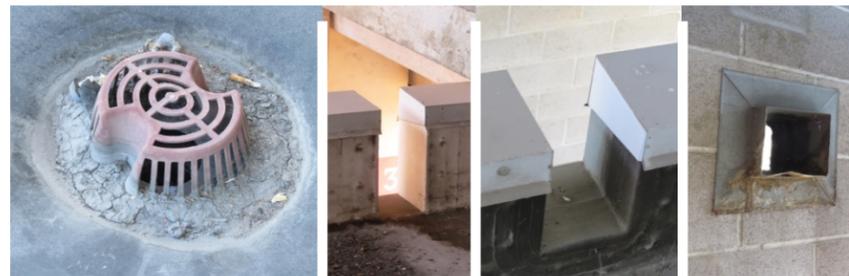
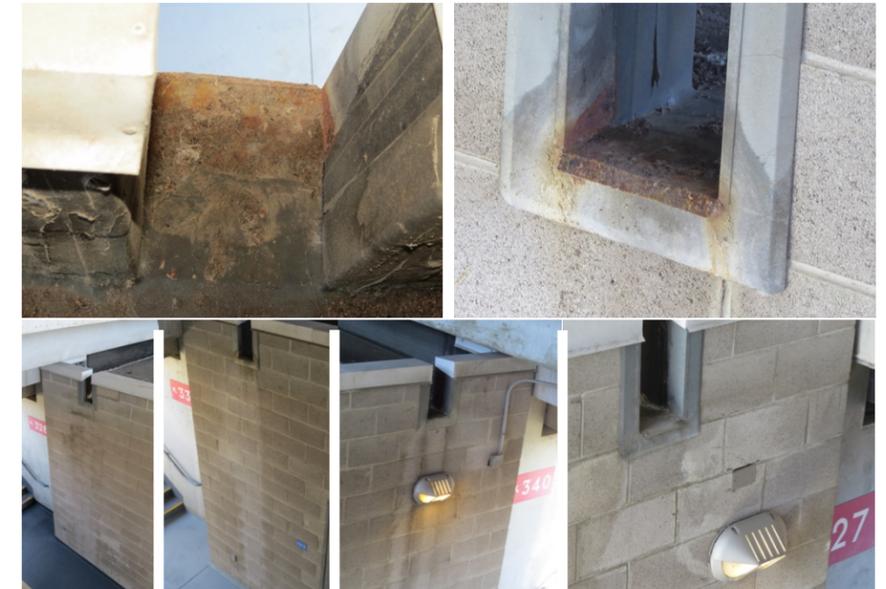
Water is removed from most low-slope roof areas via interior roof drains (above left) or open-cut through-wall scuppers (2<sup>nd</sup> photo above). Many areas also utilize open-cut overflow scuppers (3<sup>rd</sup> photo above) functioning as “secondary” (overflow) drainage elements. The interior roof drains are connected to the storm drainage system, but most scuppers allow water to simply cascade down the exterior face of CMU walls (photos below). As a result, there are moisture stains on the CMU walls beneath many through-wall scuppers (photos far below). A few metal scupper liners are badly rusted (photos above right and immediately below); leakage/damage may occur if a scupper liner were to become rusted completely through. Many scupper openings are poorly located, being placed nearly or directly above wall-mounted electrical boxes and/or light fixtures (3<sup>rd</sup> and 4<sup>th</sup> photos far below). Water effluent from the scuppers could damage the electrical system and/or cause electrical hazards.

**Drainage Elements:** Roof drainage on this facility is rather simplistic; some roof areas utilize interior roof drains that are connected to the storm drainage system. The roof drains appear to be in fair condition; however, a few roof drains are badly clogged with silt/debris, mostly due to the lack of periodic cleaning/maintenance of the roofs and drainage elements. Clogged drainage elements can cause water retention on the roofs, often resulting in shortened service life.

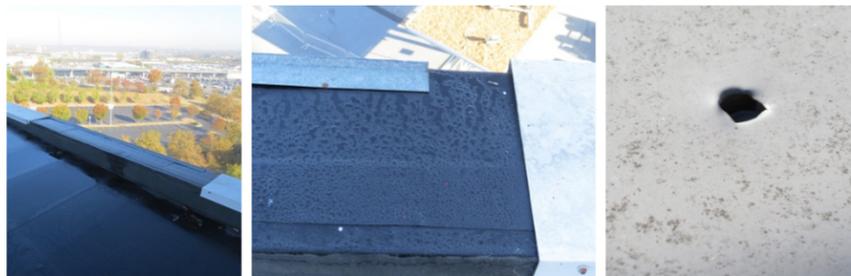
**Perimeter Flashing Conditions:** Most of the roof perimeters utilize elevated parapets with sheet metal copings. The metal copings are generally intact, but one missing section was noted. Some joints in the metal copings do not appear to be watertight; however, the missing section of coping showed that the EPDM membrane flashings are extended up and across the top of the parapet. One instance was noted of a hole punched through the metal coping and underlying membrane flashing.

*A section of metal coping is missing from the parapet (above left and center); it should be noted that the EPDM flashing membrane is (properly) extended atop the parapet, helping to protect the parapet structure from moisture infiltration. A joint between two sections of metal edge flashings is poorly flashed*

*with membrane and does not appear to be watertight (photo immediately below left). Expansion joints that intersect roofs are flashed with pre-manufactured EPDM/metal expansion joint flashings (photo immediately below right). Junctions between parapets and vertical walls/columns are flashed with EPDM membrane that is extended above the metal coping and terminated with a metal termination bar. The existing sealant along some junctions between parapets and walls/columns is deteriorated and does not appear to be watertight (photos at bottom).*

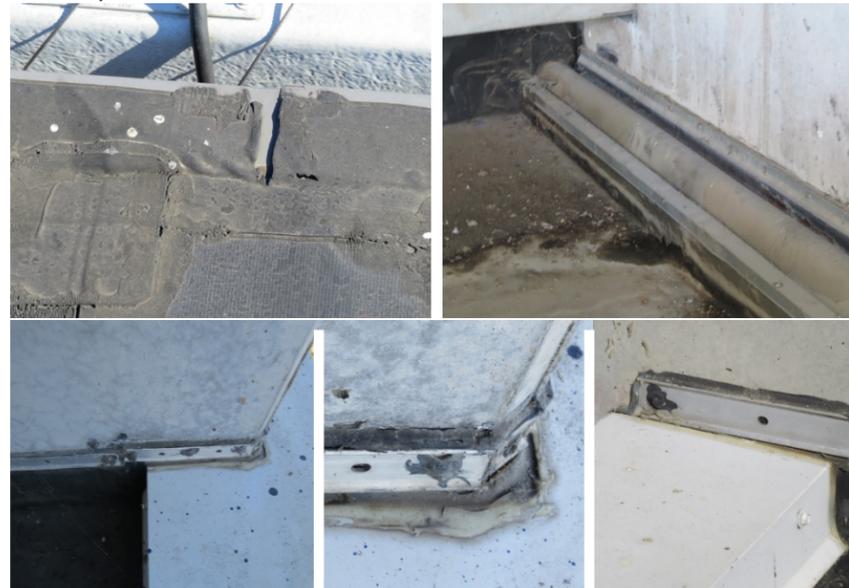
A few junctions between metal copings and concrete walls or columns are dependent upon caulk/sealant for water tightness. The sealant joints along some junctions are cracked/deteriorated, and do not appear to be watertight.

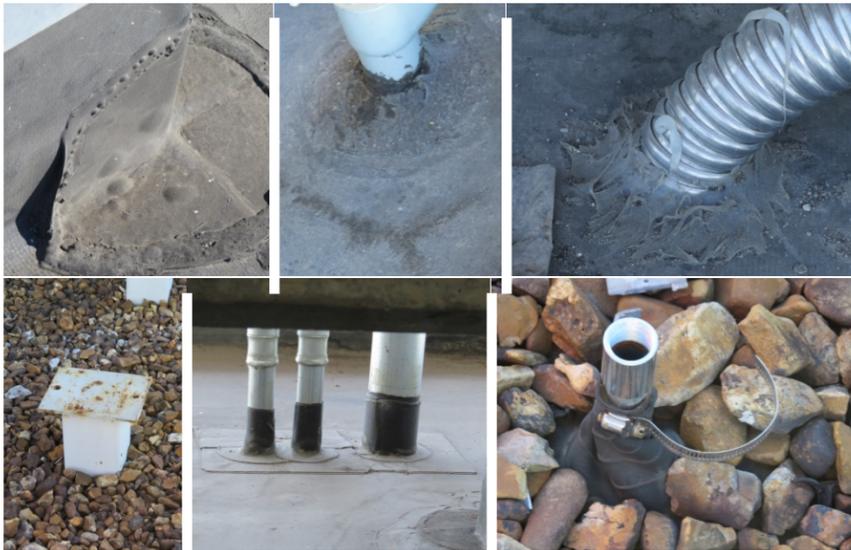
*Flashings for numerous small roof penetrations (pipes, vent stacks, conduits, equipment supports, etc.) are in very poor/failing condition, and many are non-watertight. Some small roof penetrations are flashed with pre-manufactured EPDM flashing boots, while others are flashed with a “field-wrap” of EPDM sheet membrane. Adhesives, utilized to adhere the membrane flashings to the EPDM roof membrane, are failing, rendering many membrane flashings non-watertight.*

**Roof Penetrations/Flashings:** Most small items penetrating the roof (vent stacks, pipes, conduits, etc.) are flashed with pre-manufactured EPDM flashing boots that are adhered to the EPDM roof membrane with adhesive. The adhesive utilized to secure many such flashing boots is failing, and many of the EPDM flashing boots are detached and non-watertight. It appears that none of the EPDM flashing boots have ever been repaired or replaced since original construction.

Several penetrations for pipes/conduits appear to have been installed more recently. Some of the penetrations are flashed with a “field-wrap” of EPDM membrane (which is an acceptable method of flashing penetrations); however, the flashing membrane lacks proper termination along the top edge (such as elastomeric sealant). One roof penetration for a new non-watertight flexible electrical conduit is simply caulked with silicone sealant; this type of detail does not meet minimum industry standards, and is not watertight.

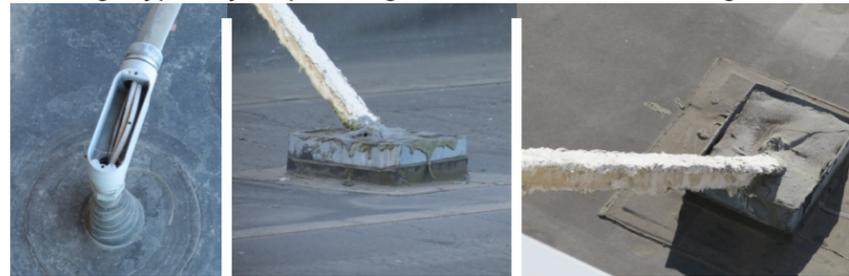
EPDM membrane patches, generally applied over corners of roofing/flashing membrane, are delaminated in many places (top left), potentially allowing moisture infiltration into the roof covering system. A few roof penetrations were noted that are not properly flashed in accordance with industry standards (top center and right). These penetrations have only a poorly-installed application of elastomeric sealant; this type of detail does not meet minimum industry standards, and these penetrations do not appear to be watertight. Several roof penetrations for steel supports, pipes, and conduits are flashed with EPDM membrane; however, the membrane on some penetrations is not properly extended up onto the penetration min. 8 inches (photo immediately above left), as compared with other pipes that appear to be properly flashed (photo immediately above center). Another roof penetration for a conduit appears to be properly flashed (photo immediately

above right); however, the unused conduit is open on top, potentially allowing moisture into the electrical system. Another conduit exiting the roof is missing a cover on the LB (angle) fitting (below left). Open pitch pocket flashings are utilized for flashing some irregularly-shaped/angled roof penetrations (below center and right). The filler material in many open pitch pocket flashings on this project is shrunken, cracked/split/deteriorated, retains water on top, and in some pitch pockets, does not appear to be watertight. Pitch pocket flashings typically require regular maintenance/refilling.

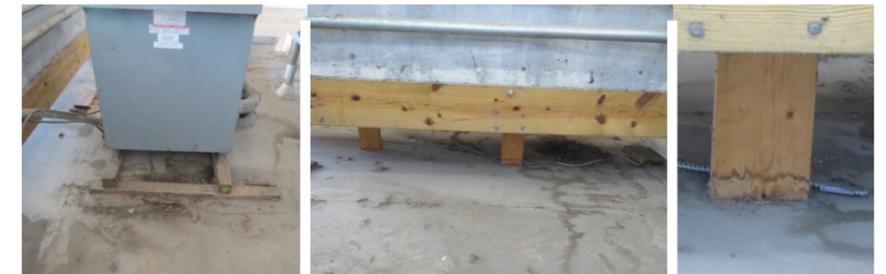
**Roof Membrane Damage:** There are several areas on the PVC/TPO-covered roofs where heavy rooftop equipment is installed atop wood sleepers that rest directly on the (unprotected) surface of the roof membrane. The weight of the heavy equipment can potentially compress the wood sleepers into the membrane and underlying insulation, causing damage to the roof membrane, and possible puncture/leakage.

Several large/heavy pieces of rooftop electrical/mechanical equipment are installed atop wood sleepers (above), and the wood sleepers (improperly) rest directly on the unprotected surface of the roof membrane. The weight of heavy equipment can potentially compress sharp edges of the wood sleepers into/through the single-ply roof membrane, causing damage/leakage. Fragments of spalled concrete have fallen from overlying seating bowl sections onto the roof membrane,

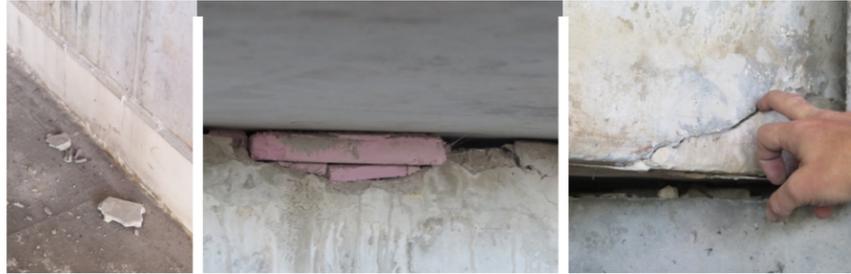
*potentially causing damage/leakage (below left). Several places were noted with spalled/cracked/missing concrete from the seating bowl structures (below center/right).*

There are several roof areas with debris, fallen fragments of concrete (spalled from the overlying precast concrete seating bowl structure), and/or deposits of grease/oil (from exhaust fans/vents from food preparation areas below) on the roof surfaces. Any of such items may potentially damage the roof membrane, and sharp-edged debris/concrete fragments may potentially cause a puncture in the roof membrane if they were to be stepped upon.

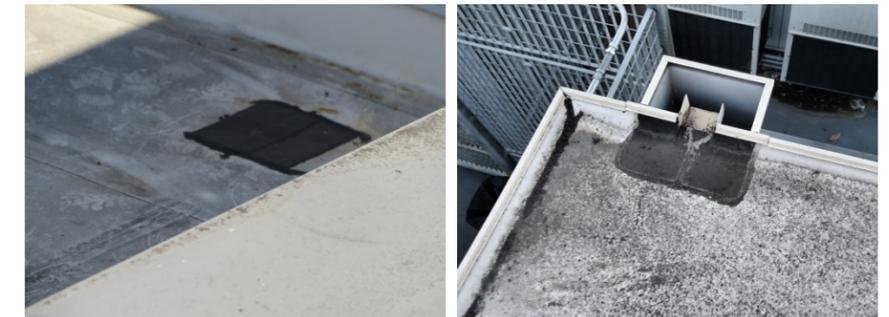
**Roofing/Flashing Membrane Repairs:** Generally, there appear to be very few areas of the PVC roofing/flashing membrane that have sustained repairs. There were, however, some roof repairs made with membrane that does not match the original PVC/TPO membrane system; several repairs are made with (what appears to be) self-adhering EPDM membrane, rather than with matching membrane that is heat-welded atop the original membrane. In our opinion, this type of repair cannot be expected to perform for the duration of the existing PVC/TPO membrane roof covering system, and may require additional repairs with time.

*Several patches/repairs to the existing PVC/TPO roof covering systems are (improperly) made utilizing black self-adhering membrane (presumably EPDM), rather than membrane that matches the existing/adjacent membrane, heat-welded to the existing roof membrane (above). A roof drain appears to have been repaired with some type of sealant (below left); however, the sealant is poorly installed and does not appear to be compatible with the roof membrane, nor does it form a reliable bond with the membrane. This repair does not appear to be watertight. A through-wall overflow scupper appears to be blocked by signage installed on the exterior wall (below right). Another through-wall scupper is damaged/non-watertight (bottom left), and may allow moisture infiltration into the masonry wall system. Metal conductor heads are utilized on some scuppers where water drains onto a lower roof area (bottom right).*

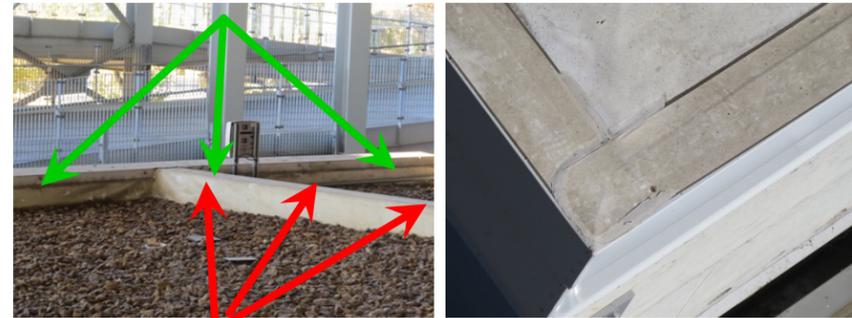
*Typical parapets are flashed with membrane and capped with metal copings (green arrows, above left); however, a few areas were noted on which parapets between roof areas are flashed only with membrane, and lack metal copings (red arrows, above left). Flush edges on the elevator tower roofs are flashed with metal edge flashings that are strip-flashed with membrane (above right). The membrane strip flashings utilize self-adhering membrane, rather than heat-welded membrane. Walls and columns are flashed with membrane, and the membrane is terminated with a metal termination bar and elastomeric sealant (below left). Expansion joints that traverse roofs are flashed with pre-manufactured EPDM/metal expansion joint flashings. Depending upon the configuration, the expansion joints are flashed with either a curb-to-curb expansion joint flashing (below center), or a curb-to-wall flashing (below right).*

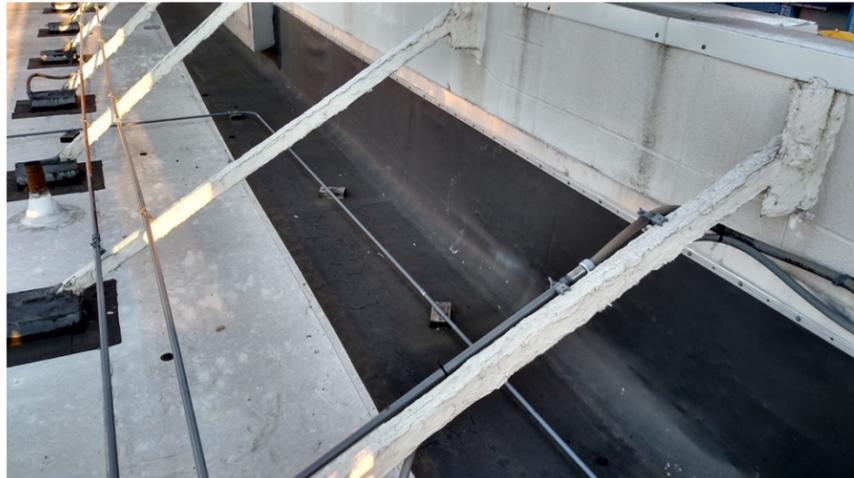
One very unusual perimeter flashing condition was noted on the two Logan’s Road House concession stands in the north and south end zones. It appears that when the stands were retrofitted/converted to Logan’s (in/around 2010), taller parapets were constructed along the storefronts of the stands, and at that time, the parapets were re-flashed with single-ply membrane. For some reason, sheets of black EPDM membrane were incorporated into the white (PVC or TPO) roof covering system. The purpose of this type of flashing detail is unknown. Combining different membrane materials into one roof covering system in this manner does not meet minimum industry standards; it would not comply with any roof covering system manufacturers’ specifications/recommendations, nor would it be acceptable for issuance of a manufacturer’s warranty for the roof covering system.

Parapets on the two end-zone Logan's Road House concession stands are (improperly) flashed utilizing black EPDM flashing membrane, rather than white membrane to match the existing roof covering system.

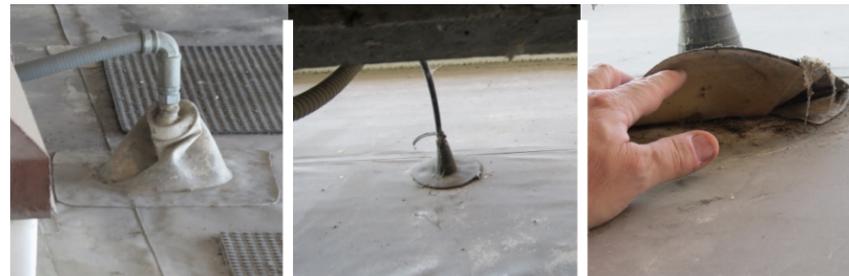
**Roof Penetrations/Flashings:** Curbs for rooftop equipment are typically flashed with PVC/TPO membrane that is heat-welded into the roof covering system. Smaller penetrations (pipes, conduits, equipment supports, etc.) are typically flashed with either a field-wrap of membrane (heat-welded to the roof membrane), or pre-manufactured roof flashing boots. During our inspection of the roofs, we noted several pre-manufactured flashing boots that are poorly installed, and at least one that is completely failing and detached from the roof membrane. Sealants on many flashing boots are poorly installed, and several do not appear to be watertight.

There are several electrical conduits that penetrate the roof and are flashed with pre-manufactured flashing boots; however, the conduits are unused, not capped, and wide open to moisture infiltration into the conduits.

We noted one instance where a flexible electrical conduit (more recently-installed) is simply inserted through a hole in the roof membrane and caulked with silicone sealant; this condition does not meet minimum industry standards, and can be expected to fail in a relatively short length of time.

Many small roof penetrations are flashed with pre-manufactured flashing boots that are (supposedly) heat-welded/sealed to the roof membrane (above); however, some flashing boots are poorly installed (above left), and one was noted as totally failing and non-watertight (above center and right). Several unused electrical conduits penetrate the roofs that are not properly capped and allow moisture infiltration (below left). A flexible electrical conduit penetrates the roof and is simply (improperly) caulked with sealant, rather than being properly flashed (below center); this roof penetration does not appear to be watertight. The filler materials in many open pitch pockets is poorly installed and shrunken, causing water retention on top (photos below right and bottom left). A steel support frame for a rooftop mechanical unit is badly rusted (bottom right) and needs to be properly cleaned/prepared/primed/painted.

A steel rooftop mechanical unit support frame is badly rusted and needs to be properly cleaned/prepared/primed/painted.

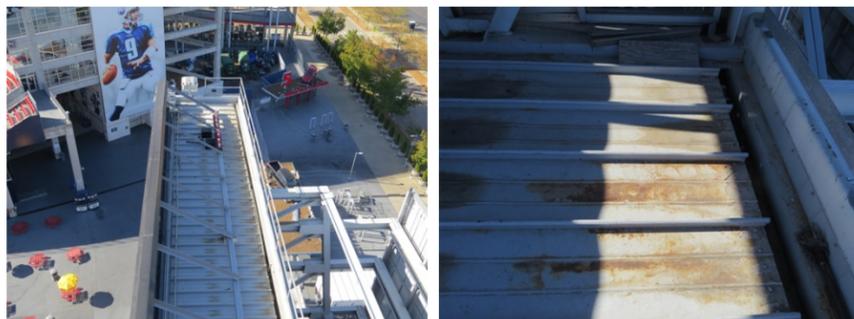
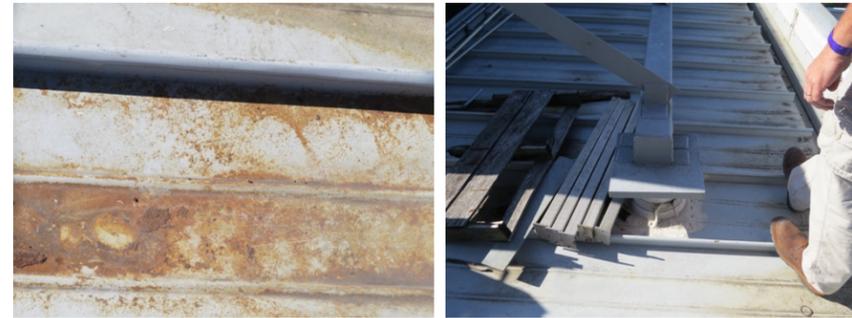
Scoreboard & Loudspeaker Enclosure Roofs: The premanufactured metal panel roof covering systems atop the scoreboards/ loudspeaker enclosures appear to have been repainted at some time since original construction; however, the paint/finish on the metal roofing is generally in poor condition, and the metal roofs are rusted in many areas. There are unused materials and debris accumulated on the roofs and gutters, potentially clogging the gutters/downspouts and/or damaging the paint/finish on the metal roof covering systems.

Many roof penetration flashings and fastener heads are covered-over with elastomeric sealant. This type of repair is temporary, at best, requiring regular maintenance/replacement.

*Roofs atop the scoreboards and loudspeaker enclosures utilize pre-manufactured pre-finished metal roofing panels that are screw-fastened to the steel roof framing. The metal roofs appear to have been repainted at some time since original construction; however, the metal panels are surface-rusted throughout, and badly rusted in some areas (photos top right and immediately above left). Abandoned/unused materials are stored on roof surfaces, and trash/debris is accumulated on the roofs in some areas (photos immediately above right and immediately below left). Gutters are also clogged with trash and debris (photos immediately below right and bottom left); clogged gutters can result in water retained on roof surfaces and potential leakage. Fastener heads and some roof flashings are coated with elastomeric sealant (photos immediately below right and at bottom). The sealant is poorly installed and cannot be expected to perform over a long period.*

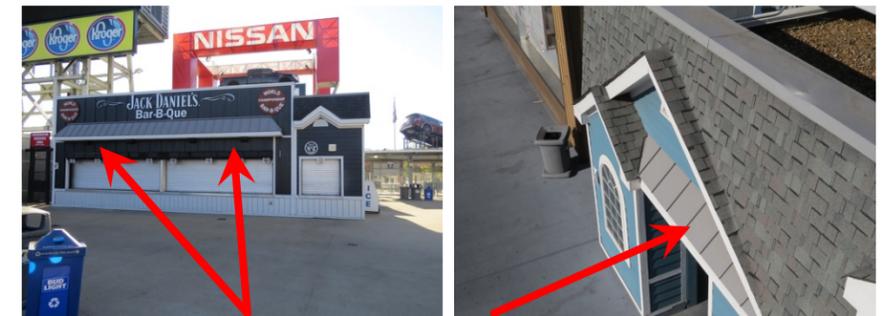
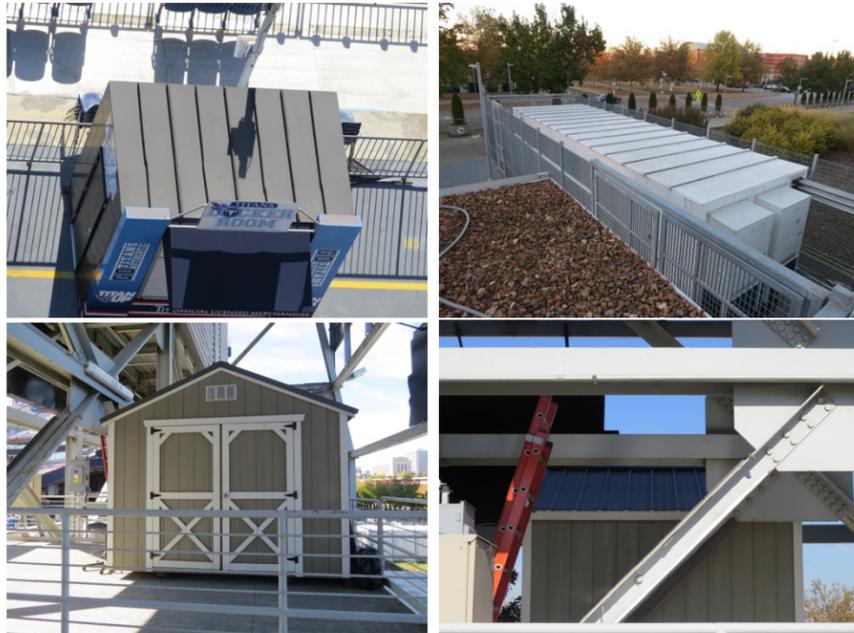
Storefront Mansard Roofs: There are several small mansard roofs on storefronts and end-zone concession stands/restroom buildings that utilize a combination of metal roofing and asphalt shingle roofing. These roofs are generally architectural in nature; however, they do function to protect the exterior building envelope from the elements. The metal roofs generally appear to be in good condition.

*Mansard roofs on end-zone concession stand storefronts utilize pre-finished standing-seam metal panels (above); the metal roofs appear to generally be in good condition. Four pre-manufactured buildings utilize pre-finished metal roof panels (below); these roofs appear to be in good condition. A pre-manufactured storage shed, placed on overhead staging (north end zone) also utilizes a pre-manufactured/pre-finished metal roof (bottom), and the shed/roof generally appears to be in good condition.*

**Pre-Manufactured Buildings/Roofs:** There are three small pre-manufactured metal buildings on-site; two buildings are utilized as retail/ novelty shops, and one appears to be utilized for telecom equipment/operations. The pre-manufactured/pre-finished metal panel roof covering systems on these buildings generally appear to be in good condition.

**Storage Shed:** A pre-manufactured storage shed is installed on an overhead stage area in the north end zone. The shed utilizes a pre-manufactured/pre-finished metal panel roof covering system. The shed appears to be relatively new, and the metal roof covering system appears to be in good condition.

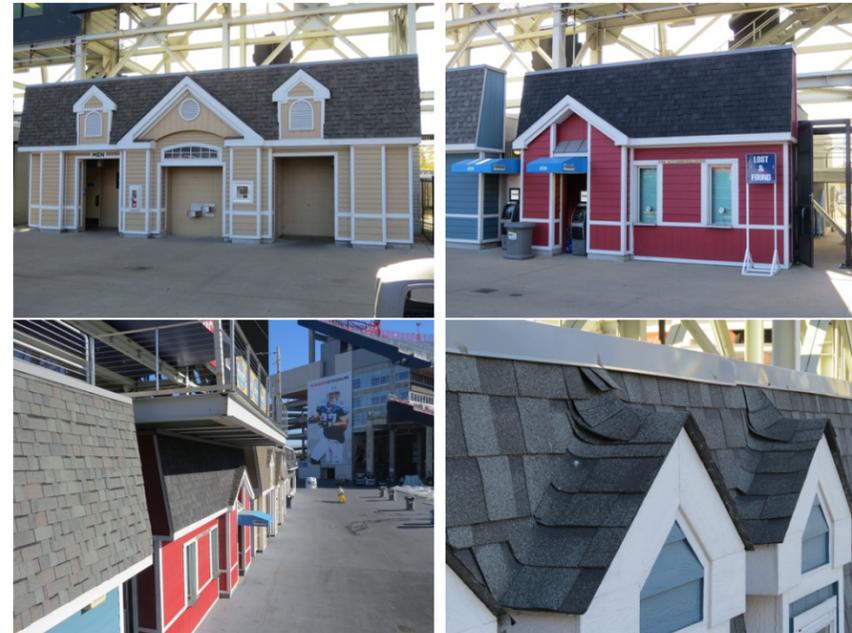
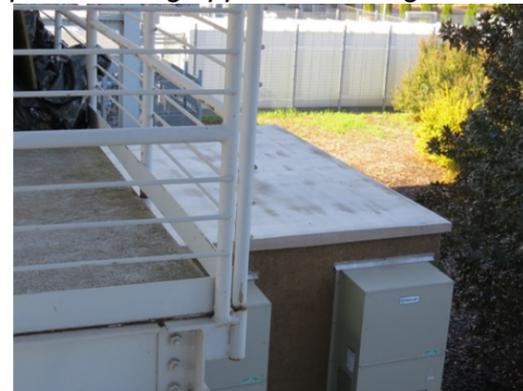
*Mansard roofs on end-zone concession stands and restroom building storefronts utilize laminated asphalt/fiberglass roofing shingles that are nailed, through a felt underlayment, to the roof deck (photos above and at top). A small pre-manufactured storage shed, near Entrance Gate 10, also utilizes a laminated asphalt/fiberglass shingle roof covering system (below left). All of the shingle roofs generally appear to be in good condition. A small radio/telecom equipment building in the north end zone utilizes precast concrete walls and roof slab (below right). The concrete roof slab is simply painted and does not utilize any other type of roof covering system. The concrete roof slab and paint/coating appear to be in good condition.*

several mansard roofs on the end-zone concession stands/restroom buildings that utilize a combination of metal roofing and asphalt shingle roofing. The asphalt shingle roof covering systems generally appear to be in good condition.

**Storage Shed:** A pre-manufactured storage shed is installed near the southeast entrance to the facility (Entrance No. 10). The shed appears to be relatively new, and the asphalt shingle roof covering system appears to be in good condition.

A small building in the north end zone appears to be utilized for radio/telecom equipment. The building, including the roof, is constructed of pre-cast concrete. The concrete slab roof is simply painted, and does not utilize any other type of roof covering system. The slab/roof appears to generally be in good condition.

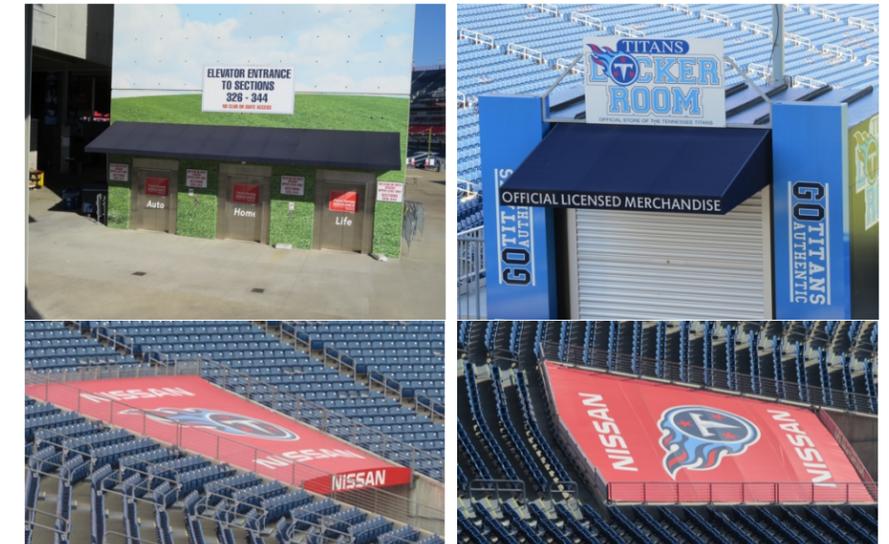
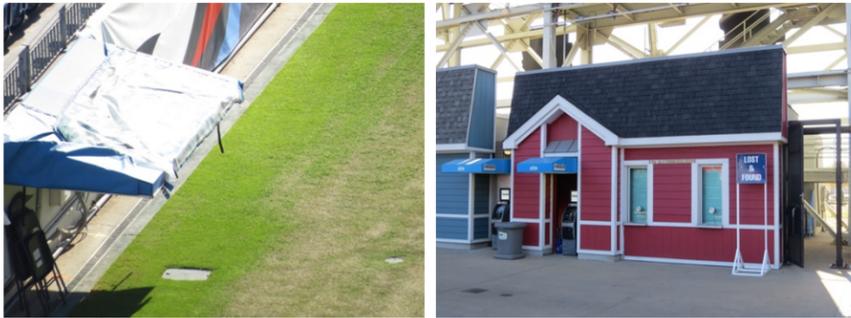
There are several small canopies above entrances, elevators, retail counters, ATM machines, etc., that utilize conventional canvas and/or plasticized canvas, which is stretched over and secured to a lightweight metal frame (photos above/below). The canvas canopies generally appear to be in fair-to-good condition.

Canvas Canopies: Most of the canopies on the facility are of this type; these canopies utilize canvas (or plasticized canvas) which is stretched over, and secured to, lightweight metal framing. These canopies vary in size and age, and they generally appear to be in fair-to-good condition. There are two small canopies on the sidelines (along field perimeters) where the canvas canopy was covered by fabric tarps, and these canopies were not visible for inspection.

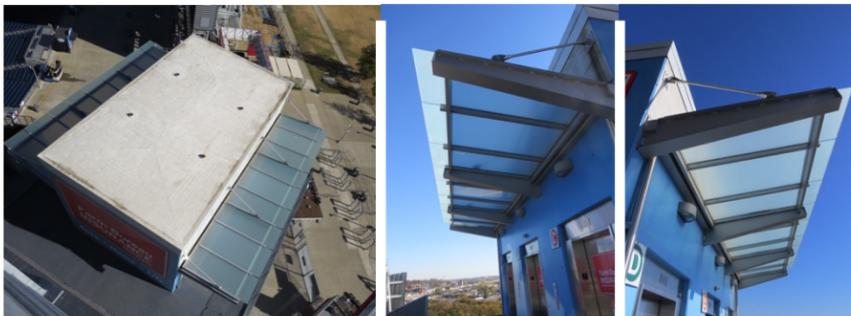
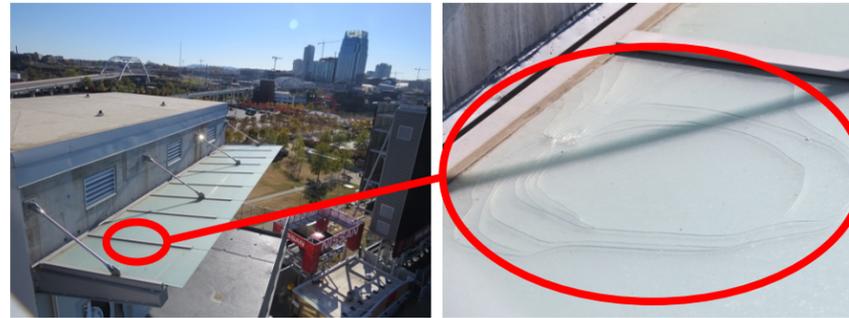
*Canopies above elevator doors, at upper concourse level (new elevator towers) utilize translucent laminated (safety) glass panels that are supported/secured by steel framing (photos above/below). One glass panel is badly cracked, and may pose a safety hazard if the panel were to collapse.*

Glass Canopies: There are 4 canopies above elevator doors at the Upper Concourse level (recently-constructed elevator towers). Each of these canopies utilizes a series of translucent, laminated glass panels that are supported/secured on steel framing. These canopies also incorporate metal built-in gutters and downspouts that discharge into the storm drainage system. These canopies appear to generally be in good condition, except that one glass panel was noted to be badly cracked; this cracked glass panel appears to pose a potential safety hazard if the panel were to collapse.

7. The existing canvas and glass canopies are generally in fair-to-good condition and can be expected to remain serviceable for at least several more years; however, it is recommended that the cracked glass panel (elevator tower canopy) be removed/replaced as soon as possible to avoid any potential safety hazard. It is recommended that the canopies be periodically inspected and cleaned to help preserve and prolong the service life of the canopies.

- h. Replace the cracked glass panel in the elevator tower canopy.

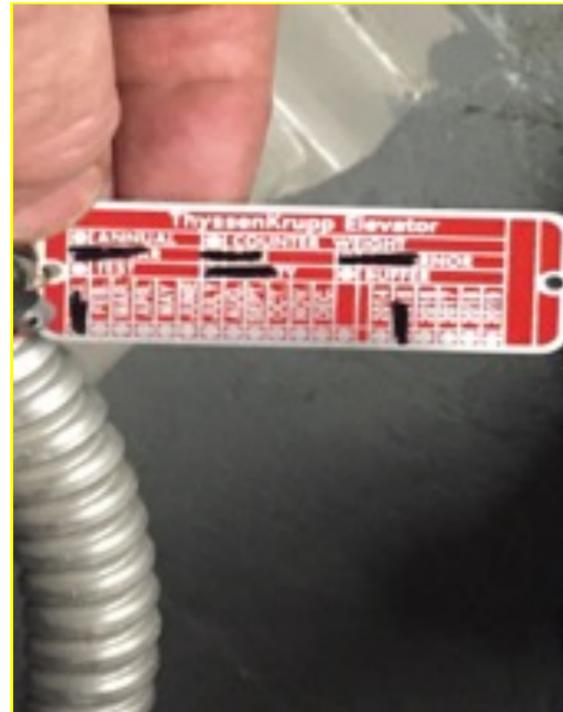
*Typical Passenger 5 Year Test Tag*

The machine room was clean and did have a spare parts cabinet available. Both elevators are up to date with required state inspections, and the required 5-year full load Category 5 tests were performed in January 2015. The Annual Category 1 Test requirement will go into effect in 2017. The governors did have identification indicating the month when the full load tests were performed. The equipment is generally very reliable although there is an obsolescence concern with the solid-state drive components, which can be resolved with an upgrade from ThyssenKrupp or Access Electronics. However, these upgrades can be costly, and since the equipment is eighteen (18) years old and near the end of its expected life-cycle of twenty to twenty-five (20-25) years, consideration should be given to a complete modernization in the near term. The DC drive hoist motors need to have the carbon dust blown out to help prolong motor life. The machine room temperature was acceptable, and gear oil levels were adequate on that date of the review. Installation of hoist rope lubricators should be considered as a part of the modernization program.

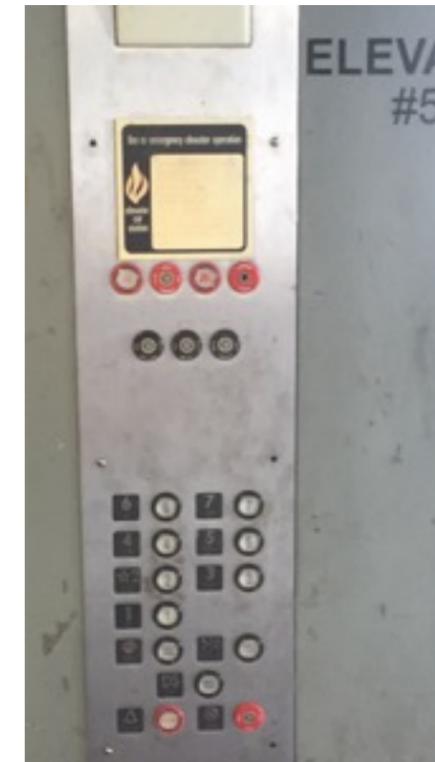
Typical Freight Car Station

All push button fixtures were standard plastic style buttons that are susceptible to vandalism. It is recommended that they be replaced with vandal resistant fixtures soon with buttons that have "Titan" logo and team colors embedded into the buttons. Currently there are TV monitors in this elevator.

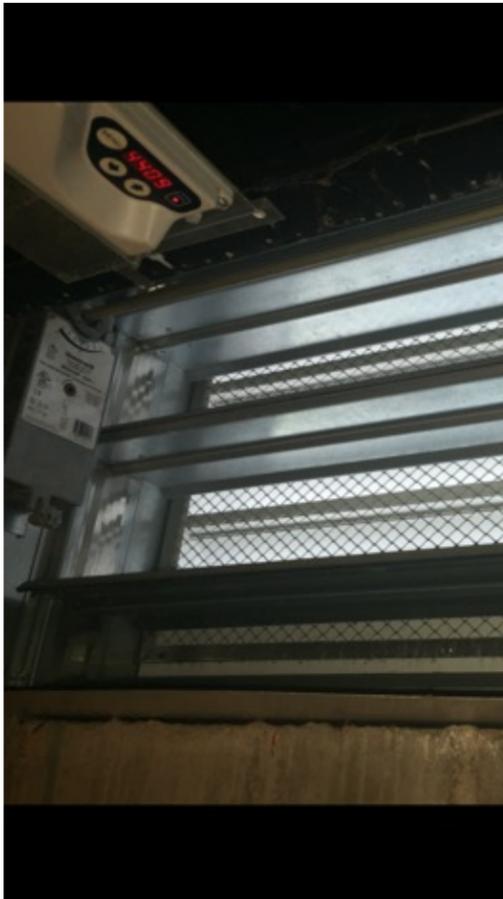
Annual Category 1 Test requirement will go into effect in 2017. The equipment is newer than the other elevators in the stadium and is operating as designed. The ride is considered rough, but the arrival to the destination is swift. The machine room temperature was acceptable upon our evaluation, but we were advised by the route mechanic that it gets very warm in the machine room during game day. It is recommended that the machine room HVAC be designed to keep the room between 60 and 85 degrees to help prolong the life of the equipment and improve reliability. All machines and overhead equipment need to be cleaned down and painted, as it is beginning to rust. The automatic louver ventilation at the top of the shaft is open on several of the units and is causing the equipment in the overhead to rust. There are very expensive components including the hoist machine in this area, and damage caused by rust and water intrusion is not typically covered by the maintenance agreement; the probability is high that these repairs will be billed back to the facility down the road. There is a toggle switch at the top of the hoistway that can activate the power louver. It is recommended that the louver be returned to power open, making the louver typically closed at all times on all three (3) units. Installation of hoist rope lubricators should be considered. The overall condition of most of the units was good. Elevator #11 was shut down upon our evaluation. Hoistway access on elevator #10 was not working.

*Typical Hoistway Louvered Vent*

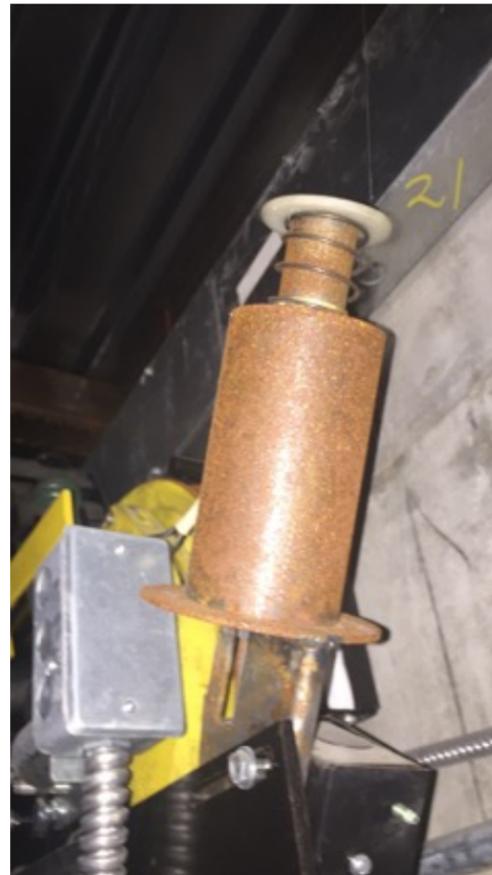
*Typical Rusted Governor Equipment Express*

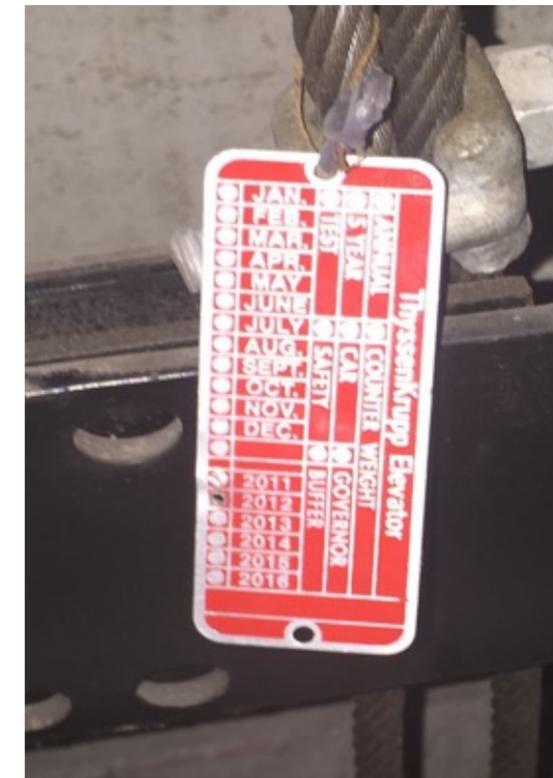
*Typical Test Tag on Express Cars*

The machine room was clean and did have a parts cabinet available. All elevators are up to date with required state inspections, and the required 5-year full load Category 5 tests were performed in 2012, although exact month is unknown. We recommend that the elevator contractor properly tag all units. Annual Category 1 Test requirement will go into effect in 2017. The equipment is newer than the other elevators in the main building and is operating as designed. The ride is considered rough, but the arrival to the destination is swift. The machine room temperature was acceptable upon our evaluation, but we were advised by the route mechanic that it gets very warm in the machine room during game day. It is recommended that the machine room HVAC be designed to keep the room between 60

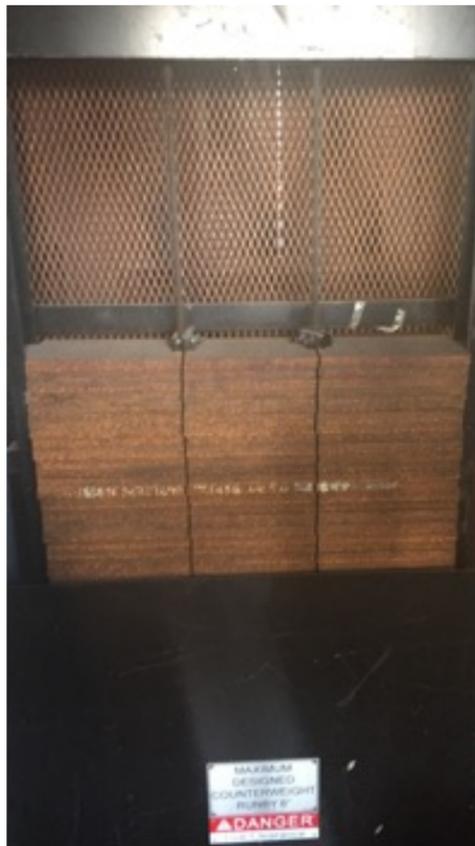
All unit car tops are clean and free of debris. It is suggested that all car top equipment be painted soon to help prevent rust and prolong equipment life. All door operator belts appeared to be in good condition and operating smoothly. ThyssenKrupp 08- LD Linear door operators are in use. All elevator equipment in the overhead needs to be painted with rust inhibiting paint.

*Typical Rusted Counterweights on Express Cars*

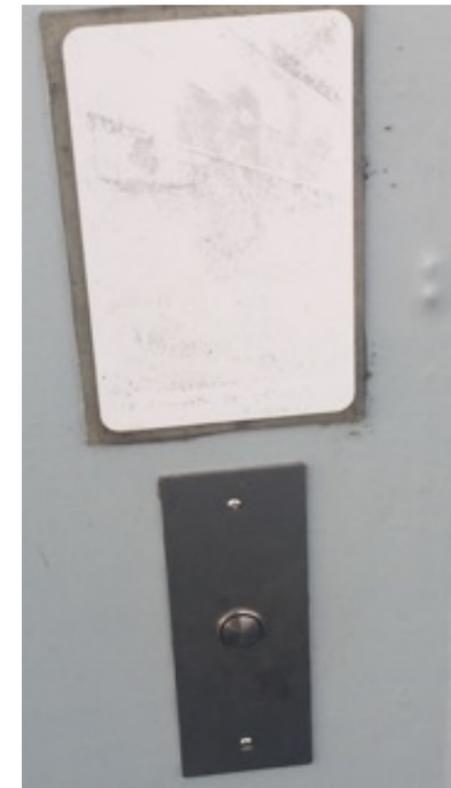
*Sun Damaged Signage*

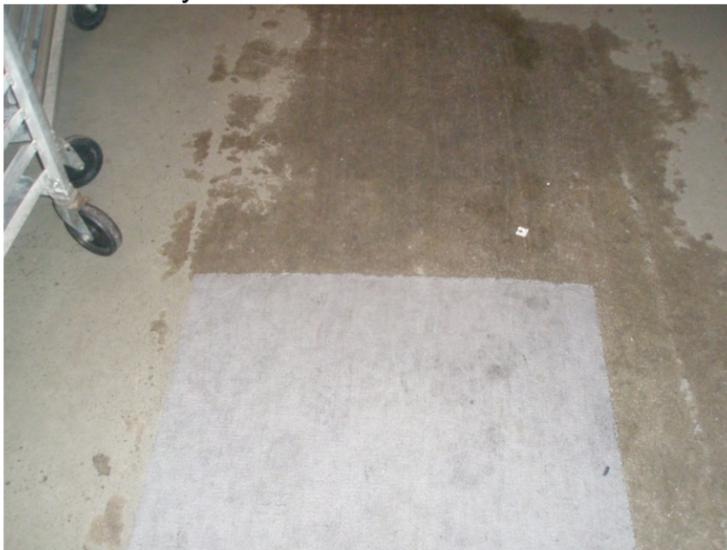
In addition, the kitchen floor covering has various patches and should be fully resurfaced.

*Damaged floor surface*

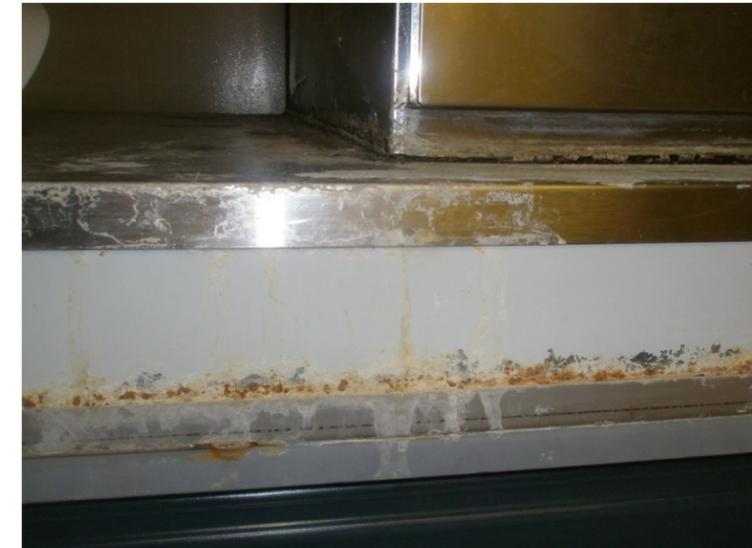
Aramark indicated that all the Manitowoc black ice makers were new in 2014; however, we observed numerous instances where along with the old machines, these new machines were already corroding from mineral build-up along the seal between the ice maker and the ice bin below.

*Mineral Build Up on Ice Machine*

All the ice makers need to be thoroughly cleaned and inspected along with the water filters to determine the cause of the corrosion.

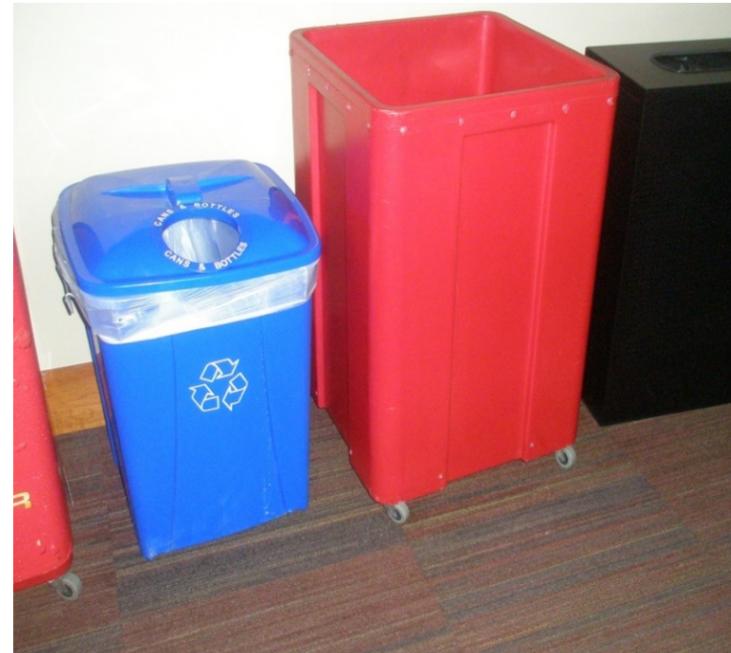
Existing original suites have 3 Sterno open flame chafing dishes and brightly colored vendor supplied plastic ice bins and recycling bins which provide a very amateurish look.

These \$8,000 Spring credenzas are professional looking and eliminate open flames in the suites, which can be a fire hazard.

Thirty of the suites have recently been remodeled, including adding three or four induction warmers built into a credenza table in each of those suites. Some suites we saw only had three induction warmers. For future renovations, we recommend four induction warmers in all typical sized (20 seat) suites.

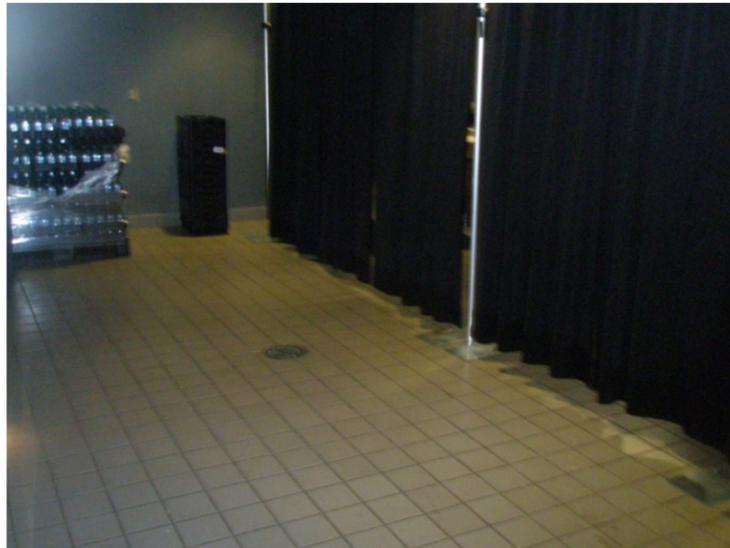
3.27.02 Press Dining; The room is a mixture of different types of portable equipment and just pipe and drape separating the front servery from the back prep station.

Temporary food staging area

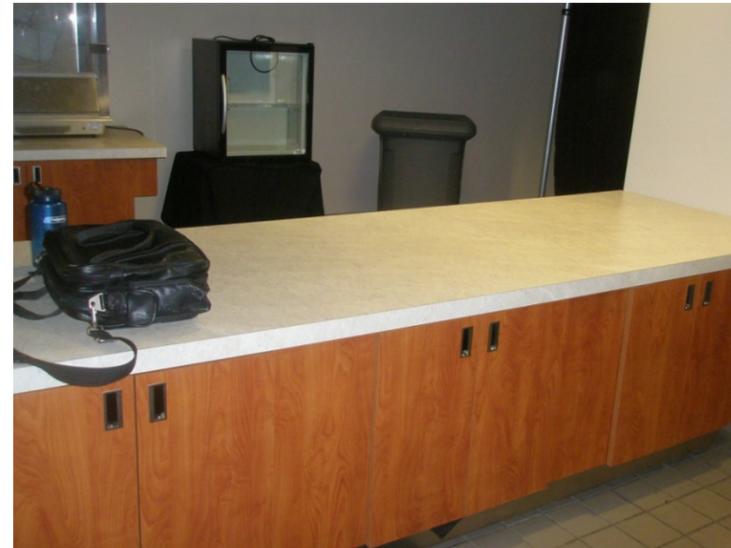
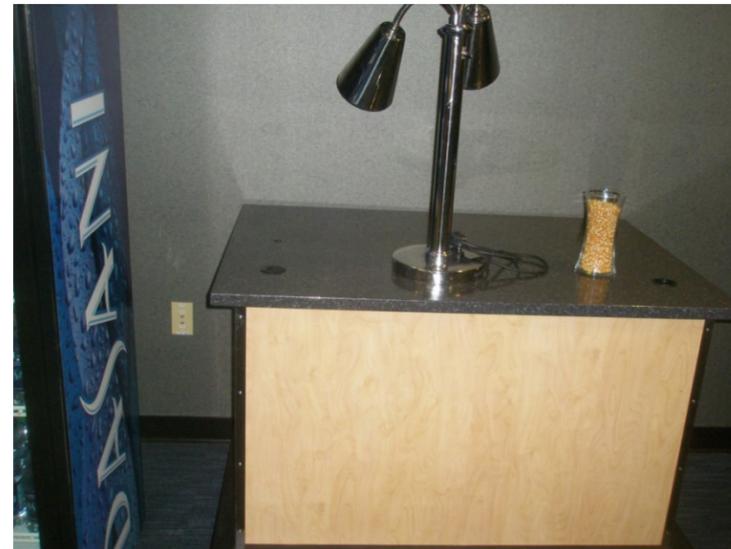
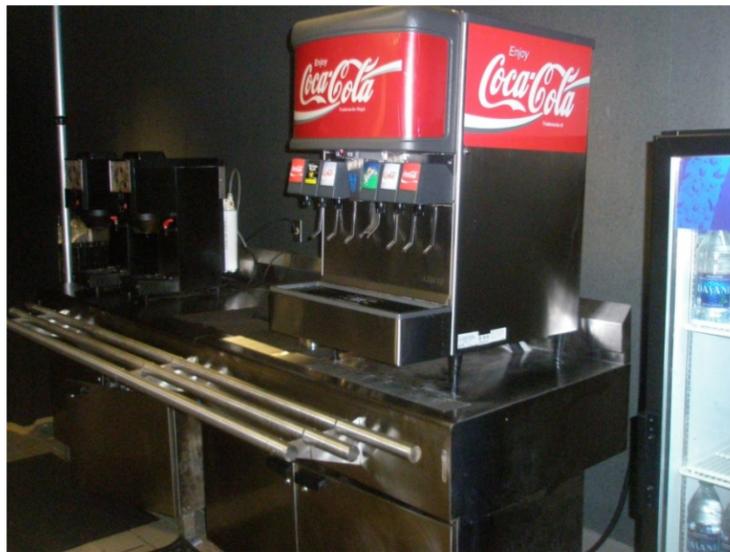
The front service area (25'x25') is tiled, but all the flooring could be redesigned.

Press dining is an expense of the team, and some teams elect to do more for the media than others. Most teams have upgraded to permanent equipment, rather than mobile cabinetry and even have a hot cooking line in the servery (exhibition cooking) serving the meals, which we would recommend.

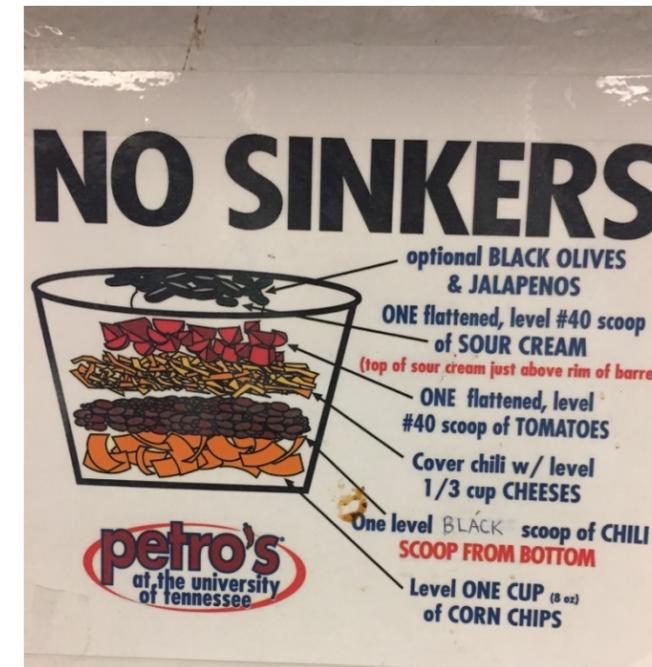
Petro's is another well-known regional brand from Knoxville that licenses their name to Aramark, who then manages the stand. Unfortunately, not all the signage is created with professional graphics. Instead, a laminated sheet was taped to the stand to explain the product. Professional graphics are needed at the Petro Stand to enhance its professional appearance.

10. Clean, repair and replace corroded ice makers and bins.
11. Replace dishwasher and tilt skillet in main kitchen.
12. Upgrade graphics in Petro's stands.

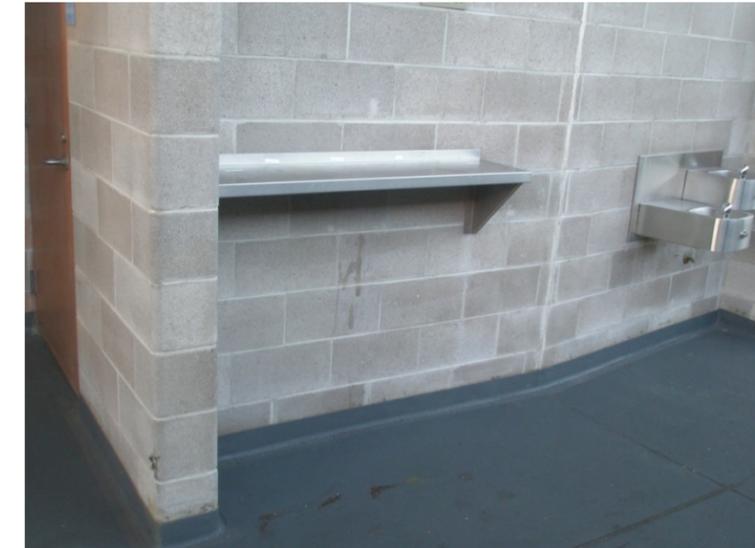
Condiments are served on a variety of stainless steel shelves mounted to the walls. While the shelves work in some locations, most the condiment shelves are mounted too high (42") to be Americans with Disability Act (ADA) compliant at 34". The shelves and walls are plain without any merchandising around them.

Shelving either needs to be relocated to meet ADA guidelines or new condiment carts for each concession stand should be purchased. We would also recommend the use of vinyl wrap on condiment carts or behind condiment shelves to provide appetizing color and allow sponsorship opportunities for the food purveyors at the stadium.
