# Facility Condition Assessment

April 3, 2017

## Nissan Stadium

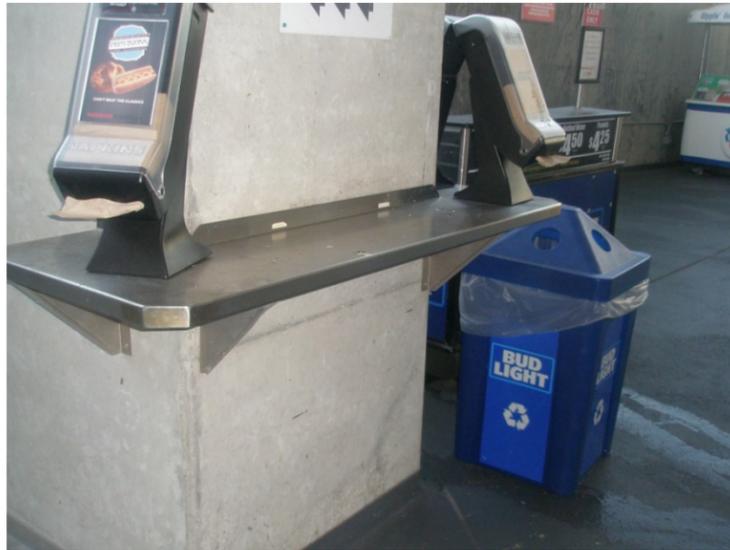
We also found concession stand (#105) counters at 36" height. Again, normal ADA height is 34", but these may have been approved at 36".

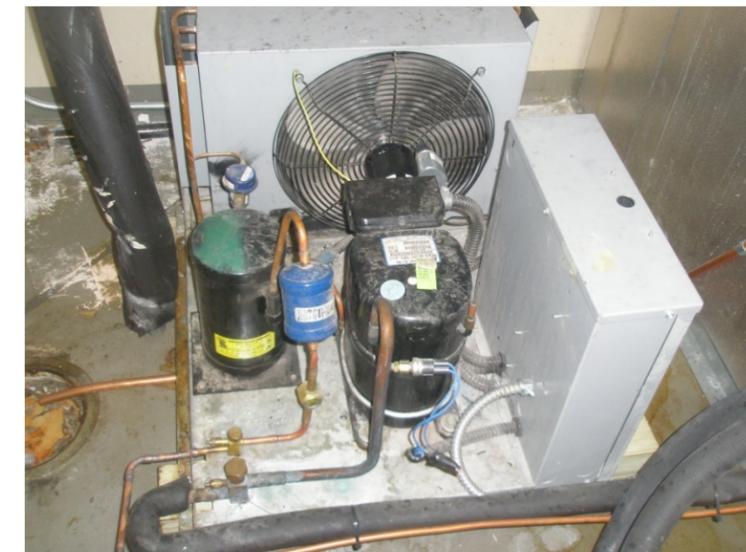
This stand gets extremely hot, so maintenance leaves the covers off compressors and roof tiles are removed to allow for more air circulation. Unfortunately, both remedies also lead to more dirt getting into the unit.

Operator needs to check on air current and add a fan and/or ventilator in the roof or louvered door as necessary.

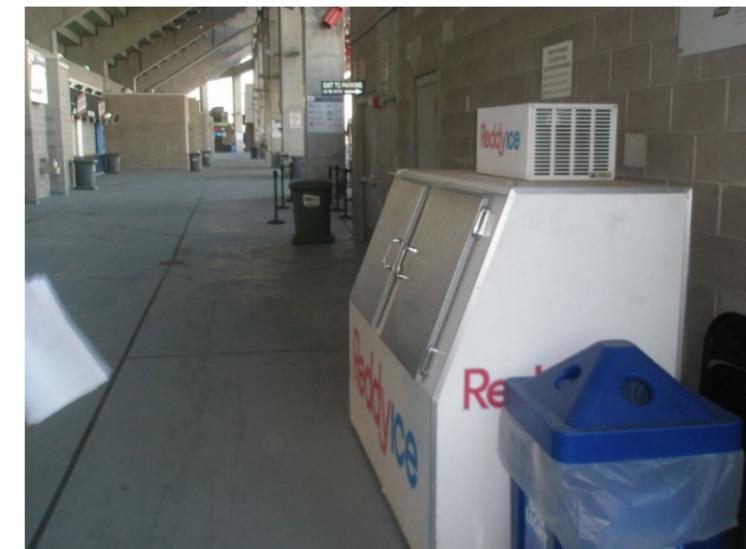
Ice dispensers "clutter" the presentation of the concourses

We recommend either purchasing larger ice makers to eliminate the need for merchandisers or building attractive enclosures to prevent the public from seeing these around the stadium.

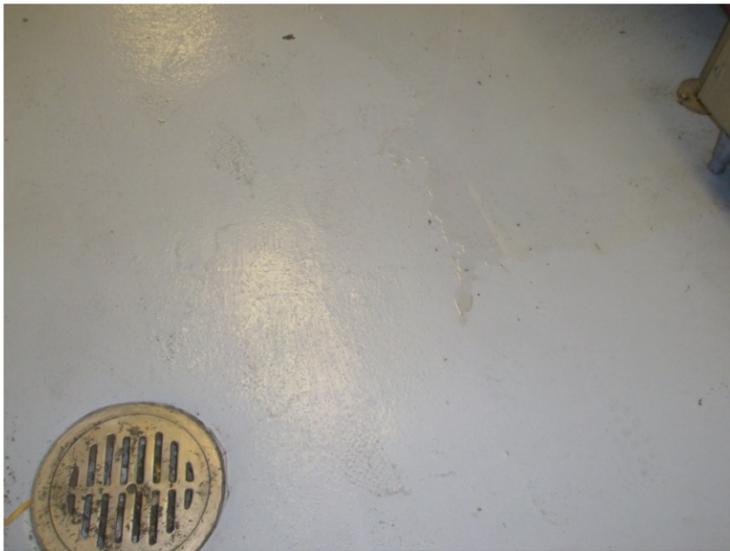
Many of the concession stands on the upper concourses are lower than the exterior concourse and had standing water on the floor. It appears that the concrete floors do not slope to the floor drains, and there are no thresholds at the doorways holding back water. Floors should be repaved to provide sloping to the floor drains.

*Floor slopes away from floor drain in concession stand*

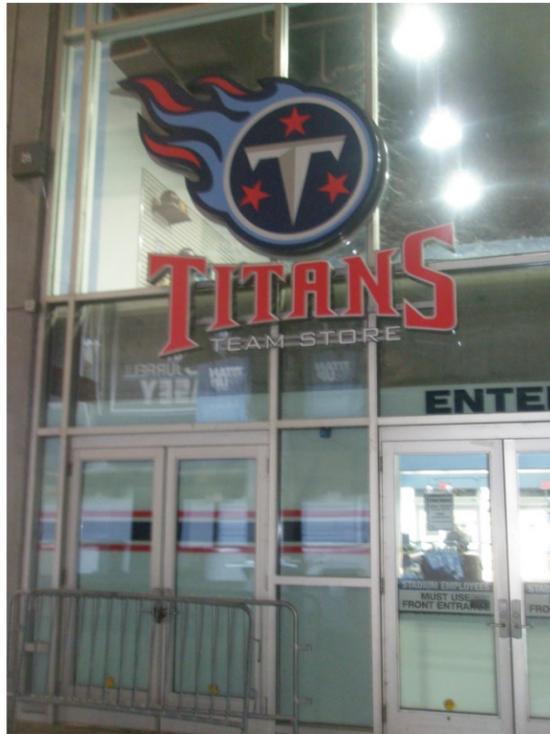
The team store is approximately 3,600 square feet, which is small in comparison with the newer NFL stadiums that can have upwards of 7,000 to 10,000 square feet. While we were told the stands and team store were updated in 2014 with new slat walls and lighting, they still appear very dated in appearance. The blue and white team colors are the only colors in the store against white slat walls and do not have a vibrant feel.

As many teams have done, we would recommend a retail consultant be hired to give all of the stands, and particularly the team store, a bolder and more vibrant look. They can use team colors but also accent them with other shades to create a more professional and inviting retail look. Also, use of interactive football related displays will enliven the team store space.

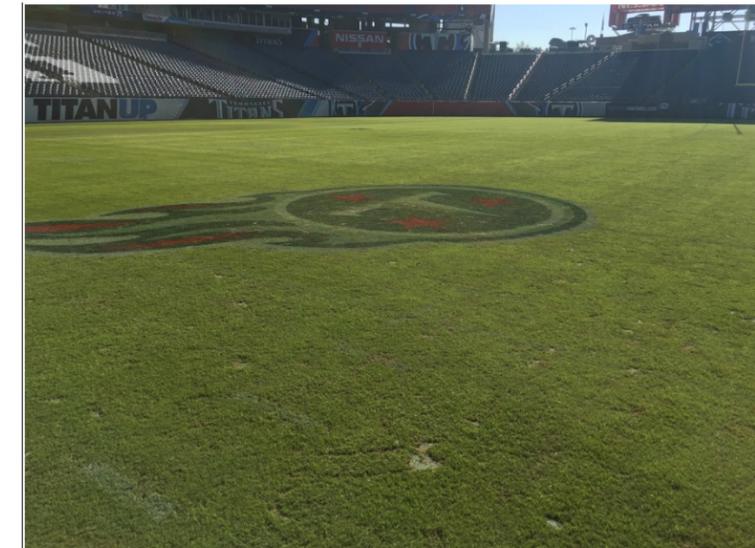
*Sod Wear/Damage at Mid-Field – Mid November*

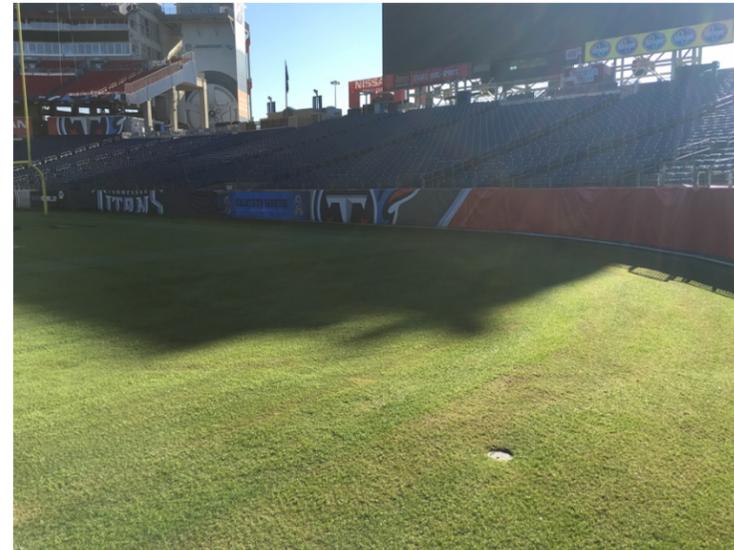
In addition, the inclusion of a perimeter warning track would greatly reduce the wear currently experienced by the sod in the areas between the sideline and the field wall. Sod health is typically compromised in these areas due to intense foot and vehicle traffic, as well as excessive shade, especially in the southern end zone late in the season.

Mid-Morning Shade Pattern – South Endzone – Mid November

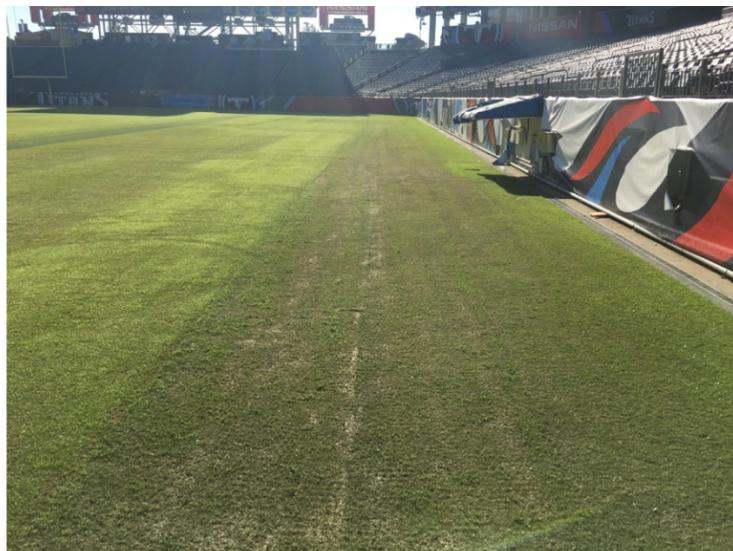
Sod Wear/Damage at Sideline – Mid November

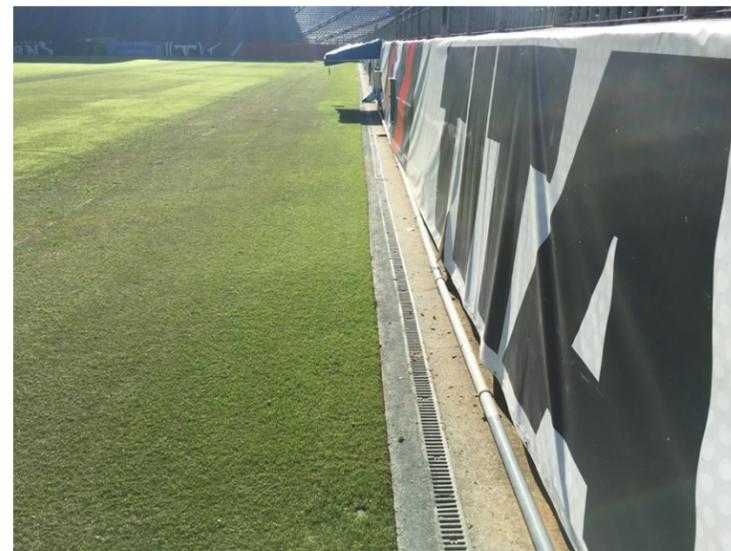
*Perimeter Trench Drain Condition*

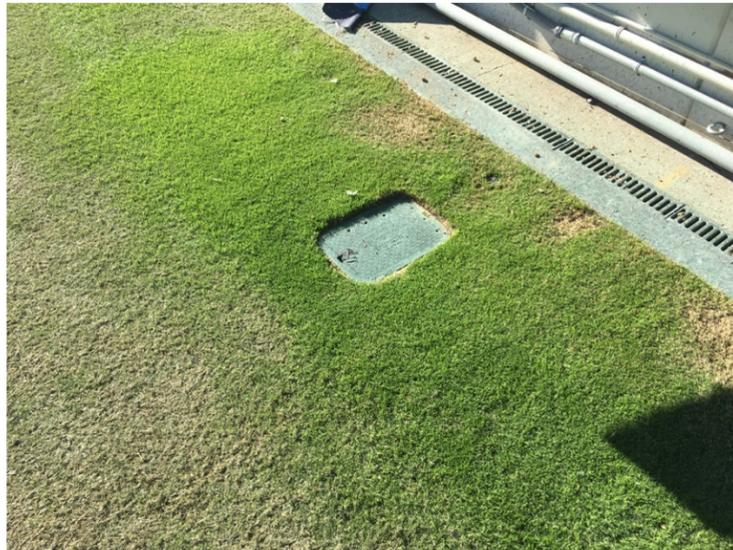
Perimeter Irrigation Remote Control Valve
