# 232 W Marthona Road Culvert Replacement

## Existing Conditions

## Proposed Conditions

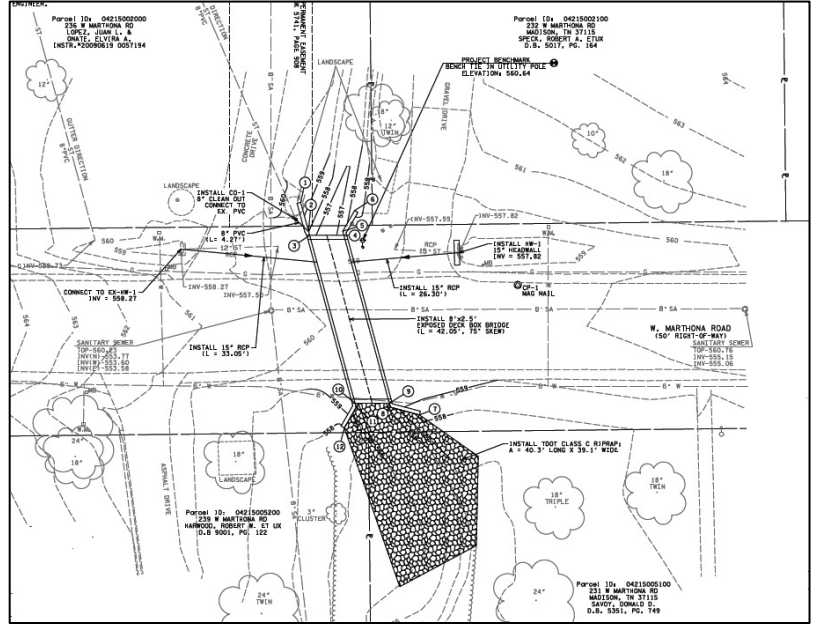
Plan Layout

The proposed culvert replacement will include replacing the CMP Culvert with a Reinforced Concrete Box Bridge, Reinforced Concrete Wingwalls, Roadway Reconstruction, and Site Restoration.
