3007 Lakeland Drive Culvert Replacement

Existing Conditions

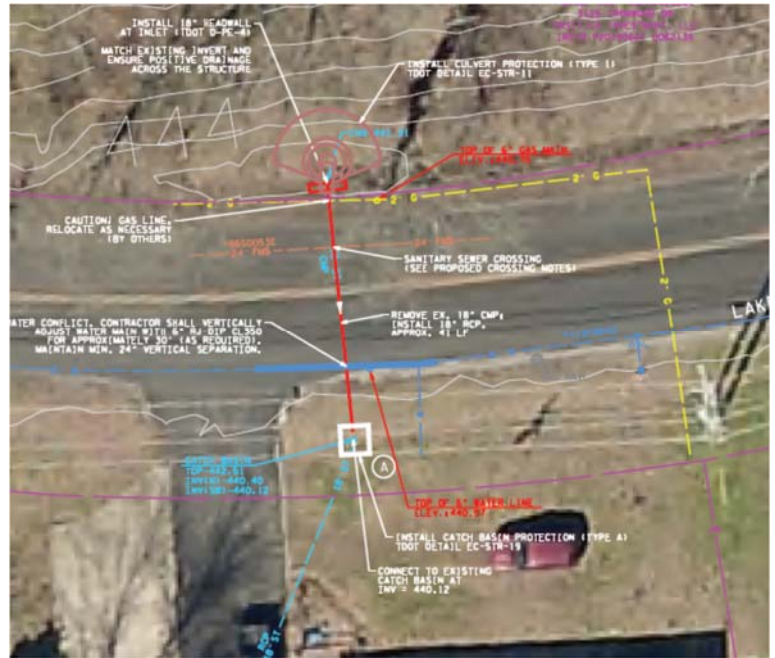
Plan View

The proposed culvert replacement will include replacing the existing 18" CMP, installing an 18" reinforced concrete pipe (RCP), reinforced concrete inlet headwall, and tie into the existing outlet catch basin as well as site restoration and roadway reconstruction. The culvert replacement will also require the vertical adjustment of a water main.
