# 4861 Little Marrowbone Road #1 Culvert Replacement

## Existing Conditions

# 4861 Little Marrowbone Road #2 Culvert Replacement

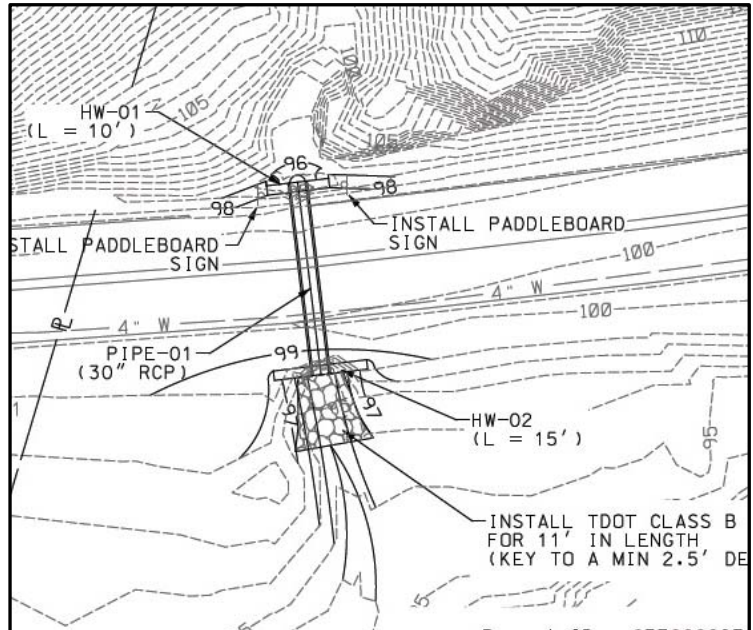
Plan View

The proposed culvert replacement will include the installation of a 30' long 30" RCP culvert with reinforced concrete headwalls. The installation of channel and embankment protection as well as site restoration and roadway reconstruction.
