## STAFF RECOMMENDATION

317 Broadway  
September 19, 2012

**Application:** New construction-rear addition and exterior alterations  
**District:** Broadway Historic Preservation Zoning Overlay  
**Council District:** 19  
**Map and Parcel Number:** 09306402100  
**Applicant:** Preston Quirk, architect  
**Project Lead:** Robin Zeigler, robin.zeigler@nashville.gov

**Description of Project:** The project includes alterations to the primary façade including moving the primary entrance, removing the glass façade, and replacing upper story windows with double doors, transoms and railings. The project also includes a rear three-story uncovered deck with enclosed stairwell.

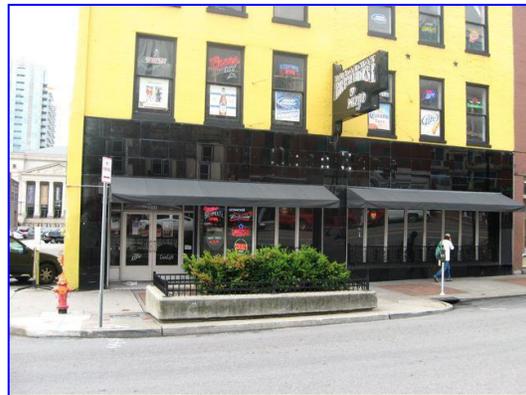
Storefronts: A structural glass (Carrera/Vitrolite) veneer was added to the storefront in the first half of the twentieth century. Although the glass is not the original storefront, it is a typical alteration to downtown buildings primarily between 1920 and 1960 as a way to update storefronts. Glass store fronts, such as this one, are considered a significant architectural detail as they tell the story of the evolution of the district.

The glass was repaired in 1990 with new caulking and 16 missing or broken pieces were replaced with black spandrel glass. In more recent years, some pieces have been replaced with matching Plexiglas squares. The application now requests complete removal of the glass/Plexiglas veneer. According to the design guidelines historic storefronts should be retained and repairs made where needed; therefore, staff finds removal of the glass veneer to be inappropriate and does not meet section II.A.1 of the design guidelines. Cracks in original glass pieces can be sealed. Broken pieces can be replaced with plexiglass or spandrel glass and the visual result is essentially seamless.

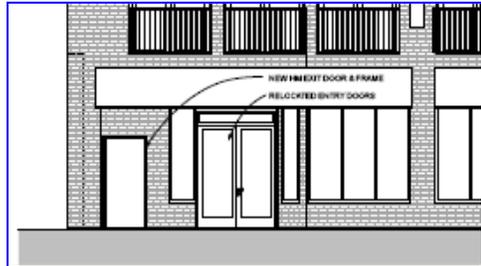
Doors and Entryways: The application includes relocation of the primary entrance and the installation of a new secondary door on the main façade within the current recessed entry. The storefront windows are not original as they were replaced with aluminum accordion windows sometime after 2004; however the configuration of the storefront does not appear to have changed. The existing entrance has a tile floor and earlier photographs show an entrance at the current location. In keeping with the design guideline's requirement to retain original entryways, staff does not recommend moving the current doorway and adding a second one. The proposed action does not meet section II.A.2 of the design guidelines.

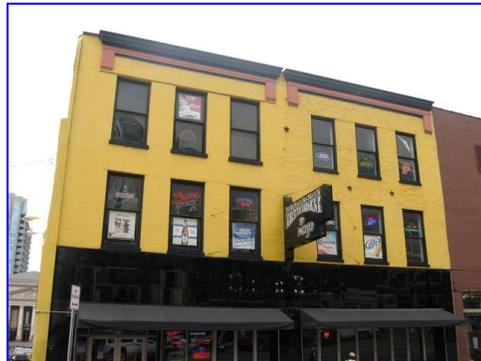
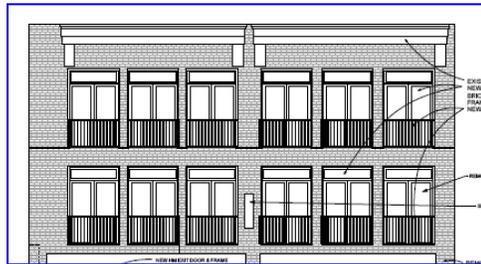
Windows: The existing windows were repaired with some lintel replacements in 1990. The applicant requests to remove the existing windows and alter the existing dimensions of the openings to accommodate double-doors with transoms and a railing. The guidelines require that existing window openings, as well as windows themselves be retained. In addition, it states that new window openings should not be introduced and balcony rails are inappropriate. (Railings have only been approved on non-contributing buildings.) Staff recommends repair of the existing windows, if needed, but not removal and alteration of the openings' dimensions. The proposed action does not meet section II.B.1 of the design guidelines for "upper facades."

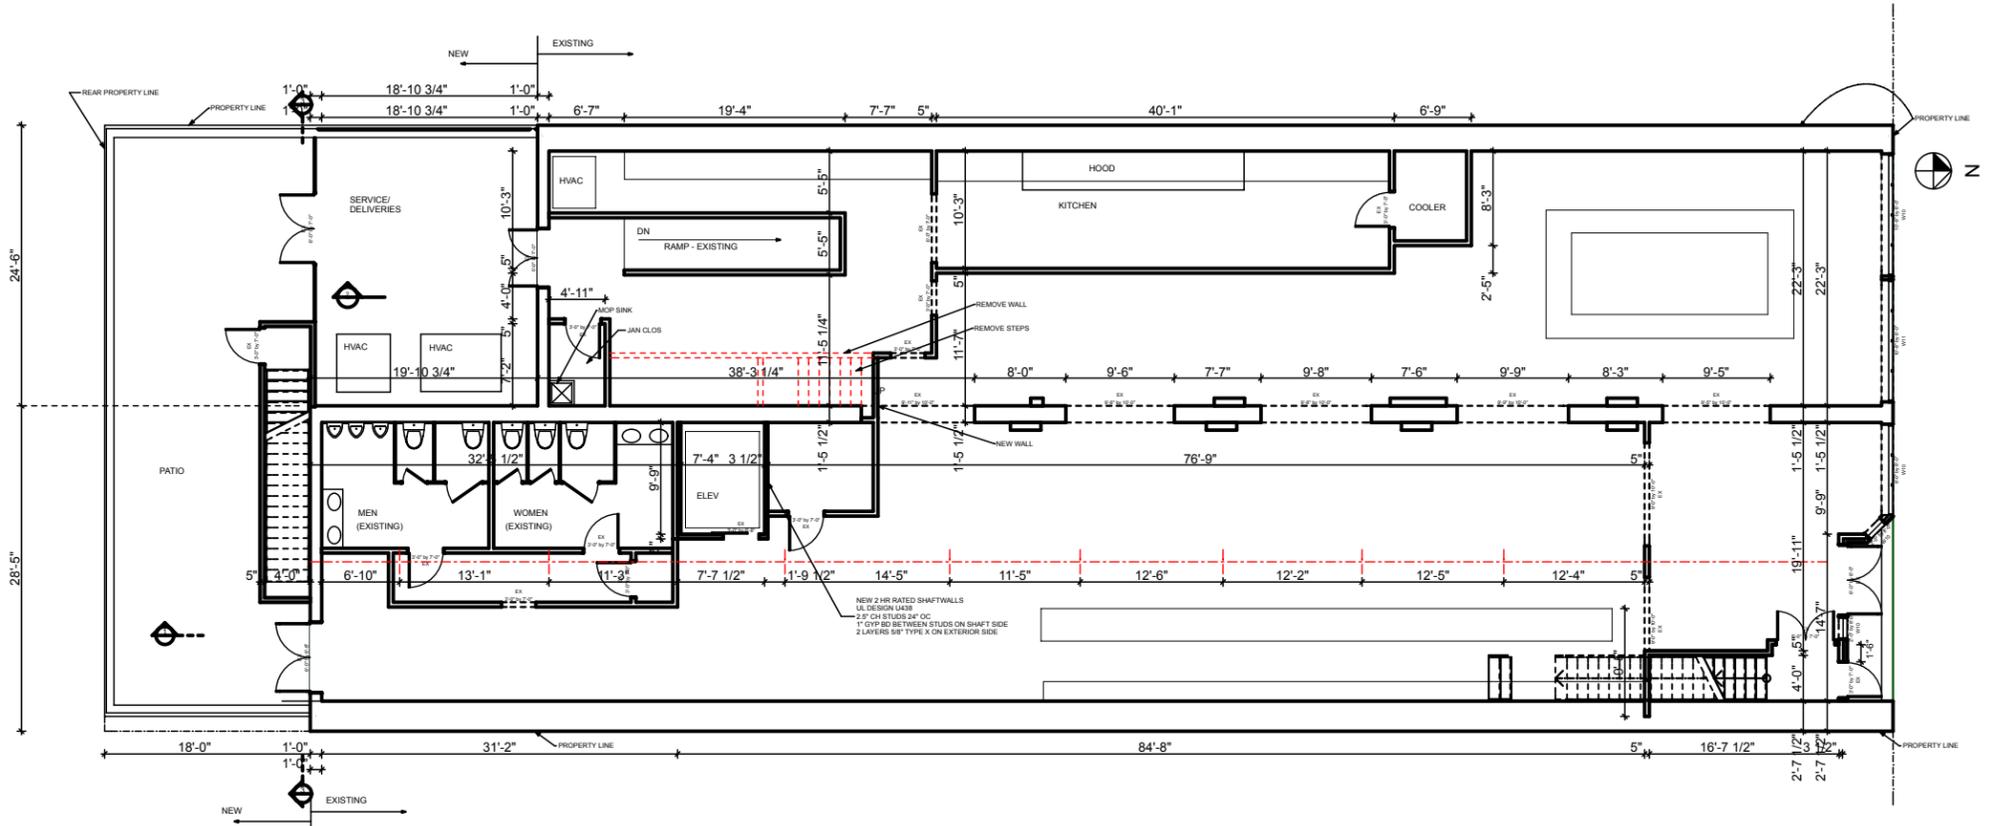
1ST FLR PLAN

**1** 1ST FLOOR PLAN/Site Plan  
 SCALE: 1/16" = 1'-0"

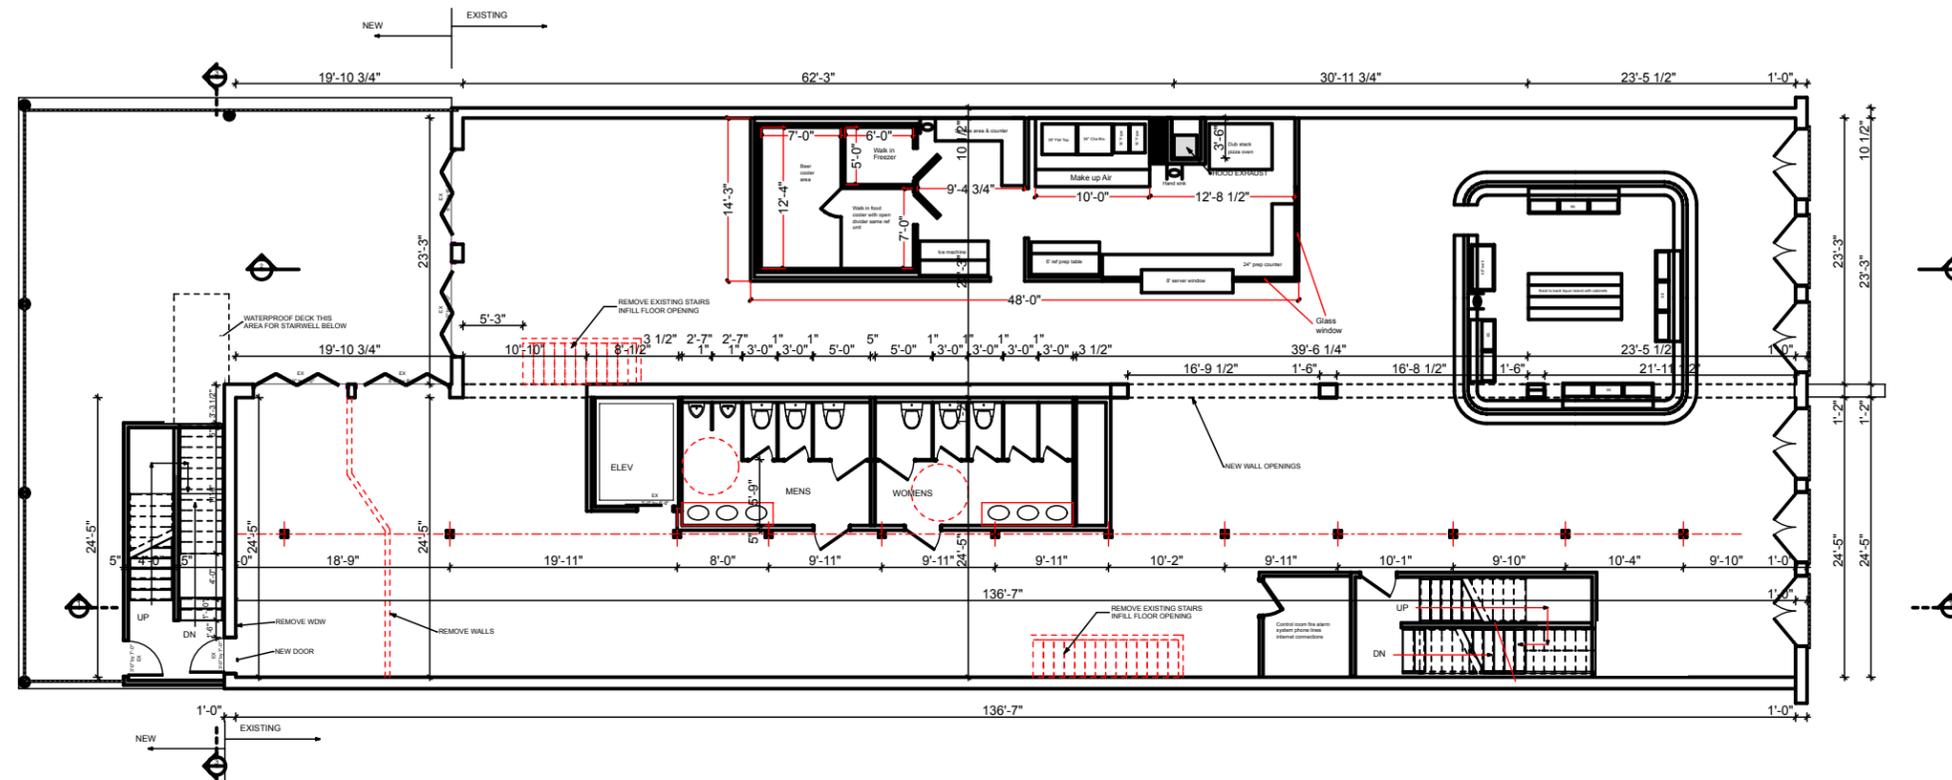
2ND FLR PLAN

**1** 2ND FLOOR PLAN  
SCALE: 1/16" = 1'-0"

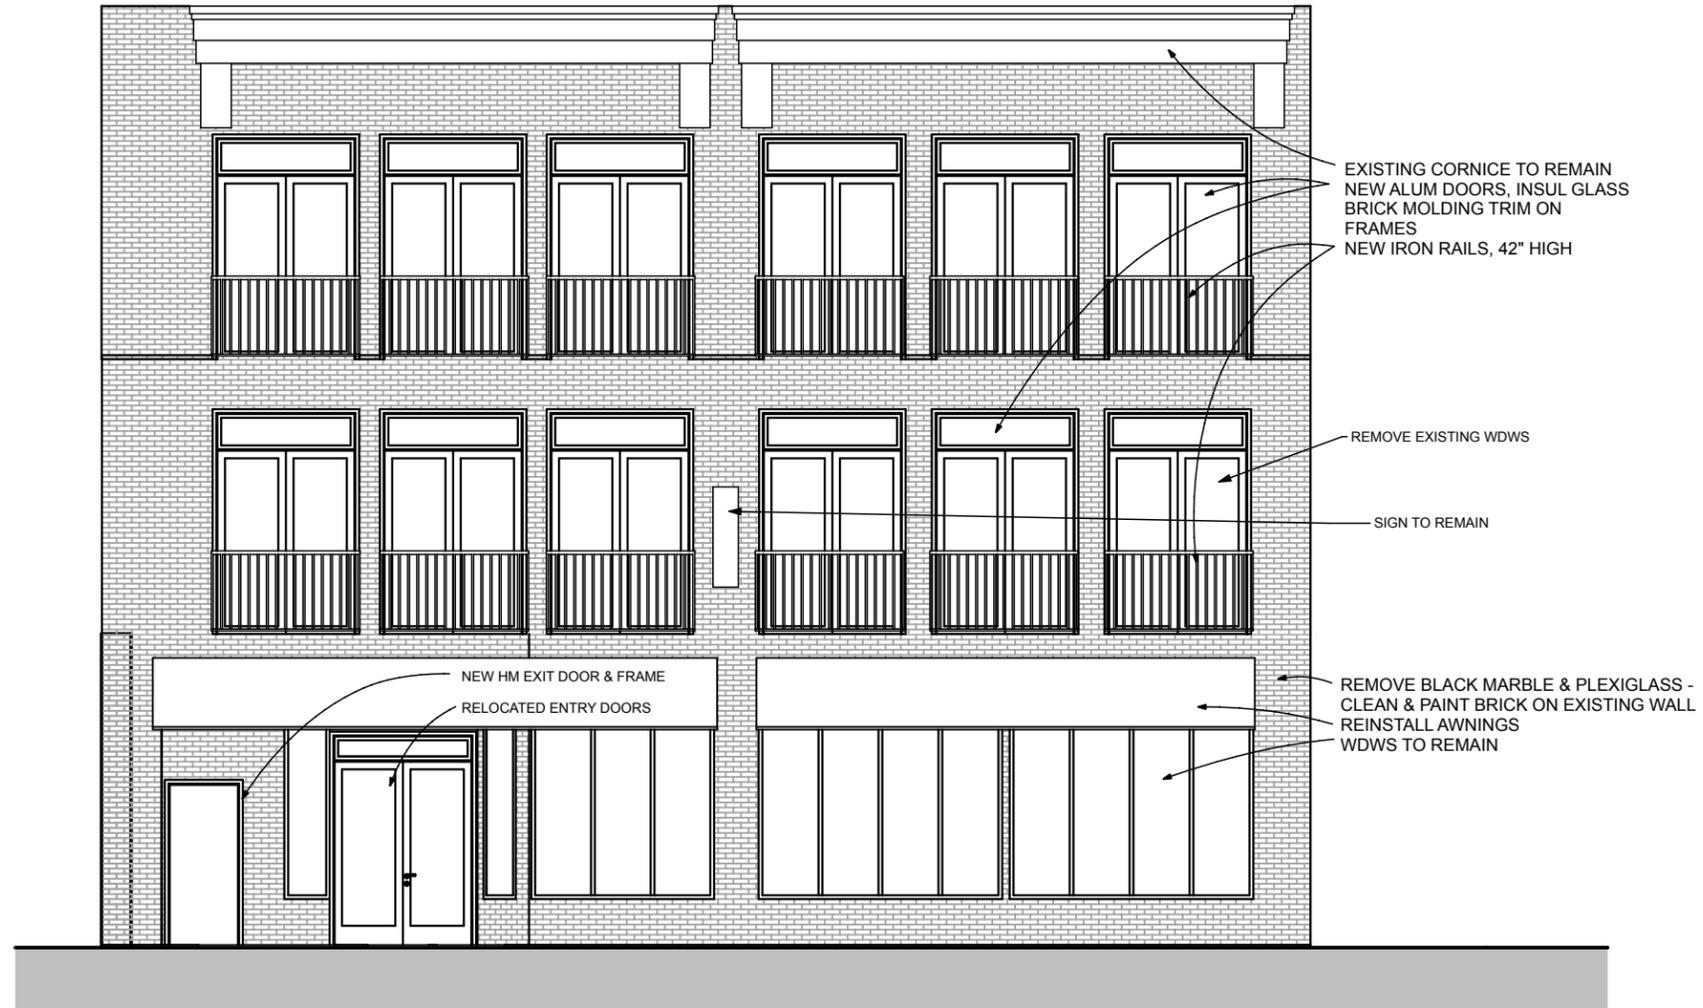
FRONT ELEV.

**1** FRONT ELEVATION  
 SCALE: 1/8" = 1'-0"

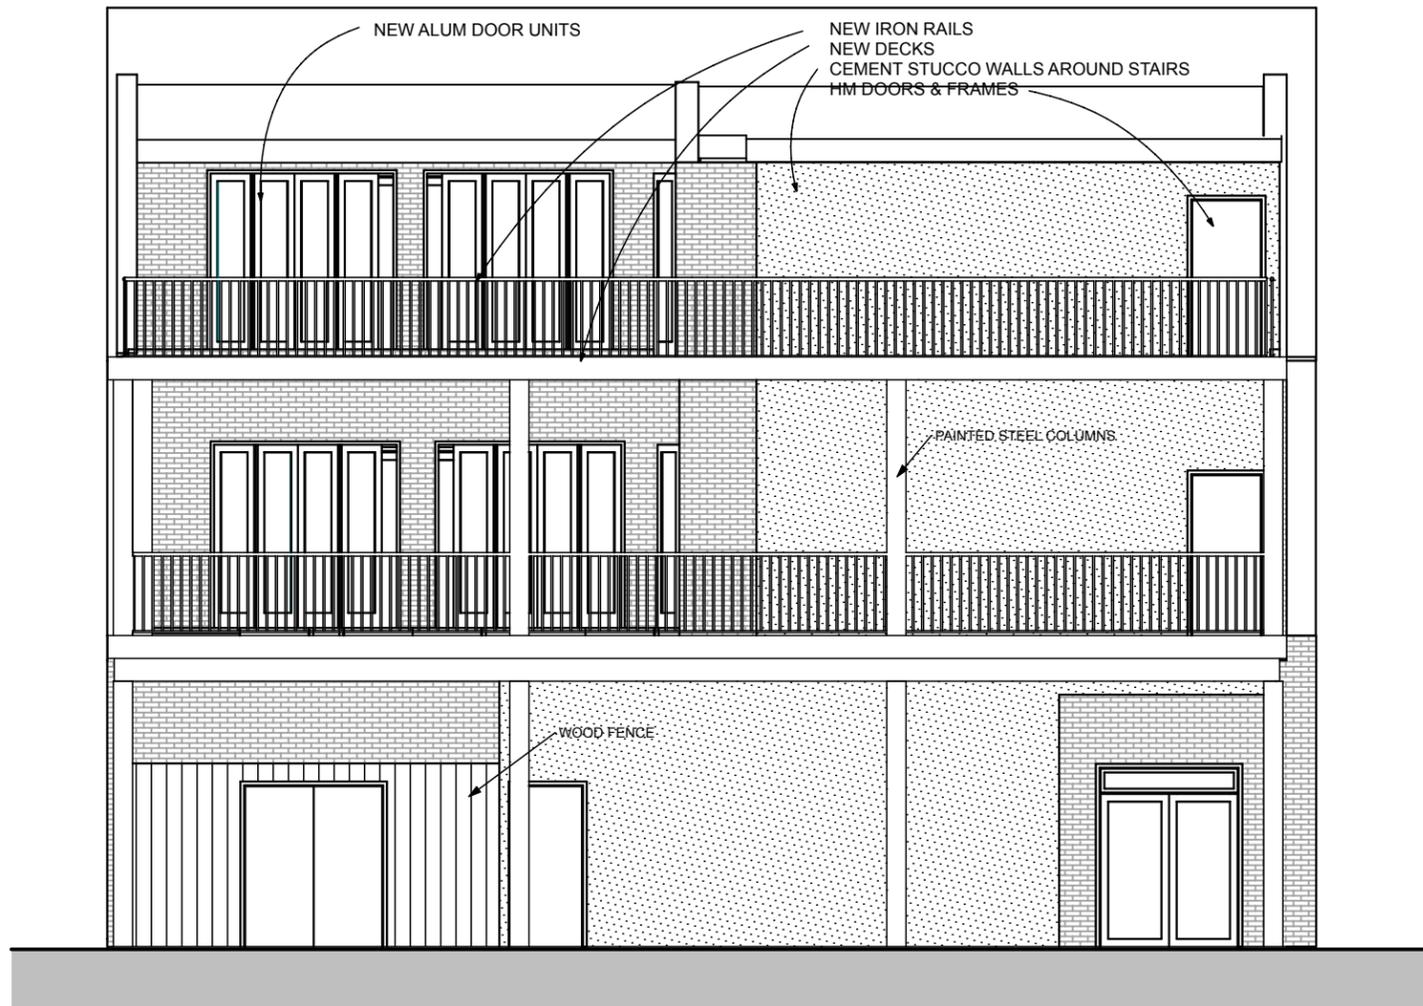
REAR ELEV

**1** REAR ELEVATION  
 SCALE: 1/8" = 1'-0"

Additions to Existing Buildings: The addition is a three-story uncovered deck with an enclosed stairwell. The addition is located on the rear and will not be seen from Broadway. It will require the alteration of some existing windows and doors; however, these are not character defining features because of their location on the rear. Materials for the addition include a stucco enclosure for the stairwell, iron railings, aluminum doors, and painted steel posts. Staff finds that the rear addition meets the design guidelines.

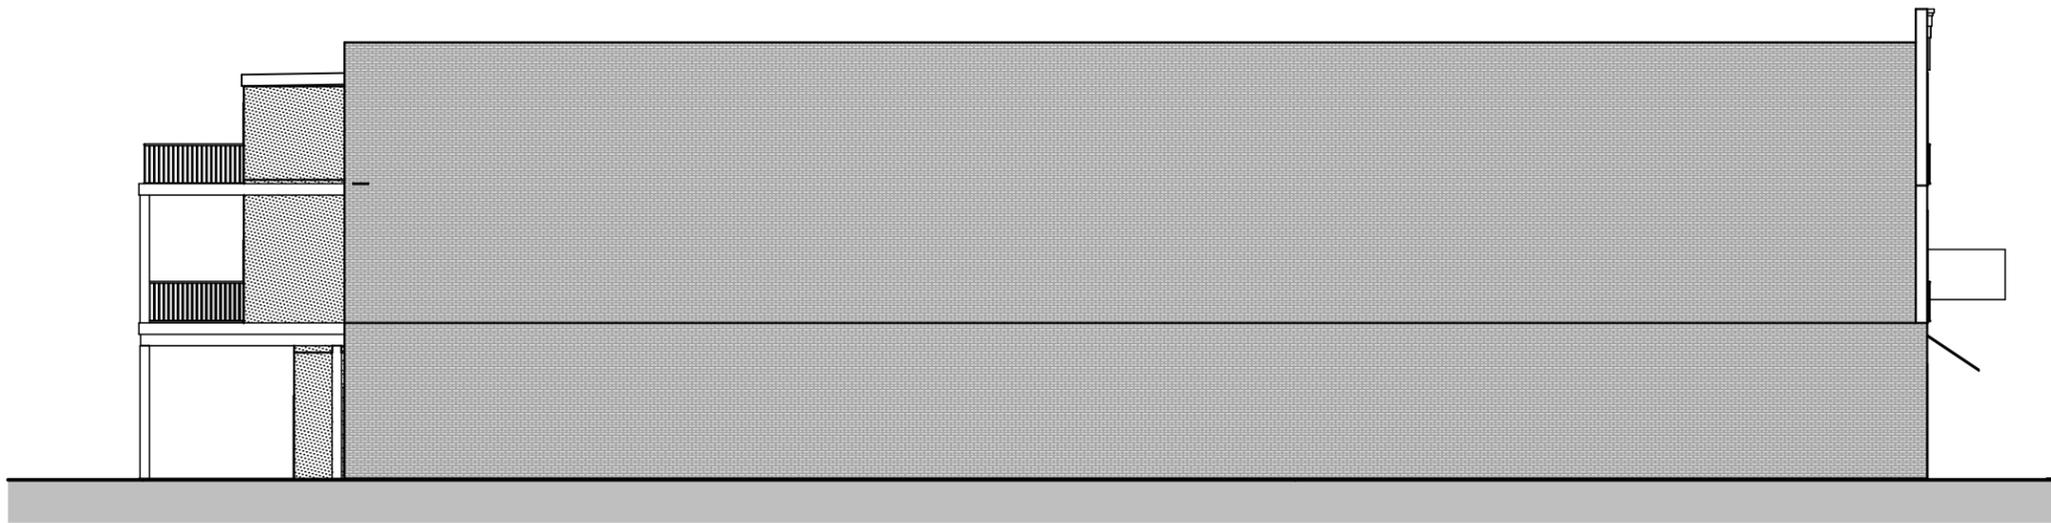
**1** LEFT ELEVATION  
SCALE: 1/16" = 1'-0"

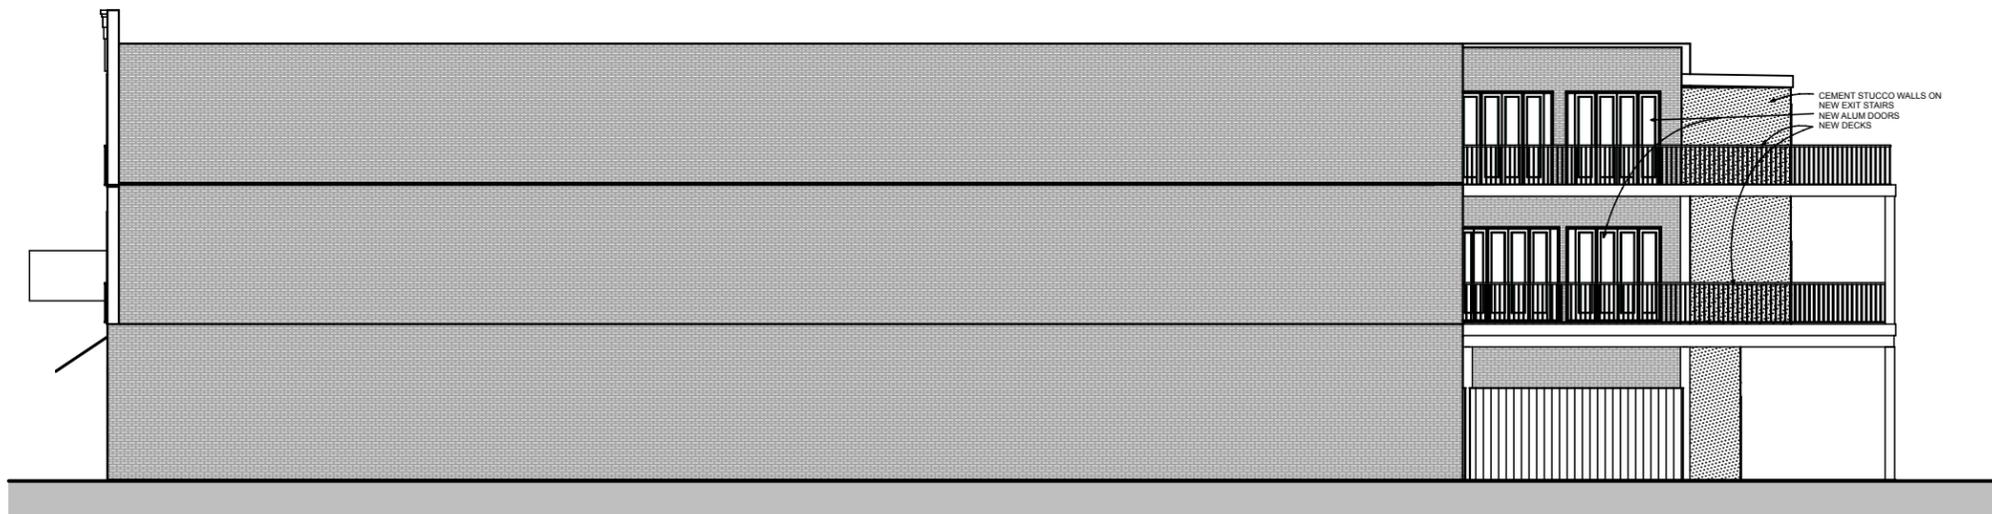
**2** RIGHT ELEVATION  
SCALE: 1/16" = 1'-0"
