### STAFF RECOMMENDATION 400 Broadway July 20, 2016

**Application:** New construction—addition; Alterations  
**District:** Broadway Historic Preservation Zoning Overlay  
**Council District:** 19  
**Map and Parcel Number:** 09306308200  
**Applicant:** Joshua Hughes, Tuck Hinton  
**Project Lead:** Melissa Baldock, melissa.baldock@nashville.gov

**Description of Project:** Application is to construct a rear and rooftop addition, to alter historic and non-historic windows, to alter window openings on the rear façade, and to alter the storefronts.

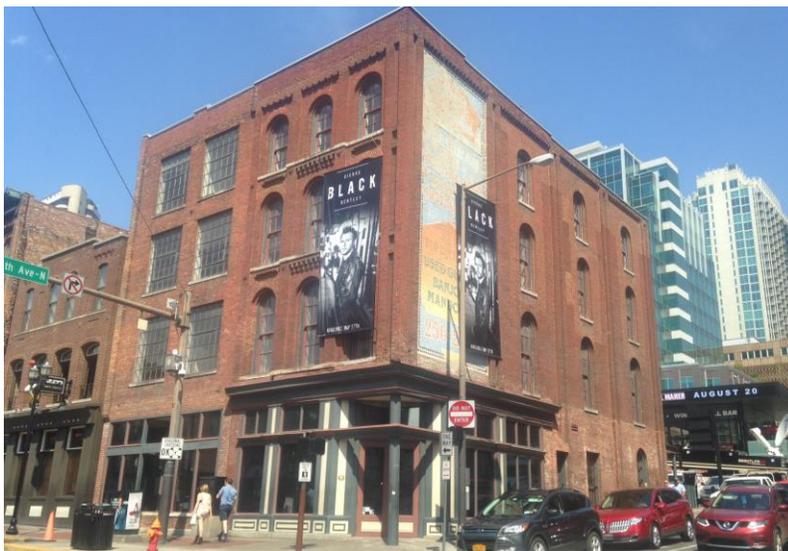
Figure 1. 400 Broadway.

**Background:** 400 Broadway is a c. 1870 brick commercial structure that contributes to the Broadway Historic Preservation Zoning Overlay (Figure 1). The western-most portion of the building was altered in the early to mid-twentieth century with new window openings and steel windows. The building was altered again in 1990. The storefronts date to that restoration.

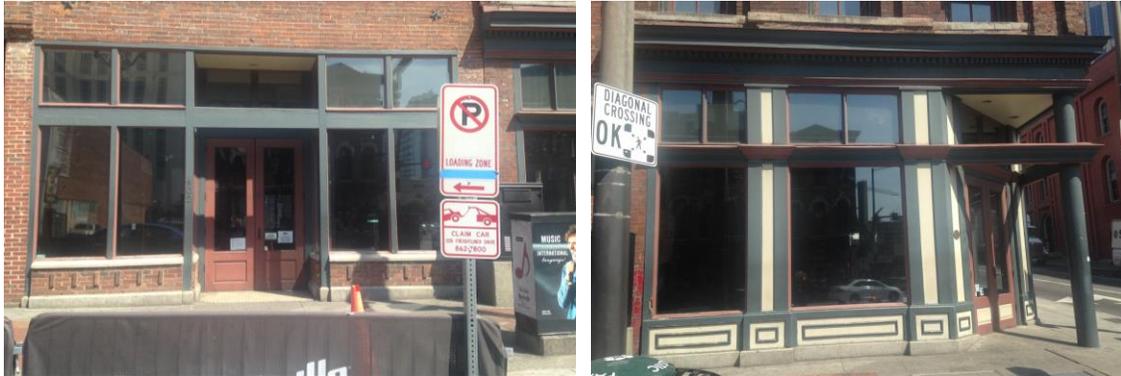
Figures 2 & 3 are the existing storefronts, which date to 1990.

Storefront alterations: The applicant plans to alter the storefronts on both the western/left and the eastern/right portion of the building. The storefronts are not historic, but date to a 1990 renovation of the structure (which was prior to the creation of the Broadway Historic Preservation Zoning Overlay) (Figures 2 & 3).

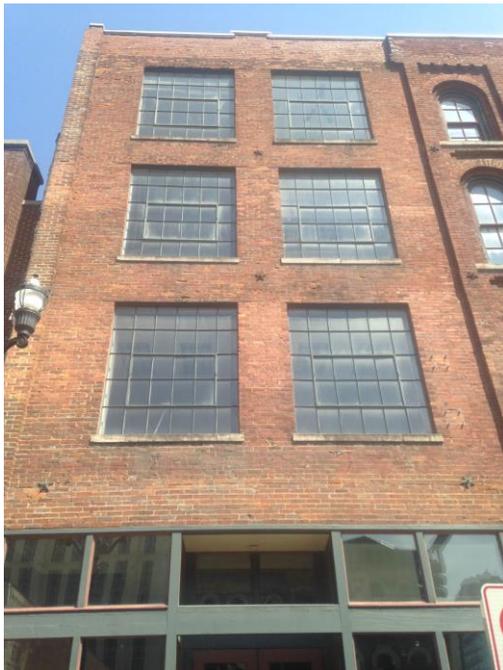
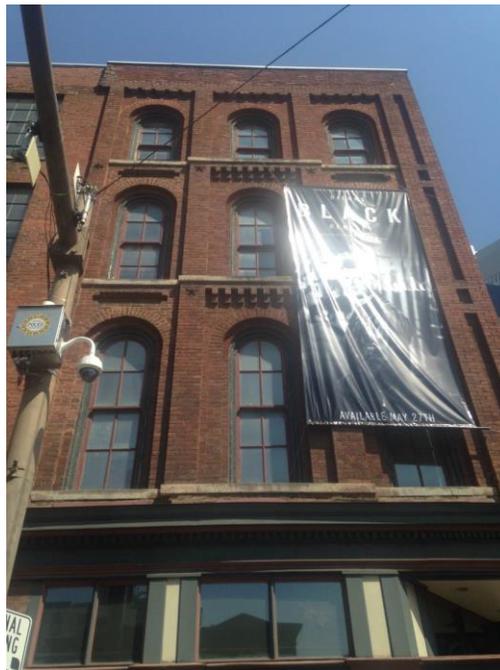
Figure 4 (left) and Figure 5 (right) show the existing conditions of the historic windows.

Window alterations: The double-hung windows on the Fourth Avenue North façade and on the eastern/right portion of the Broadway façade are not historic (Figure 5). They were installed as part of the 1990 renovation of the building. The multi-light steel windows on the western/left portion of the façade date to the mid-20<sup>th</sup> century (Figure 4). Although they are not the original windows, they have acquired a significance of their own and are considered to be a contributing element to the historic building and the Broadway Historic Preservation Zoning Overlay. In 1990, they were restored and reglazed, so the window frames are historic, but the glass is newer.

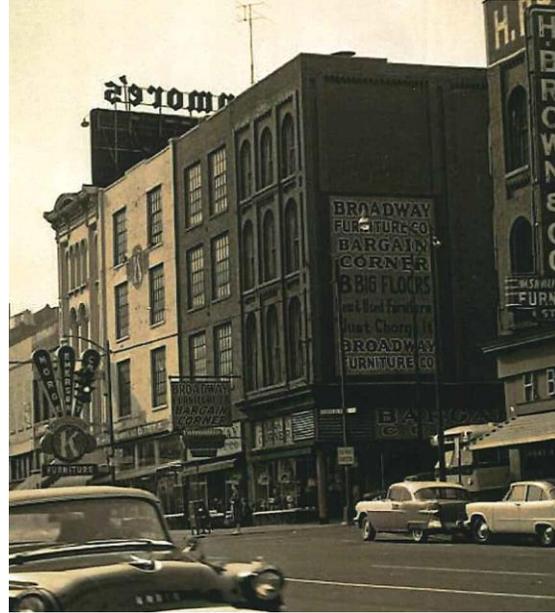
Figure 6. A mid-century historic photo shows the historic windows on 400 Broadway.

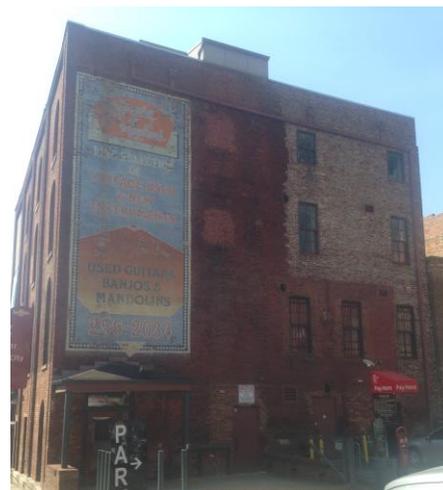
Figure 7. The rear façade.

The applicant plans to retain the existing openings and windows on the rear façade (Figure 7). The

Rear Addition: The applicant is proposing a stairwell addition at the rear (Figure 7). On the ground floor, approximately two feet (2') of the existing rear wall will be retained before a new doorway is created. On the upper stories, the rear addition will be situated about nine inches (9") off the back corner of the historic structure. The rear addition will cover less than half of the existing rear façade. It will be approximately twenty-three feet, six inches (23'6") wide, eight feet (8') deep. It will extend approximately three feet (3') above the parapet wall at the rear, but because the parapet wall steps down along Fourth Avenue North, the addition will be no taller than the front parapet of the building along Broadway. The cladding material for the addition is proposed to be an "exterior cement composite façade system." Staff recommends that a condition of approval be that staff review a material sample for the addition prior to purchase and installation. There will be no window openings on the addition.

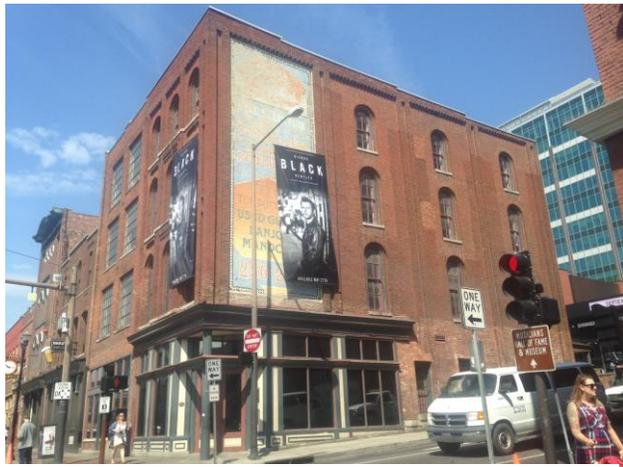
Figure 8 shows the stepped parapet along 4<sup>th</sup> Avenue North.

The design guidelines require that rooftop additions be a maximum of fifteen feet (15') above the parapet wall. The addition will extend thirteen feet (13') above the parapet wall along Broadway. Because the parapet wall steps down along the Fourth Avenue North façade, a back portion of the addition will extend sixteen feet (16') above the parapet at its lowest point (Figure 8). Staff finds this to be appropriate because the majority of the addition will be less than fifteen feet (15') above the parapet, and because the portion of the addition that extends taller because of the lower parapet is pushed the rear, where it will be less visible.

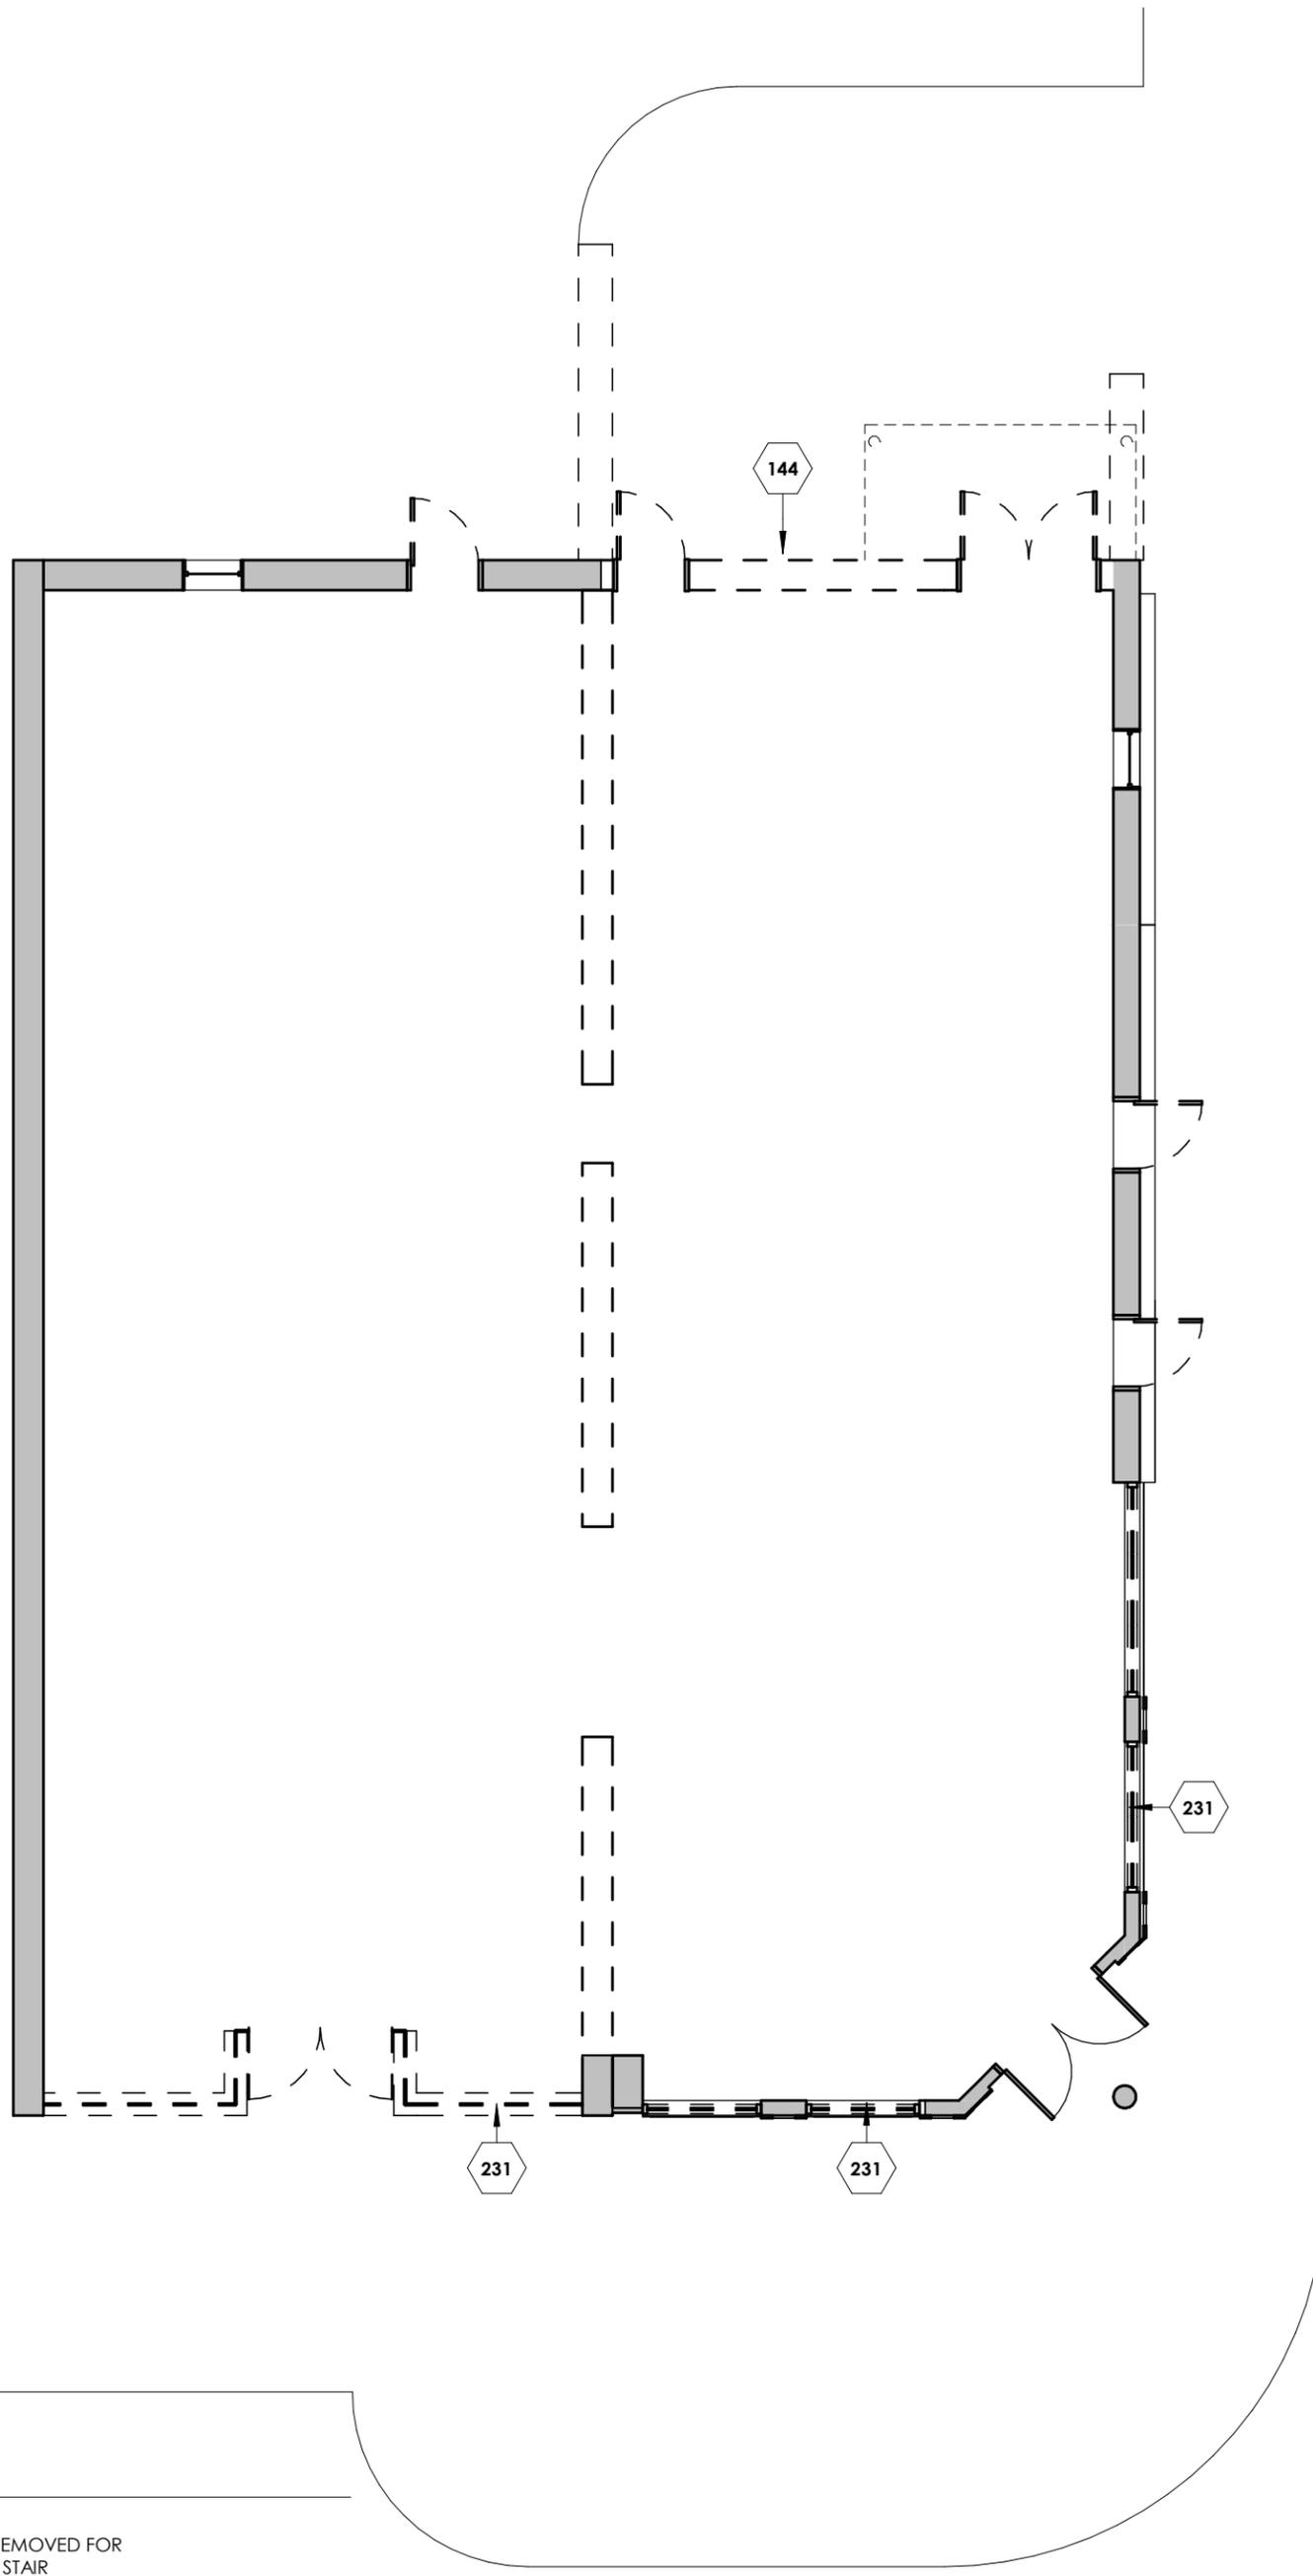
DEMOLITION PLAN LEVEL 1

- 144 MASONRY WALL TO BE REMOVED FOR CONSTRUCTION OF FIRE STAIR
- 231 NON-ORIGINAL STOREFRONT TO BE REPLACED WITH FULLY OPERABLE FOLDING GLASS WALL SYSTEM

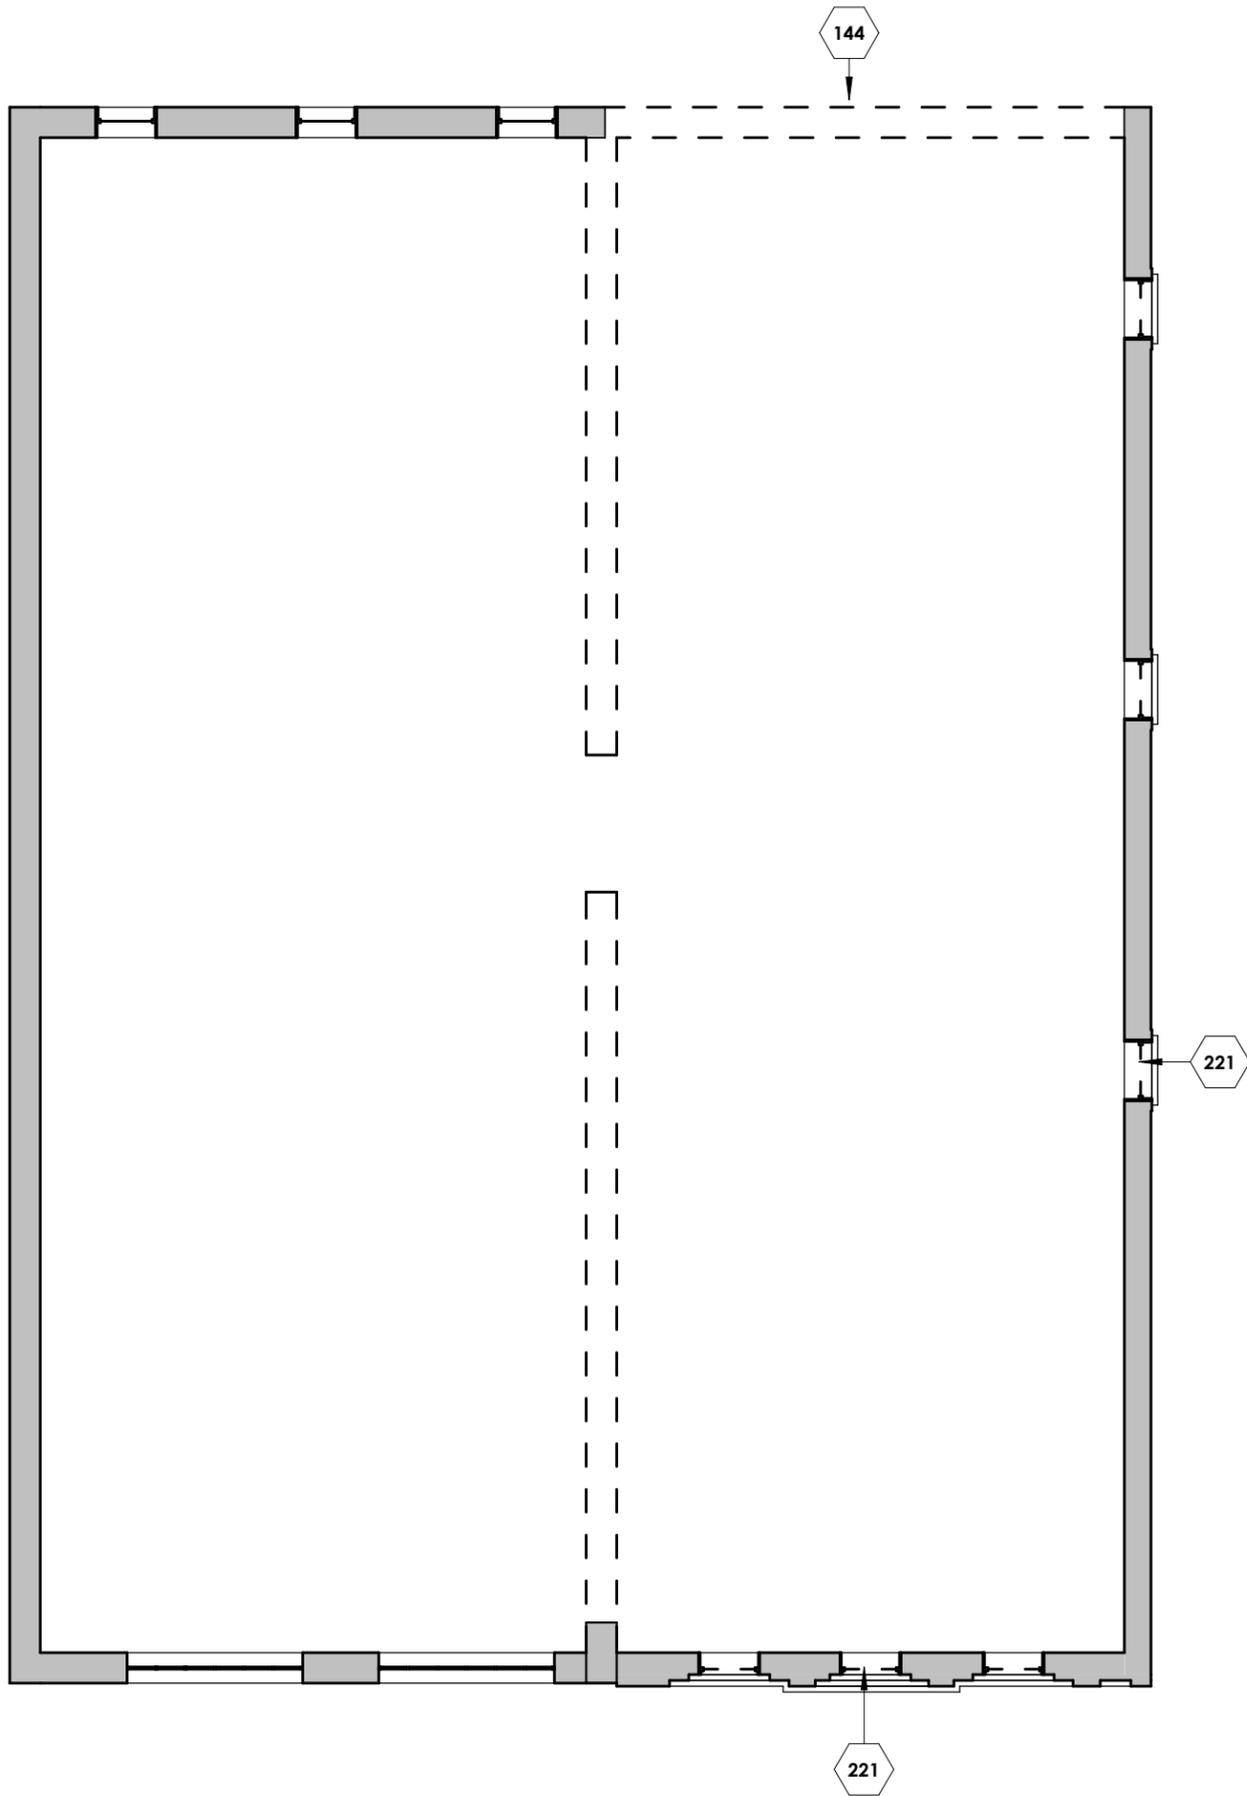
DEMOLITION PLAN LEVELS 2 & 4

- 144 MASONRY WALL TO BE REMOVED FOR CONSTRUCTION OF FIRE STAIR
- 221 NON-ORIGINAL WINDOWS TO BE REPLACED WITH FULLY OPERABLE CASEMENT WINDOW TO MATCH

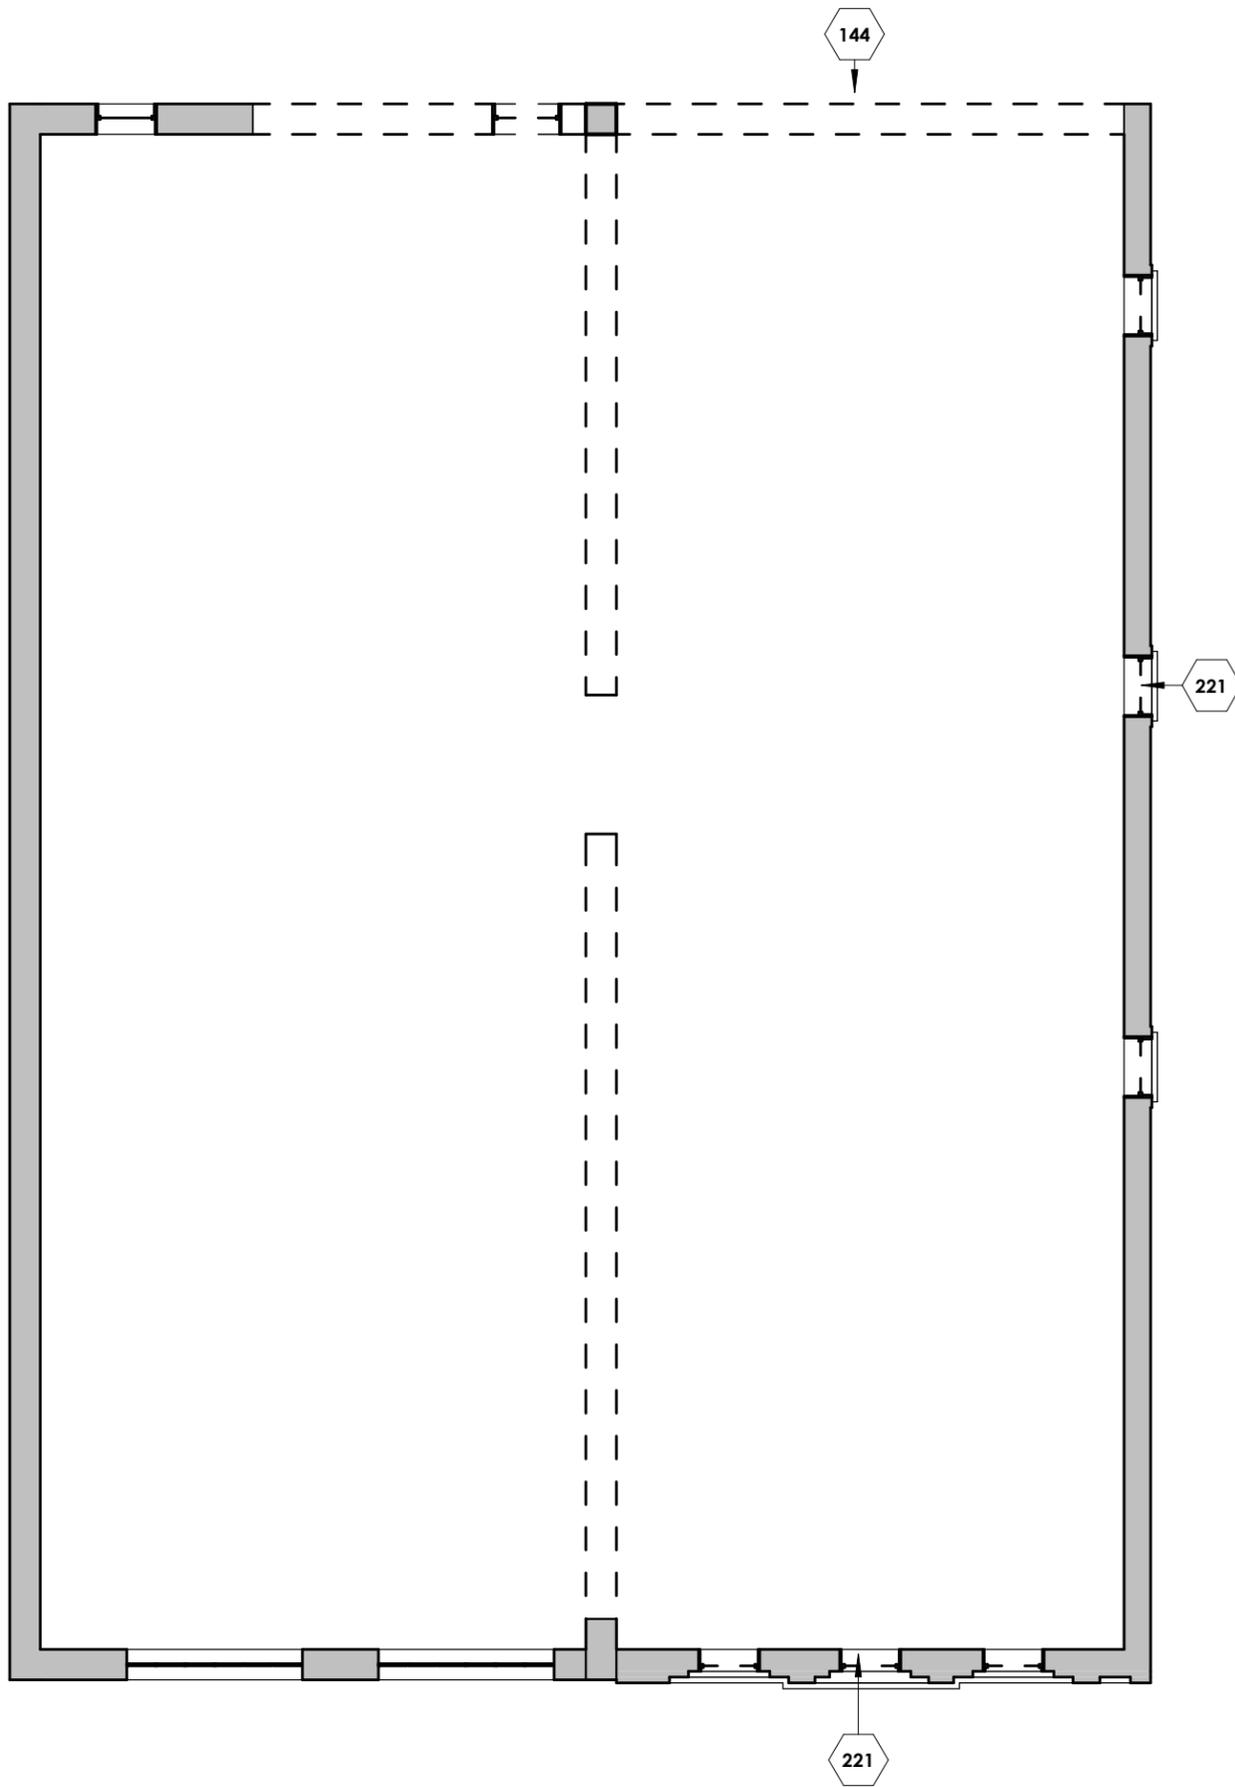
DEMOLITION PLAN LEVEL 3

- 144 MASONRY WALL TO BE REMOVED FOR CONSTRUCTION OF FIRE STAIR
- 221 NON-ORIGINAL WINDOWS TO BE REPLACED WITH FULLY OPERABLE CASEMENT WINDOW TO MATCH

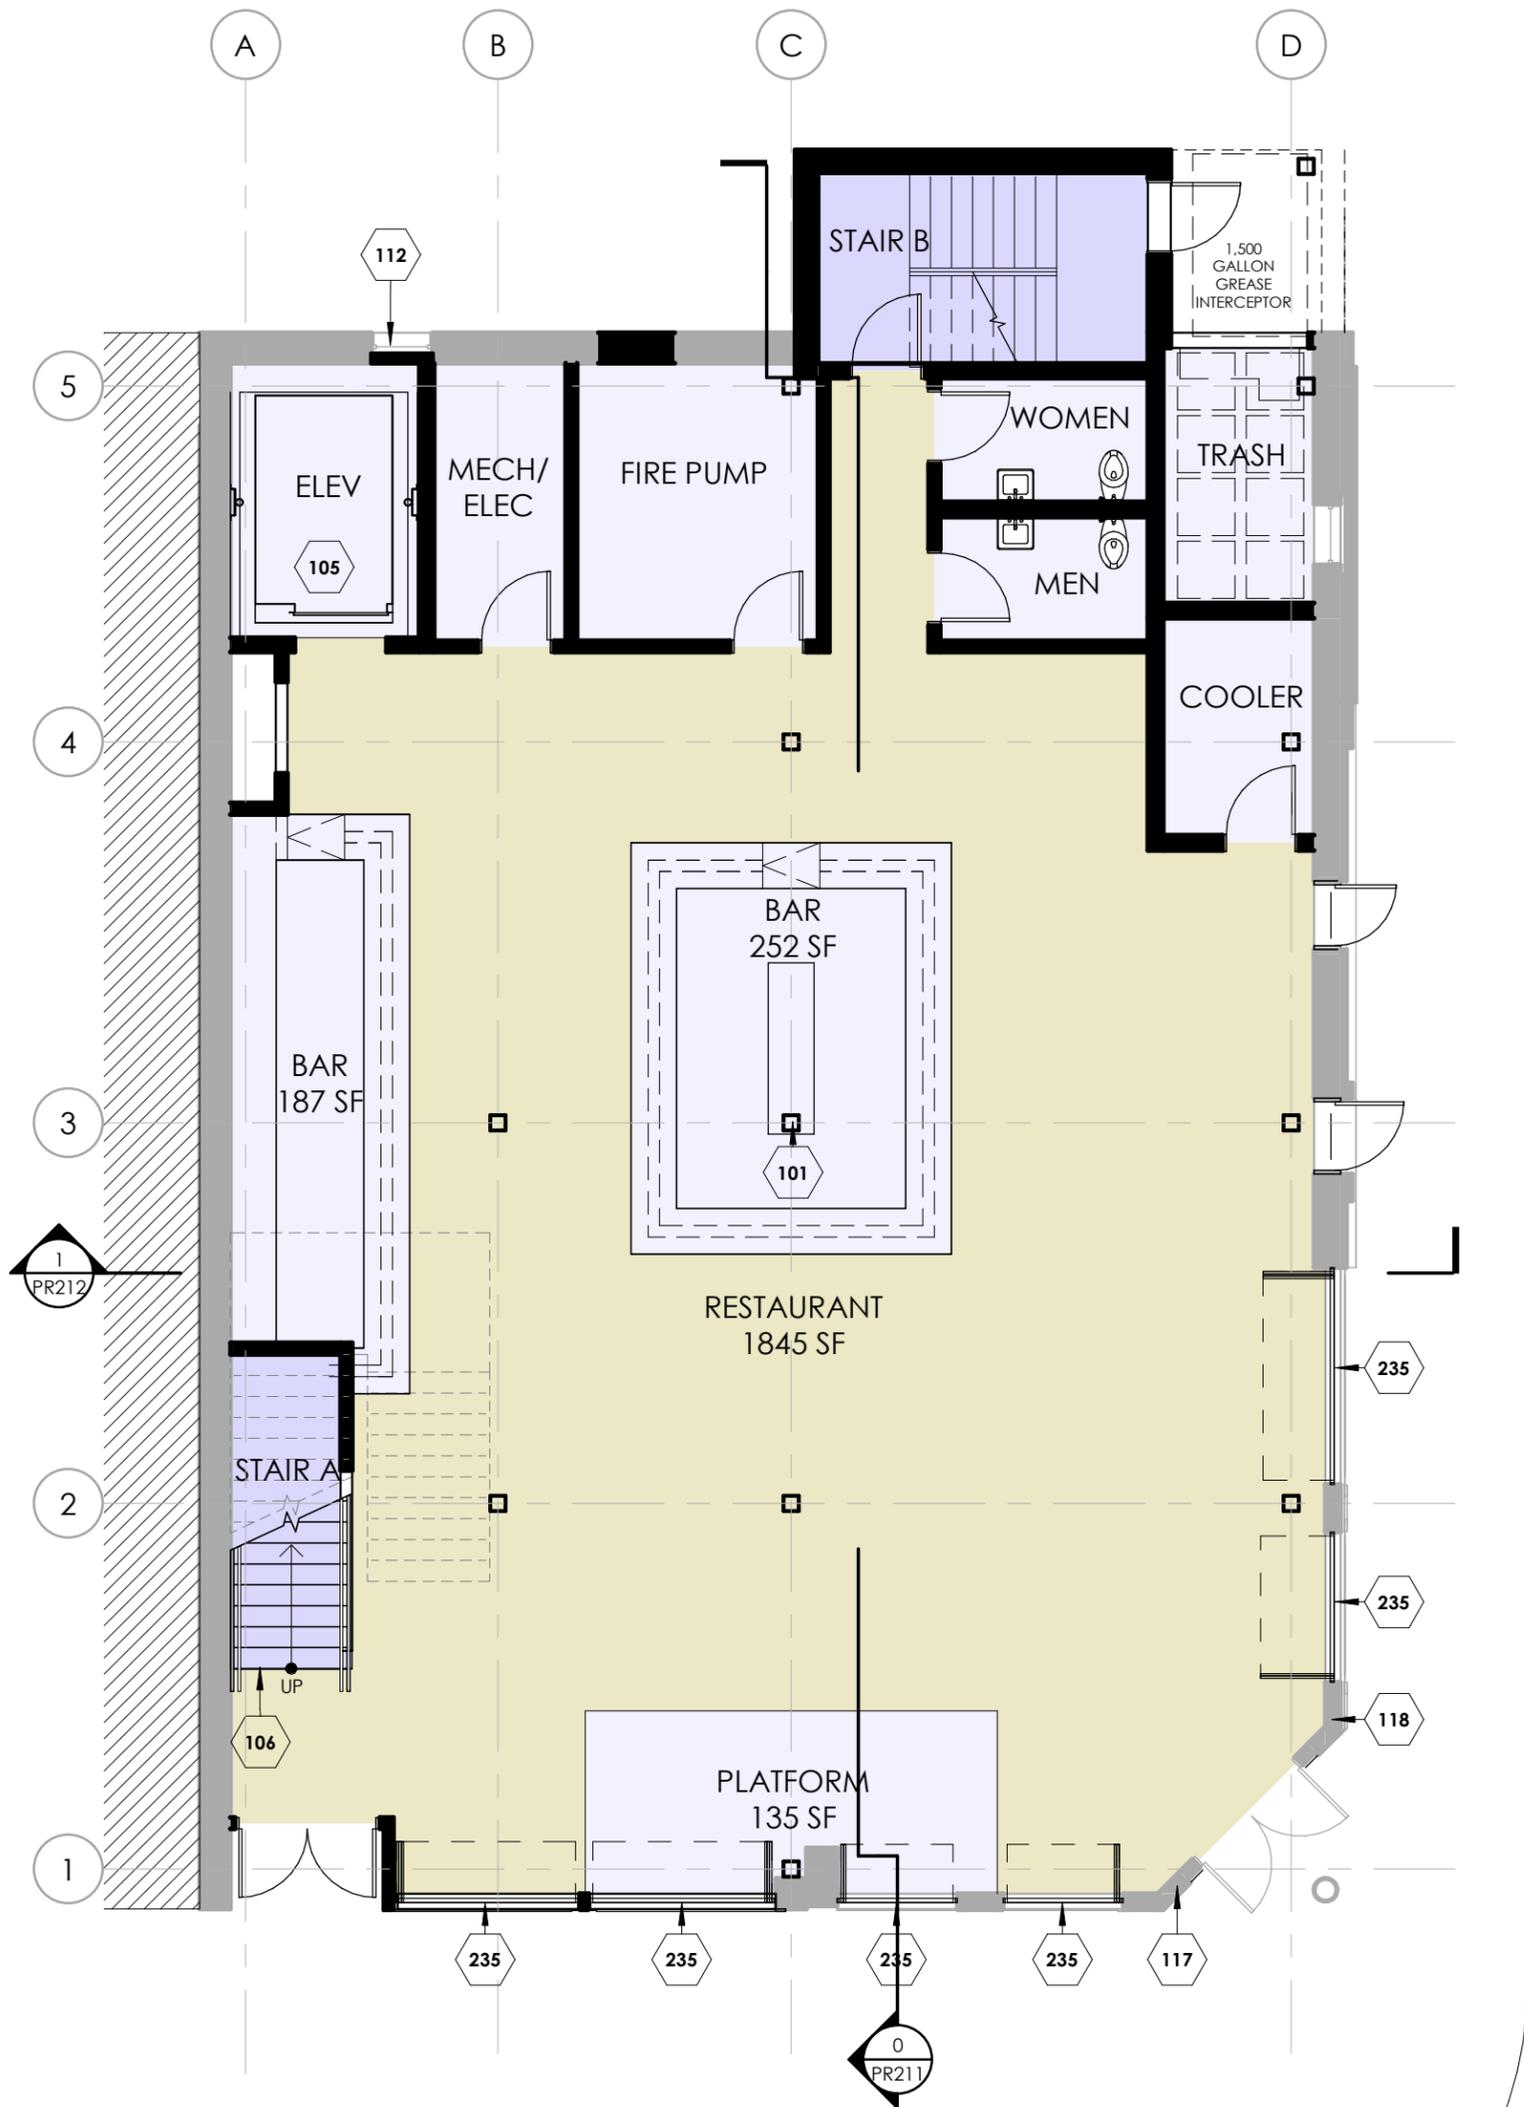
LEVEL 1 PLAN

- 101 1 HOUR PROTECTED STEEL COLUMNS, TYP.
- 105 FREIGHT | PASSENGER ELEVATOR
- 106 CONCRETE FILLED METAL PAN STAIR
- 112 EXISTING WINDOWS TO REMAIN, TYP.
- 117 EXTERIOR LIGHTING
- 118 SIGNAGE
- 235 FULLY OPERABLE FOLDING GLASS WALL SYSTEM

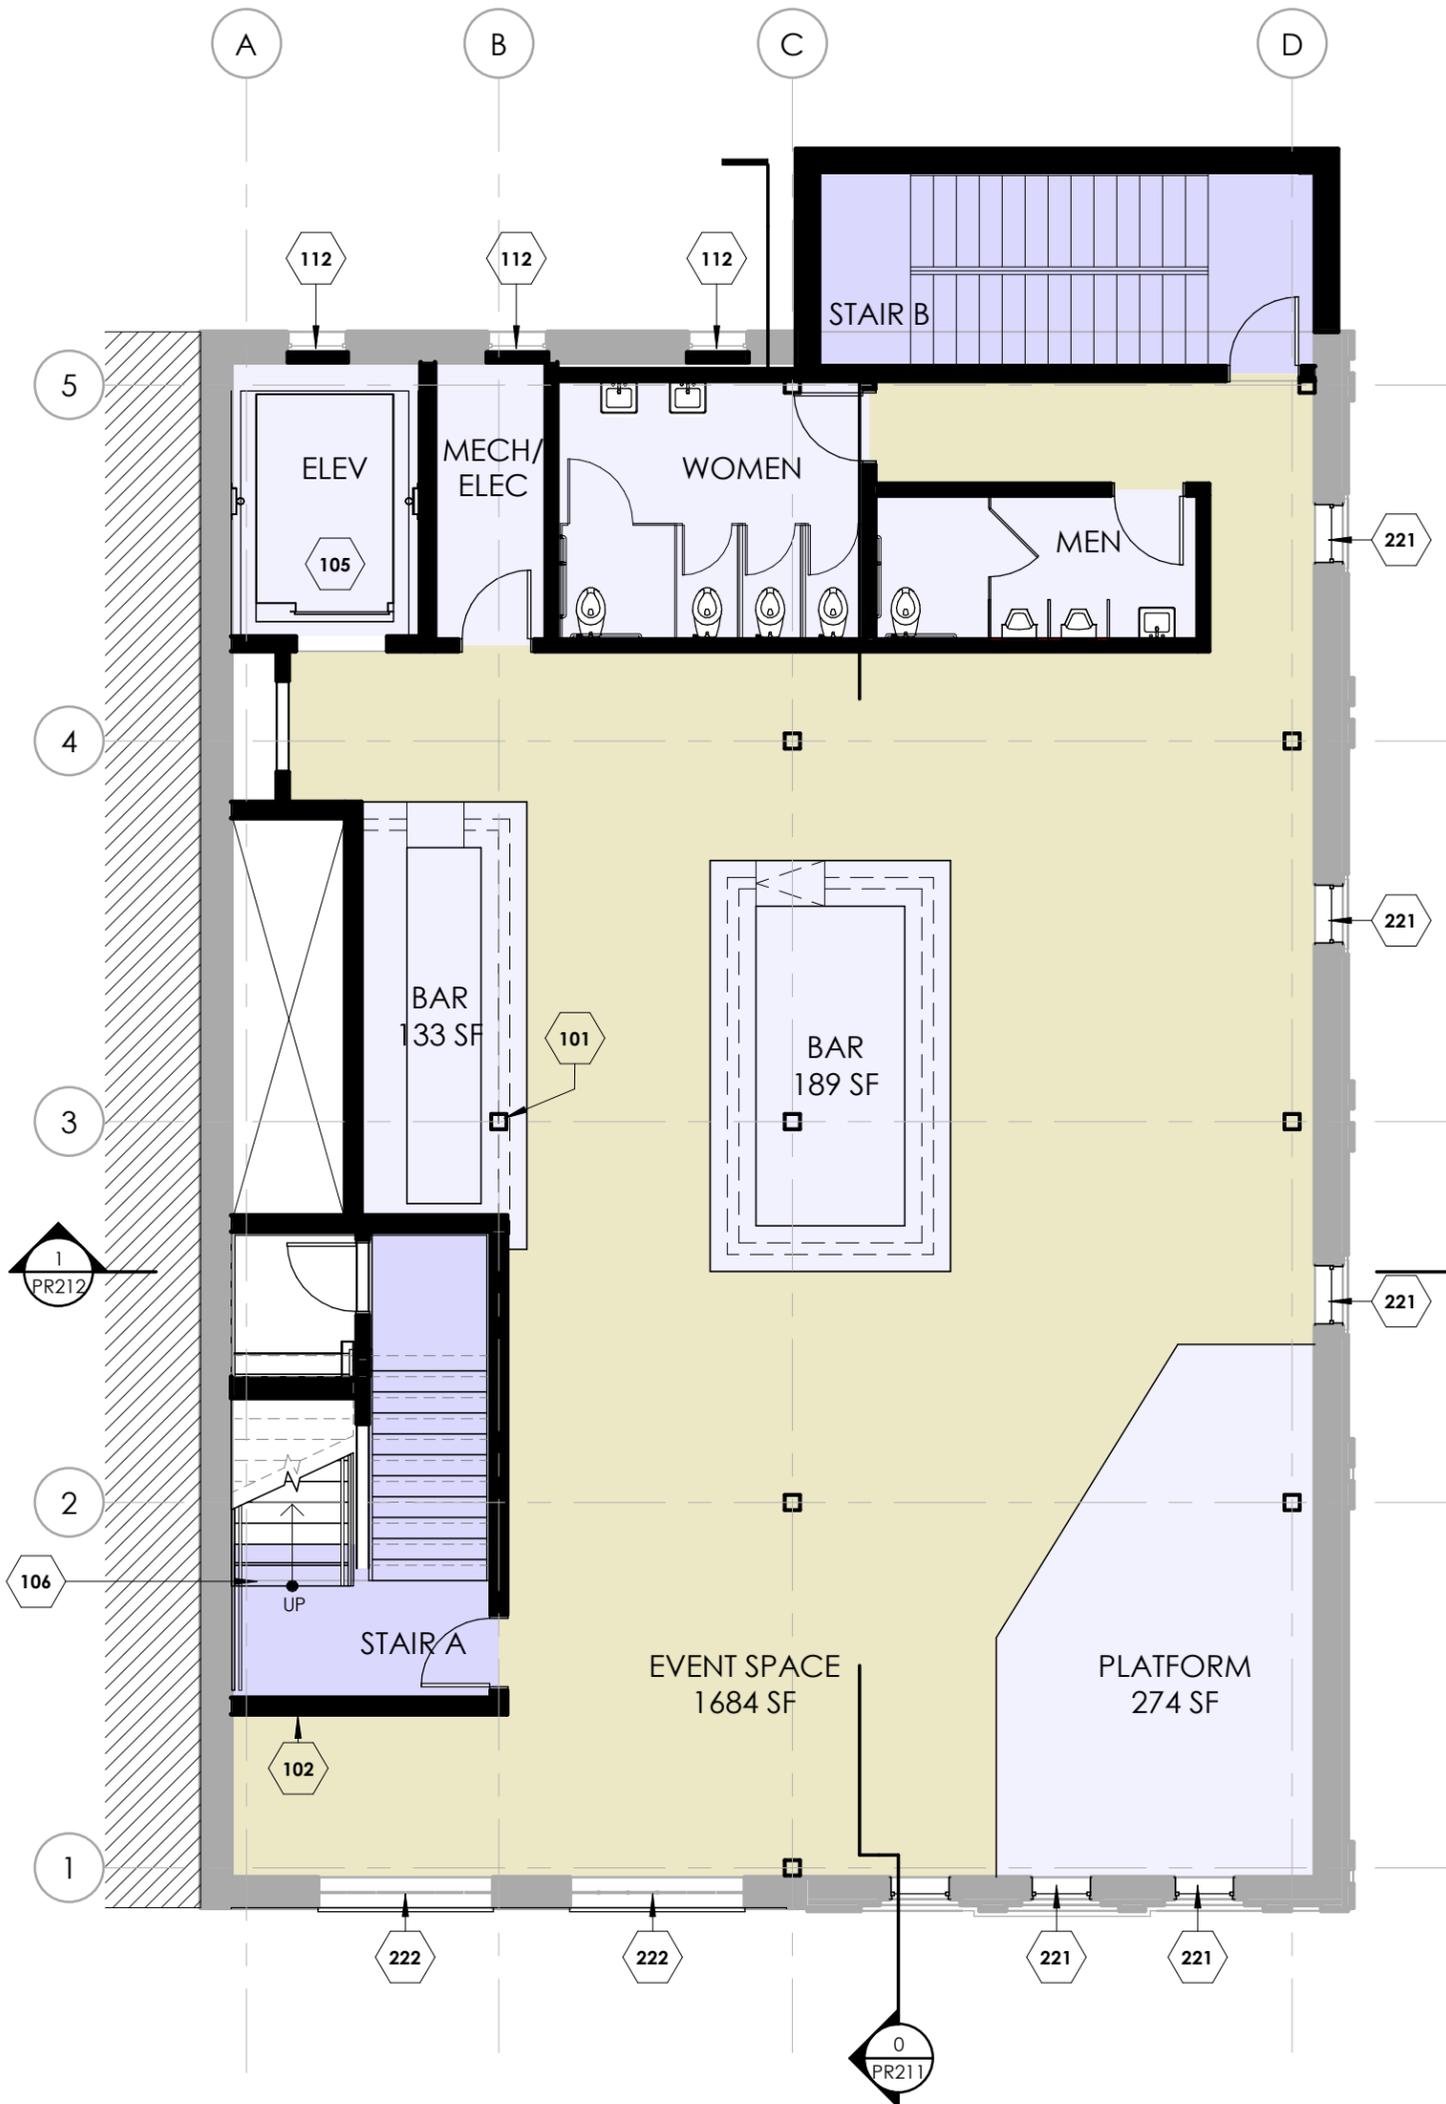
LEVEL 2 PLAN

- 101 1 HOUR PROTECTED STEEL COLUMNS, TYP.
- 102 2 HOUR RATED WALL ENCLOSURE
- 105 FREIGHT | PASSENGER ELEVATOR
- 106 CONCRETE FILLED METAL PAN STAIR
- 112 EXISTING WINDOWS TO REMAIN, TYP.
- 221 NON-ORIGINAL WINDOWS TO BE REPLACED WITH FULLY OPERABLE CASEMENT WINDOW TO MATCH
- 222 STEEL FRAME WINDOWS TO BE REGLAZED AND REFILLED AS REQUIRED; FRAME TO BE RETROFITTED FOR FULL OPERABILITY

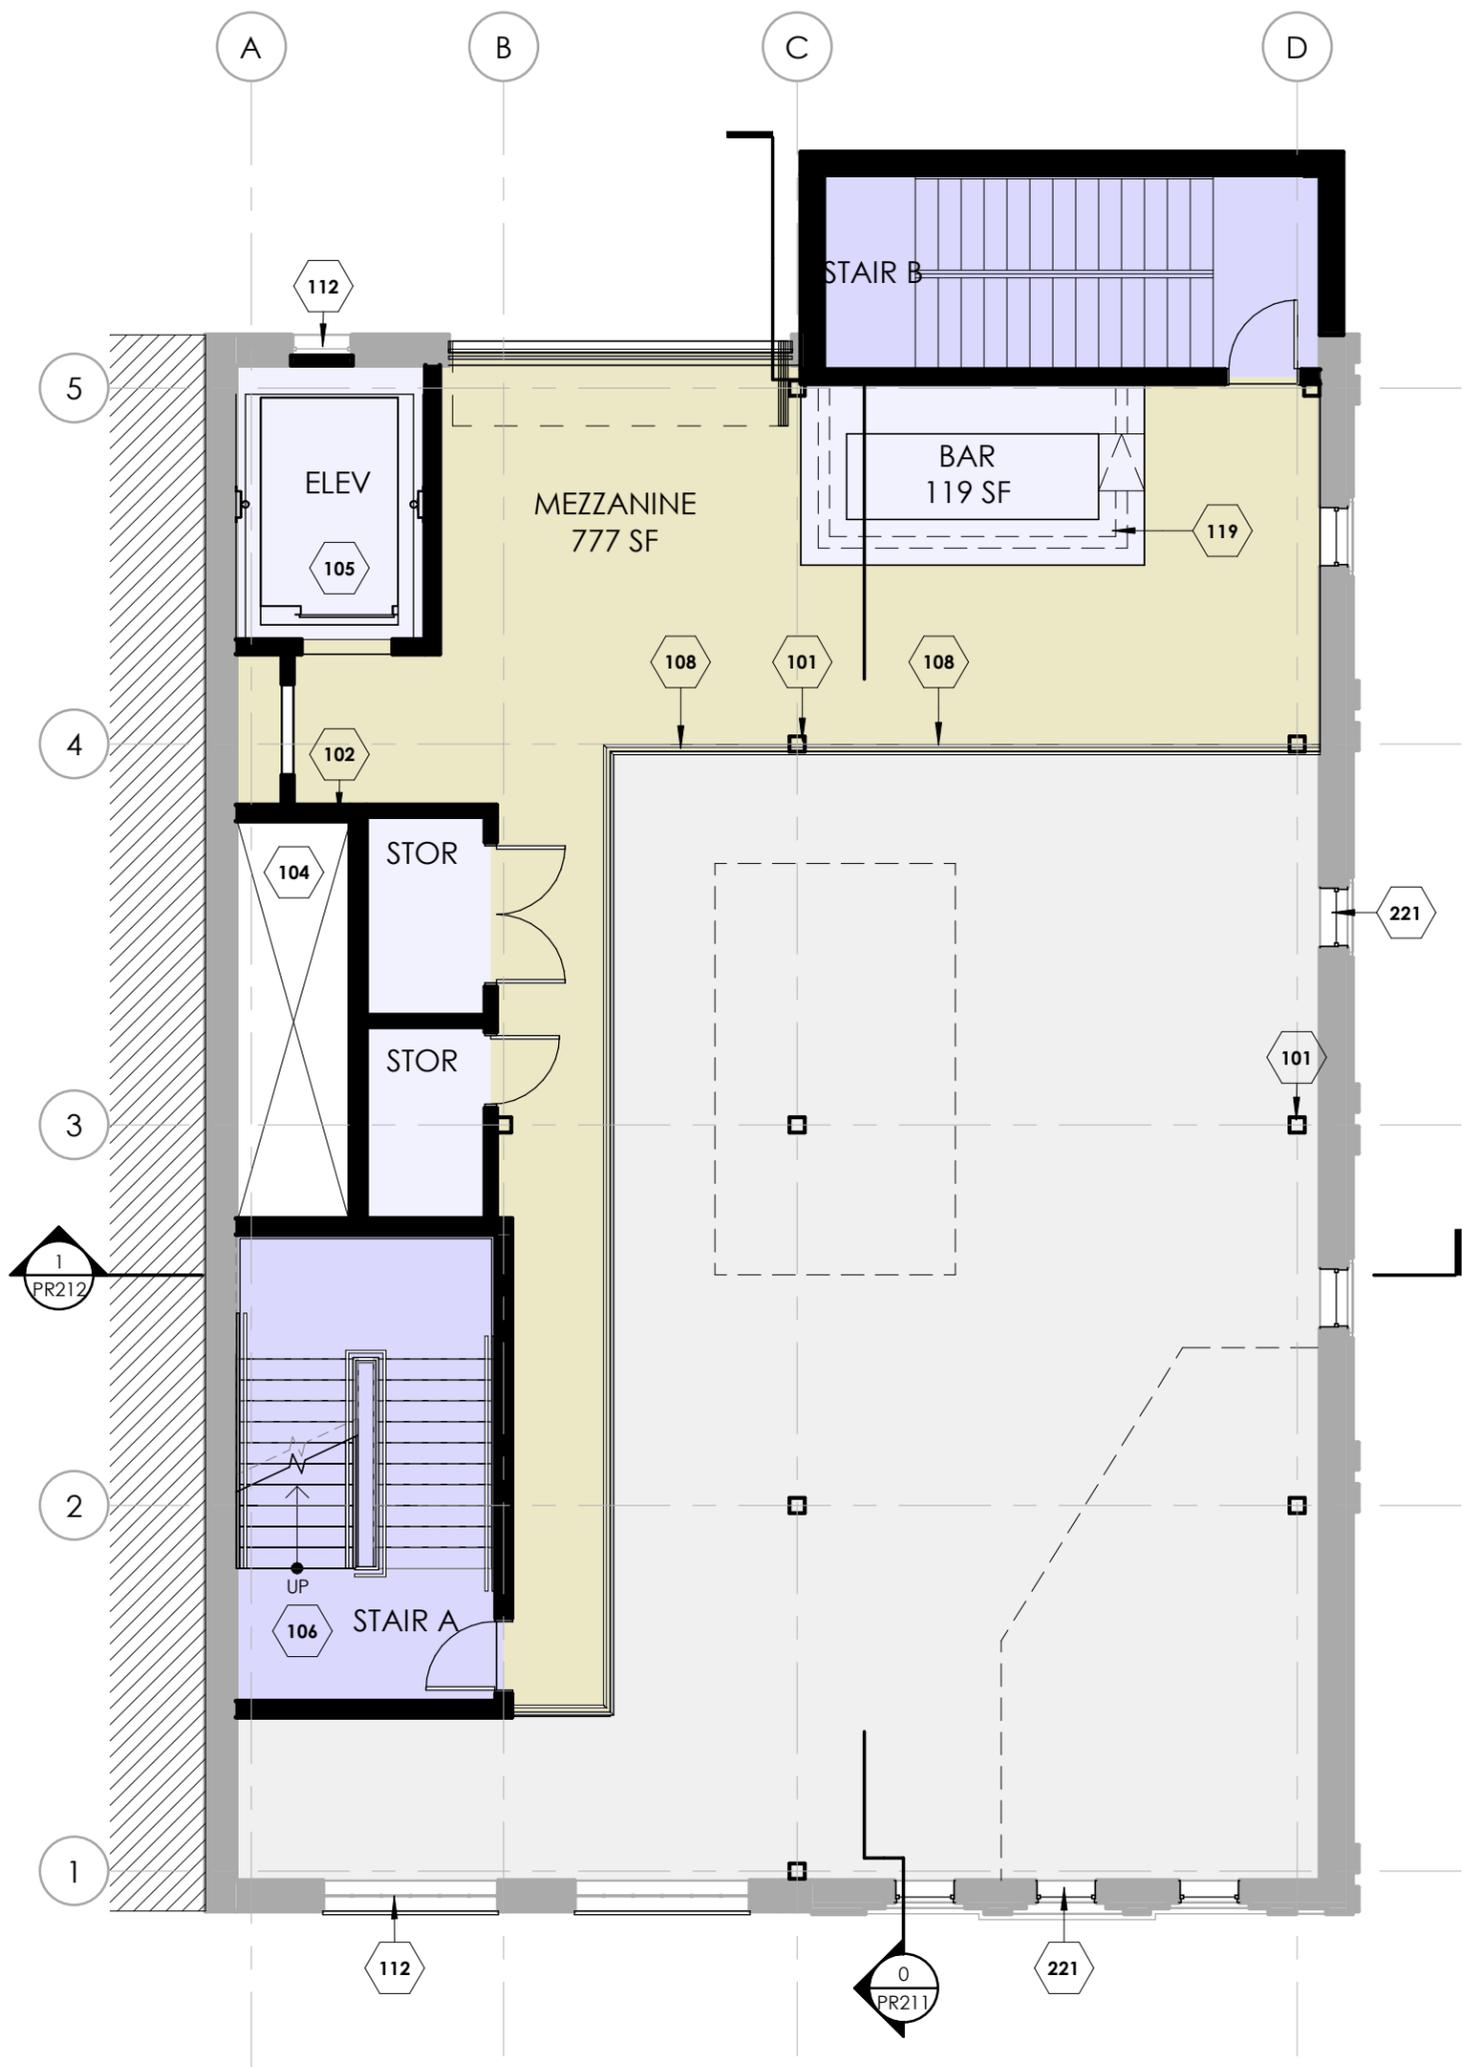
LEVEL 2 MEZZANINE PLAN

- 101 1 HOUR PROTECTED STEEL COLUMNS, TYP.
- 102 2 HOUR RATED WALL ENCLOSURE
- 104 MECHANICAL CHASE
- 105 FREIGHT | PASSENGER ELEVATOR
- 106 CONCRETE FILLED METAL PAN STAIR
- 108 DECORATIVE STEEL HANDRAIL
- 112 EXISTING WINDOWS TO REMAIN, TYP.
- 119 MILLWORK (BAR)
- 221 NON-ORIGINAL WINDOWS TO BE REPLACED WITH FULLY OPERABLE CASEMENT WINDOW TO MATCH
